### *HOME INSPECTION REPORT*

## **SAMPLE REPORT**

*The purpose of this summary is to provide a "quick view" of the results of the home inspection. Please be sure to read the full body of the inspection report, as it contains much more detail about your new home. Any recommendations for additional evaluation must be performed prior to the conclusion of the inspection contingency period. The following is a summary of the inspection performed at 1234 Fifth Street, HomeTown, OH 67890:*

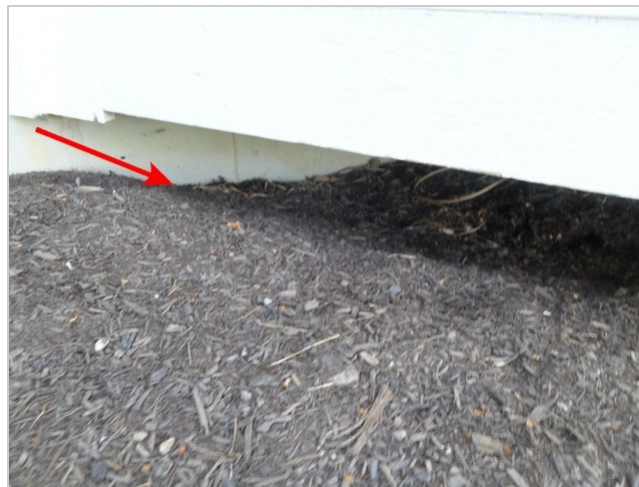
**REVERSE GRADE:** A reverse grade condition exists in the rear of the home under the bay window. Reverse grade is a condition where the grade is lower at the foundation than in adjacent areas. This condition will cause rain water to be directed toward the foundation which can, over time cause damage to the foundation and structure. Recommend the grading be corrected so that rainwater is directed away from the foundation.

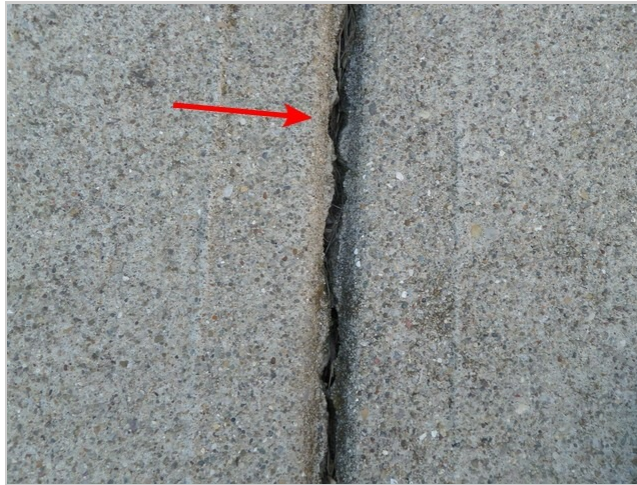
Control joints in walkway need to be sealed.

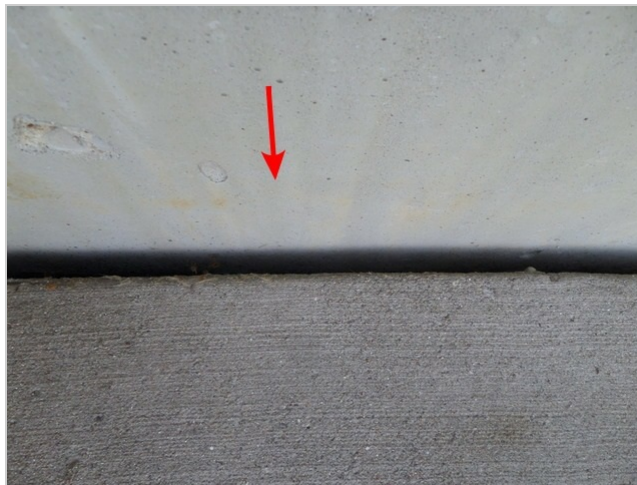
The patio needs to be sealed where it meets the foundation.

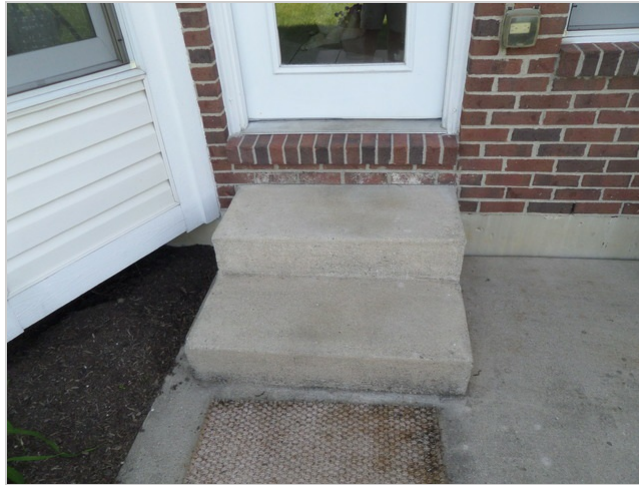
**The steps on the patio to the house needs a handrail for safety.**

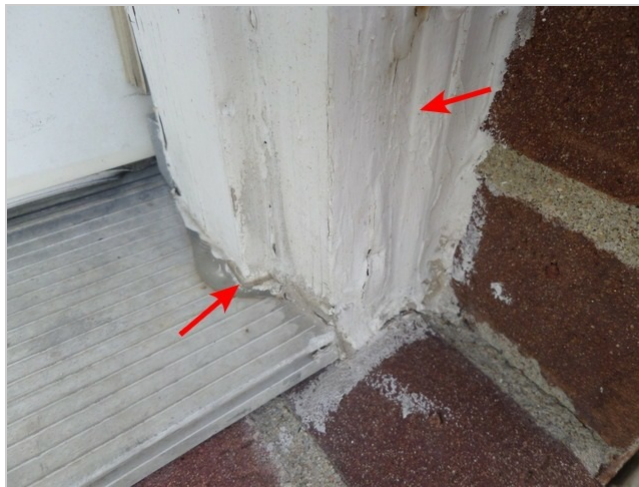
**The door to the patio has wood rot on the framing around the bottom that needs to be repaired.**

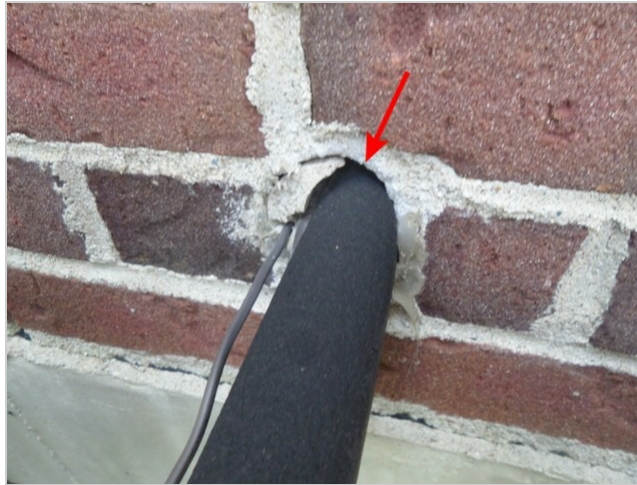
**The area of the siding where the A/C lines enter the home need to be sealed to prevent water intrusion.**

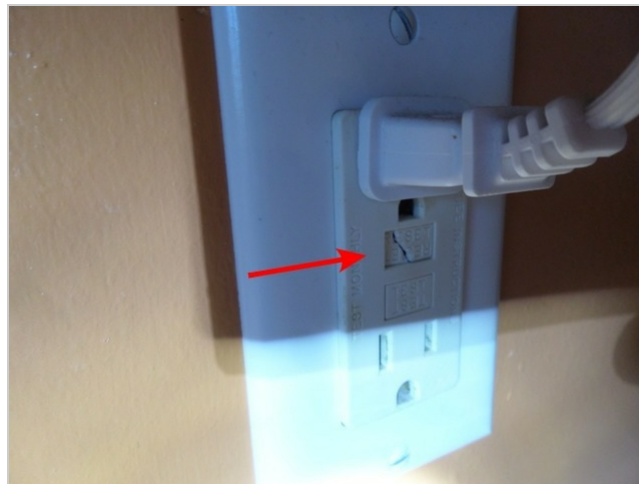
**The GFCI reset button in the receptacle right of the kitchen stove is broken and receptacle needs to be replaced.**

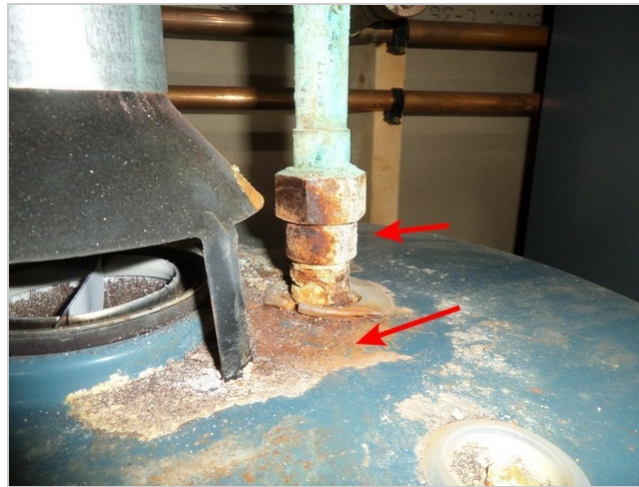
**There was a lot of corrosion on the cold water supply line to the water heater. Recommend further evaluation by a qualified plumber.**
