HomeTeam[®]

HOME INSPECTION REPORT

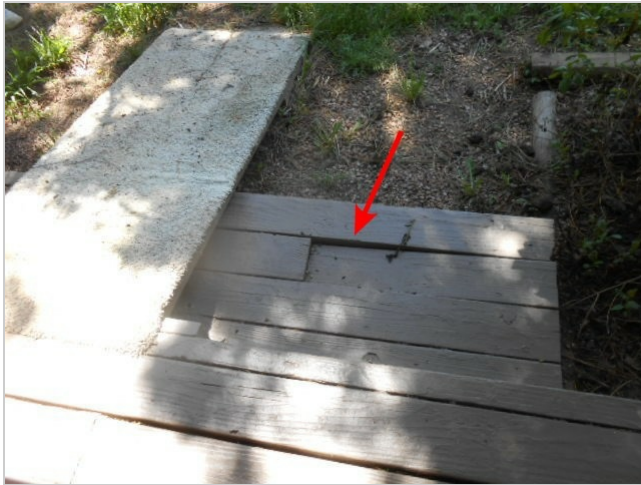
The underside of the deck was unable to be fully inspected due to the deck being very close to the ground or earth below. There were however several deck boards that were loose or were deteriorated indicating the need for further evaluation and repairs to the deck (as needed) by a qualified contractor, prior to closing.

Loose or deteriorated deck board on the rear deck.

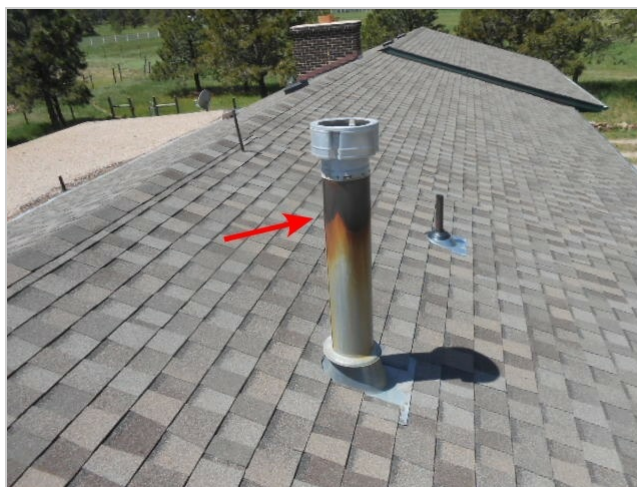
The furnace vent pipe (which penetrates the roof line) is rusted or deteriorated and is recommended to be replaced by a qualified HVAC contractor or roofer, prior to closing.

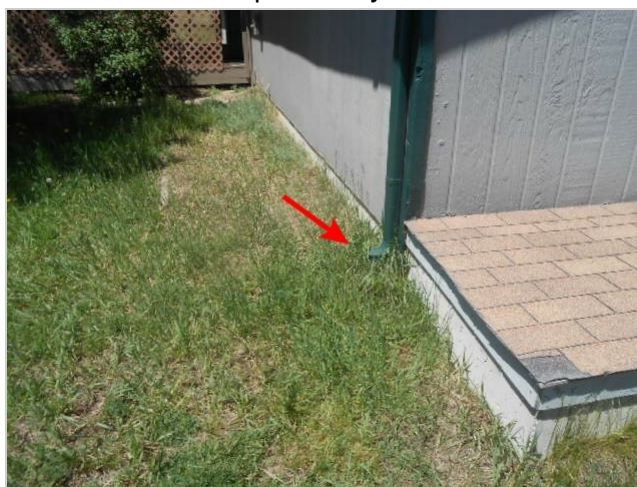
One of the downspouts on the left, rear of the home was missing the extension. This condition can allow for rain water to accumulate along the home and the possibility of water in the crawlspace if not repaired.

- One of the downspouts on the left, rear of the home was missing the extension. This condition can allow

for rain water to accumulate along the home and the possibility of water in the crawlspace if not repaired.
