### *HOME INSPECTION REPORT*

## **SAMPLE REPORT**

The inspected property consisted of a two story wood-framed structure, with a basement, that was occupied at the time of the inspection. The approximate temperature at the time of the inspection was 50 to 60 degrees Fahrenheit, and the weather was sunny and clear.

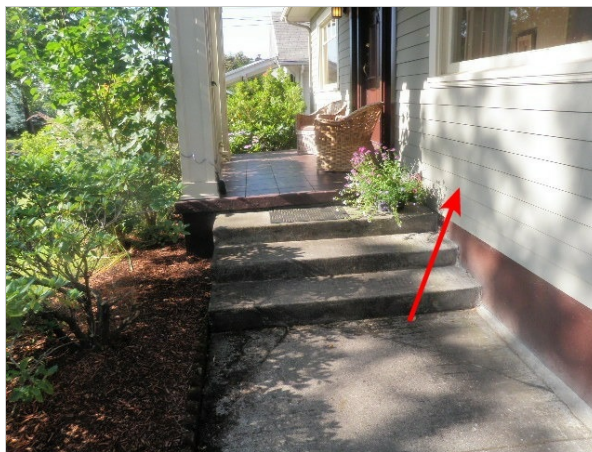
- **It is recommended to have handrails installed on the front exterior steps.**

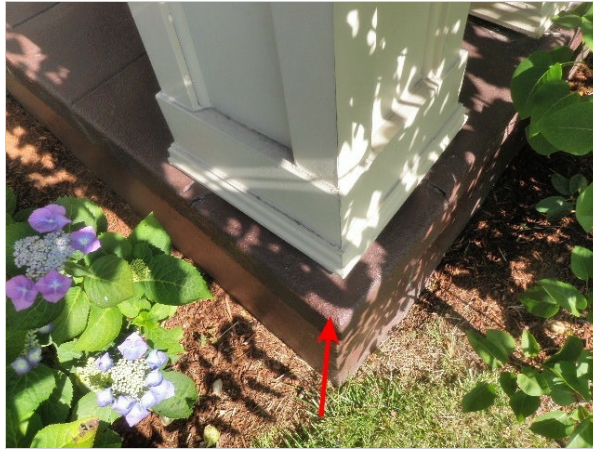
- **Plant growth was observed against the front and rear of the home.** All trees and bushes should be trimmed 6-inches to 12-inches from the home. It is recommended to remove this plant growth away from the siding to prevent possible damage including insect infestation.
- **The left front corner of the front porch was damaged and should be repaired.**

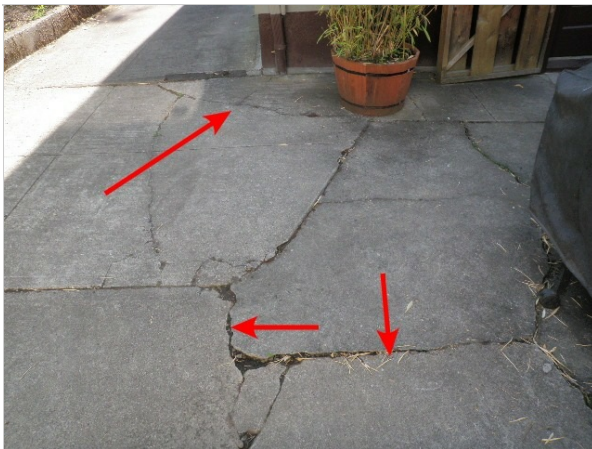
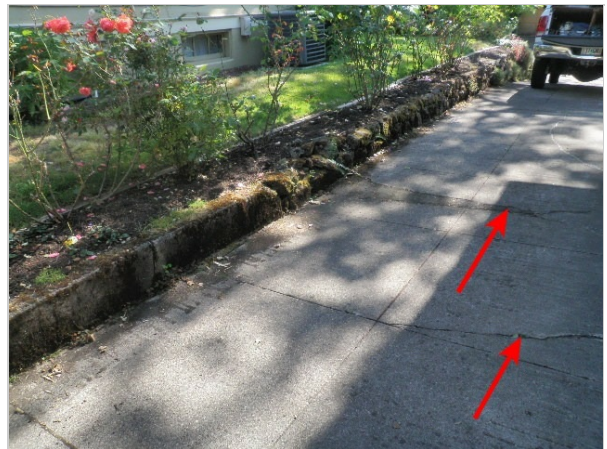
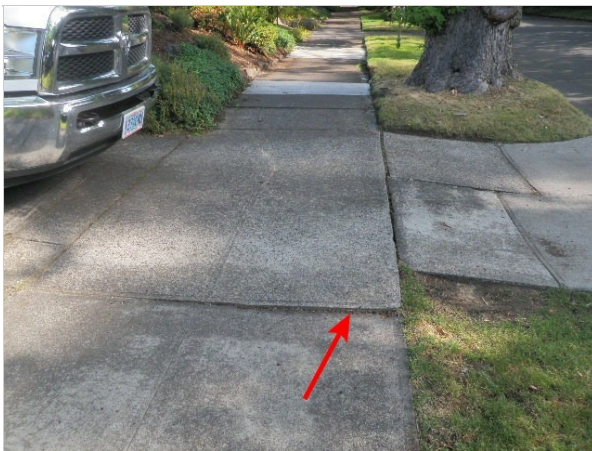
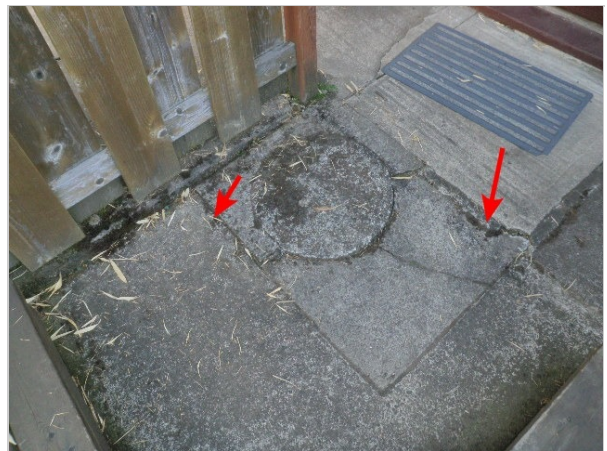
- There were trip hazards located on the property. They are the number one cause of accident and injury around the home. It is recommended to use caution in areas where trip hazards exist and to eliminate trip hazards in affected areas to help ensure safety of occupants. There damaged concrete or walkway located on the front sidewalk, driveway, and rear walkway.

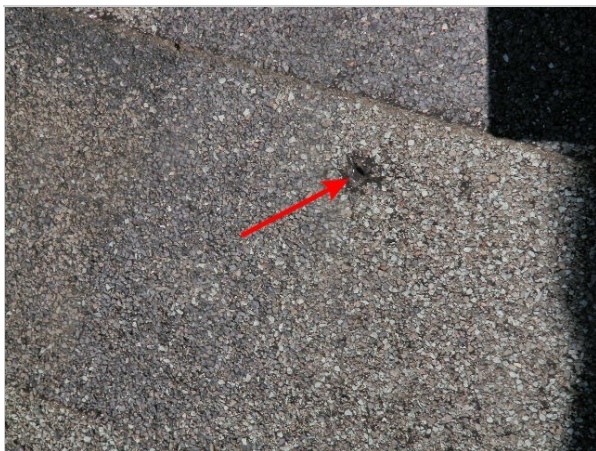
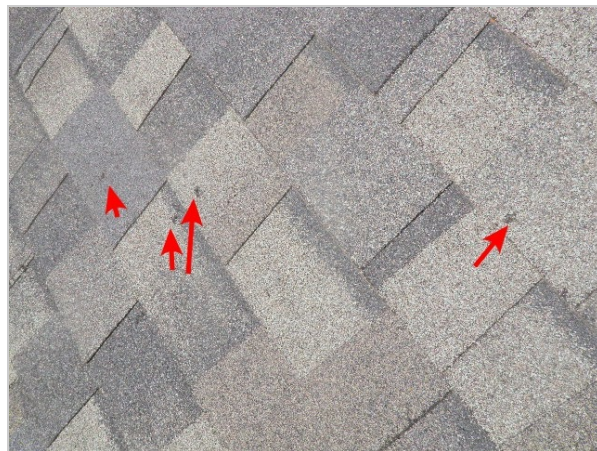
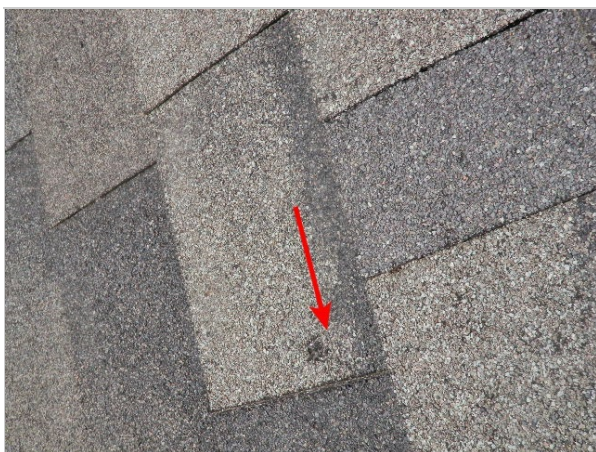
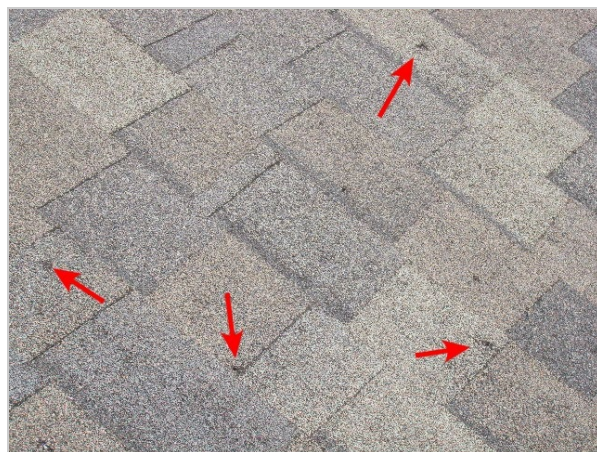
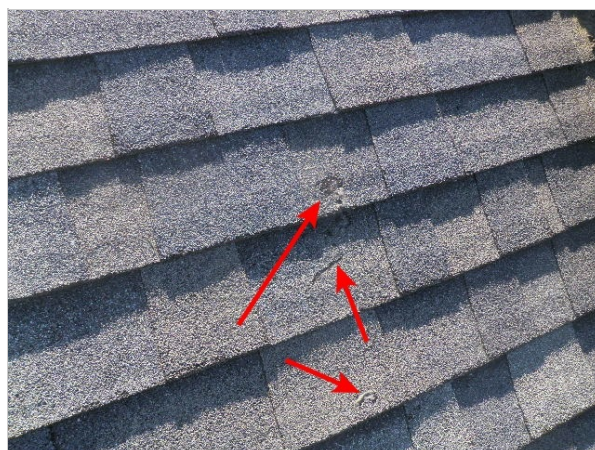
- **There were damaged shingles on the front and right rear of the home that should be repaired or replaced.**

- **There were visual defects noted on the roof that included but were not limited to the following items. It is recommended to have a licensed roofer examine and address all roofing issues noted or found on**

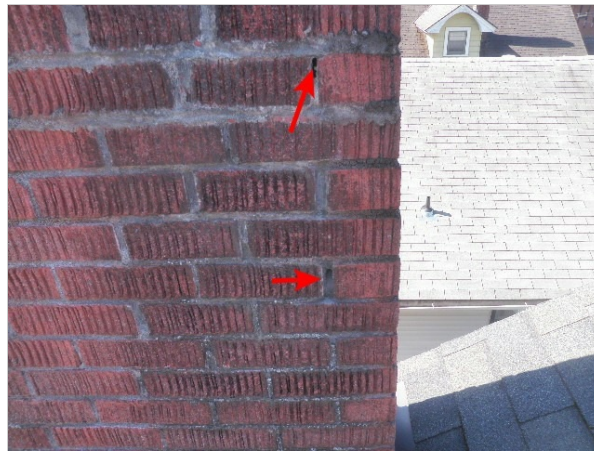
- **Tuck pointing is needed on the chimney.** The most common reason for tuck pointing brick masonry is to improve water penetration resistance. Tuck pointing deteriorated mortar joints is one of the most effective and permanent ways of decreasing water entry into brickwork. This is because the most common means of water entry into a brick masonry wall is through de-bonded, cracked or deteriorated mortar joints.

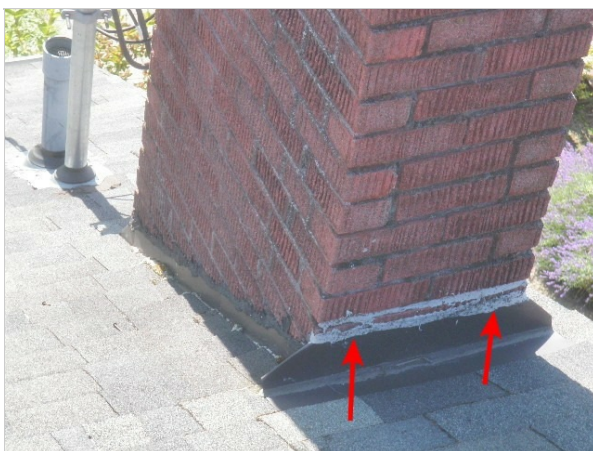
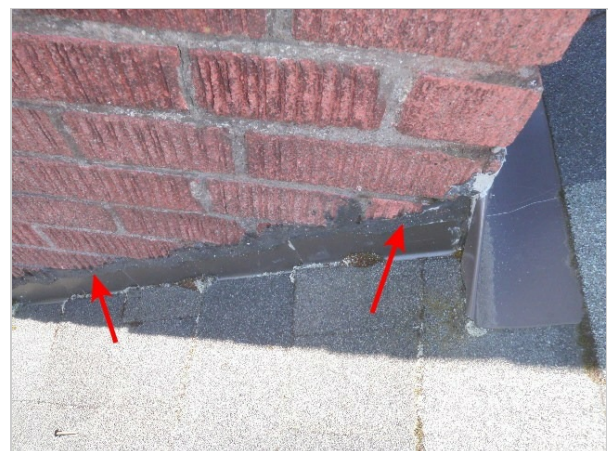
- **The flashing was caulked to the chimney. It is recommended to have it counter flashed to prevent leaking.**

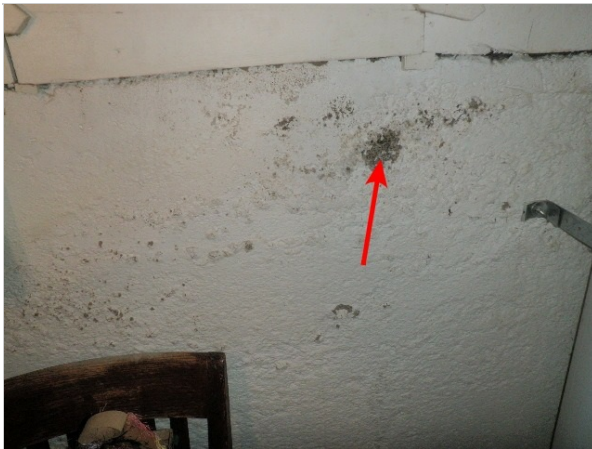
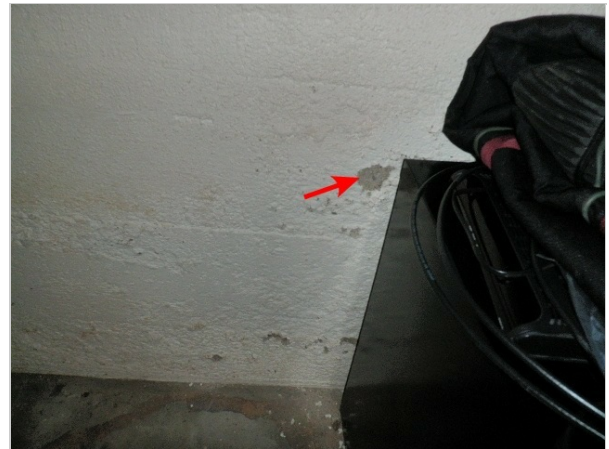
- **Skim coating is needed on the foundation wall in the utility room.**

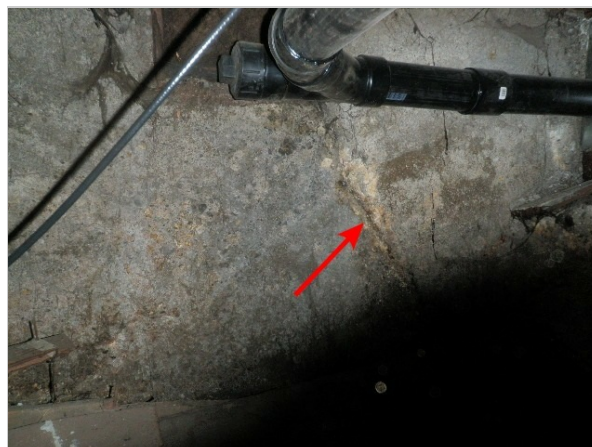
- **It is recommended to contact a licensed structural engineer to examine and address all foundation issues in the home. On the left side of the home behind the gas meter, there was a crack in the foundation which has been patched.**

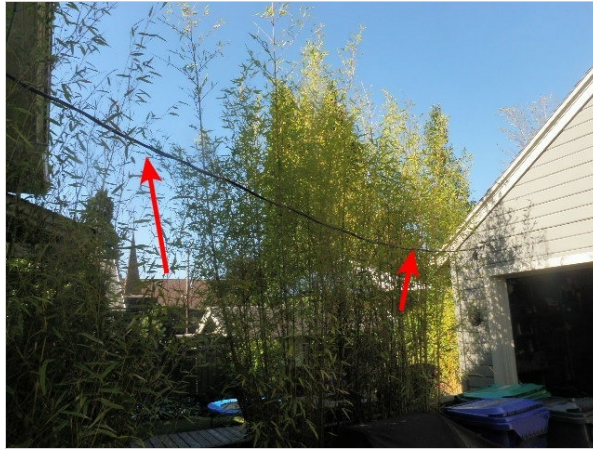
- **The main incoming power lines were too low and should be at least 12' above the driveway and 18' above the roadway.**

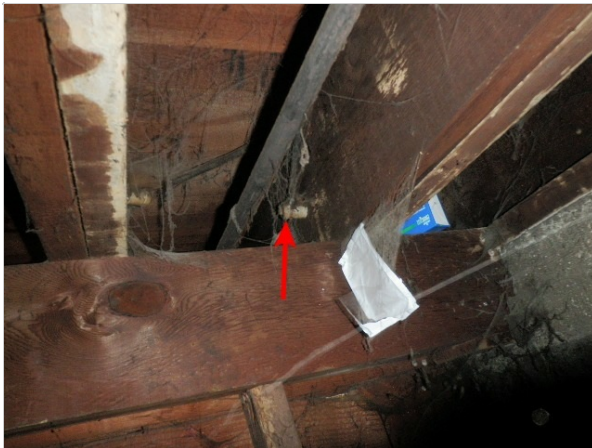
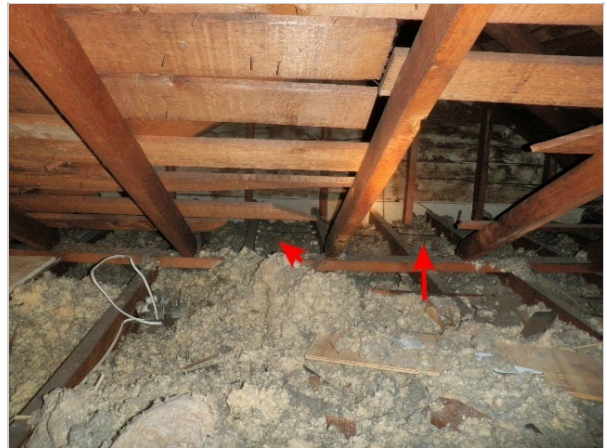
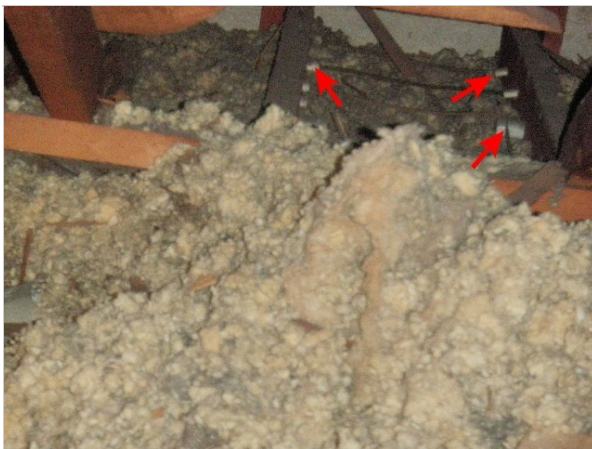
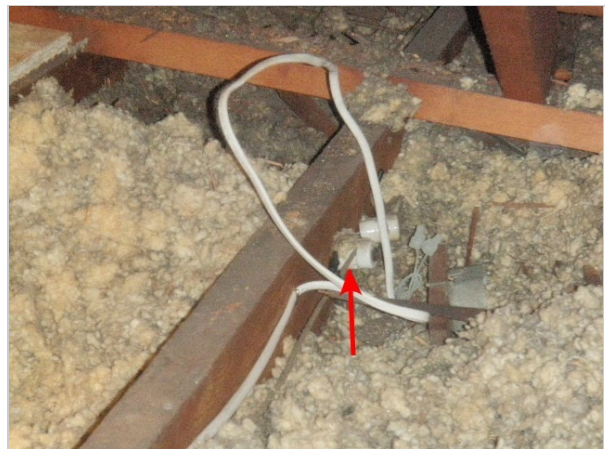
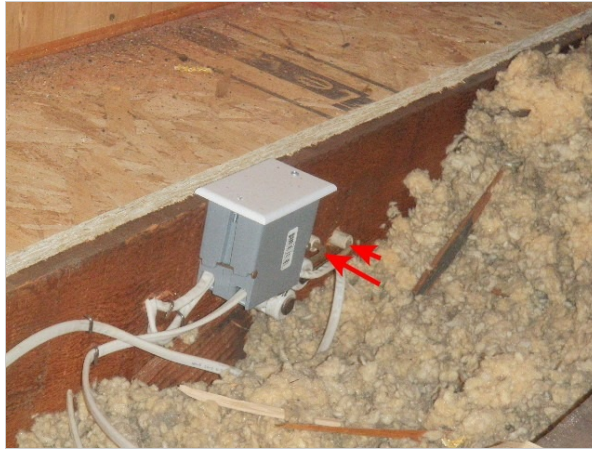
- **This home has visible Knob & Tube (K&T) wiring.** This is the original electrical system in the home and is outdated by today's safety standards. The major problem with this system is the insulation on the wires can become brittle and in some areas may be missing. It was also not designed to be covered with any material such as attic insulation. It should be noted that some insurance companies would not insure homes that have K&T wiring. For increased safety, it is recommended to have a licensed and qualified electrician evaluate the home for replacement of all K&T wiring in the structure. It is recommended to contact your insurance provider to determine if the home can be insured with this type of wiring.

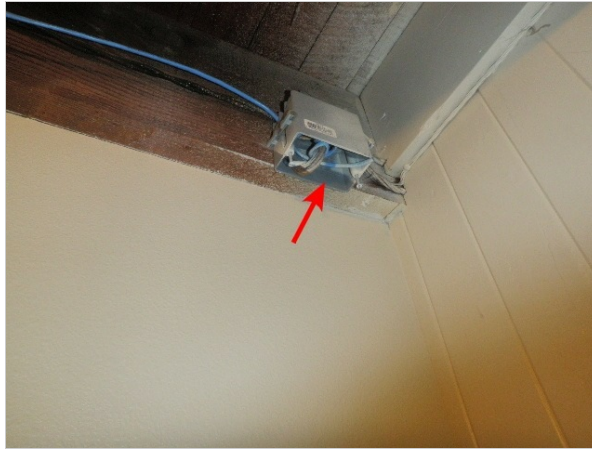
- **There was a junction box found in the laundry room that did not have a cover plate. These are required for safety.**

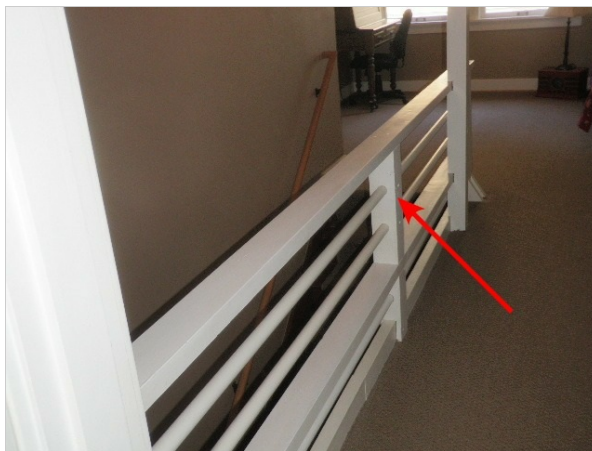
- **The guardrail was too low on the upstairs landing. It was approximately 30 ". It should be 34-38" high.**

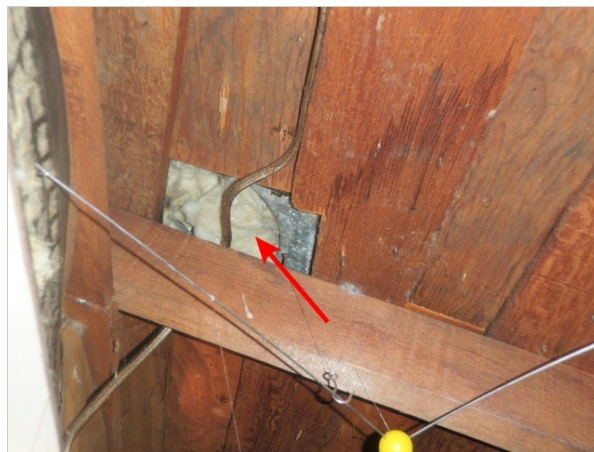
- **The static vents were plugged with insulation. It is recommended to have the insulation removed for proper insulation.**

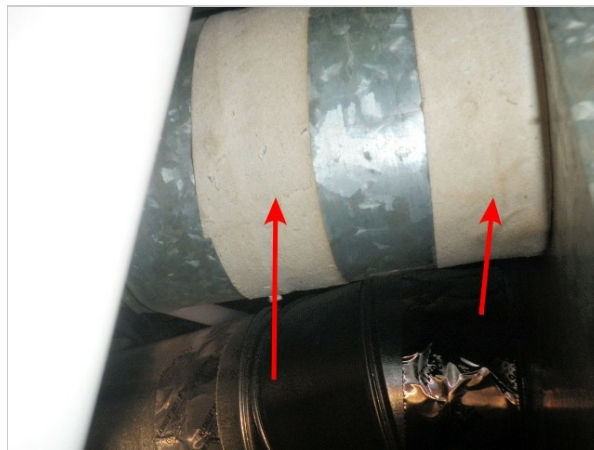
- **There appeared to be an asbestos type material on the heating ducts.** When it is necessary to disturb asbestos, you should contact a licensed asbestos contractor. You can also obtain a copy of "Asbestos in the Home", published by the U.S. Consumer Products Safety Commission. There is more information found on the Internet located on web site <http://www.cpsc.gov> or by calling (800-638-2772), which discusses the situation and makes recommendations. Remember, do not dust, sweep, or vacuum particles suspected of containing asbestos fibers.
