HOME INSPECTION REPORT

SAMPLE REPORT

Address of Inspection: **1234 Fifth Street**

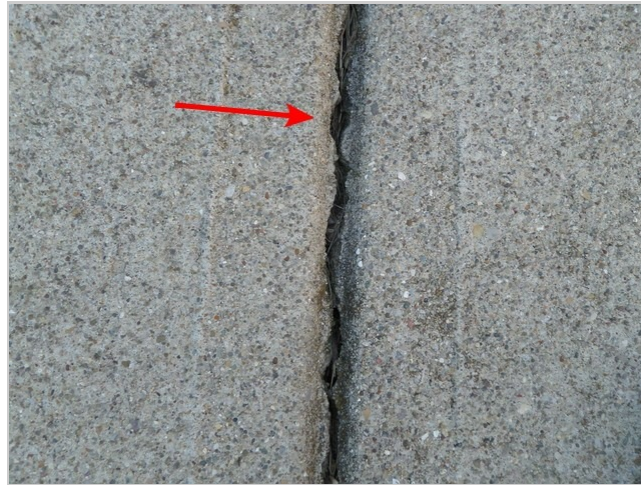
Control joints in walkway need to be sealed.

- **Control joints in walkway need to be sealed.**
- **The patio needs to be sealed where it meets the foundation.**

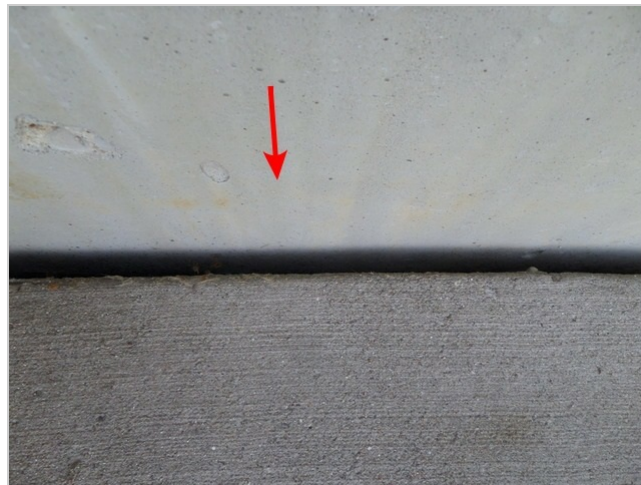
The patio needs to be sealed where it meets the foundation.

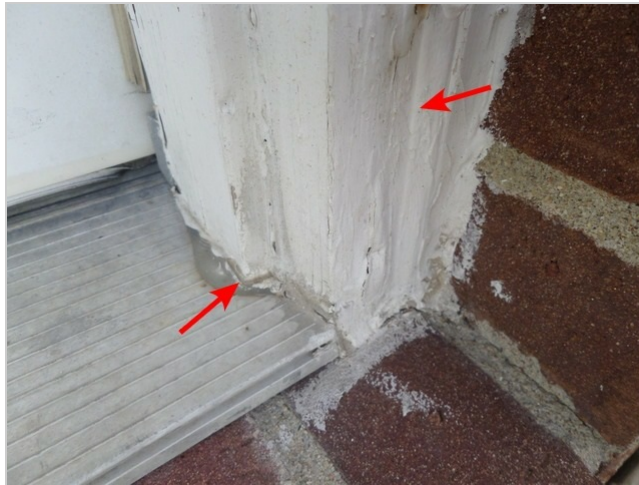
The door to the patio has wood rot on the framing around the bottom that needs to be repaired.

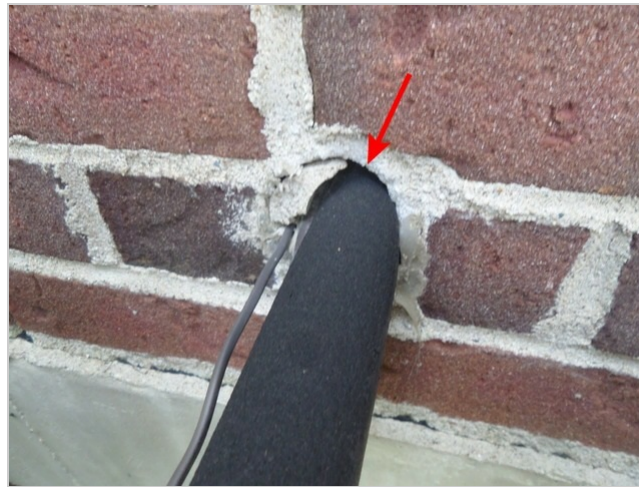
The area of the siding where the A/C lines enter the home need to be sealed to prevent water intrusion.

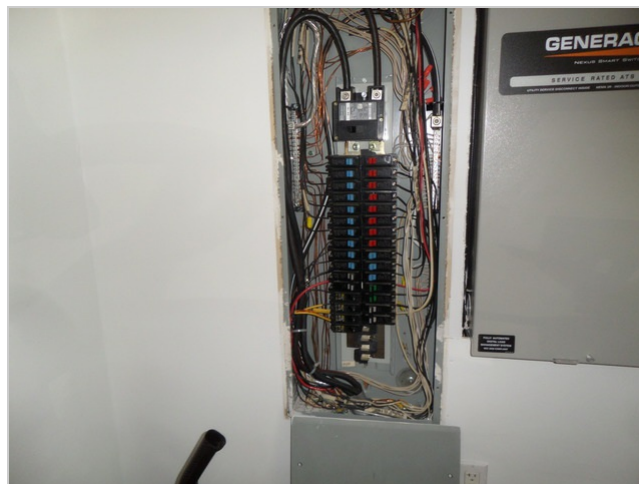
The service wire entered a Cutler Hammer service panel, located on the garage wall with a 200 amp and 120/240 volt rated capacity. The branch circuits within the panel were copper. These branch circuits and the circuit breakers to which they were attached appeared to be appropriately matched.

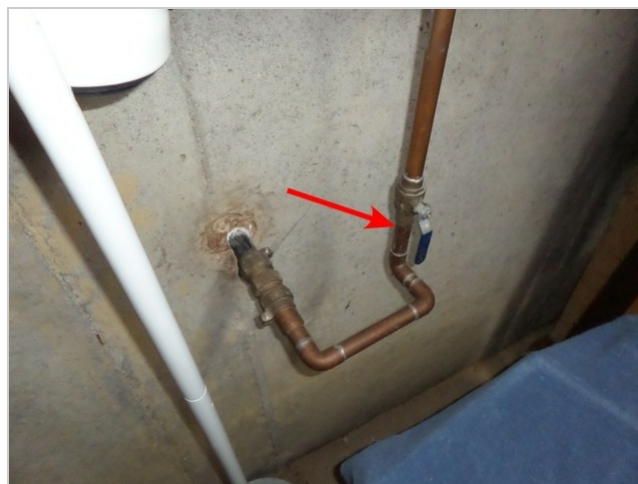
main water shut off

The water meter was located in the front yard. The main water shutoff valve for the home was located adjacent to the water service entry point in the basement.

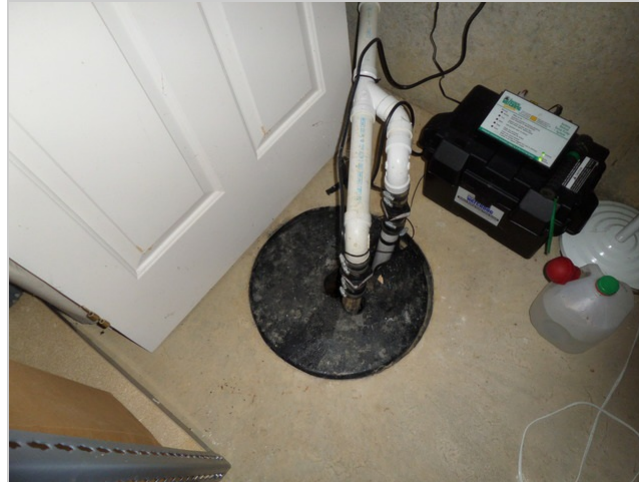
There was a sump pump located in the basement. The sump pump was functional. There was a battery backup system in the sump pit.

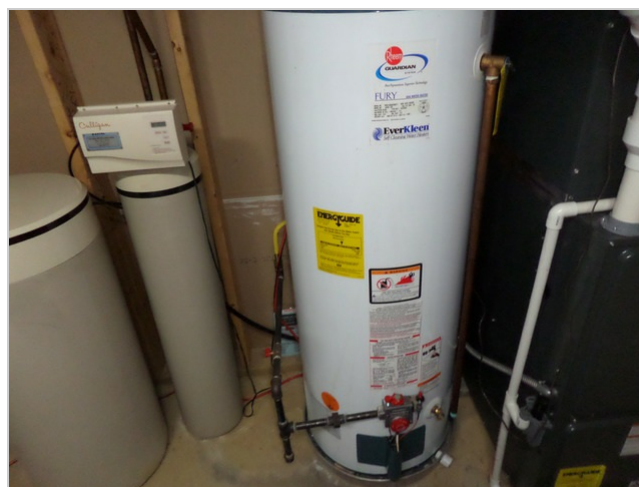
A temperature and pressure relief valve (T & P) was present. Because of the lime build-up typical of T & P valves, we do not test them. An overflow leg was present. It did terminate close to the floor. Your safety depends on the presence of a T & P valve and an overflow leg terminating close to the floor. The water heater was functional.
