# HomeTeam<sup>®</sup>

### *HOME INSPECTION REPORT*

On Monday, February 18, 2019 The HomeTeam Inspection Service made a visual inspection of 123 Sample Drive, Tacoma, WA 55555. Enclosed please find a written, narrative report of our findings in accordance with the terms of our Inspection Agreement.

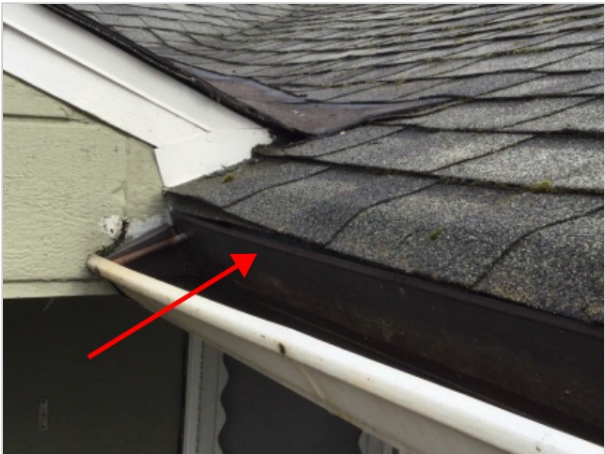
Photo 9

**Gutters appear to be leaking at the seam.** The seams should be sealed with an appropriate gutter sealant.

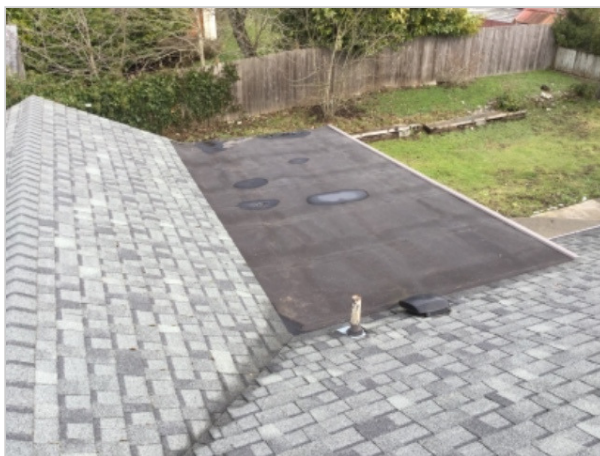
**Photo 11**

**Nails securing shingles and/or roof ventilation flashing are uncovered.** Any nails that penetrates the roof should be covered with shingles or roof tar in order to prevent possible water penetration into the sheathing of the roof structure.

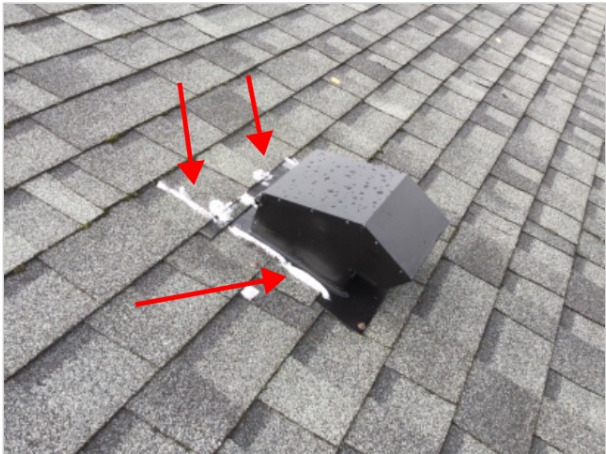
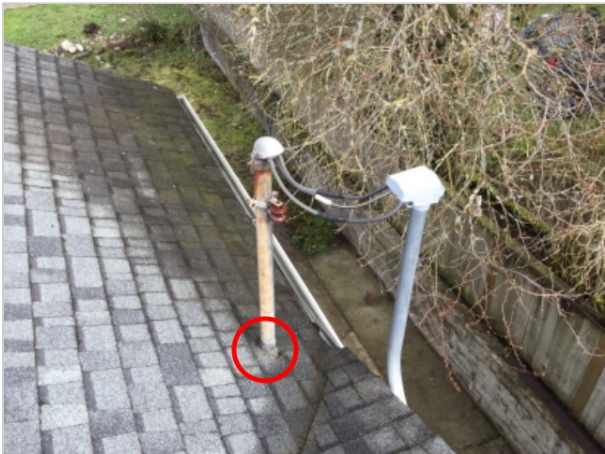
Multiple roof penetrations were previously repaired with substandard sealing material. These sealing methods may keep water from penetrating the roofing material for a short amount of time, but are not long-term fixes. Recommend repairs be made by a licensed roofing professional.

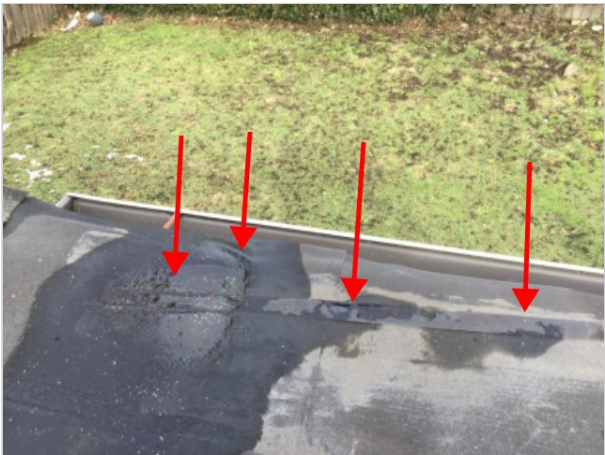
Photo 17

**The roll type roof requires repair to prolong its life.** At the time of the repairs, the roof and its components should be further assessed for any additional needed repairs, longevity, and serviceability.

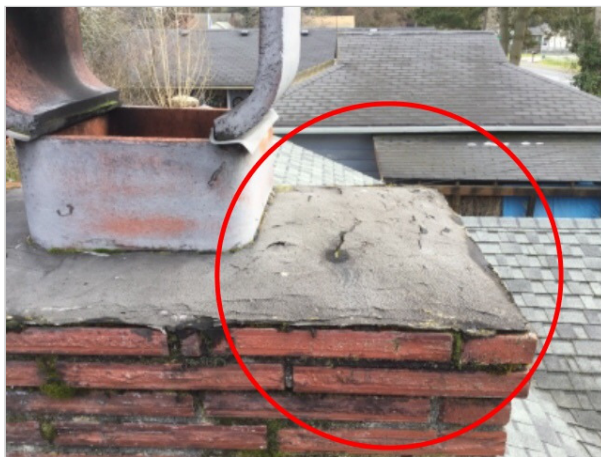
**Photo 18**

**Spalling is present on the chimney's brickwork.** Spalling of the brick is usually caused by moisture accumulation behind the brick. In cold weather, the moisture freezes and pushes the face off the brick. To help reduce spalling, the brick faces can be sealed. Some or all of the bricks may need to be repaired or replaced. Additionally, ensure the chimney cap is properly sealed. At the time of repair, the chimney should be further evaluated for any additional damage or required action. Depending on the results of that assessment, this may lead to a material defect.

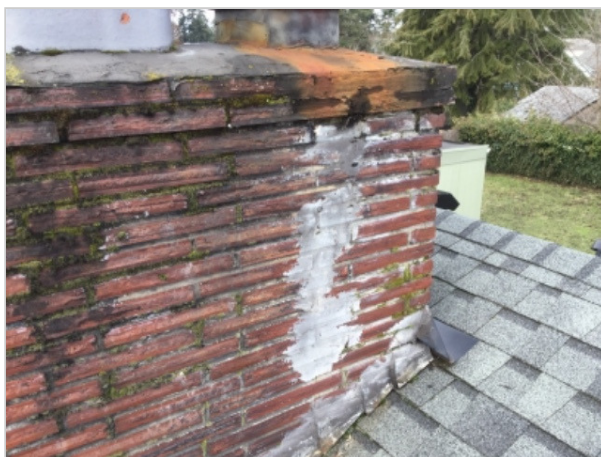
**Photo 19**

**The chimney is missing a rain cap.** A rain cap should be installed to prevent excessive water intrusion and deterioration of the chimney and its components.

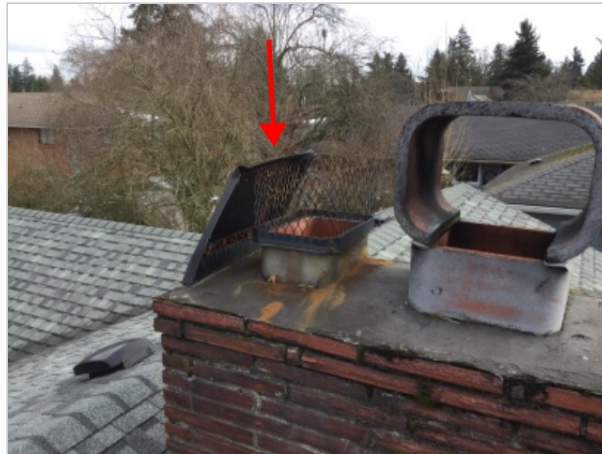
**Photo 20**

**The flashing around the chimney requires repair.** Flashing is a critical component that helps prevent water intrusion. At the time of repair, the technician should investigate the area for any previous water intrusion or damage.

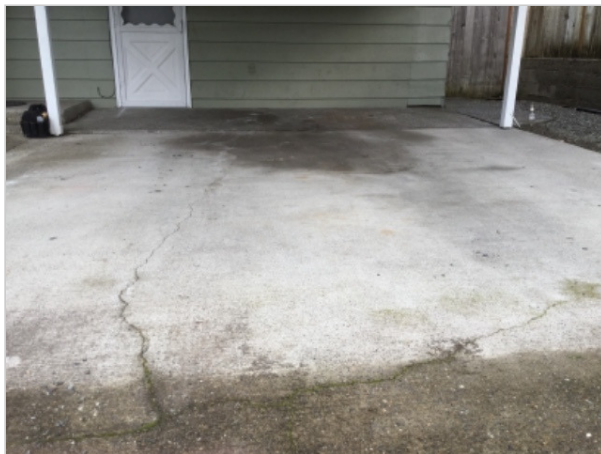
**Photo 22**

**Areas of the driveway have settled.** This condition indicates a possible void under the driveway. Driveway settling has led to potential tripping hazards. The areas should be monitored and repaired as needed.

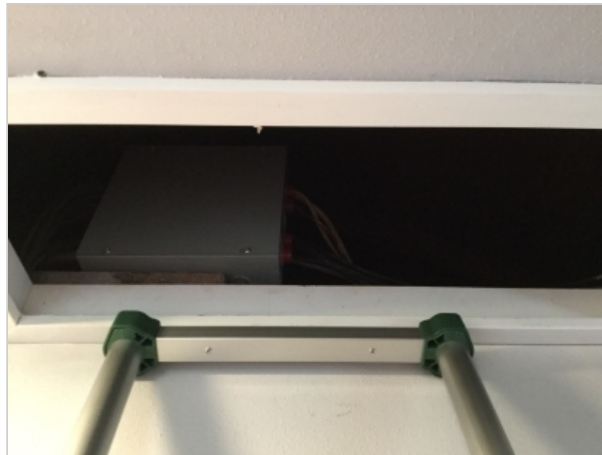
**Photo 25**

**Evidence of an active roof leak was observed in the attic.** Consult with a qualified roofer for evaluation and repair recommendations.

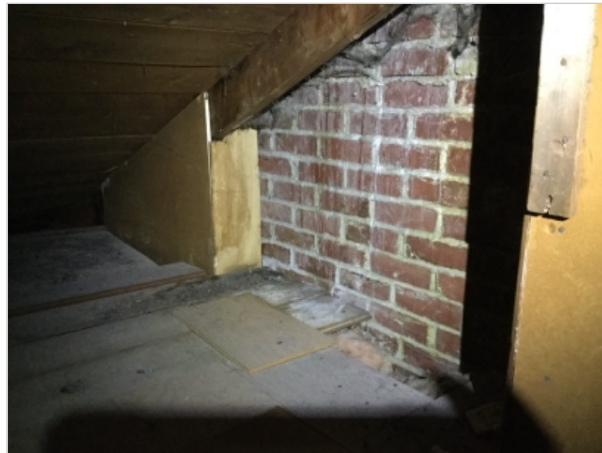
**Photo 26**

**Areas of the attic were not properly insulated.** This can lead to excessive energy bills and undesirable temperature variations within the structure. Insulation should be added to the affected areas.

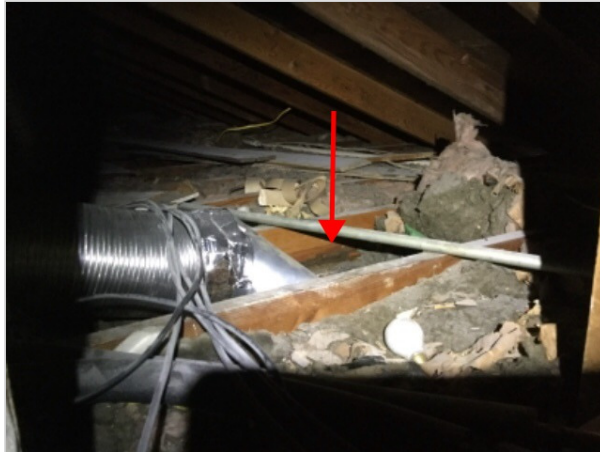
**Photo 27**

**Insulation or other items blocked many of the soffit vents.** The areas around the vents should be cleared to allow proper ventilation of the attic.

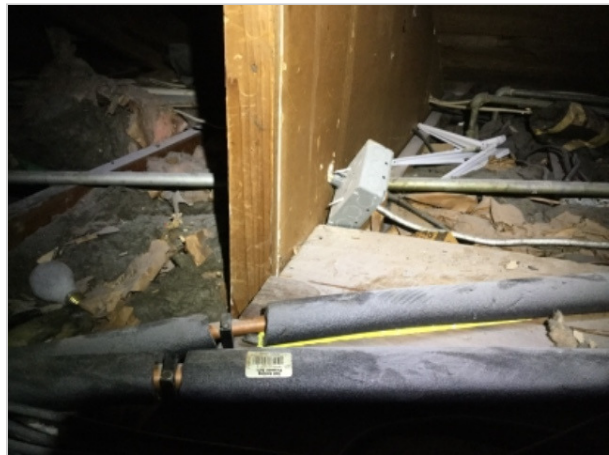
**Photo 29**

Electrical junction box not properly fastened.

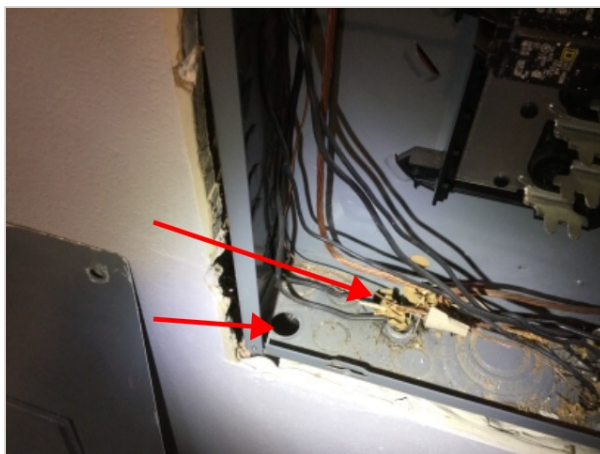
**Photo 35**

**An open knockout was observed in the electric service panel, creating the potential for electric shock. All service panel openings should be covered to prevent access to high voltage and risk of electrical shock. Electrical related repairs should be performed by a qualified electrician.**

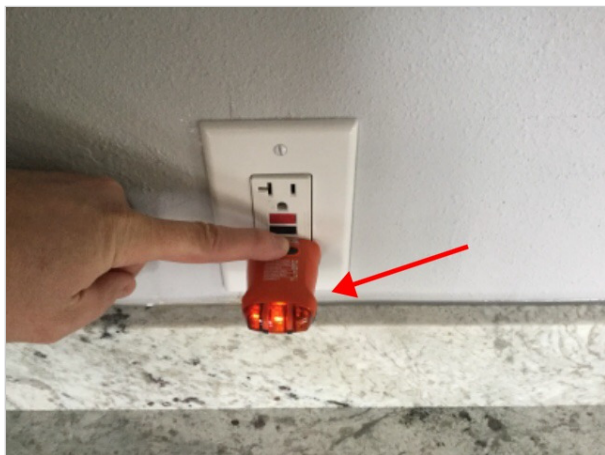
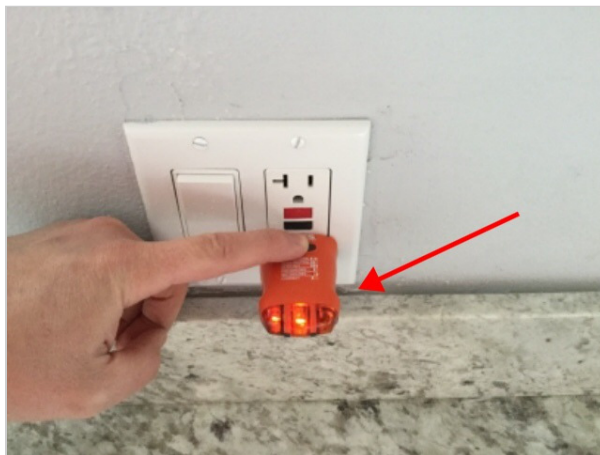
**Multiple receptacles have hot and neutral wires reversed.** This is a safety concern and should be repaired and further assessed by a licensed electrician. Please note that we only test outlets that are visible and readily accessible at the time of the inspection.

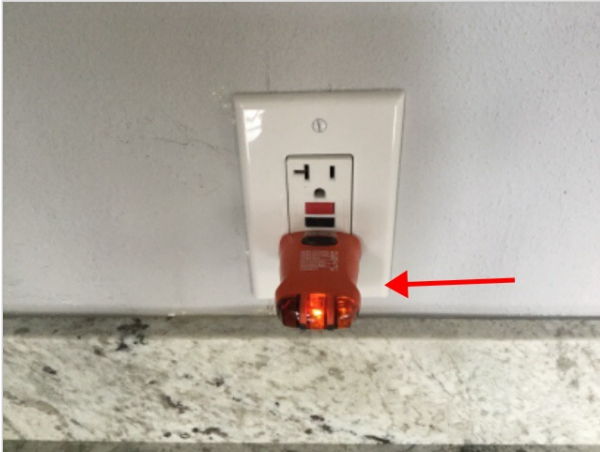
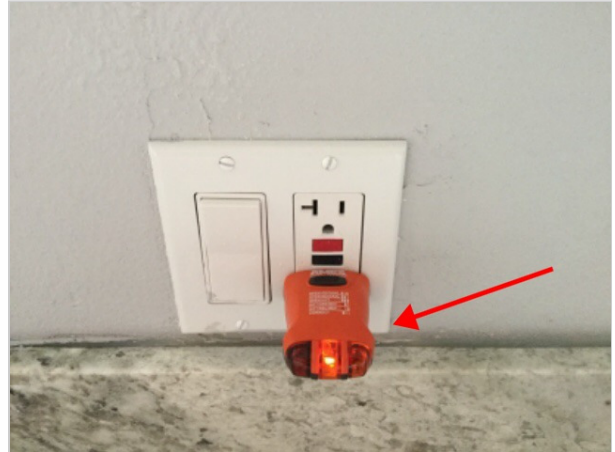
**Multiple three prong type outlets in the structure had an open ground. The affected outlet(s) should be grounded, replaced with two-prong outlets, or connected to GFCI circuits to improve safety.** This condition means that the third prong, also known as the ground prong, is not doing its job. This is often caused by a missing or disconnected ground connection at an electrical device in the circuit. Consult with an electrician for the best course of action.

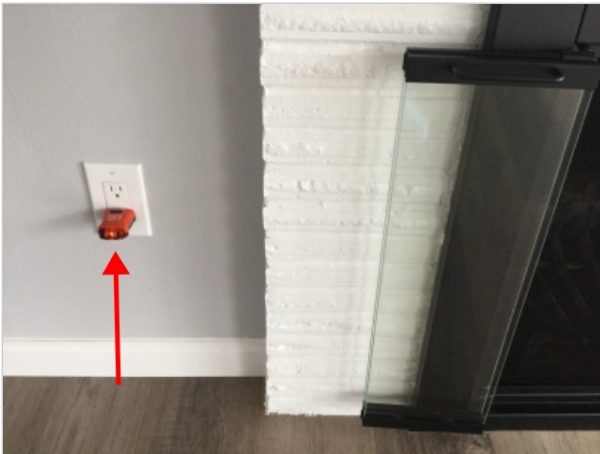
Living room next to fireplace. One of many examples

**Evidence of amateur wiring was observed in many areas.** Amateur wiring may not conform to standards methods and could be a safety concern. Consult with a qualified electrician for repairs and further evaluation.

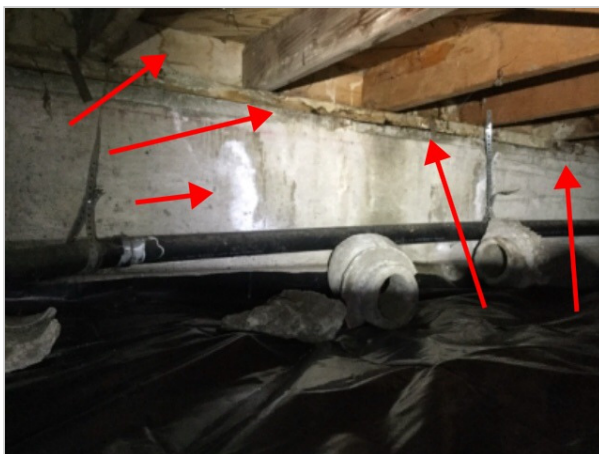
Along kitchen wall adjacent to back porch

**The sub-floor above the crawlspace lacks insulation.** Adding insulation may help regulate the temperature of the living space above the crawlspace and may assist in preventing moisture intrusion.

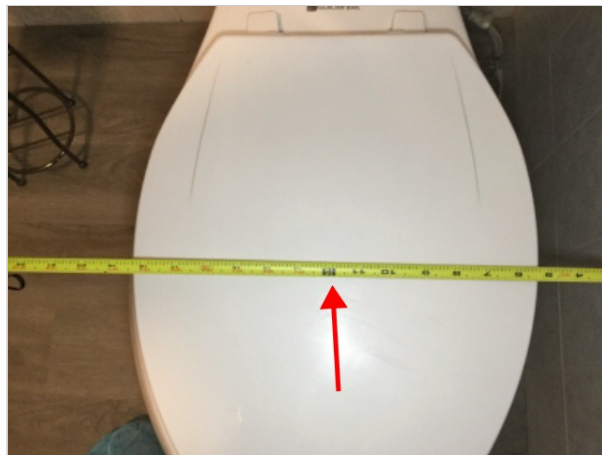
Master bathroom toilet

Toilet is situated too close to wall. Recommend re-situating, so that center of the toilet to the wall is at least 15 inches.

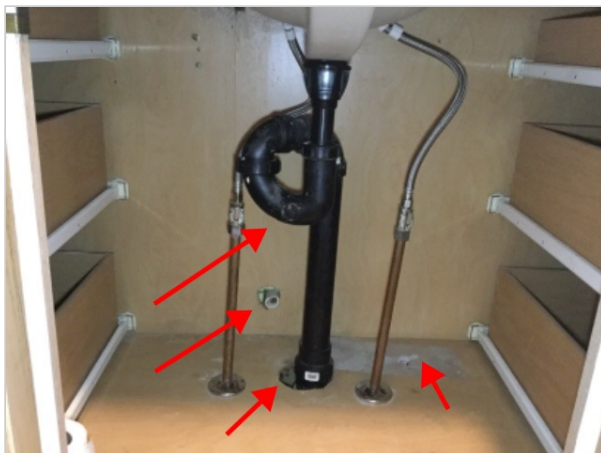
S trap -master sink

An S-style trap was observed under the sink in the master bathroom. Recommend replacing with a P-style trap.

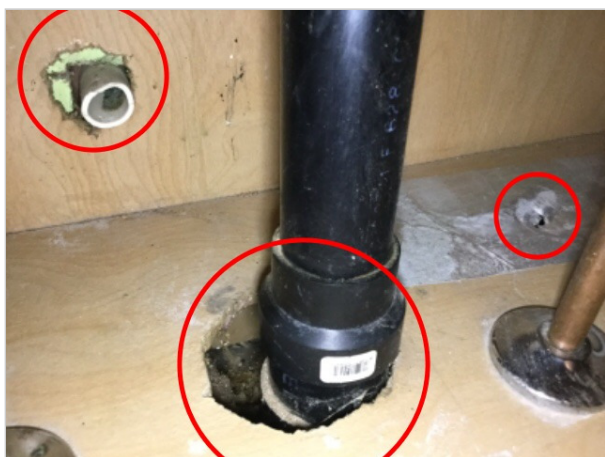
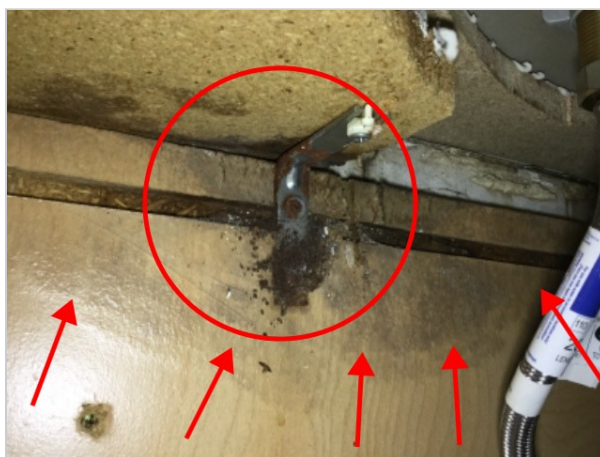
Master bathroom under sink

A significant dank smell was noticed under the master bathroom sink. Also observed were several unfinished penetrations and rust on metallic parts. Recommend evaluation by a licensed professional to ensure no persisting water intrusion that is not visible at time of inspection.

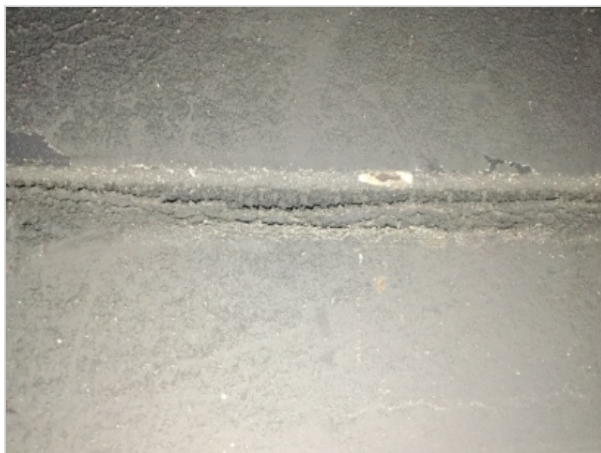
**Photo 64**

**A buildup of soot and/or creosote was evident in the chimney in the living room fireplace.** The unit should be cleaned and further assessed by a qualified fireplace service company.

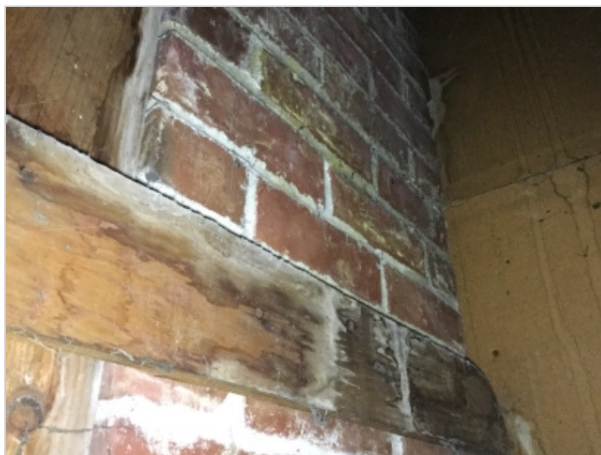
**Photo 65**

Hearth extension not present or visible. Recommend removal of decorative flooring and hearth extension installed if wood-burning is intended.

Evidence of water intrusion along the fireplace chimney next to the furnace. Current or past moisture evident on wood members as well as on brick. Recommend further examination by a licensed professional.
