**123 Main St  
Anywhere, NC**

### *HOME INSPECTION REPORT*

File Number: **655439**

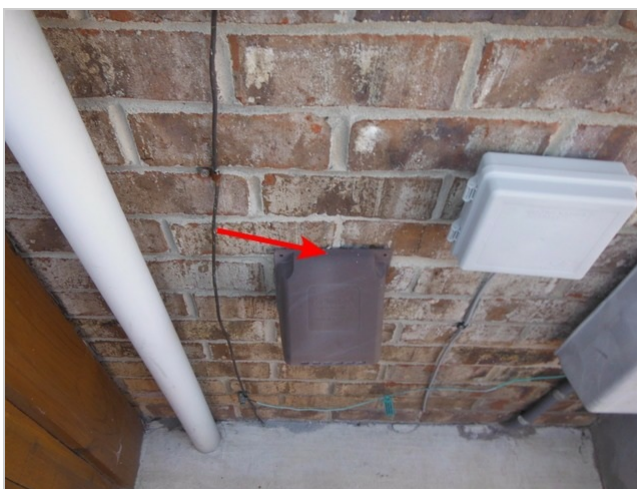
Unsealed-Right

***Unsealed penetrations through brickwork in areas at but not limited to right side around dryer vent, and left side around HVAC piping and water spigot. This is a water penetration concern. Recommend repairs as necessary.***

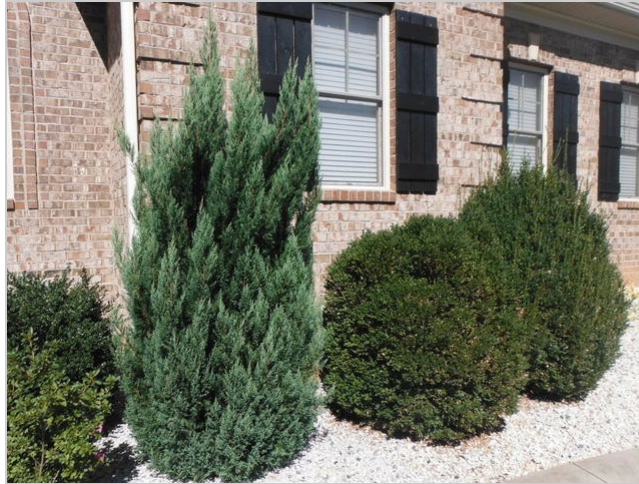
Vegetation at house-Front

***Vegetation touching front side of the house. It is recommended to have an 18-24 inch clearance between vegetation and siding to minimize moisture/pest concerns. Recommend repairs by qualified person.***

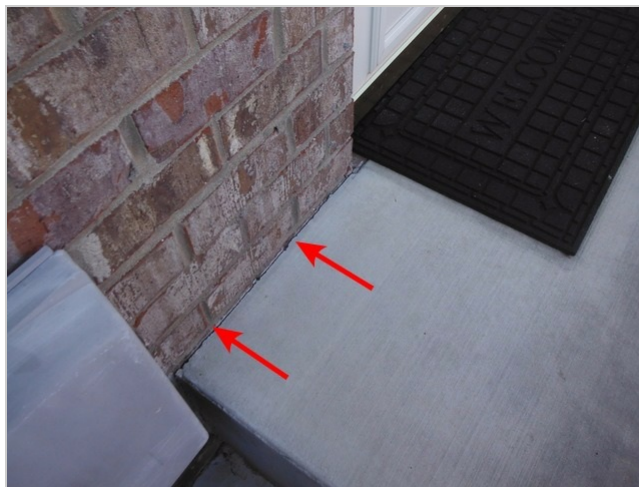
Open joints-Right

***Open mortar joints observed at right side porch/patio. This is a water penetration/settlement concern. Recommend repairs by a qualified person.***

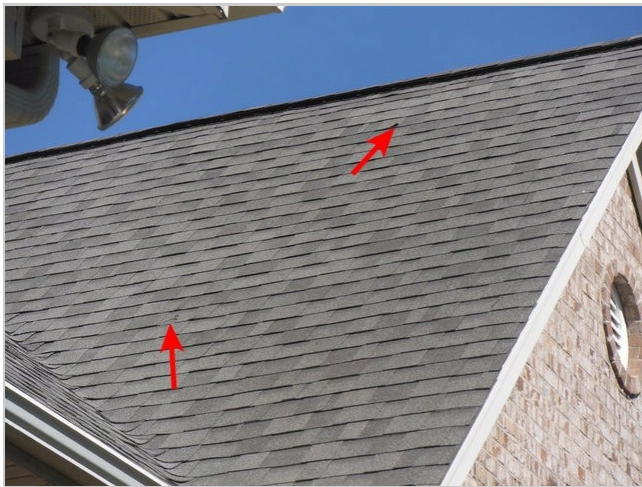
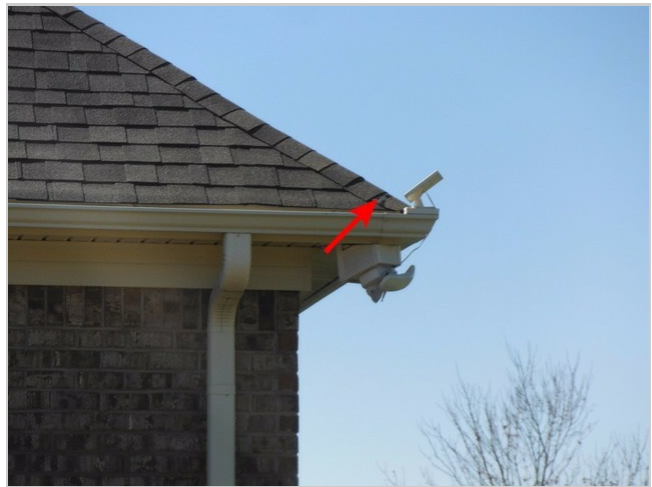
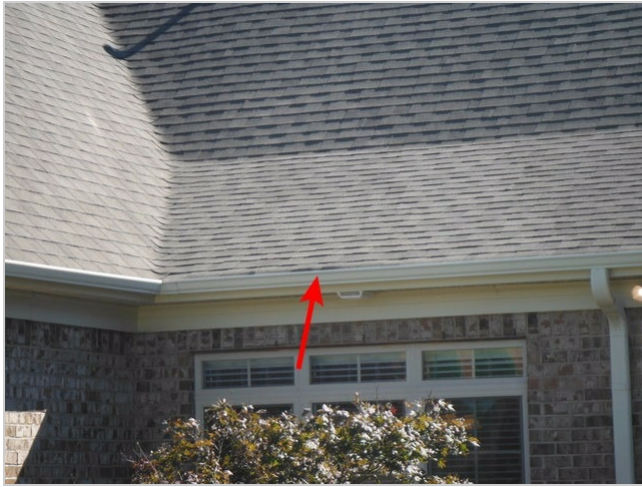
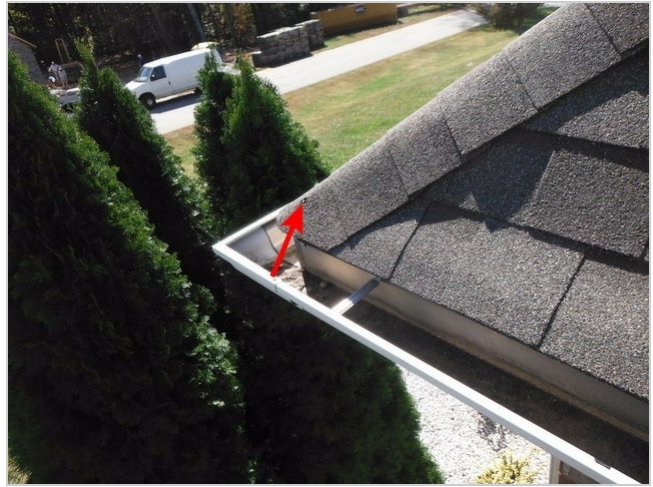
1. ***Raised shingles at but not limited to the front and rear roof of the house. This is a water penetration/wind lift/nail wear through concern.***
2. ***Damaged shingles observed on areas at but not limited to the front, rear right, and rear roof. This is a water penetration/substrate damage concern.***

Damage-Front

Damage-Rear

Damage-Front right

***Recommend review and repairs as directed by qualified contractor.***

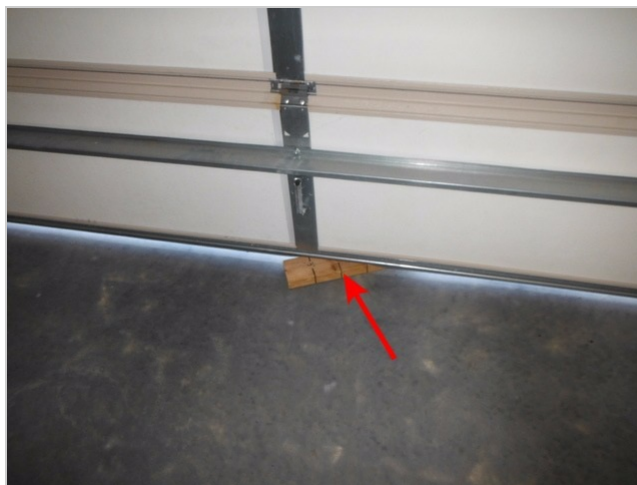
***The rear most garage door did not reverse when met with reasonable resistance (as tested with a 2x4 block). This is a safety concern. Recommend repairs/adjustments by qualified person and verifying proper operation prior to closing.***

Did not reverse

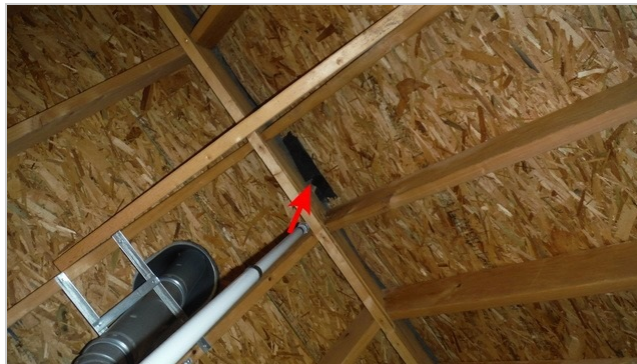
***Observed damaged roof decking at the right rear of the attic. This is a support concern. Recommend repairs by a qualified contractor.***

Damaged

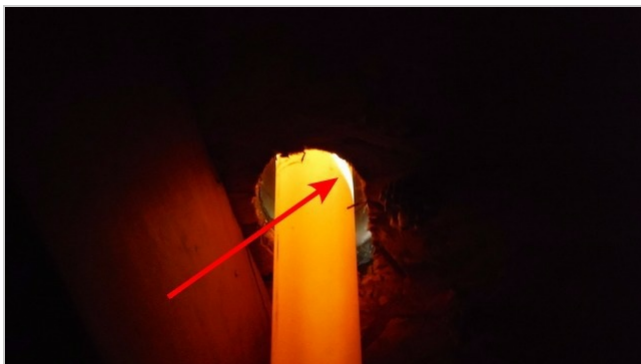
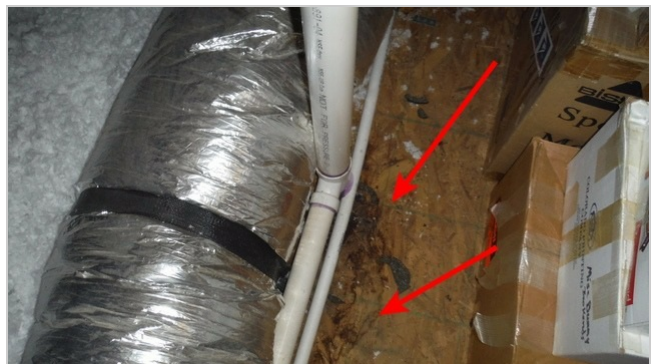
***Exhaust vent stack in the right rear attic space had light visible around boot area and stained OSB decking below indicating possible leak. This is a possible leakage/damage concern. Recommend review and repairs as directed by qualified contractor.***

Penetrating daylight-attic

Deck staining below exhaust vent-attic

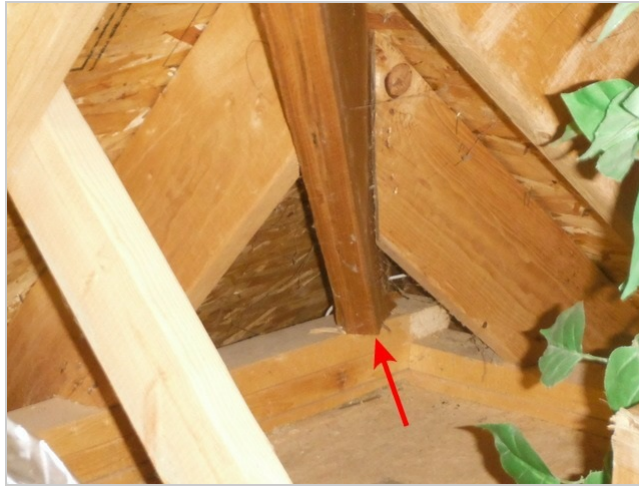
***LVL framing at the front right of house is not fully bearing at the heel cut. This is a***

***support/installation/damage concern. Recommend repairs as directed by qualified contractor.***

Not fully bearing

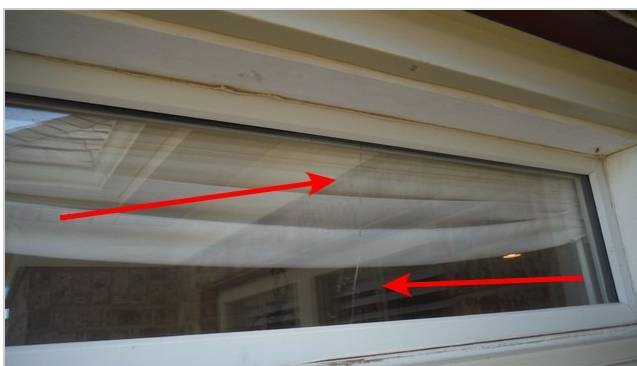
***Window pane above rear entry door of the home was cracked at the time of the inspection. This is a damage concern. Recommend repairs by a qualified contractor.***

Cracked window pane-rear entry door

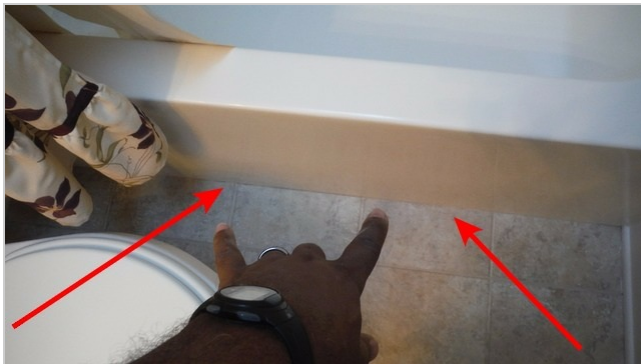
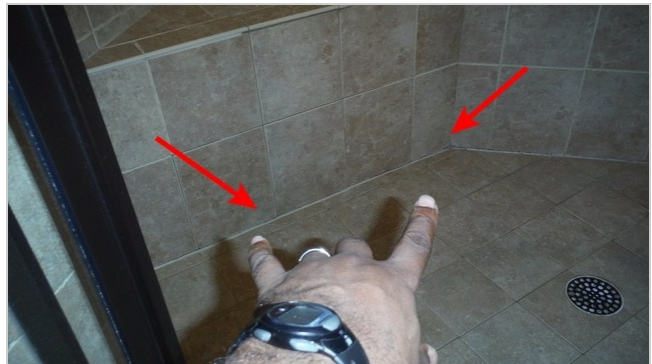
***Unsealed areas at bath surrounds in the master and upstairs bathrooms. This is a water penetration/substrate damage concern. Recommend repairs by qualified person.***

Upstairs bathroom surrounds

Master bathroom shower surrounds

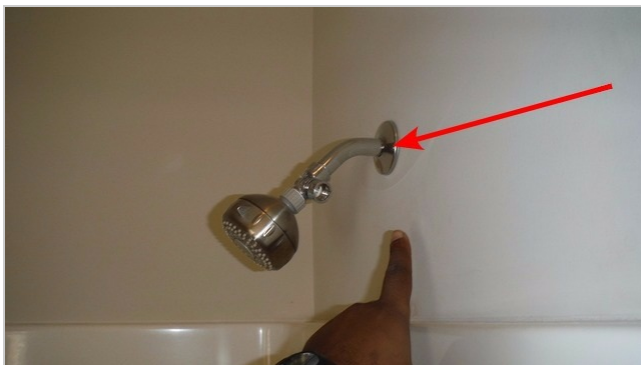
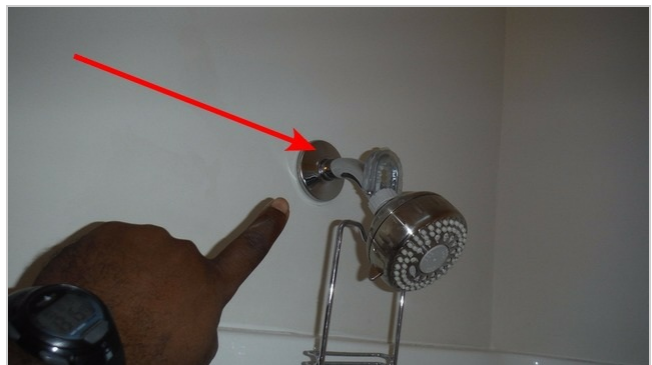
***Observed loose shower stems in the upstairs and downstairs hallway bathrooms. This is a movement concern. Recommend repairs by a qualified person.***

Downstairs hallway bathroom shower stem

Upstairs bathroom shower stem

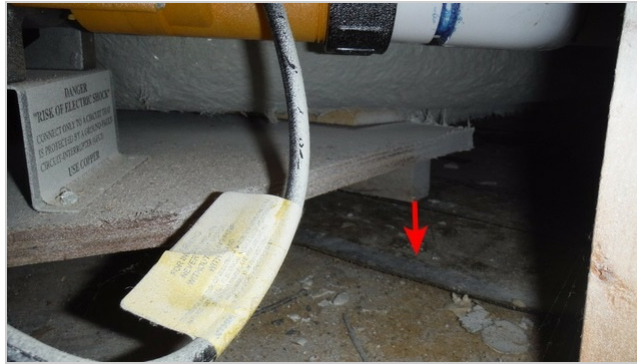
***Gap observed between bottom of jetted tub and subfloor. This is a support/damage concern. Recommend repairs by a qualified contractor.***

Jetted tub-master bathroom

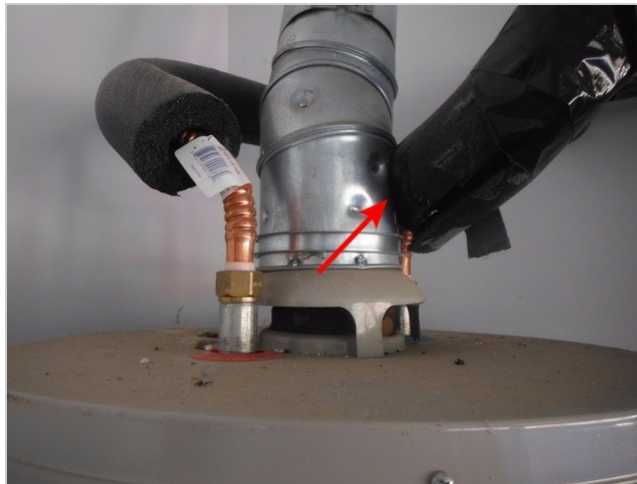
***Water heater exhaust vent is contacting combustibles near unit. There is typically a 1 inch gap to combustibles to minimize safety/damage concerns. Recommend repairs.***

Contacting combustibles

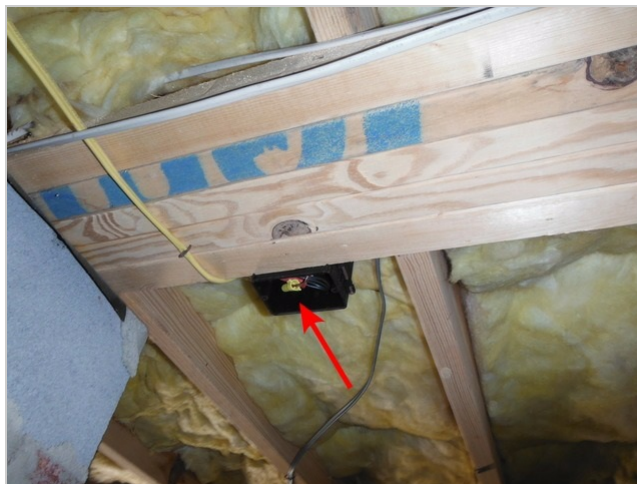
***Open junction box observed at but not limited to the rear left of crawlspace. This is a damage/shock concern. Recommend repairs by a qualified person.***

Open junction box-Crawlspace

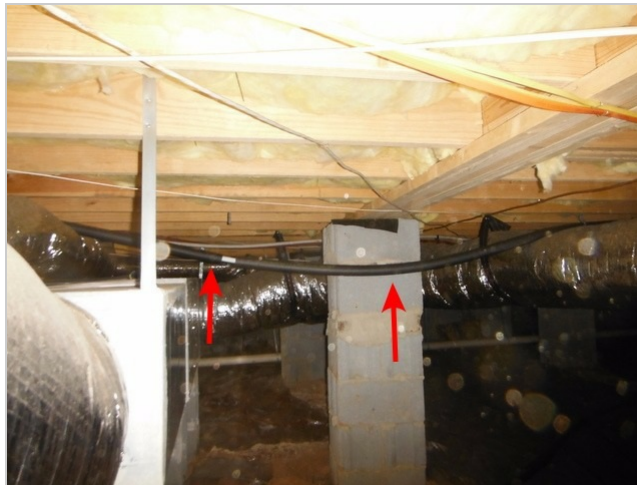
***Water lines in areas at but not limited to the center of the crawlspace are not fully supported. This is a movement/damage concern. Recommend repairs by qualified person.***

Water line not fully supported

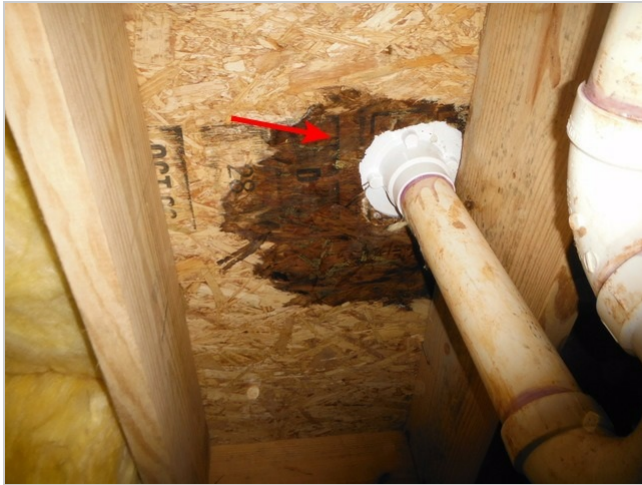
1. ***Staining/elevated moisture underneath master bath stall shower. This is a leakage/substrate damage concern.***
2. ***Leaking observed around master bath jetted tub into the crawlspace. This is a leakage/substrate damage concern.***

Staining/elevated moisture-Stall shower

***Recommend evaluation and repairs as directed by qualified contractor.***

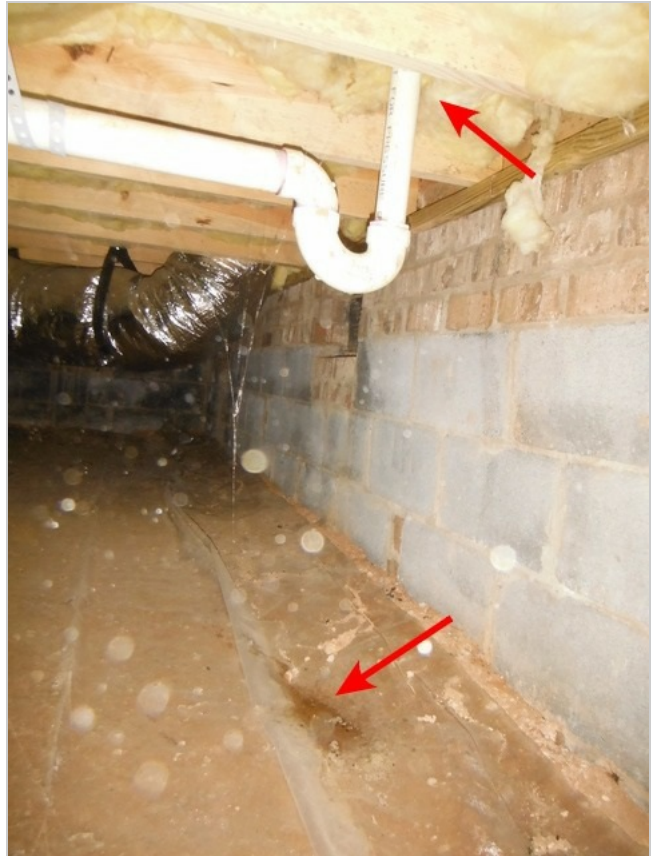
Leaking-Jetted tub

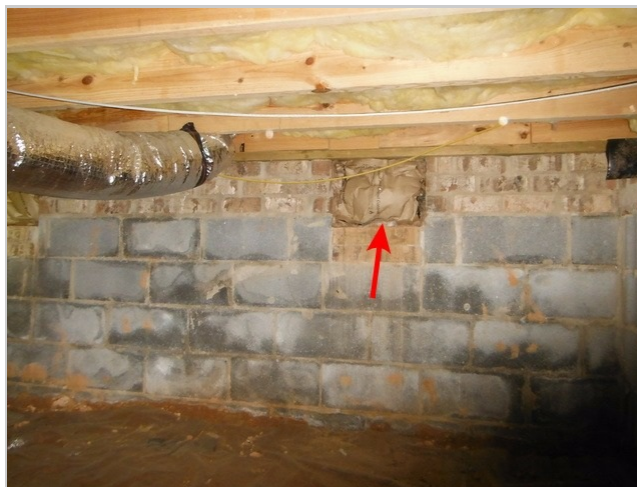
1. ***Staining on foundation wall, and around vent openings at areas around the house. This is a water penetration/adverse moisture concern.***
2. ***Foundation vents have been blocked/covered up at the right and rear of house. This may not allow for proper air flow/ventilation.***

Blocked vent

***Recommend repairs as necessary by qualified person.***
