*HOME INSPECTION REPORT*

On Monday, March 31, 2025 The HomeTeam Inspection Service made a visual inspection of 123 Anywhere St., City, ST 12345. Enclosed please find a written, narrative report of our findings in accordance with the terms of our Inspection Agreement.

Tony Erlenbach  
HomeTeam of West Cleveland  
Home Inspector OHI.2025001072

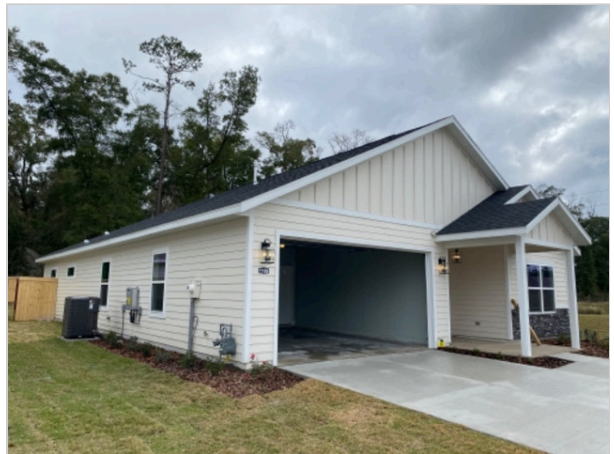
Photo 6

**Damaged siding was observed on the right side of the structure. Consult with a qualified contractor for replacement.**

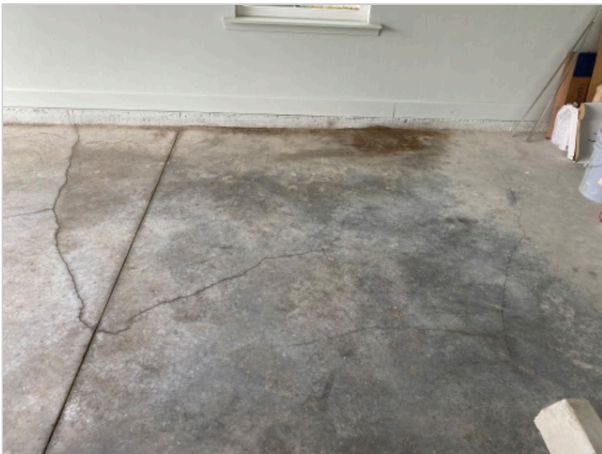
**Photo 20**

The garage floor had minor spider cracks observed. These cracks did not appear to be a structural issue. These cracks should be sealed and monitored.

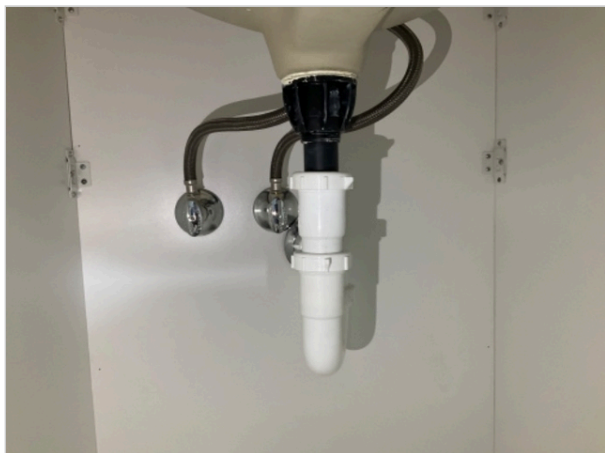
**Photo 42**

Leaks were observed at the toilet shut off in the Jack and Jill bathroom when in use. The tub and sink in the hall bathroom drain slowly. A licensed plumbing company should be called to evaluate the system and make any repairs.

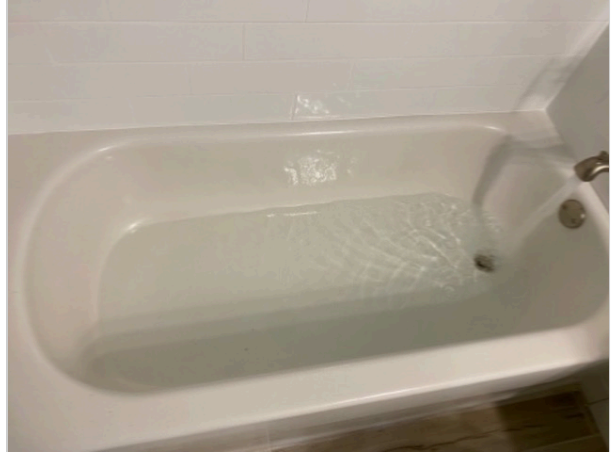
Photo 46

Hall bathroom drains slowly.

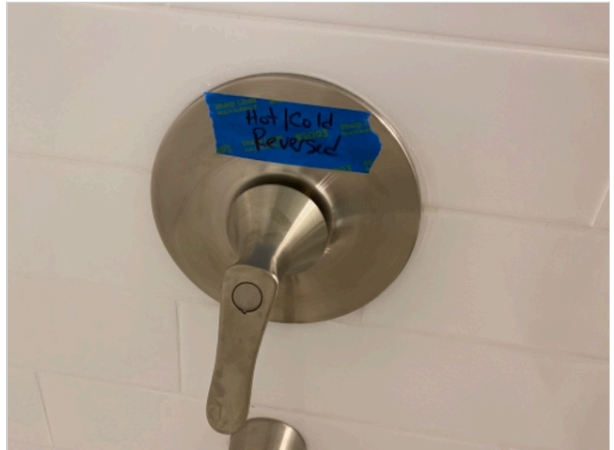
Photo 48

The shower controls in both guest bathrooms had the hot/cold reversed, which is a possible scald issue and should be corrected.

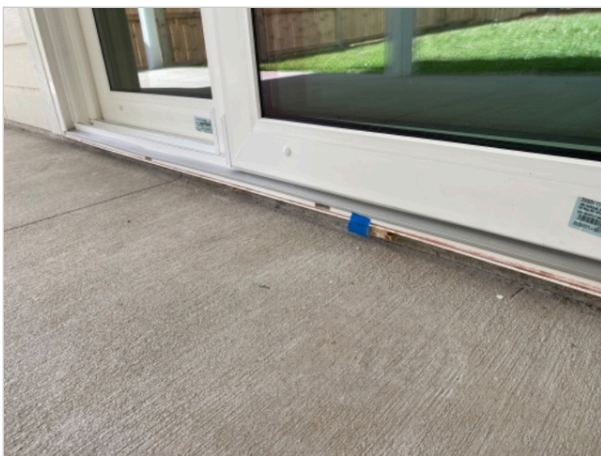
**Photo 57**

**The rear sliding door threshold extends over the edge and is not supported properly. Recommend a qualified contractor to repair as needed.**

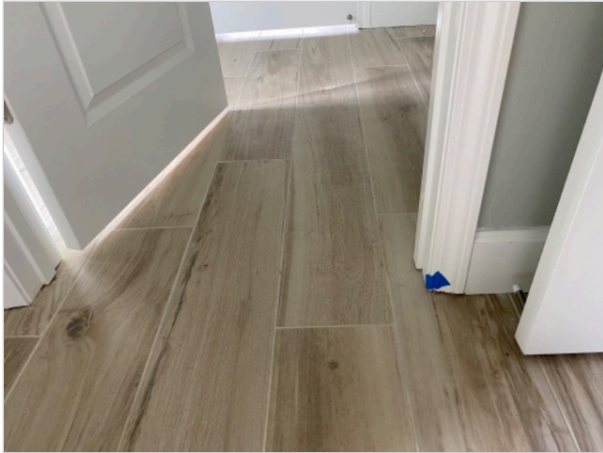
Photo 59

**An exposed nail was observed at the guest bedroom/ jack & jill bathroom door frame that should be removed**

and has been marked with blue tape to help the builder and contractors identify said issues.

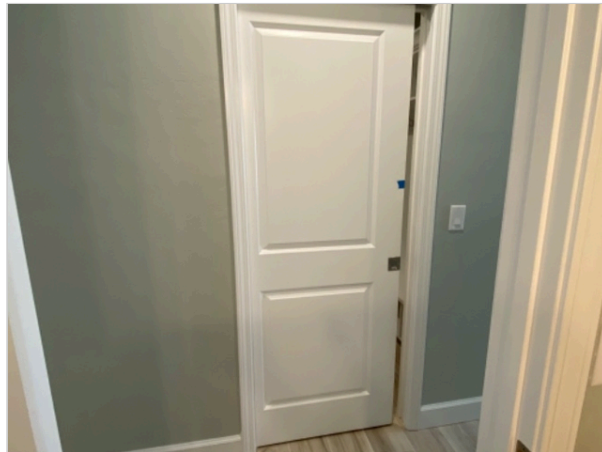
Photo 61

The pocket door for the laundry room is difficult to open and should be adjusted.

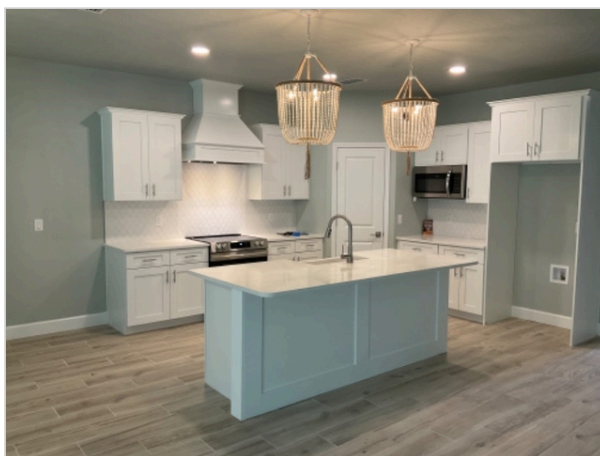
**Photo 70**

**Portions of the kitchens cabinets were not completely secure to the wall.** The cabinets should be secured to prevent them from falling.
