HomeTeam[®]
INSPECTION SERVICE

RE: 123 Sample Drive
Anytown, IN 46112
Inspection #: XXXX

HOME INSPECTION REPORT

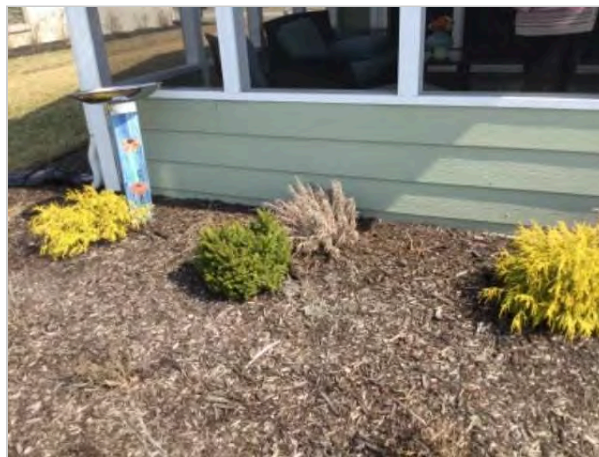
Photo 3

LANDSCAPING MULCH ON SIDING: There are areas where the landscaping mulch is too high and in contact with the siding. Even with exterior brick, mulch that is in contact with the siding can retain moisture and cause damage or insect infestation. Recommend removal of the mulch to an acceptable level.

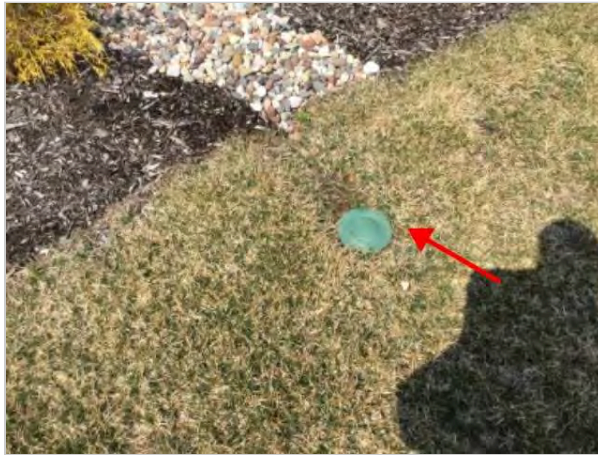
Photo 4

There were termite bait stations located around the perimeter of the house. Termite bait stations are sometimes installed as a preventative measure and sometimes used as a treatment method. Termite bait stations require regular servicing. It is recommended that you consult with the current home owner to determine if the bait stations are being regularly serviced by a pest control company.

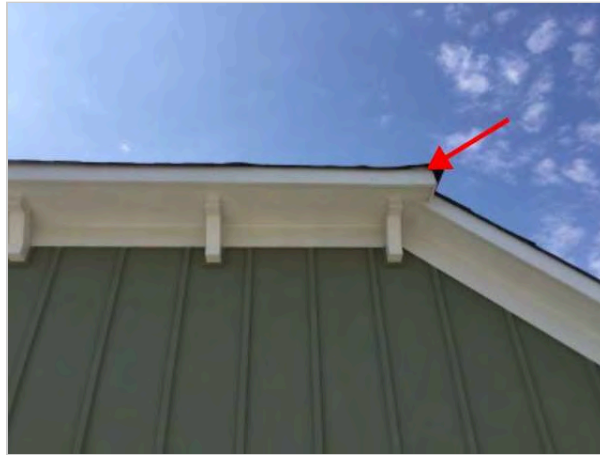
Photo 13

ROOF EAVE OPENINGS: There were opening visible at the eaves of the roof. This is a possible water or pest intrusion area. Recommend installation of drip edge or proper sealing of the areas by a licensed contractor.

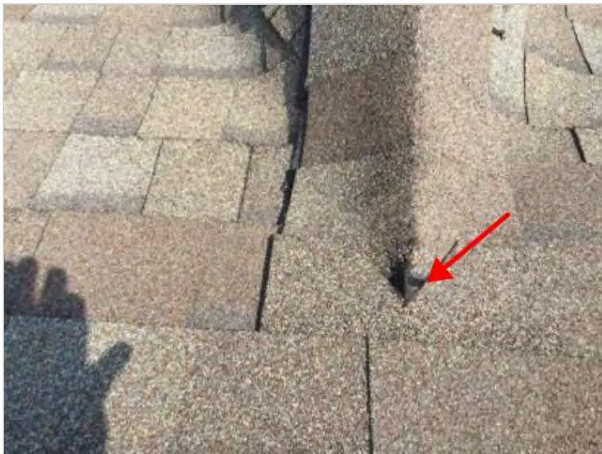
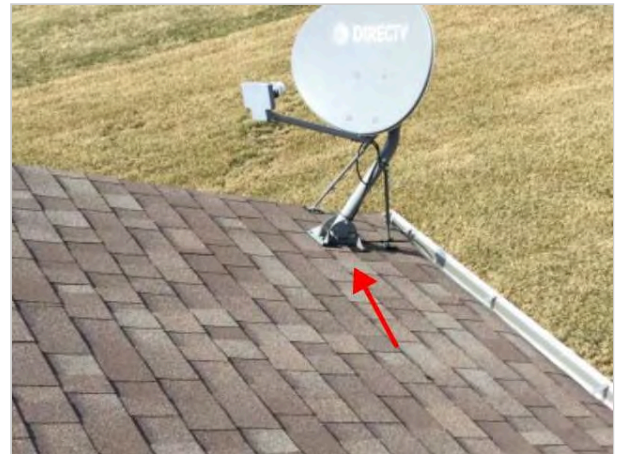
ROOFING TAR: There were areas of the roof or flashing that have been coated with roofing tar. Roofing tar is considered a temporary repair because it will eventually dry, crack and require continued maintenance.

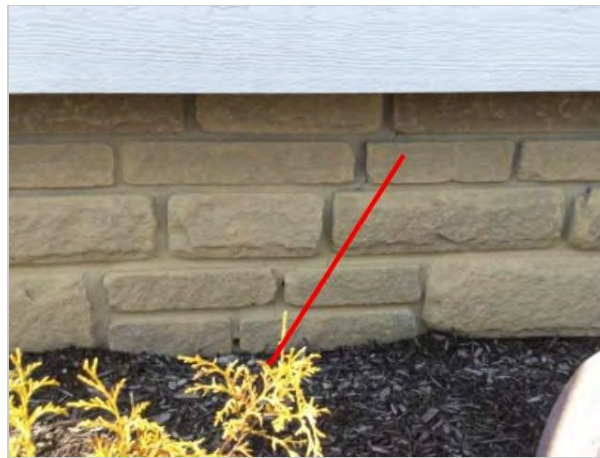
Photo 22

BRICK CRACKS: There were minor cracks in the exterior brick. The brick work on the exterior of the house is not a supporting part of the structure. The cracks did not appear to be of structural significance at the time of the inspection. Recommend the cracks be monitored to determine if movement has ceased. Also recommend keeping the cracks sealed with caulking or mortar to prevent water intrusion which can cause damage to the structure over time.

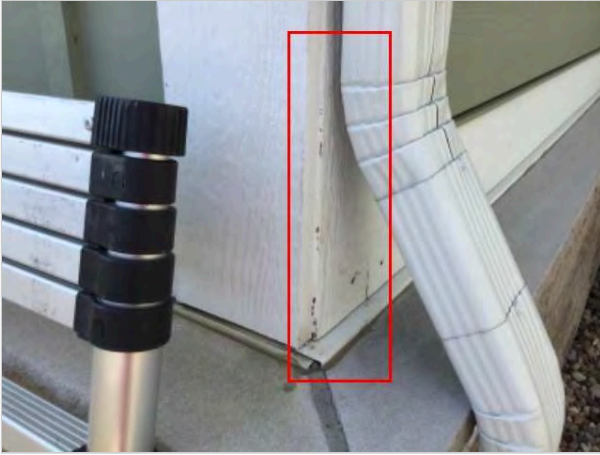
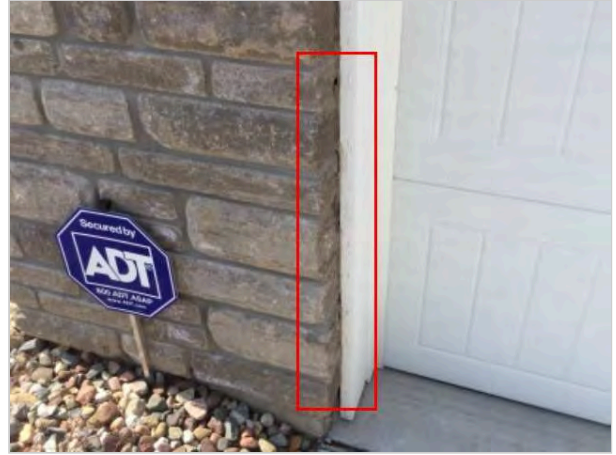
EXTERIOR CAULKING: There were areas of the caulking on the exterior of the home around the doors, trim or windows that is cracking or missing and is in need of maintenance. Recommend re-caulking the areas to prevent water intrusion and structural damage.

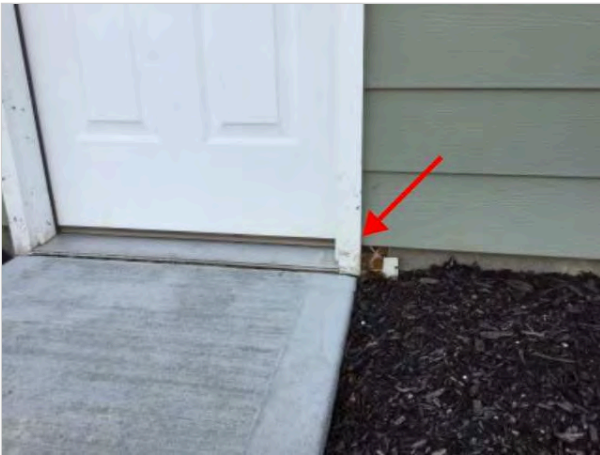
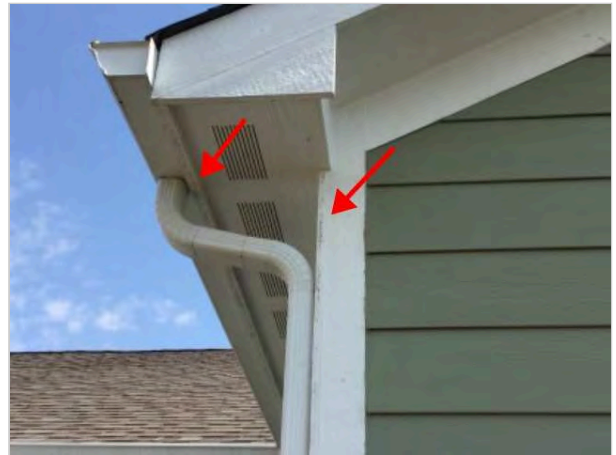
TRIM PAINTING: There were several areas of the wood trim, windows, soffit and fascia that are in need of painting. Exposed wood can deteriorate quickly if it is not painted or sealed. Painting of the wood surfaces is normal home maintenance. Recommend proper painting or sealing of the wood trim surfaces.

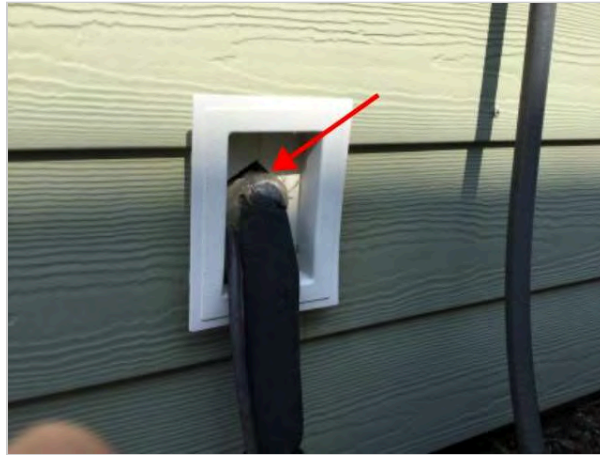
Photo 27

OPENINGS IN SIDING NEED SEALED: The opening in the siding where the air conditioning or heat pump lines go through is in need of sealing to prevent water intrusion.

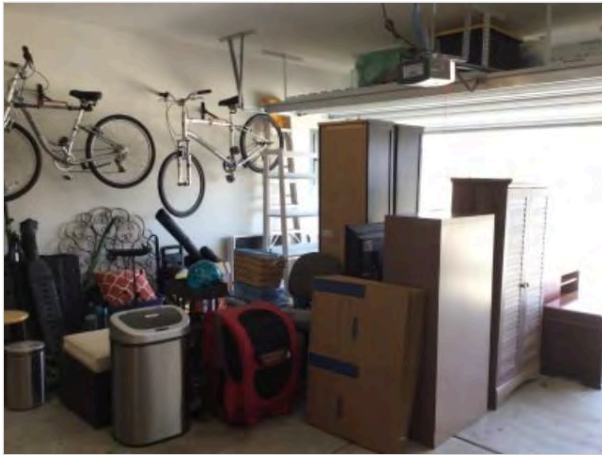
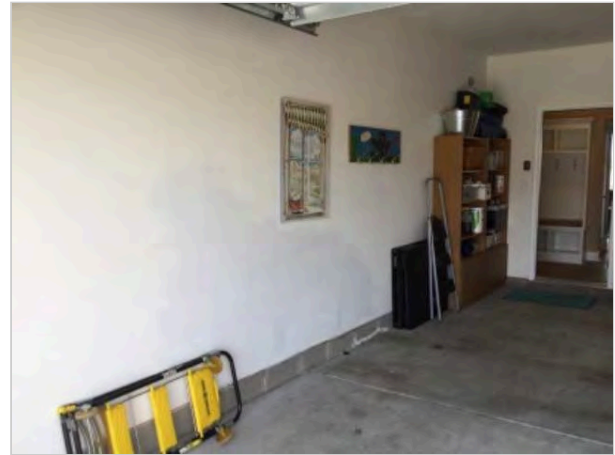
The garage contained many stored items and/or shelves at the time of inspection, therefore, several areas were unable to be inspected.

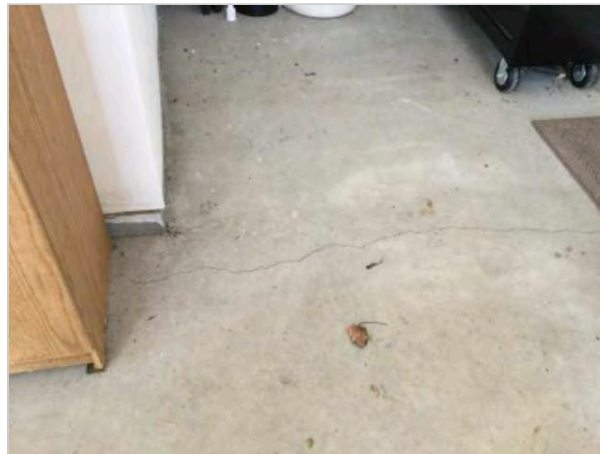
Photo 37

GARAGE SLAB: The slab in the garage shows signs of settlement and is cracked. The slab is not of structural concern to the home, and is serviceable, however repair of the concrete slab would likely fall into the major defect category.

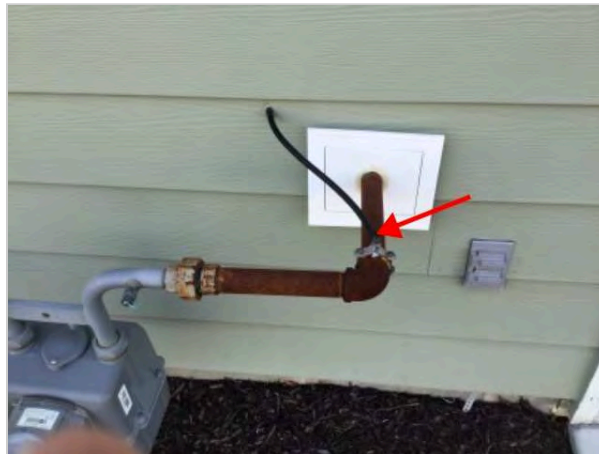
Photo 40

PIPE CONDITION: The condition of many of the visible plumbing pipes and fittings was poor. Recommend a qualified plumber to evaluate and repair to ensure no leaks occur.

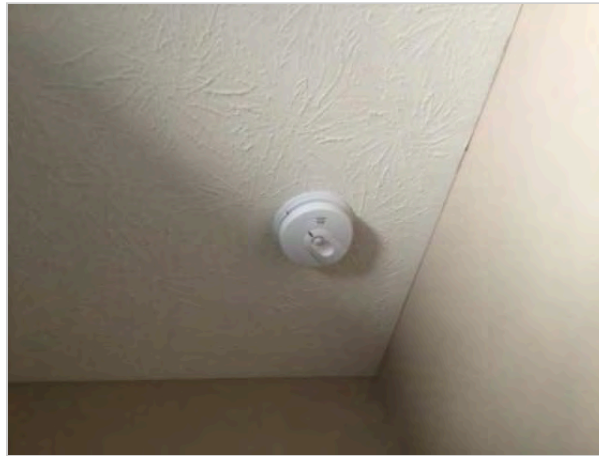
Photo 45

CARBON MONOXIDE DETECTORS: There were no carbon monoxide detectors found in the house. For safety reasons, the carbon monoxide detectors should be tested upon occupancy. The batteries (if any) should be replaced with new ones when you move into the house, and tested on a monthly basis thereafter. We recommend that you consult with your insurance carrier and local fire department regarding the requirements for number and placement of carbon monoxide detectors.

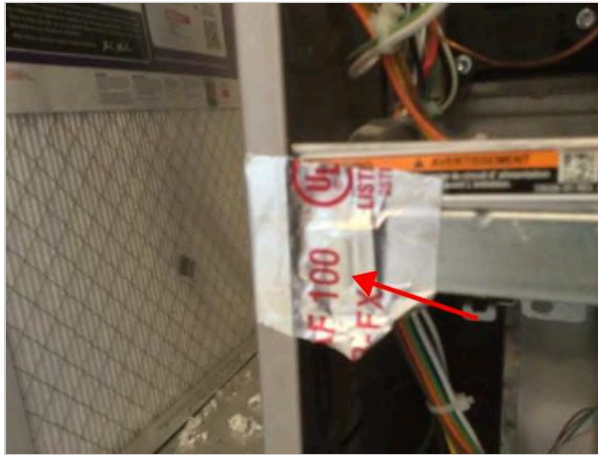
Photo 63

SAFETY SWITCH DEFEATED: The safety switch under the door of the furnace was defeated. It is recommended that the switch be in working order for your safety.

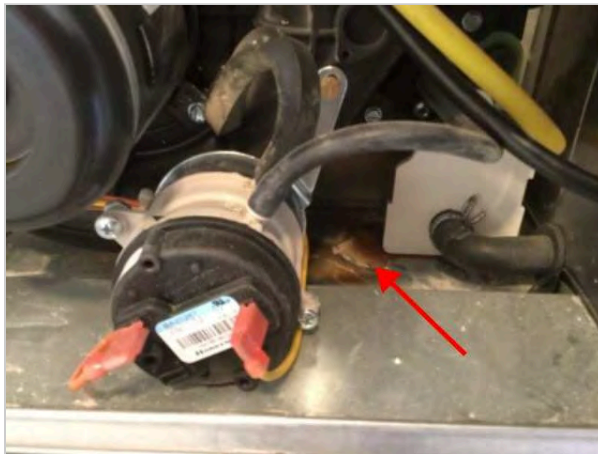
Photo 64

RUST IN FURNACE: There was rust observed inside the cabinet of the furnace. This could indicate a condensation leak or vent pipe issue. The unit should be cleaned and serviced by a licensed HVAC professional.

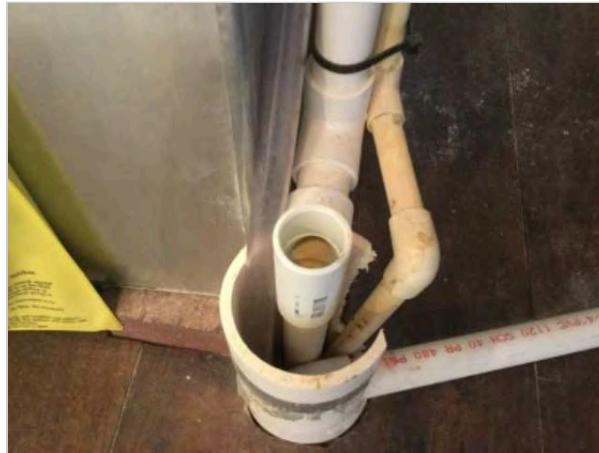
Photo 65

CONDENSATE LINES: The condensate lines from the furnace or Heat Pump are in contact with the wet drain inlet. HVAC condensate lines must be trapped and not in contact with wet drain inlets to prevent the possible migration of bacteria and mold into the air-handling system.

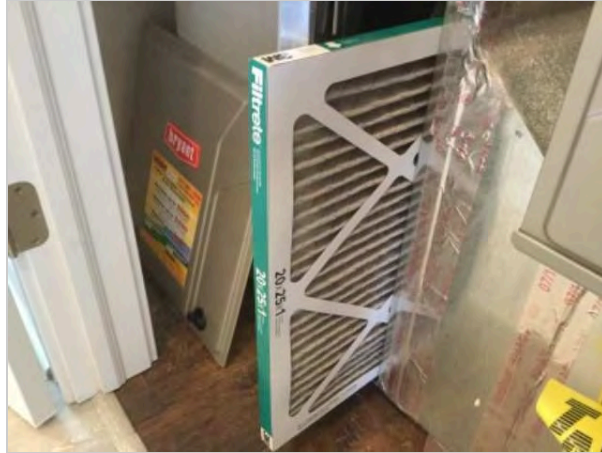
Photo 68

DIRTY FURNACE FILTER: The furnace filter was dirty and should be replaced.
