### *HOME INSPECTION REPORT*

On Sunday, November 9, 2025 The HomeTeam Inspection Service made a visual inspection of 1234 Anywhere Rd., Anytown, USA 12345. Enclosed please find a written, narrative report of our findings in accordance with the terms of our Inspection Agreement.

Michael Burton  
HomeTeam Inspection Service of Central Panhandle  
Florida Home Inspector # HI12530

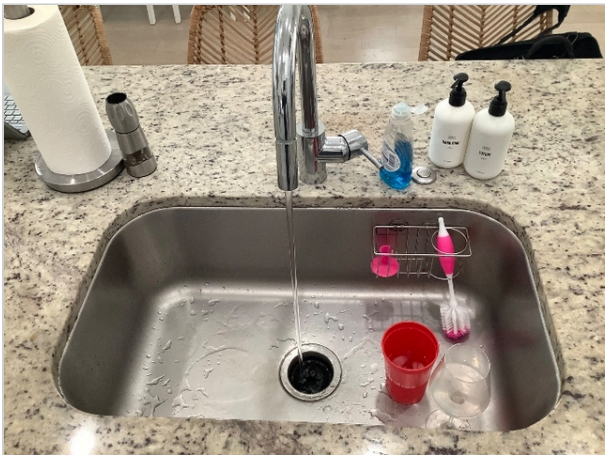
**Photo 234**

The kitchen sink faucet is loose from the counter.

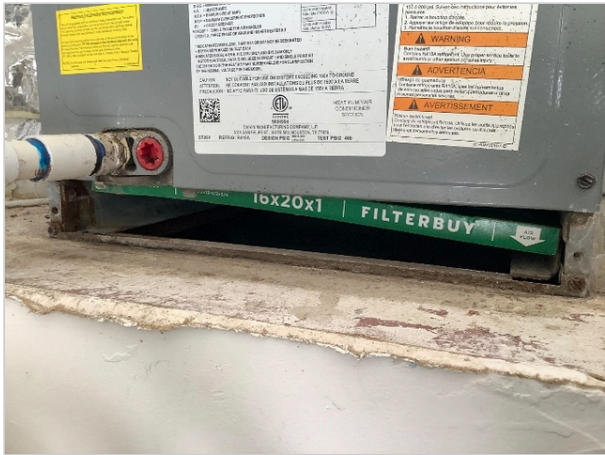
**Photo 281**

The 2nd floor HVAC system had no filter installed.
