Wednesday, November 5, 2025

RE: 1234 Anytown Rd. Anywhere, USA 12345

HOME INSPECTION REPORT

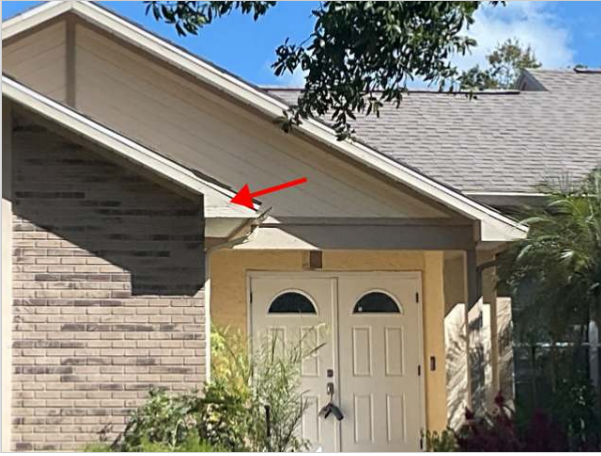
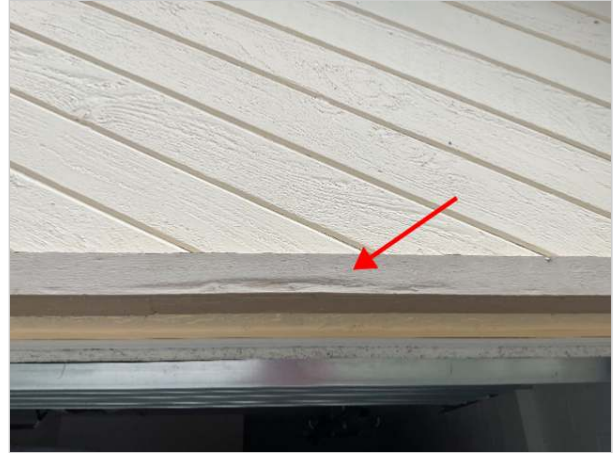
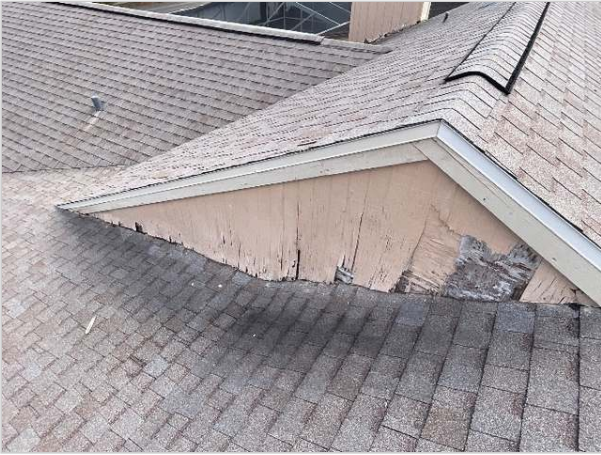
THERE WAS DETERIORATION TO THE FACIA BOARDS AND SIDING IN THE FOLLOWING LOCATIONS: NUMEROUS AREAS. FURTHER EVALUATION FOR LICENSED CONTRACTORS RECOMMENDED.

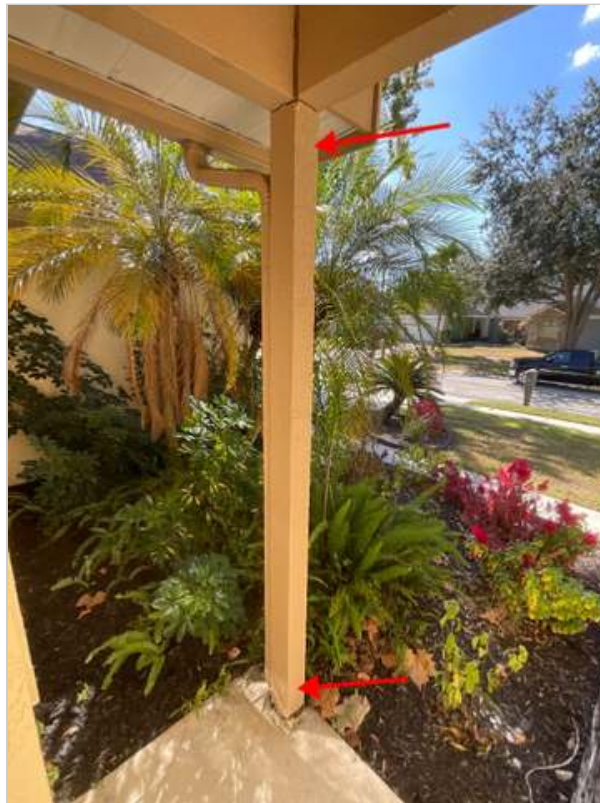
THE SUPPORT POST FOR THE ENTRYWAY ROOF WAS DETERIORATED AND NOT SECURED.

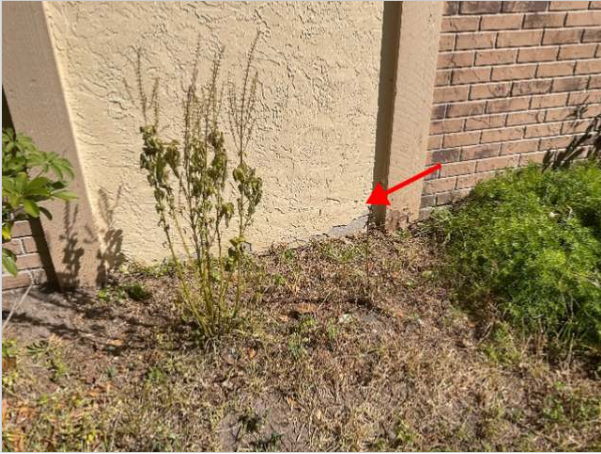
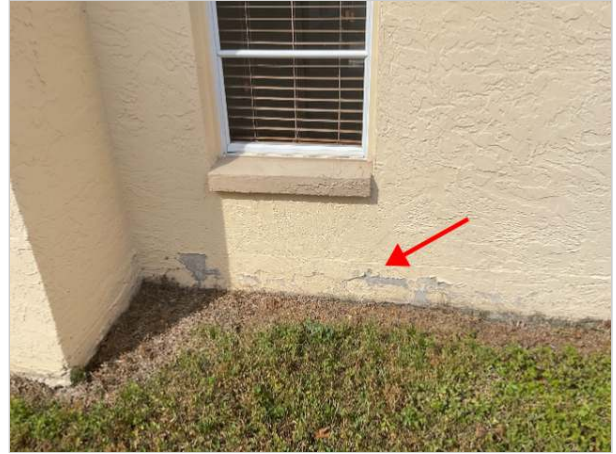
THE STUCCO AT NUMEROUS AREAS OF THE HOME WAS DETERIORATED.

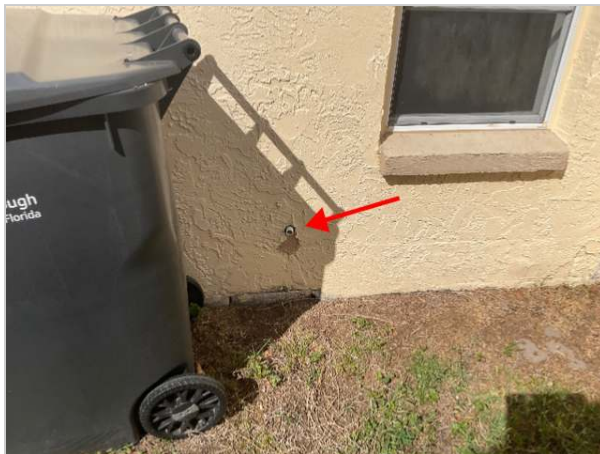
THE SIDING AROUND THE AC CONDENSATE LINE WAS NOT SEALED.

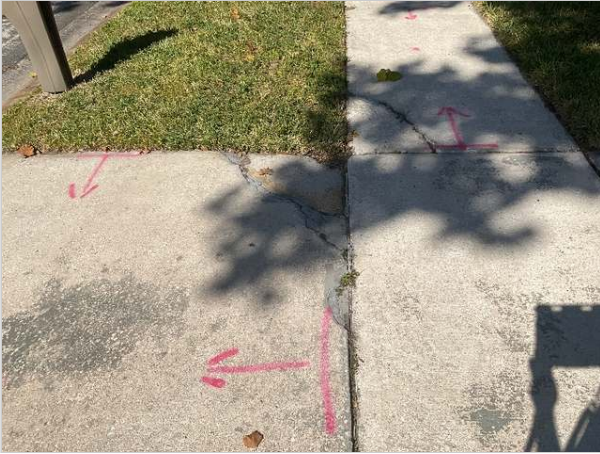
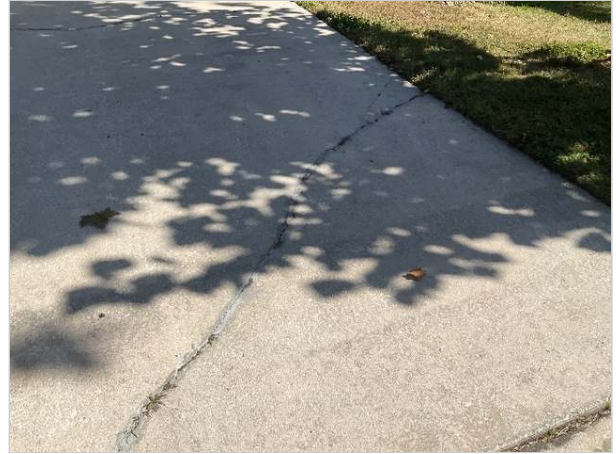
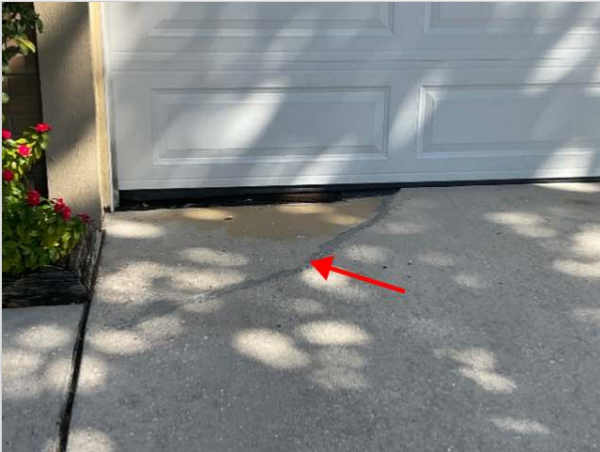
SETTLEMENT/CRACKING WAS OBSERVED IN THE FOLLOWING LOCATIONS IN THE HOME: DRIVEWAY FURTHER EVALUATION FROM A LICENSED CONTRACTOR IS RECOMMENDED.

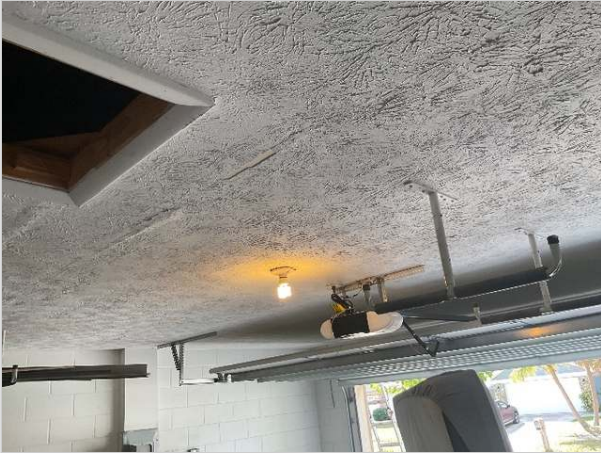
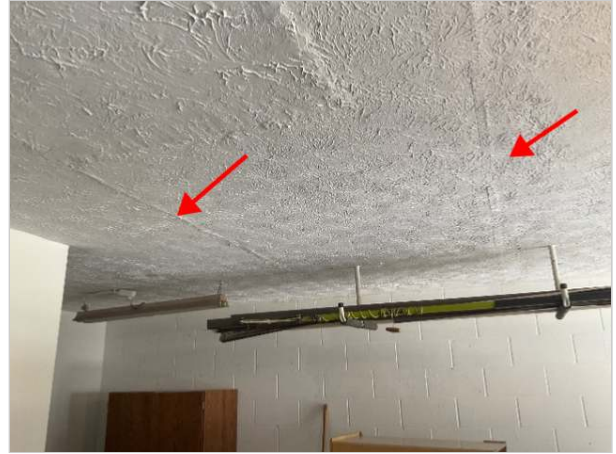
THE DRYWALL TAPE LOCATED AT THE GARAGE CEILING WAS CRACKED.

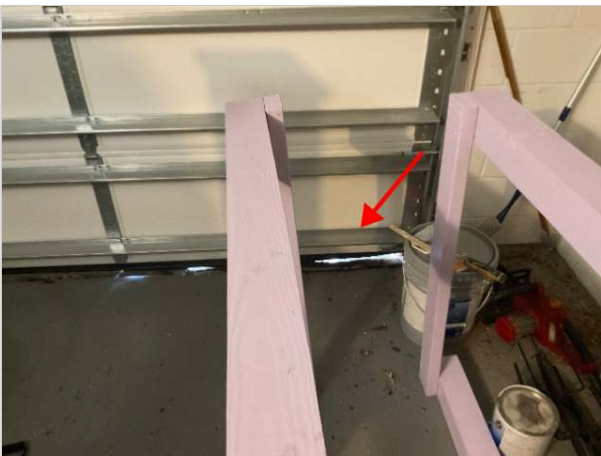
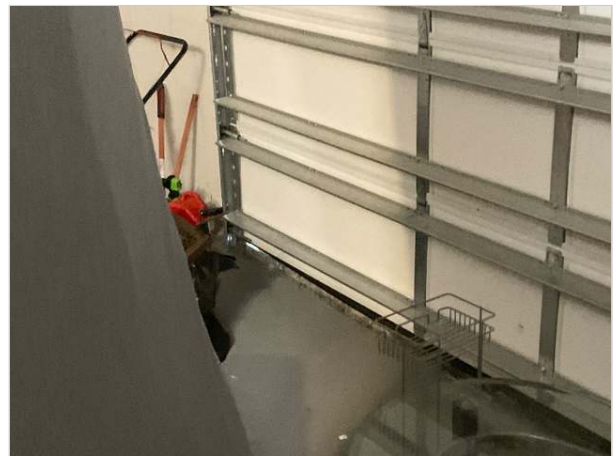
THE GARAGE DOOR WAS NOT SEALED AT THE BOTTOM.

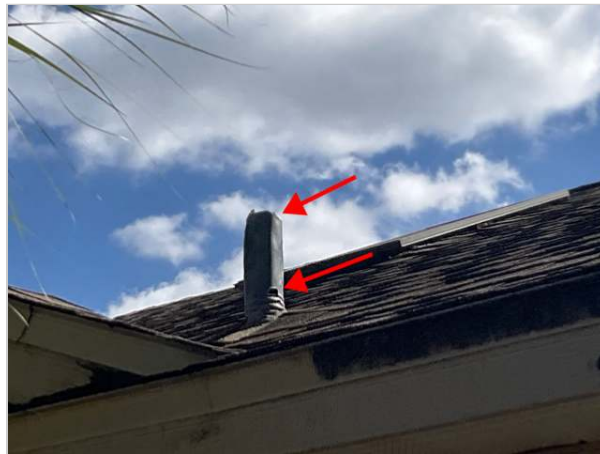
THE FLASHING AT THE PLUMBING VENT PIPE WAS DAMAGED. THE FLASHING SHOULD BE REPAIRED BY A QUALIFIED LICENSED CONTRACTOR TO PREVENT WATER INTRUSION TO THE HOME.

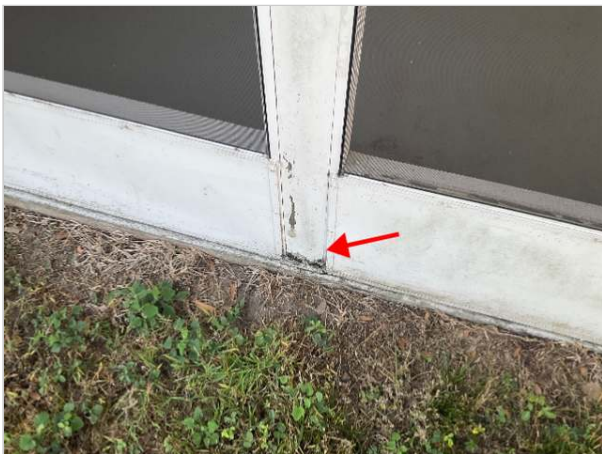
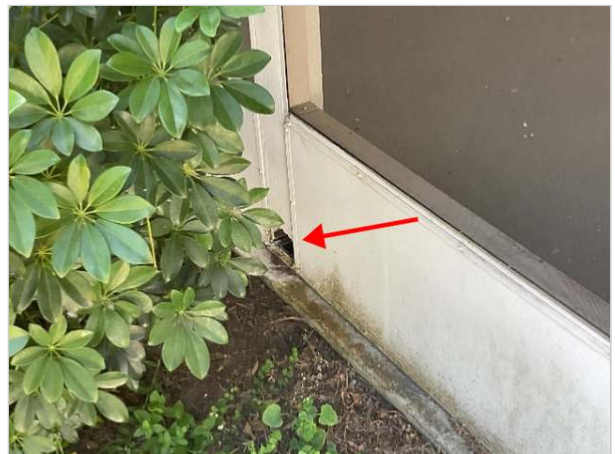
THE SUPPORT POSTS FOR THE SCREENED IN LANAI OR DETERIORATED. FURTHER EVALUATION FROM A LICENSED CONTRACTORS IS RECOMMENDED. FURTHER EVALUATION FROM LICENSED CONTRACTOR IS RECOMMENDED.

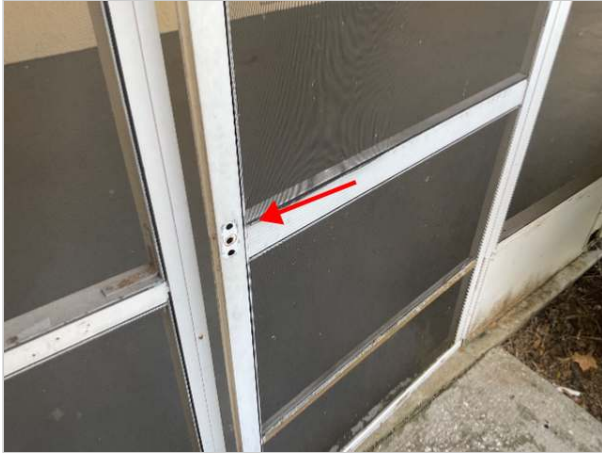
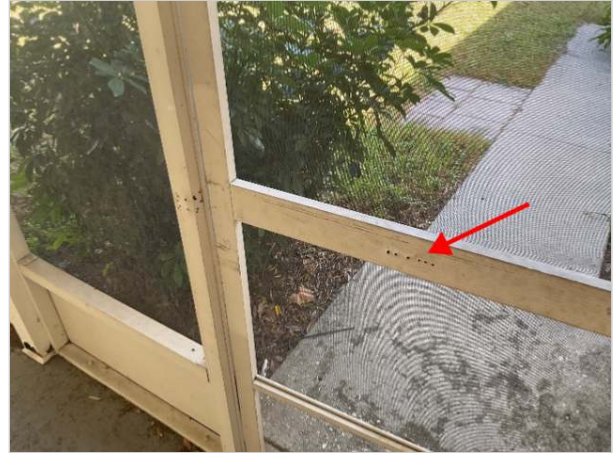
THE DOOR HANDLE AND CLOSER FOR THE LANAI SCREEN DOOR WAS MISSING.

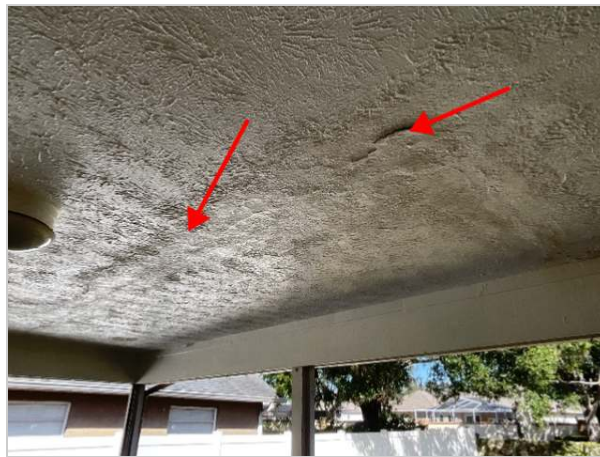
THE DRYWALL AT THE LANAI CEILING WAS DAMAGED. A MOISTURE METER WAS INSERTED AND FOUND NO ELEVATED MOISTURE READINGS.

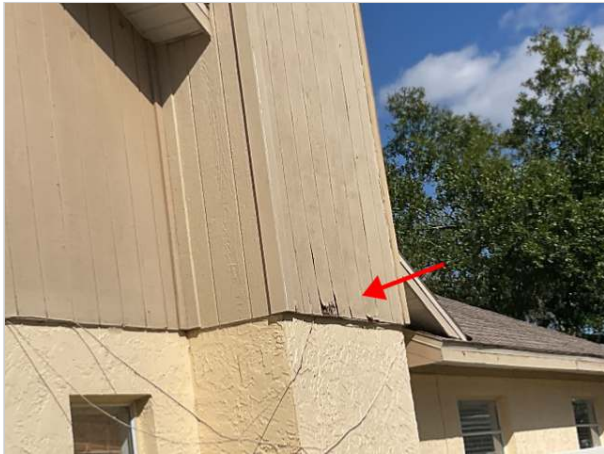
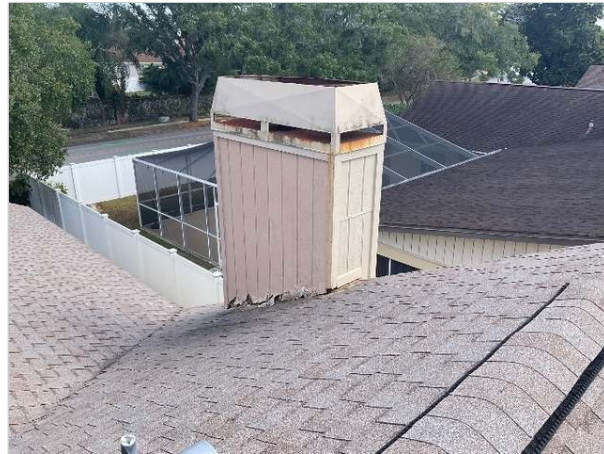
THE SIDING AROUND THE CHIMNEY WAS DETERIORATED.

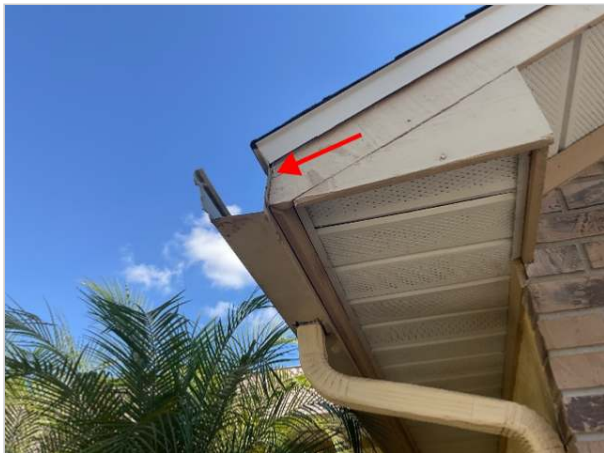
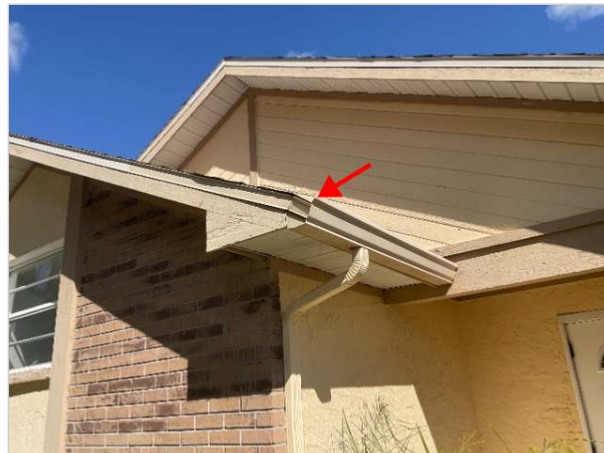
THE END CAPS FOR THE FRONT GUTTERS WERE MISSING.

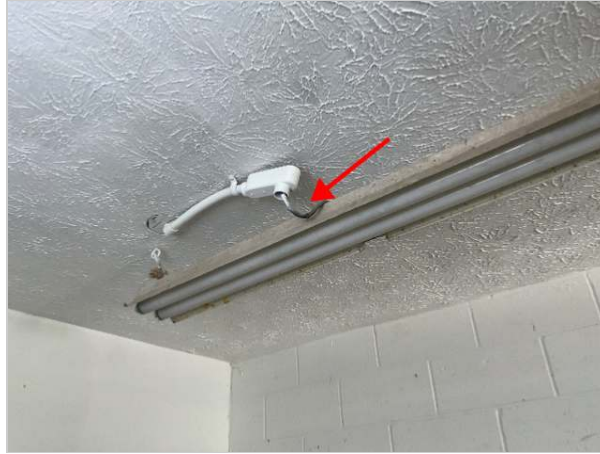
THE COVER/COVERS FOR THE LIGHTS IN THE FOLLOWING AREAS OF THE HOME WERE MISSING: GARAGE AND LAUNDRY.

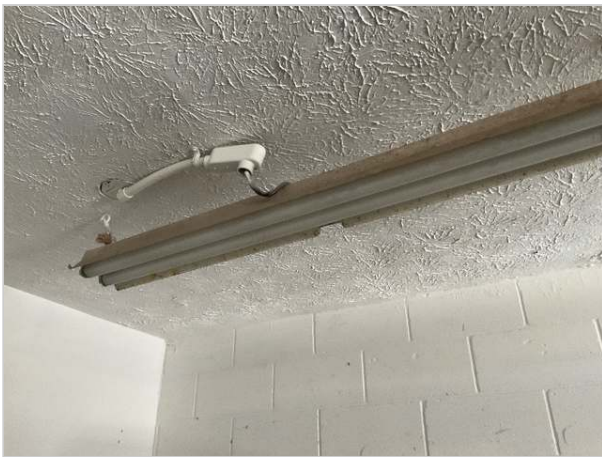
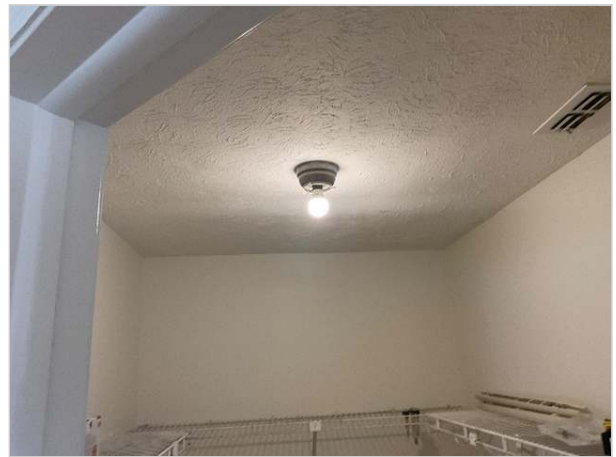
THERE WERE A NUMBER OF BURNT OUT/MISSING LIGHTBULBS OBSERVED THROUGHOUT THE HOME.

THE COVER/COVERS FOR THE LIGHTS IN THE FOLLOWING AREAS OF THE HOME WERE MISSING: MASTER BATHROOM.

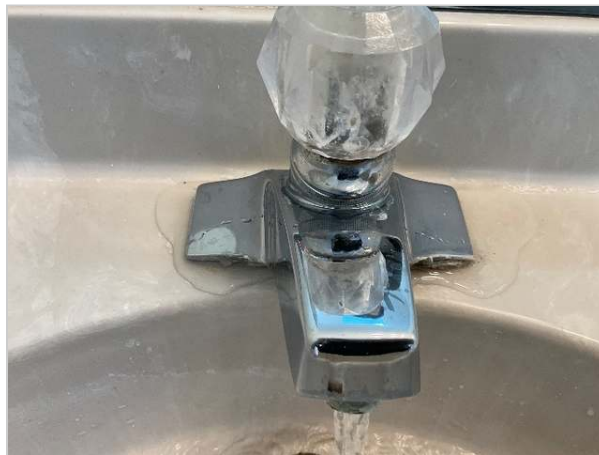
THE FAUCET HANDLE IN THE MASTER BATHROOM SINK WAS LEAKING .

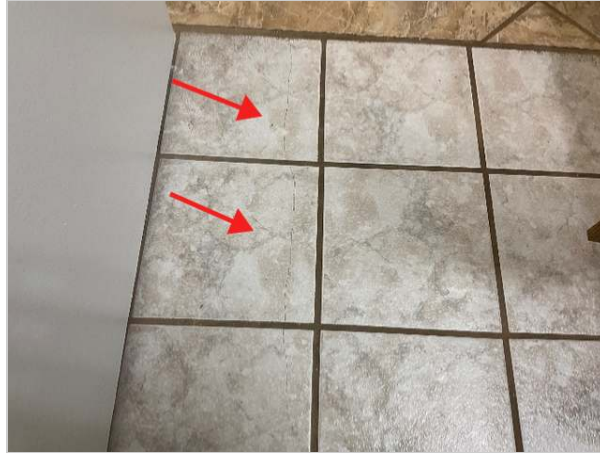
CRACKED FLOOR TILES WERE OBSERVED IN THE FOLLOWING AREAS OF THE HOME: HALL BATHROOM.

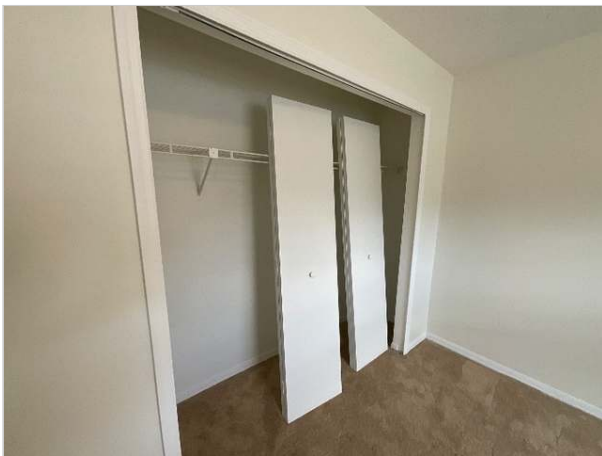
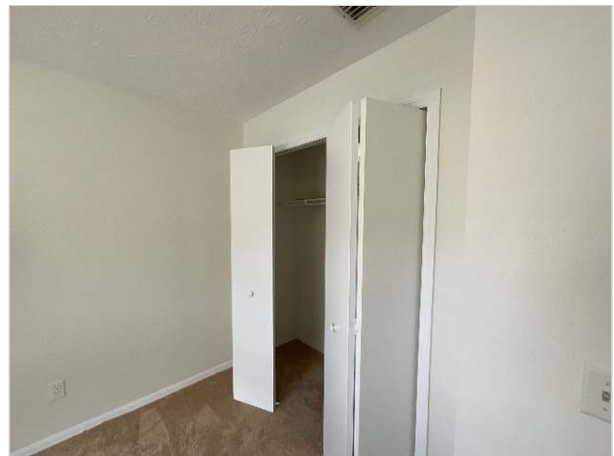
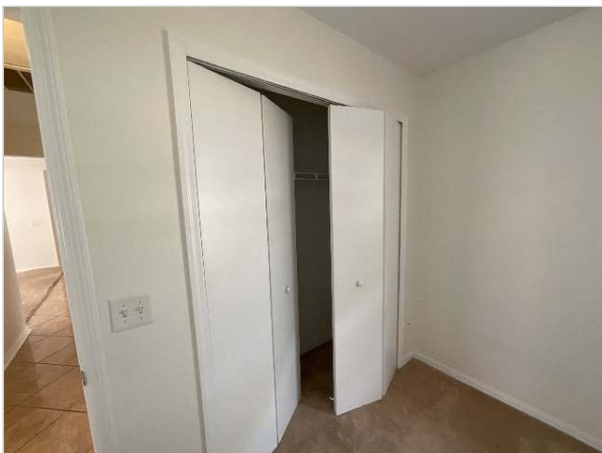
THE CLOSET DOORS IN THE HOME WERE OFF THEIR TRACKS.

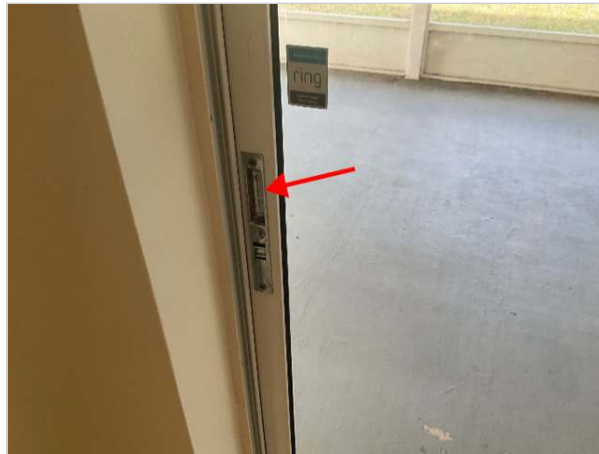
MULTIPLE WINDOWS REQUIRE MAINTENANCE. DIFFICULT OPERATION, SPRUNG BALLAST SPRINGS, AND

DAMAGED AND MISSING SCREENS WERE NOTED AT THE TIME OF THE INSPECTION.

THE LOCKING HARDWARE FOR THE SLIDING DOORS IN THE LIVING ROOM AND DINING ROOM WAS NOT FUNCTIONAL.

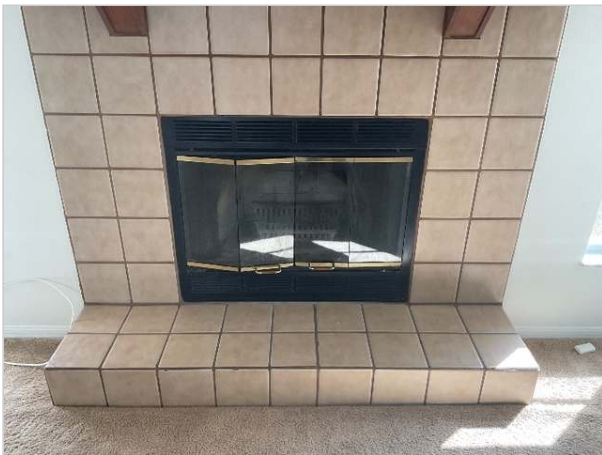
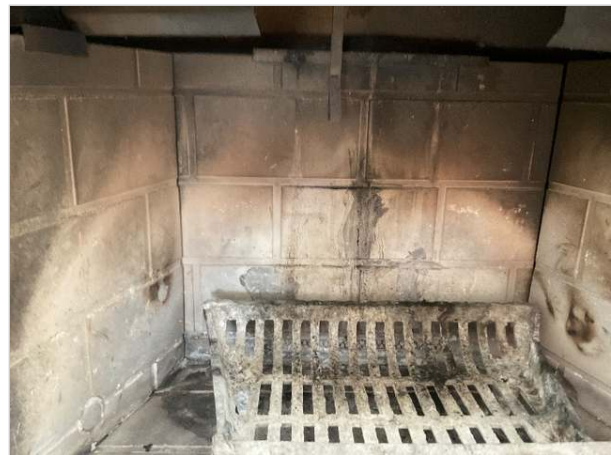
A wood burning fireplace was located in the family room. The damper did appear to be functional. There WAS visual evidence of moderate creosote buildup in the firebox and/or chimney. There were minor cracks observed in the firebox or visible portions of the chimney. For safety reasons, a fireplace and the chimney or pipe to which it is vented should be cleaned and re-inspected as there may be hidden defects, not fully visible at the time of the inspection. The fireplace was not tested for operation or function.

A HOME INSPECTION OF THE FIREPLACE AND CHIMNEY IS LIMITED TO THE READILY VISIBLE PORTIONS ONLY, AND THE FIREPLACE WAS NOT OPERATED. THE INNER REACHES OF THE FLUE ARE PRIMARILY INACCESSIBLE, AND OUR VIEW WAS NOT ADEQUATE TO IDENTIFY POSSIBLE DEFICIENCIES OR DAMAGE, EVEN WITH THE USE OF A STRONG LIGHT. FOR SAFE AND EFFICIENT OPERATION, WE RECOMMEND ANNUAL INSPECTIONS BY A QUALIFIED FIREPLACE PROFESSIONAL. A QUALIFIED CHIMNEY SWEEP CAN CLEAN THE INTERIOR IF NECESSARY, USING SPECIALIZED TOOLS, TESTING PROCEDURES, MIRRORS, AND VIDEO CAMERAS TO FULLY EVALUATE THE FIREPLACE SYSTEM. IF THE FIREPLACE HAS NOT BEEN CLEANED AND INSPECTED BY A QUALIFIED FIREPLACE PROFESSIONAL WITHIN THE PAST YEAR, WE RECOMMEND THIS BE DONE PRIOR TO USE.

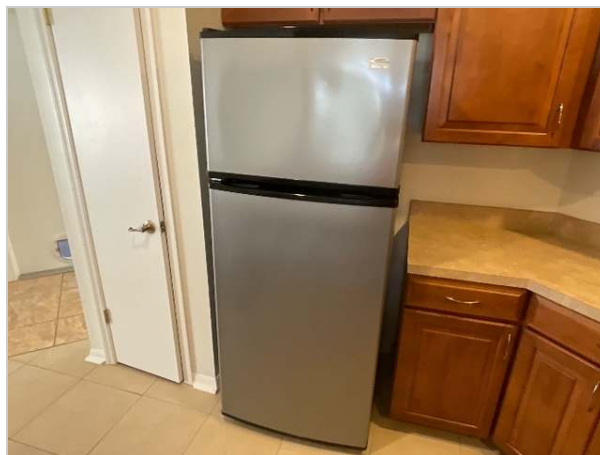
THE ICEMAKER WAS OFF AT THE TIME OF THE INSPECTION.

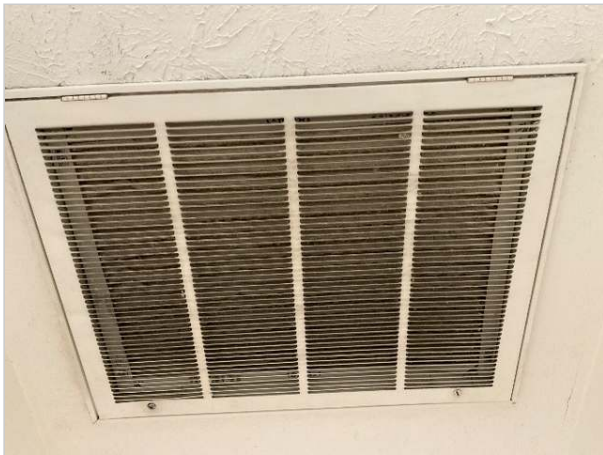
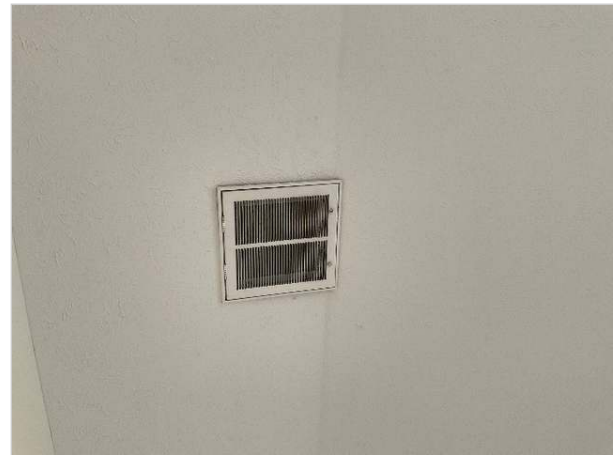
THE FILTER(S) ARE DIRTY AND NEED TO BE REPLACED.
