# HomeTeam<sup>®</sup>

### *HOME INSPECTION REPORT*

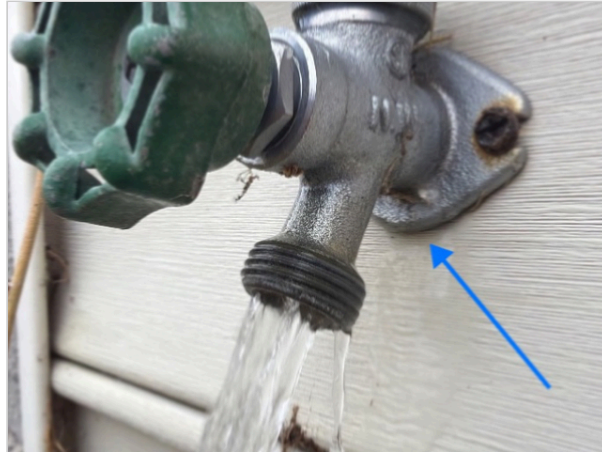
**A hose bib on the rear of the structure has a constant drip when operated.** The drip should be repaired.

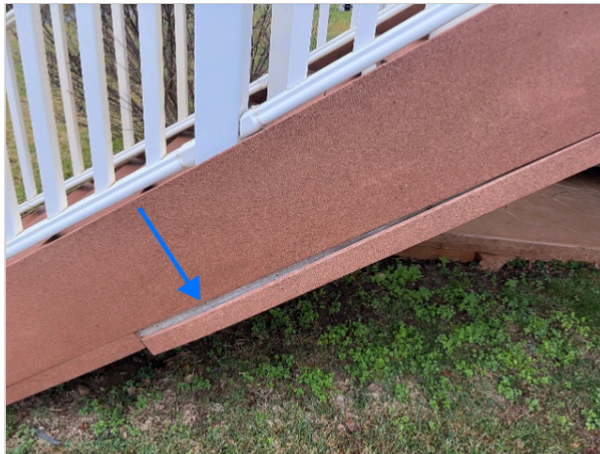
Loose trim on the right side of the steps leading to the deck. Recommend re-fastening.

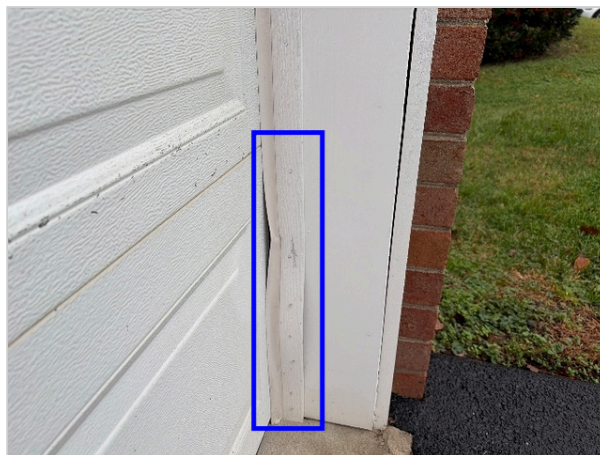
Loose weatherstripping around the right garage door. Recommend adjusting and resealing for a weather tight performance.

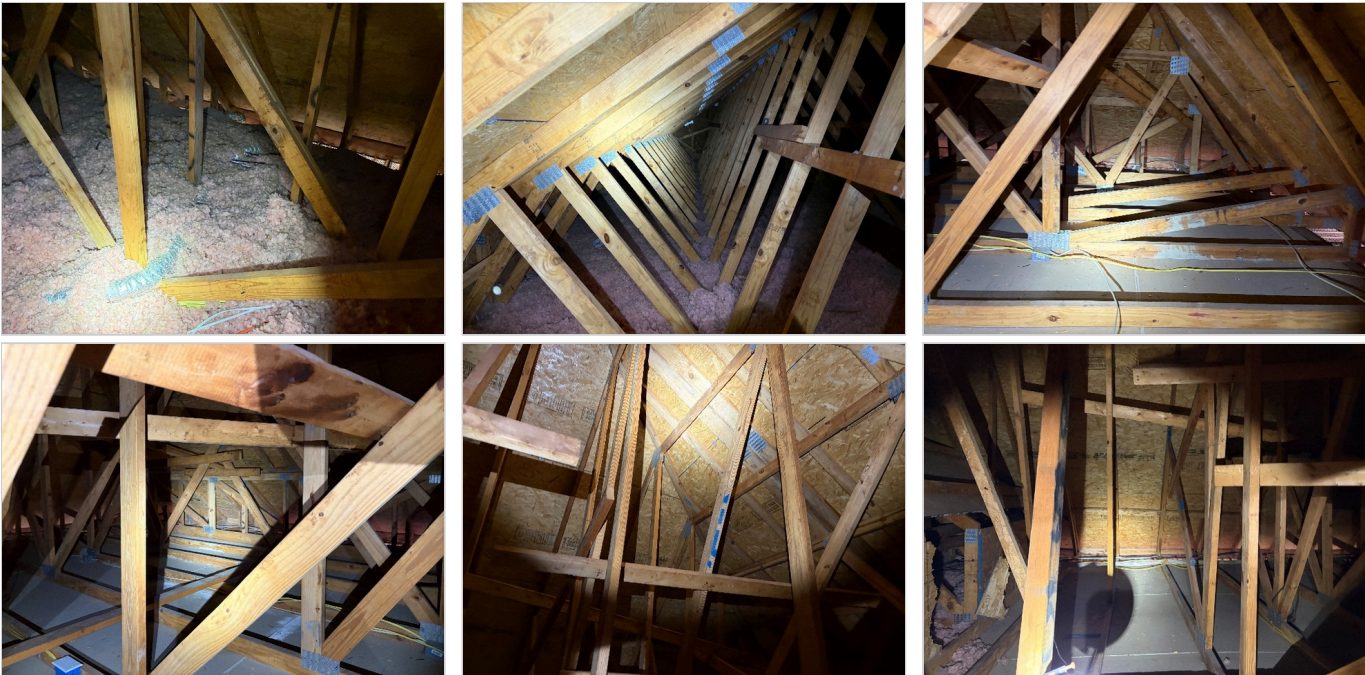
Water-damaged and deteriorated wood was observed on the exterior header board located behind the fascia on the right side of the house. This damage is not visible from the exterior and was only identifiable from within the garage attic space. The deterioration indicates moisture intrusion that may be ongoing and could compromise the structural integrity of the affected framing if not addressed. I recommend further evaluation and repairs by a licensed contractor. Corrections may include removing the fascia, replacing damaged wood, and identifying and repairing the source of moisture to prevent recurrence.

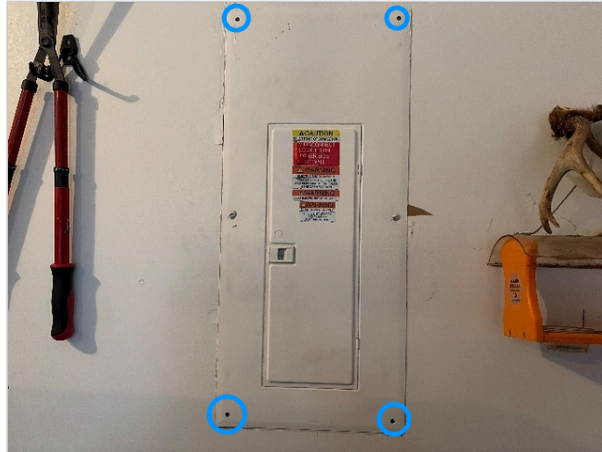
There was missing electrical panel cover screws. Recommend to provide hardware to properly attach the cover.

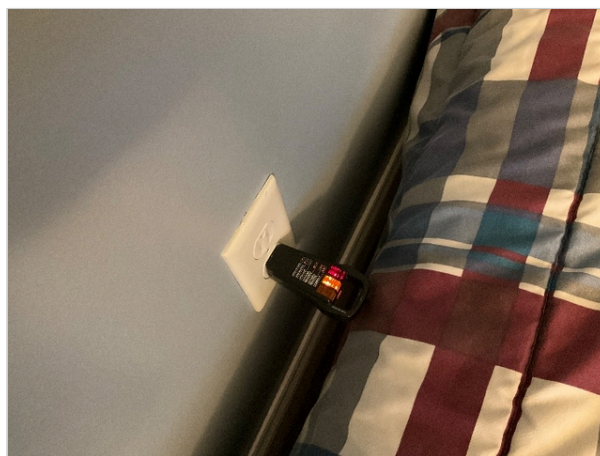
**One receptacles have hot and neutral wires reversed.** This is a safety concern and should be repaired and further assessed by a licensed electrician. Please note that we only test outlets that are visible and readily accessible at the time of the inspection.

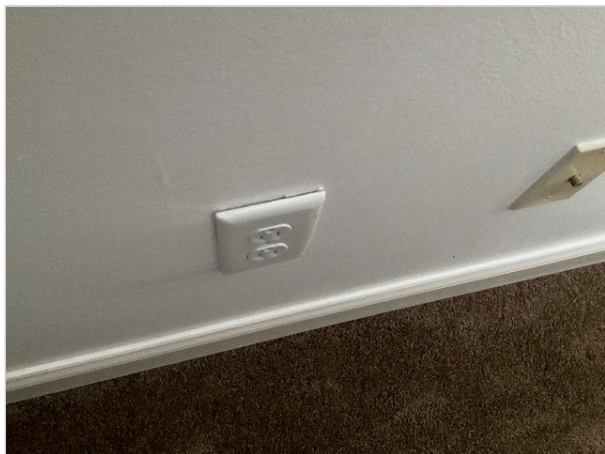
Bedroom facing street

Some of the outlets in the property were loose. Recommend to consult with an electrician.

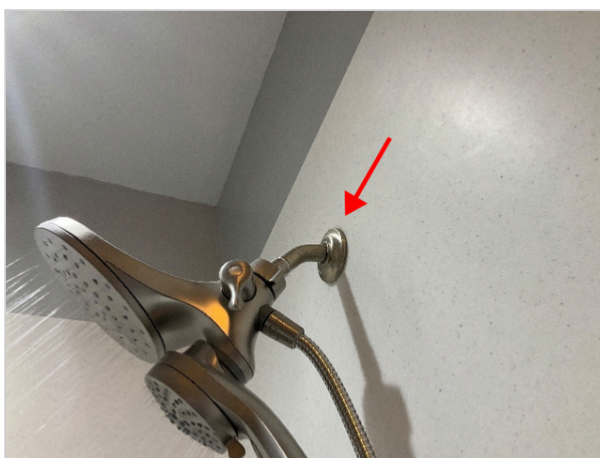
**The shower head for the master bathroom shower is loose where it attaches to the wall. The pipe should be secured and the area sealed in order to prevent water intrusion.**

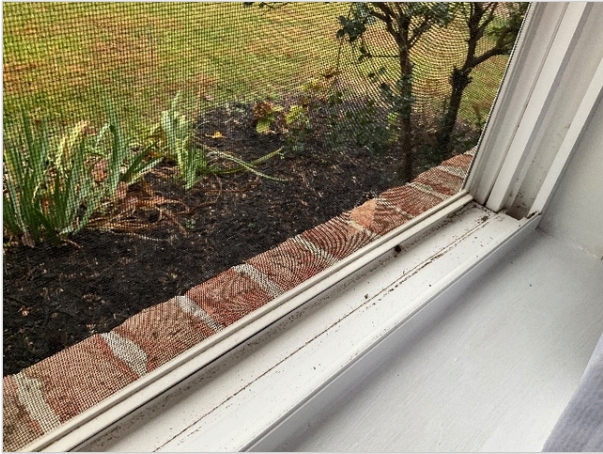
Some window screens had damage.

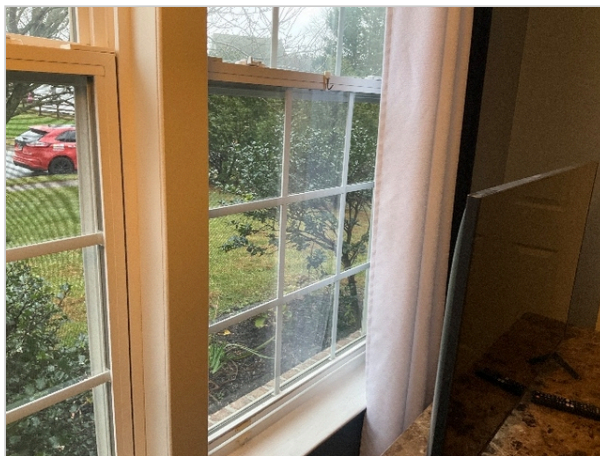
**A broken window tensioner is present on one of the windows.** This condition is usually caused by a defective balancer (or tensioner) mechanism and prevents a window from staying in the open position without support. The affected windows should be repaired, or some other safe method implemented to raise, lower, and hold position for affected windows.

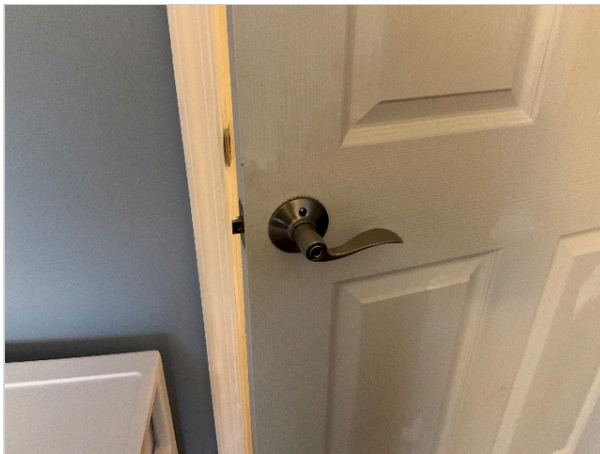
Once halfway shut, slams closed. Bedroom facing street.

**The bedroom facing the street door lock is inoperable or otherwise in need of repair.** Recommend repair or replacement.

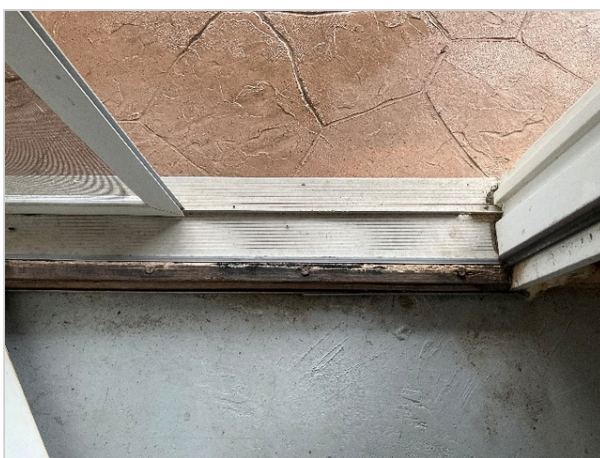
**Rotted wood was present on the basement door frame** . The areas should be repaired and further evaluated at the time of repair.

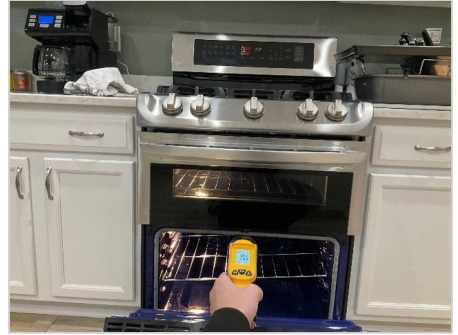
The anti tip bracket was not installed on range. If weight or pressure is applied to open oven door range can tip causing serious harm or injury. Recommend to install bracket.

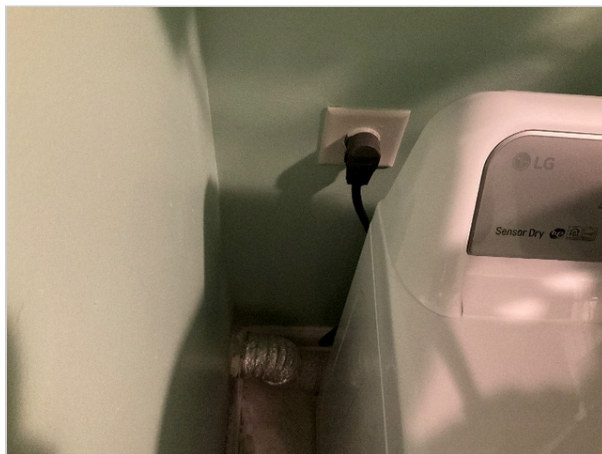
**The dryer vent duct work exceeds the recommended length, increasing the likelihood of clogs and potential heat damage.** For safety, a clothes dryer duct should not exceed 35 feet (reduced to 25 feet for gas dryers). This length should be decreased by 2.5 feet for every 45 degree turn, and 5 feet for every 90 degree turn (the elbow in the wall at the dryer connection is not to be included in this formula). The dryer ductwork should be repaired.

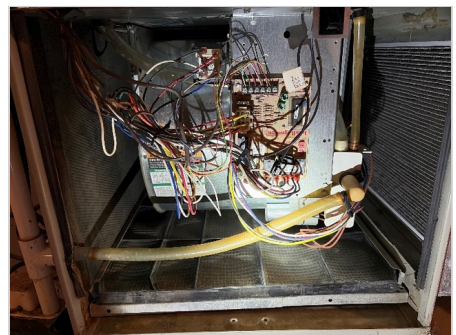
The furnace may be past its design life. This is an informational note only to help give an idea of future budgeting considerations. The system was functional at the time of the inspection unless noted otherwise. Please note that since codes change, it is possible the configuration for the flue and/or condensate lines may need to be altered at the time of a future replacement.
