# PROPERTY INSPECTION REPORT

**Prepared For:** John Doe  
(Name of Client)

**Concerning:** 1234 Anywhere St, Anytown, TX, 12345  
(Address or Other Identification of Inspected Property)

**By:** Jerimy Schiewe (# 21015) Dale Lockamy (# 22446) Bobby McDonald (# 8094) 01-01-2026  
(Name and License Number of Inspector) (Date)

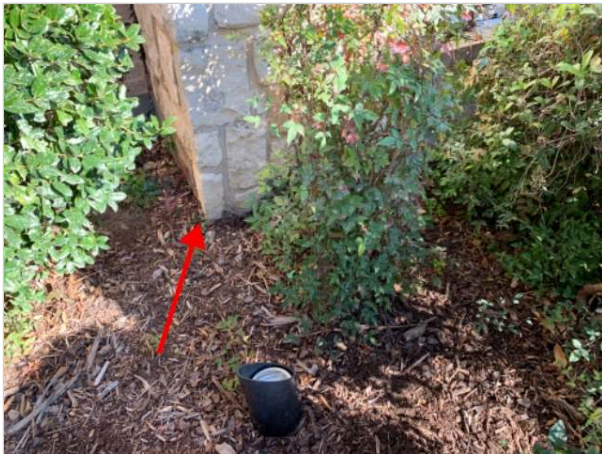
A

The soil level was too high at front (PIC A); the foundation was not fully visible. Recommend a 2"-4" exposure on the foundation below brick and/or siding around the entire perimeter.

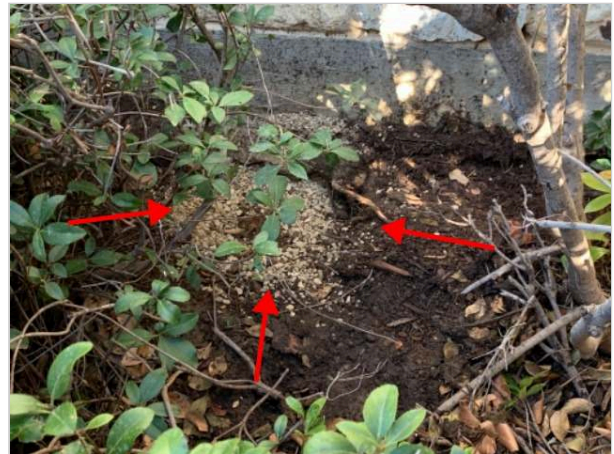
B

The soil was unlevel or too low adjacent to the foundation at front right (PIC B). Add and/or regrade soil as needed to prevent standing water at areas adjacent to the foundation.

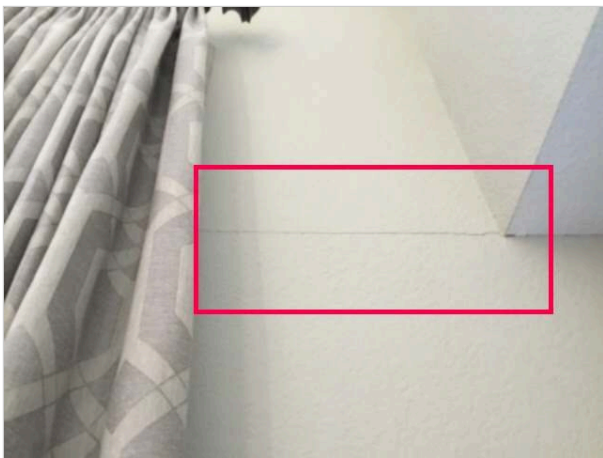
1A

Sheetrock crack(s) were observed on interior wall surfaces at rear right in rear living room (PIC 1A) and front right at door entry in upstairs rear left bedroom (PIC 1B).

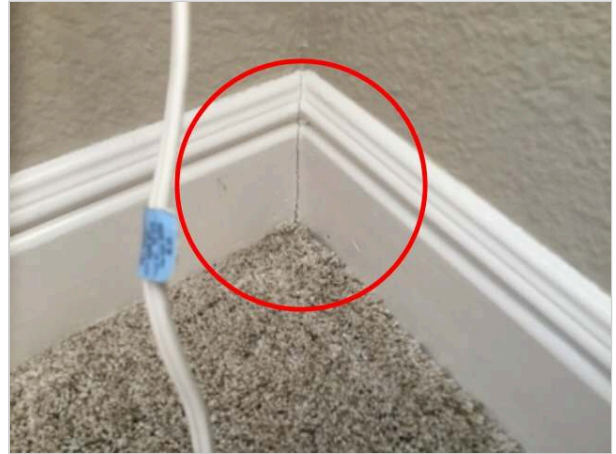
1D

Gaps were observed in baseboard joint(s) at front left corner in front dining room (PIC 1D) and rear left corner in study (PIC 1E).

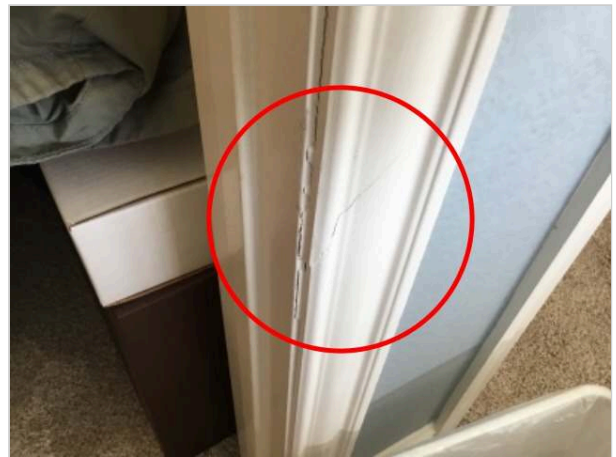
1F

Door trim was damaged at closet entry in upstairs front left bedroom (PIC 1F)

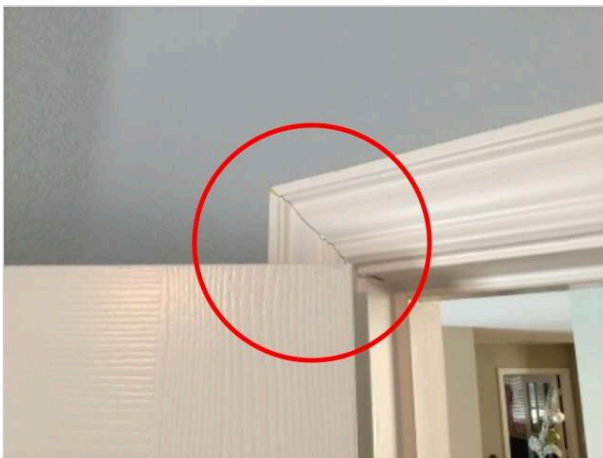
1G

Gap(s) were observed on interior door trim at upstairs rear left bedroom entry (PIC 1G) and upstairs hallway bath entry (PIC 1H).

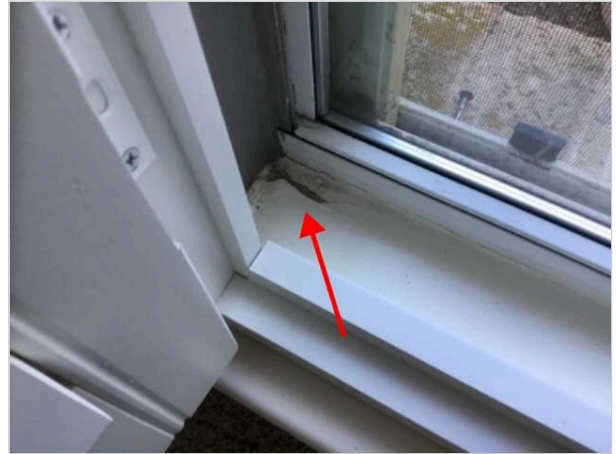
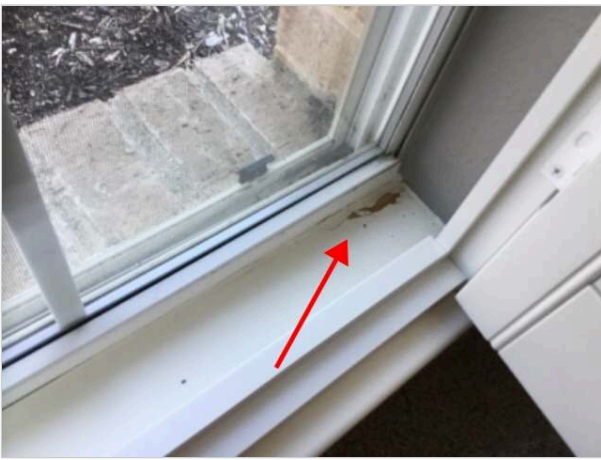
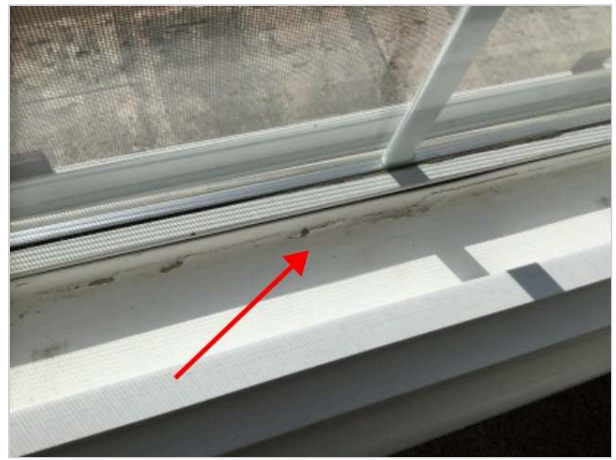
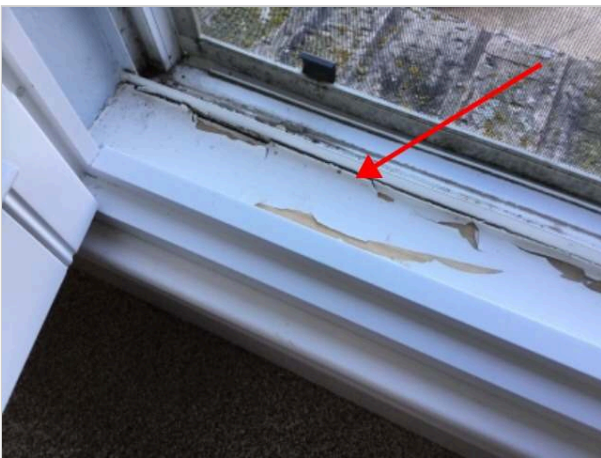
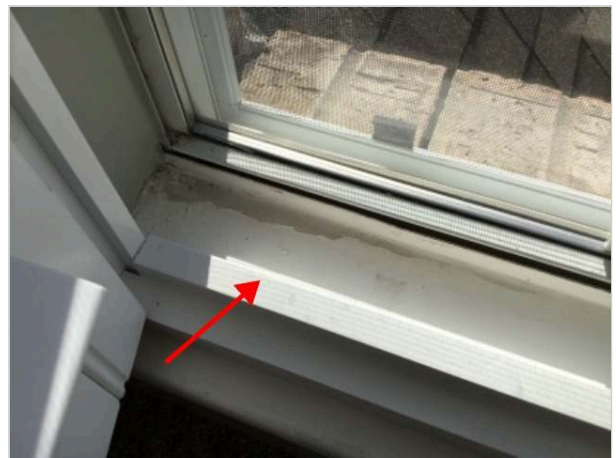
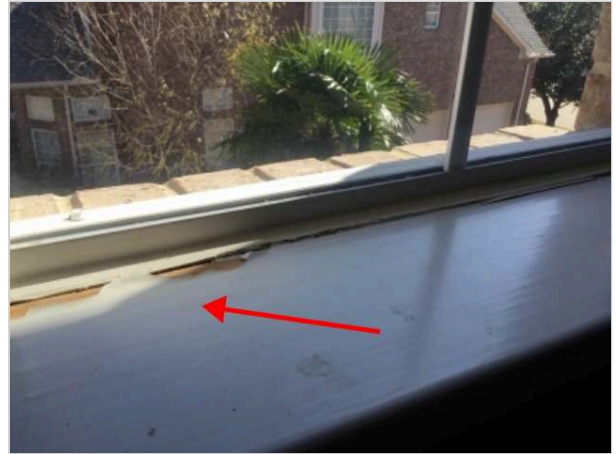
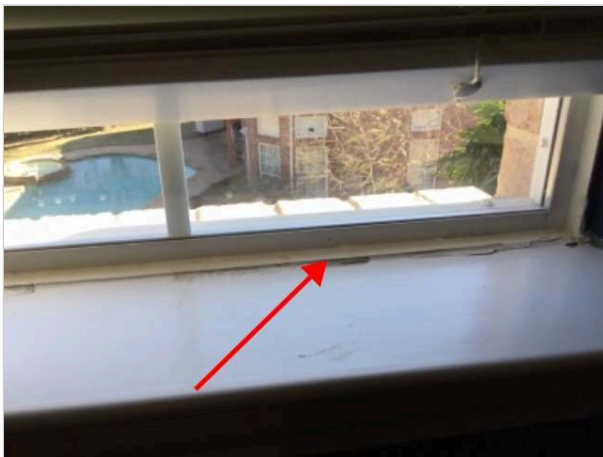
Water damage was observed on window sill(s) at multiple windows at rear in master bedroom (PIC 1I,1J,1K), left window in upstairs front left bedroom (PIC 1L), upstairs rear left bedroom (PIC 1M), upstairs front right bedroom (PIC 1N,1O) and windows in upstairs living room(4) (PIC 1P,1Q).

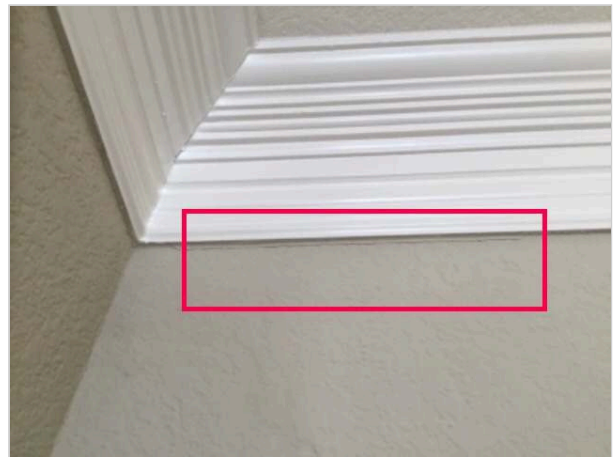
1R

Separation was observed at wall surfaces and bottom of crown molding at rear left and left side rear in front dining room (PIC 1R).

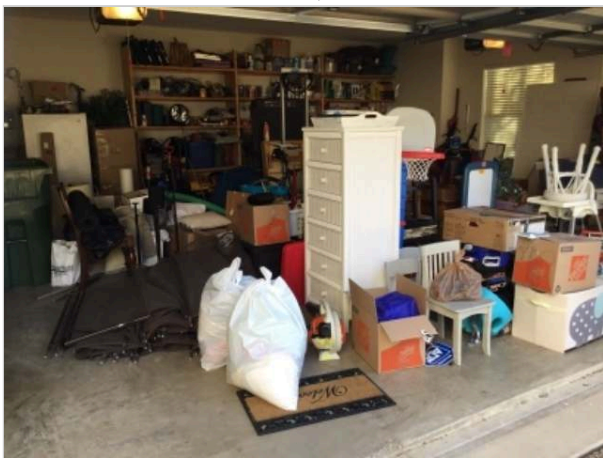
1S

Interior walls were inaccessible throughout garage due to storage and personnel belongings (PIC 1S).

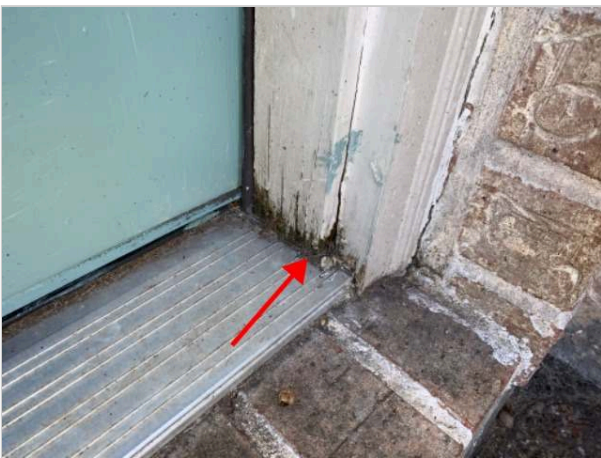
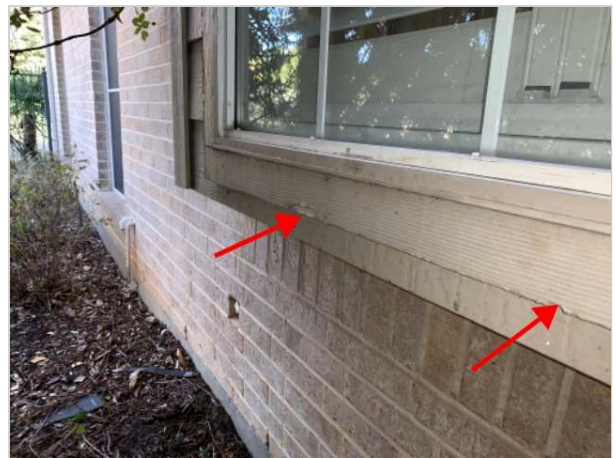
Dry rot was observed at right and left side bottom (PIC 2E, 2F) of rear entry.

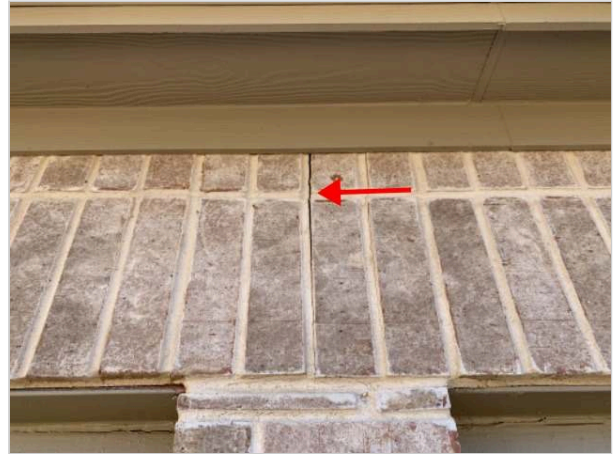
2I

Separation was observed at front right between garage doors (PIC 2I).

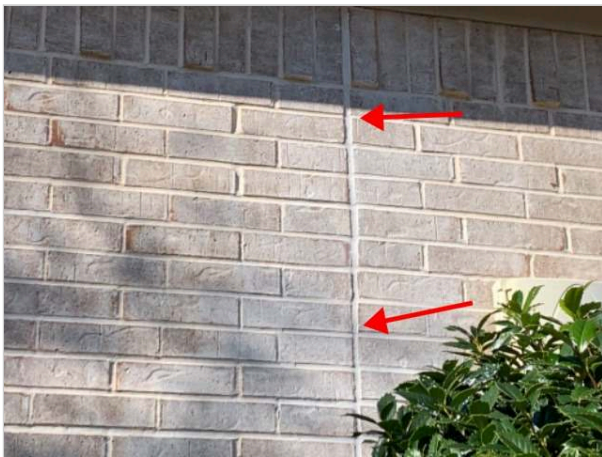
2J

- Separation was observed at front right between garage doors (PIC 2I).
- Trim all bushes, shrubs and trees away from exterior walls.
- The right side front expansion joint was filled with mortar (PIC 2J).

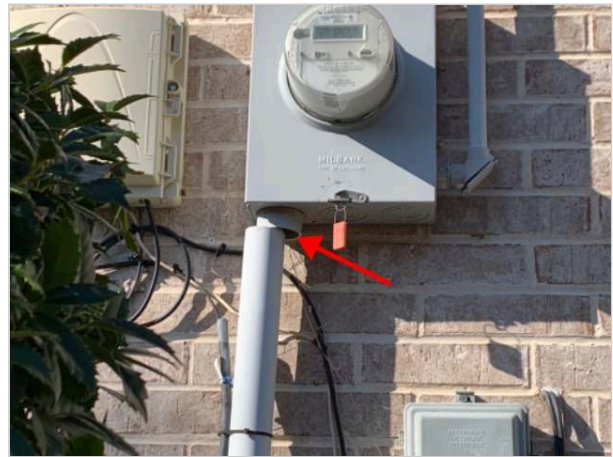
Arc-fault circuit protection has been required in some form in most cities since approximately 2002. Standards for which circuits require protection have changed over the years. There was no arc-fault circuit protection observed in the service panel at the time of the inspection. A gap was observed between conduit and meter box at right side exterior (PIC A).

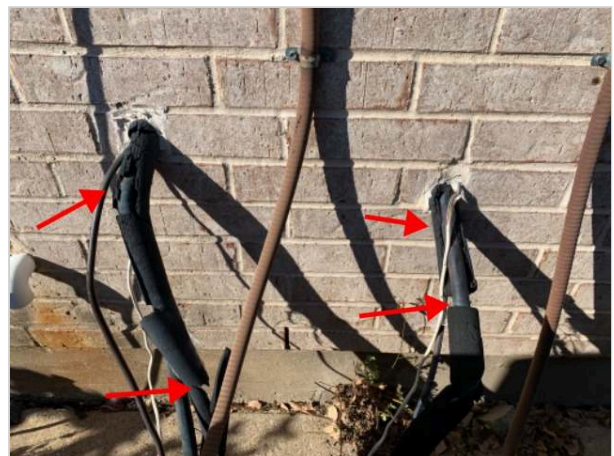
A

Insulation was damaged and/or missing on the refrigerant line(s) at right side exterior (PIC A).

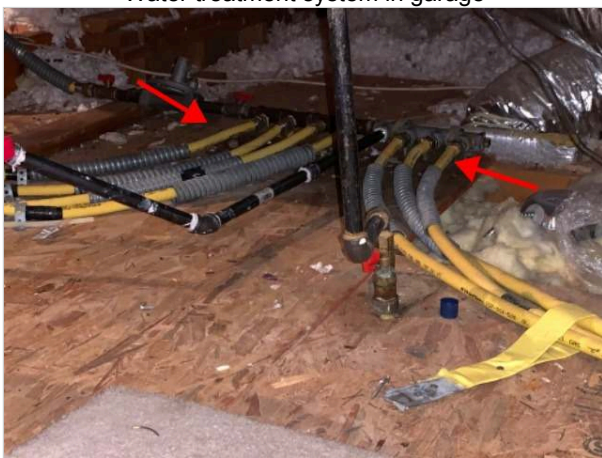
A

CSST gas lines were used for natural gas distribution; the CSST gas supply system was not inspected for proper bonding (PIC A).
