### *HOME INSPECTION REPORT*

On Tuesday, January 13, 2026 The HomeTeam Inspection Service made a visual inspection of 123 Anywhere St, Anytown, ST 12345. Enclosed please find a written, narrative report of our findings in accordance with the terms of our Inspection Agreement.

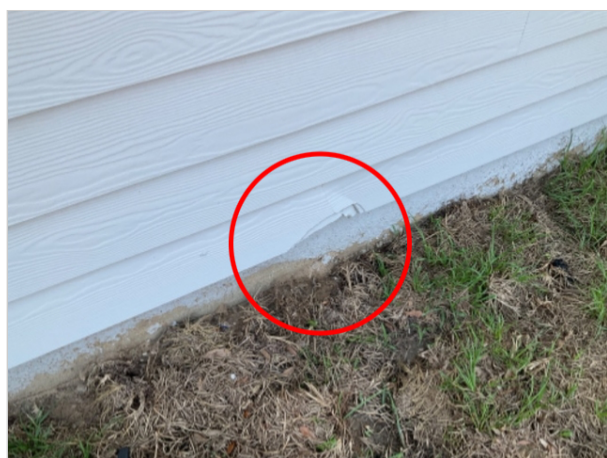
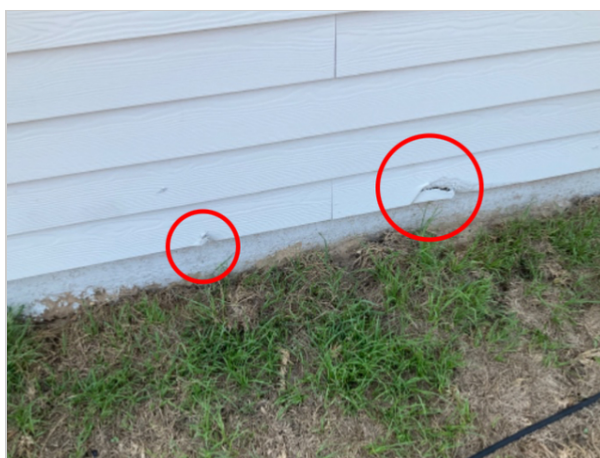
**Photo 1**

**Damaged siding was noted on the right side of the structure's exterior.** This condition does not have any effect on the structural integrity of the building. The areas should be repaired to prevent water intrusion.

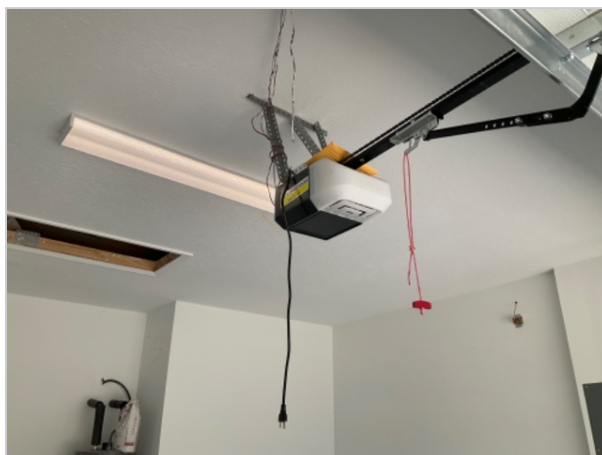
**Photo 20**

**The automatic garage door opener was not functional at the time of the inspection.** Consult with a garage door service for evaluation and repair.

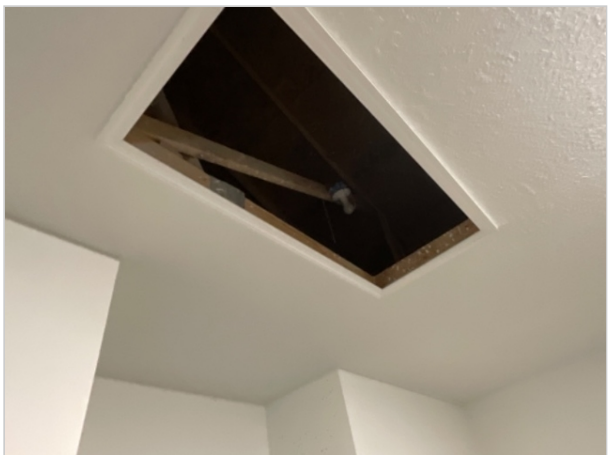
**Photo 31**

The hatch cover for the attic access is missing. The hatch and/or opening should be replaced to prevent accidental falling of the cover. This repair will also help the overall fire safety of the structure.

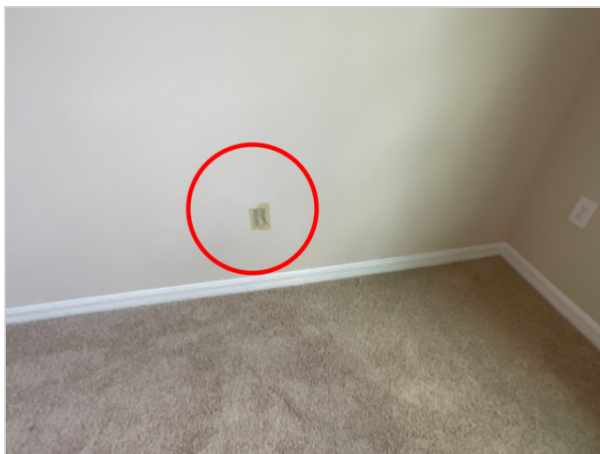
**Photo 40**

**Missing switch or outlet covers were observed in bedroom.** All switch and outlet boxes should be properly covered to avoid a shock hazard. Electrical repairs should be performed by a qualified electrician.

Front left room

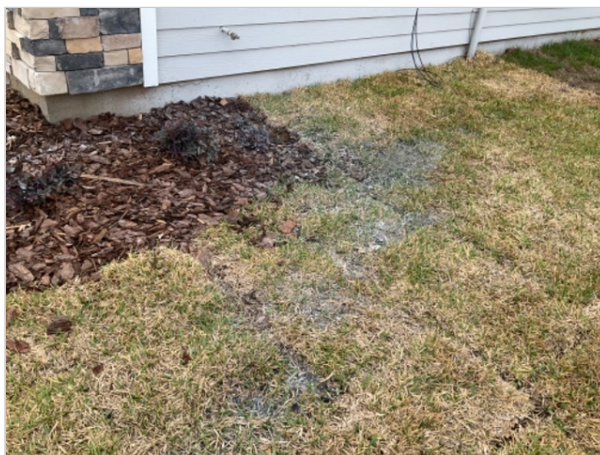
**Photo 41**

Water was found seeping out of the ground on the right side of the home. Recommend to repair or replaced damage plumbing.

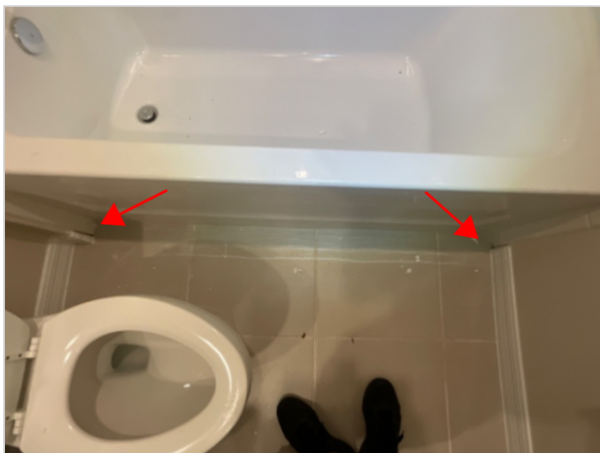
**Photo 47**

**Some of the caulk was missing from around the tub in the hall bathroom.** These areas should be sealed to prevent moisture penetration. Failure to keep walls sealed can cause deterioration and extensive moisture damage including mold growth to the interior walls, which is not always visible at the time of the inspection.

Guest bath

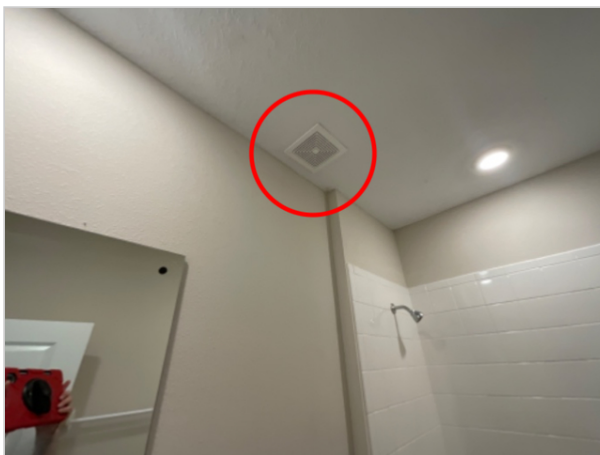
**Photo 48**

**The hallway bathroom exhaust fan was not operable** at the time of the inspection. A working exhaust fan, ducted to the exterior of the structure should be installed in the absence of an operable window. The fan should be repaired or replaced.

Guest bath

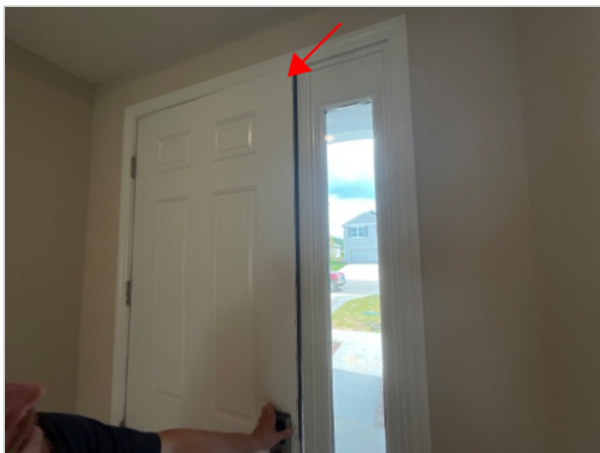
**Photo 55**

Front door door sticks when open and closing. Repair as needed.

Front door

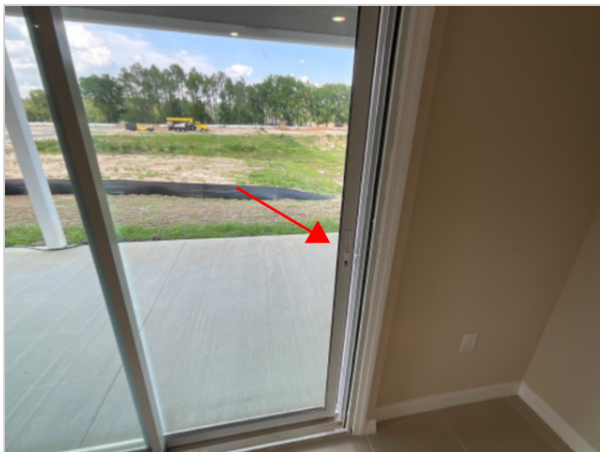
**Photo 56**

**The back lock is inoperable or otherwise in need of repair.** For personal security consult with a qualified locksmith for repair.

Rear

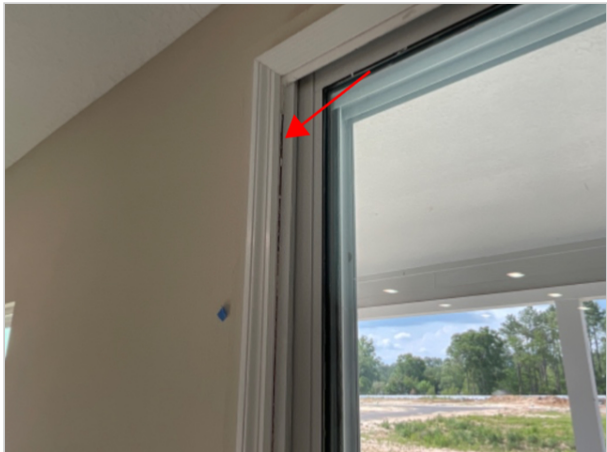
**Photo 57**

Caulking on rear door is missing. Consult builder for repair.

Rear

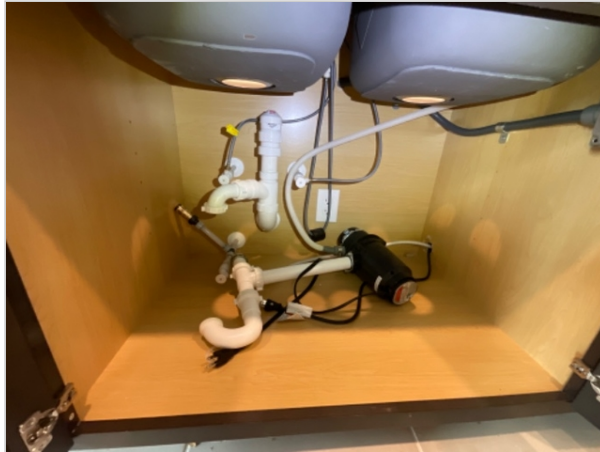
**Photo 59**

The plumbing to the kitchen sink was not complete and unable to test. Consult builder to repair as needed.

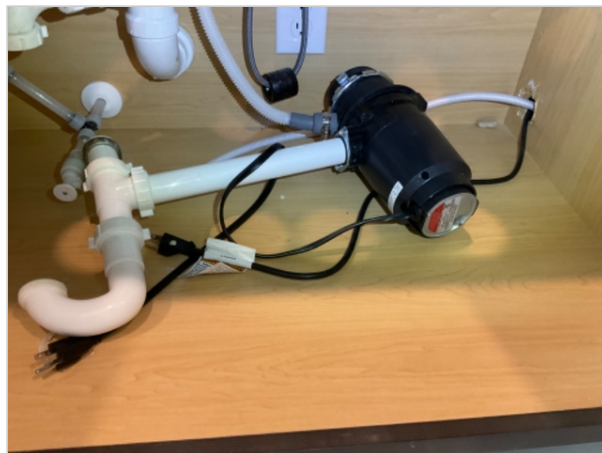
**Photo 73**

The disposal was inspected and did not appear to be functional. The efficiency rating and chopping / grinding ability of the unit is not within the scope of the inspection.

**The disposal is not operable.** Consult with a qualified plumber for repair or replacement.

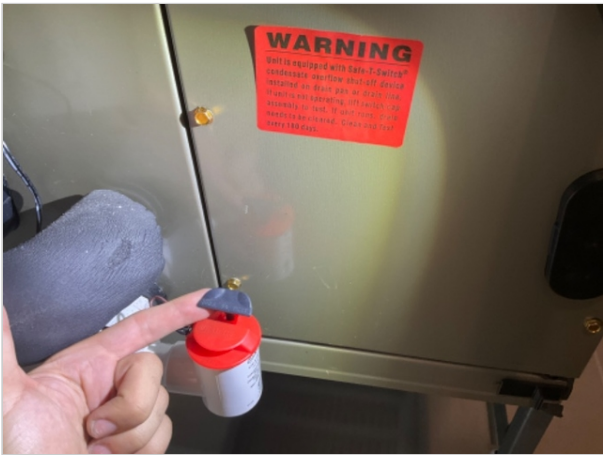
Photo 78

**The cutoff switch for the air handler did not function when tested.** The cutoff switch should be repaired or replaced to provide the intended safety features for this unit.
