**HomeTeam<sup>®</sup>**  
INSPECTION SERVICE

**123 Main Street  
RE: Anywhere, PA 12345  
Inspection #: 123-456-789**

### *HOME INSPECTION REPORT*

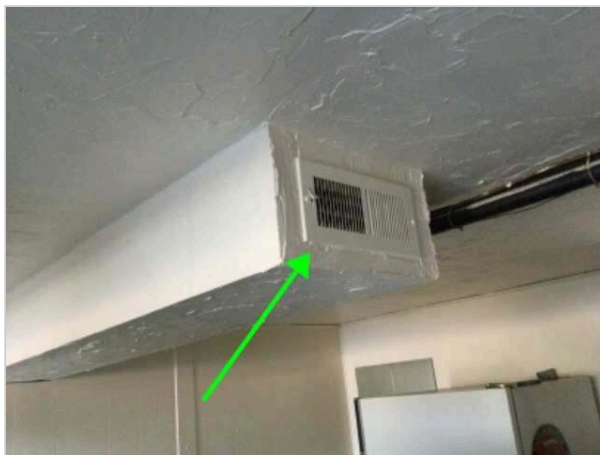
### *SAFETY NOTE: OPEN AIR DUCT IN GARAGE*

An open heating duct was noted in the garage. There should be no open air ducts in the garage. Fumes containing carbon monoxide from the exhaust of a car can enter the heating and air conditioning ducts and become a health hazard. The duct should be removed and the opening sealed.

Open air vent in garage

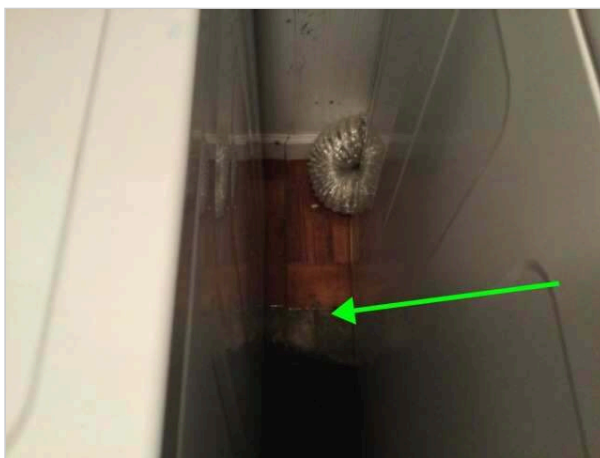
**NOTE: BASEMENT MOISTURE EVIDENCE:**

There were signs of moisture on the basement floor. The area was not dry at the time of the inspection. Dampness on basement walls is not always a sign of water intrusion. The dampness can be the result of warm humid air making contact with cool walls. In many cases the humid air condenses on the wall and forms a layer of moisture. It is important to assess whether moisture on the basement walls is the result of water intrusion or condensation. The cause of the observed condition in this case could not be determined. The exterior grading in the affected area is questionable. Many water intrusion problems can be controlled by improving the drainage on the exterior of the home. It is important that all roof drainage and surface water is directed away from the foundation. The area should be monitored during periods of heavy rain to better assess the cause.

Water under the washer

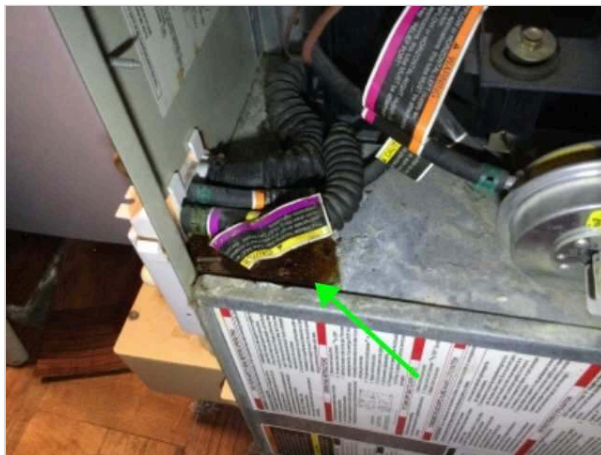
**NOTE: WATER INSIDE FURNACE COMPARTMENT:**

Water was noted inside the furnace compartment. The condition is most likely caused by a condensate leak in the furnace and/or air conditioning condensate drain lines. The water can also be caused by a leaking humidifier if one is installed. Water inside the furnace compartment can damage the furnace cabinet or other operational components and should be repaired. The furnace compartment was wet at the time of the inspection. Consult with a qualified heating contractor to determine the source of the water and correct the issue. Please also note that due to the seasonal use of heating and air conditioning systems, wet and dry conditions can change based on whether the inspection is performed during the heating or cooling season. The observation at the time of the inspection can be limited to seasonal conditions.

Water inside furnace
