# HomeTeam<sup>®</sup>

### *HOME INSPECTION REPORT*

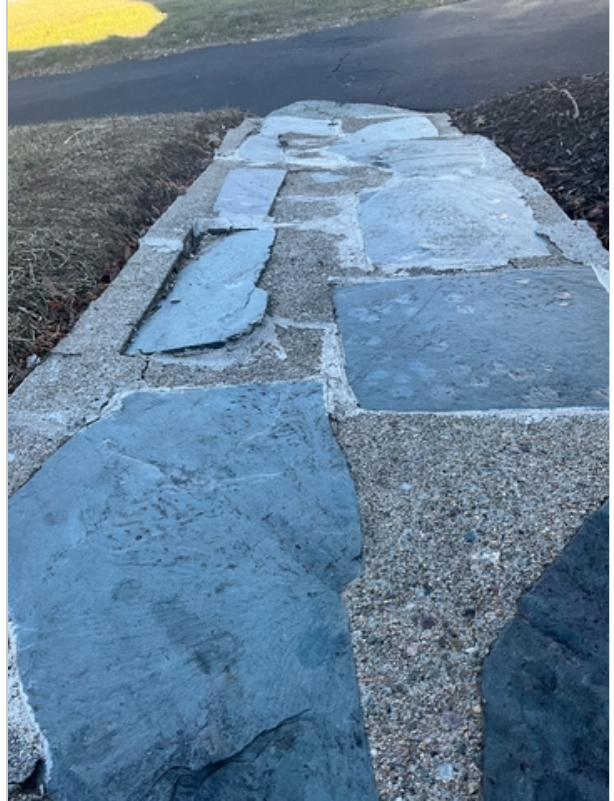
**Photo 20**

**Trip hazards were present on the walkways** around the house. The hazards can be repaired using a suitable or similar surfacing material to "feather" the out-of-level condition to make a smooth transition.

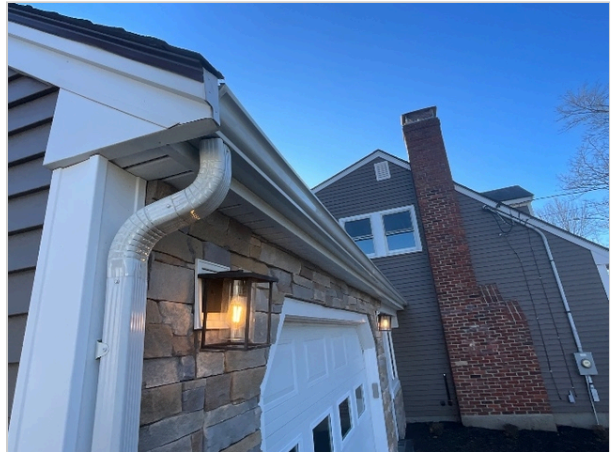
**Photo 24**

**Downspouts were draining at or too close to the base of the foundation.** To reduce the likelihood of water problems at the base of the structure, all roof drainage should be directed at least six feet from the base of the foundation.

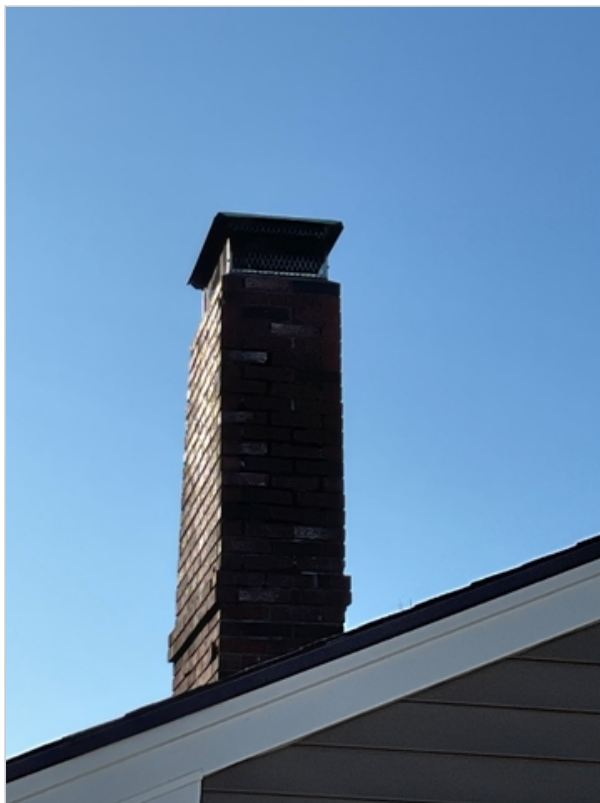
**Photo 44**

**The chimney on the back appeared to be leaning a bit outward.** Recommended monitoring in the future and, if necessary, further evaluation with a licensed contractor.

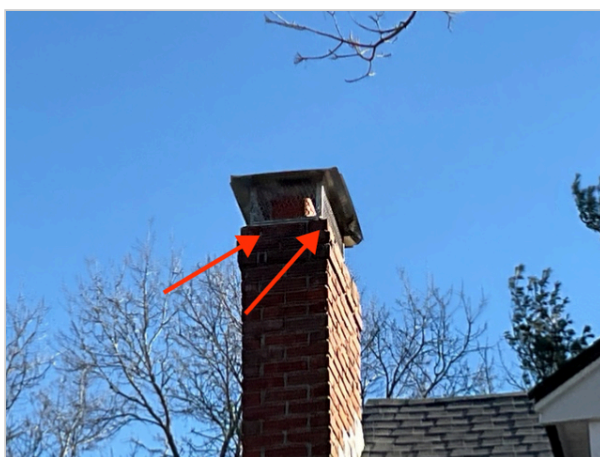
**Photo 45**

**Missing mortar was observed in the front chimney's brickwork, around the crown.** The chimney should be repaired to prevent further deterioration. Depending on the assessment and extent of interior damage, this may result in a material defect.

1. The back of the roof was in the second half of its life span
2. **Missing mortar was observed in the front chimney's brickwork, around the crown.** The chimney should be repaired to prevent further deterioration. Depending on the assessment and extent of interior damage, this may result in a material defect.
3. **The chimney on the back appeared to be leaning a bit outward.** Recommended monitoring in the future and, if necessary, further evaluation with a licensed contractor.

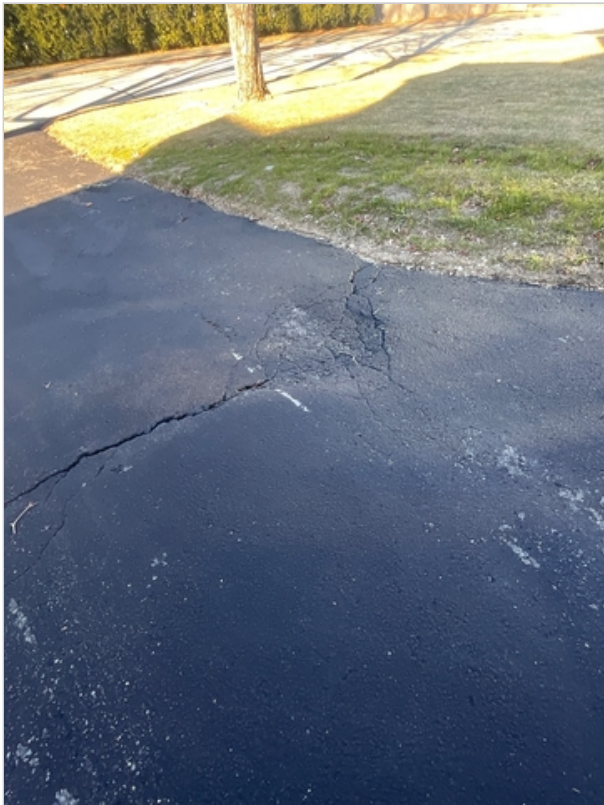
**Photo 67**

**A few areas of the driveway have settled.** This condition indicates a possible void under the driveway. Driveway settling has led to potential tripping hazards. The areas should be monitored and repaired as needed.

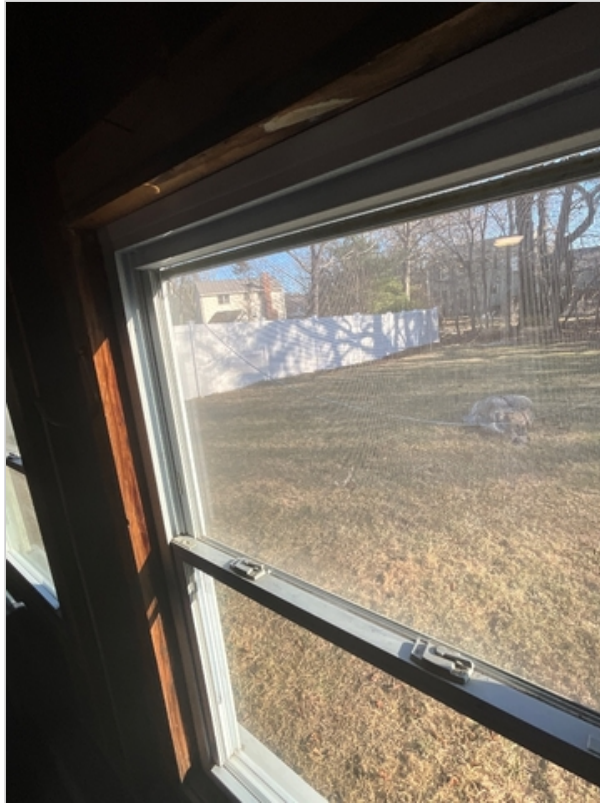
**Photo 78**

**Broken glass was observed on the garage window.** For safety and security all cracked and broken glass should be replaced or repaired.

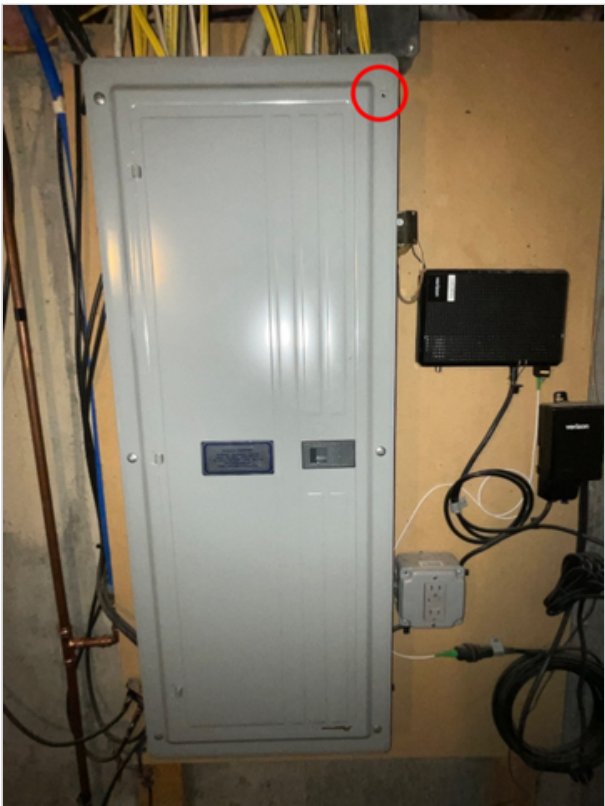
**Photo 92**

Missing screws to attached panel cover. Recommend having a licensed electrician repair.

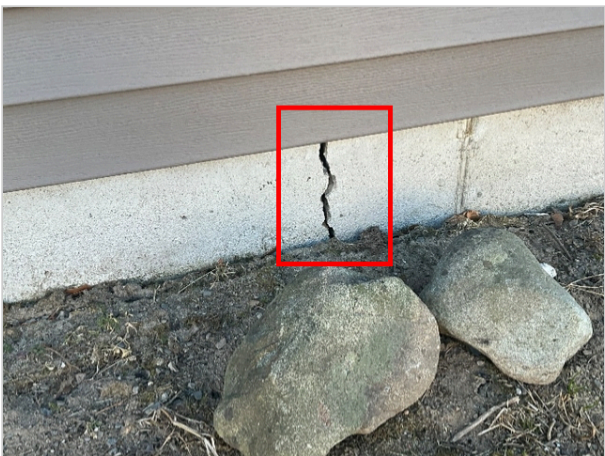
**Photo 102**

Cracks were observed on the foundation. HomeTeam recommends having these cracks professionally sealed by a foundation repair company. Cracks greater than 1/8" wide should be reviewed by foundation professional. Below-grade cracks are highly susceptible to water intrusion during times of heavy rain. HomeTeam recommends sealing these cracks.

1. Cracks were observed on the foundation. HomeTeam recommends having these cracks professionally sealed by a foundation repair company. Cracks greater than 1/8" wide should be reviewed by foundation professional. Below-grade cracks are highly susceptible to water intrusion during times of heavy rain. HomeTeam recommends sealing these cracks.

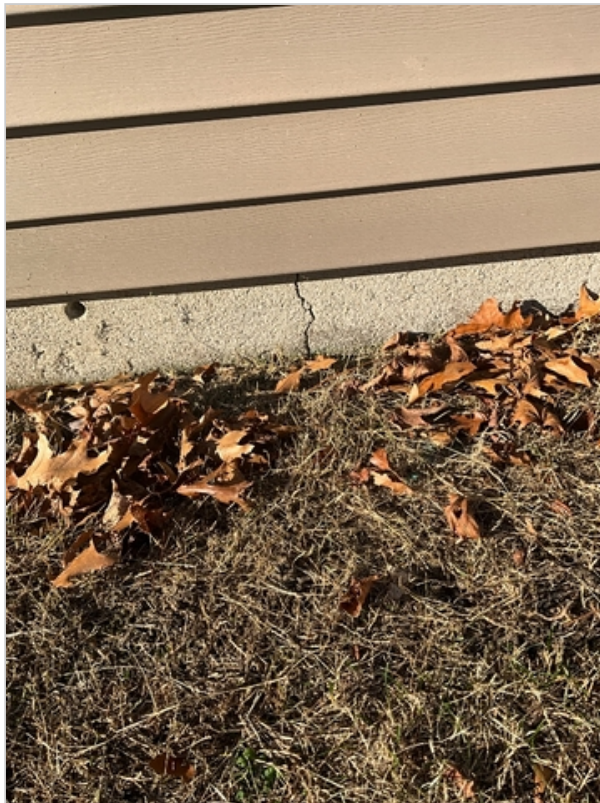
**Photo 103**

Small cracks were observed on the foundation. The homeowner should monitor these cracks for any changes, and if changes are noted, should contact a structural repair company for further analysis. Below-grade cracks are highly susceptible to water intrusion during times of heavy rain. Water staining from previous water intrusion was not visible. HomeTeam recommends sealing these cracks if a watertight basement is desired.

2. Small cracks were observed on the foundation. The homeowner should monitor these cracks for any changes, and if changes are noted, should contact a structural repair company for further analysis. Below-grade cracks are highly susceptible to water intrusion during times of heavy rain. Water staining from previous water intrusion was not visible. HomeTeam recommends sealing these cracks if a watertight basement is desired.

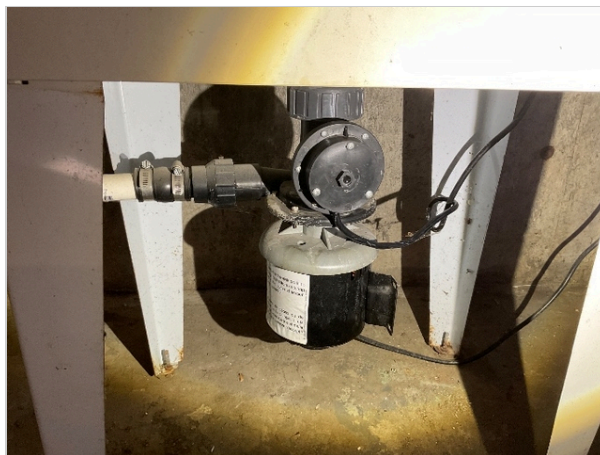
**Photo 116**

An ejector pump was present underneath the basement sink. The ejector pump was tested and found questionable .

Recommended further evaluation of the ejector pump in the basement.

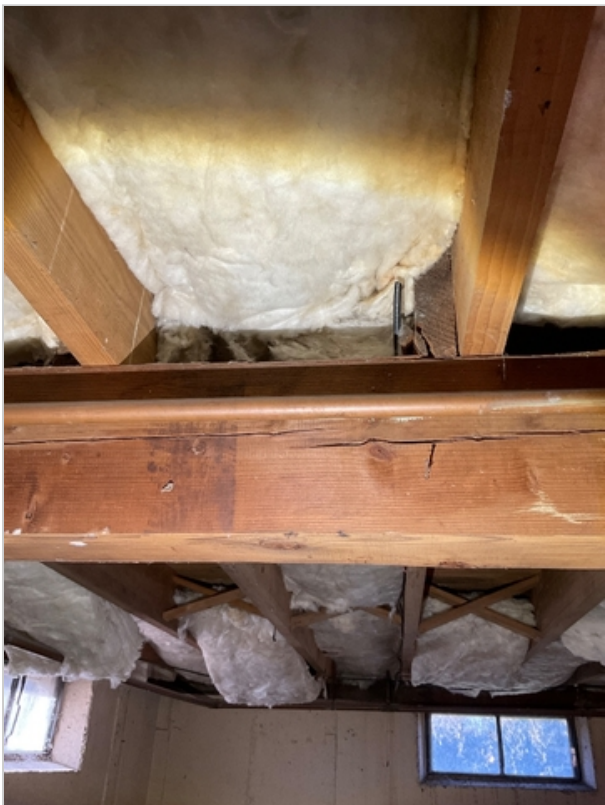
**Photo 127**

Main support beam is notched and drilled through. Consult with a qualified contractor for repair and further assessment

of this beam.

3. Main support beam is notched and drilled through. Consult with a qualified contractor for repair and further assessment of this beam.

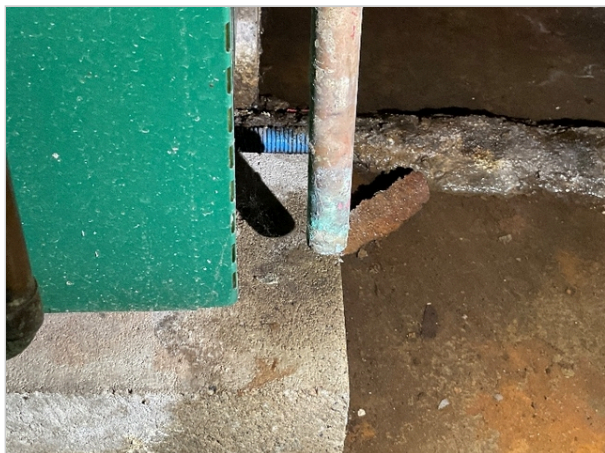
**Photo 152**

**The boiler/water heater has a leak at the TPR drain valve.** The valve should be repaired, replaced, or adjusted to eliminate the drip.

1. **Water was present in the basement at the time of the inspection.** The water is most likely due to the TPR valve on the boiler leaking constantly through the drip leg in the back of the boiler itself. Recommended further evaluation with a licensed professional.

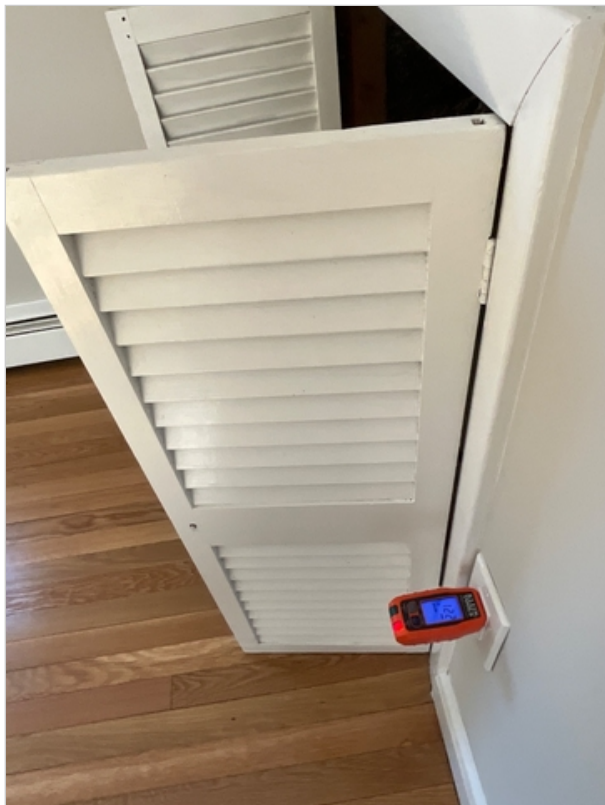
**Photo 184**

One of the three prong type outlets in the structure had an open ground. The affected outlet(s) should be

**grounded, replaced with two-prong outlets, or connected to GFCI circuits to improve safety.** This condition means that the third prong, also known as the ground prong, is not doing its job. This is often caused by a missing or disconnected ground connection at an electrical device in the circuit. Consult with an electrician for the best course of action.

1. **One of the three prong type outlets in the structure had an open ground. The affected outlet(s) should be grounded, replaced with two-prong outlets, or connected to GFCI circuits to improve safety.** This condition means that the third prong, also known as the ground prong, is not doing its job. This is often caused by a missing or disconnected ground connection at an electrical device in the circuit. Consult with an electrician for the best course of action.
2. **Interior outlets in the structure had open neutral wiring.** An electrician should repair and further assess the outlets.
3. **A loose outlet was observed in the basement.** This could be a shock hazard due to exposed electrical contacts. The affected outlet(s) should be replaced by a qualified contractor.
4. Missing screws to attached panel cover. Recommend having a licensed electrician repair.

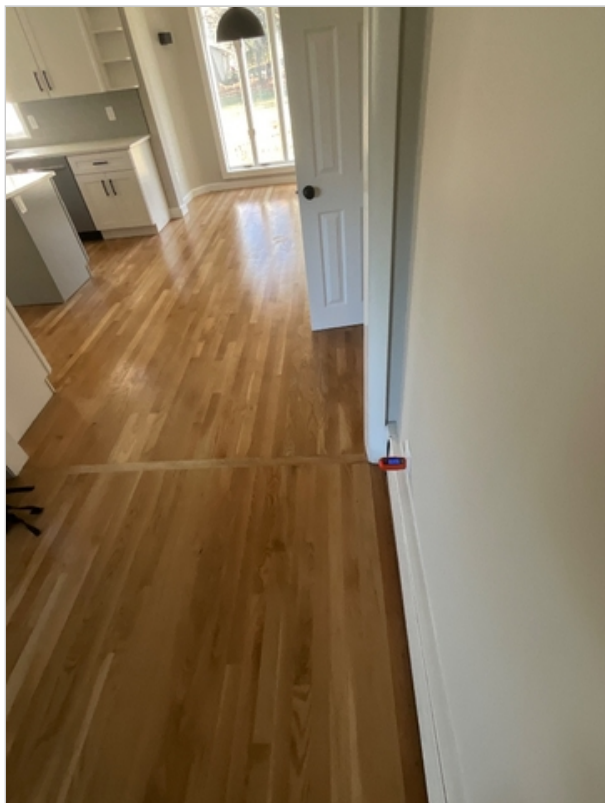
**Photo 186**

**Interior outlets in the structure had open neutral wiring.** An electrician should repair and further assess the outlets.

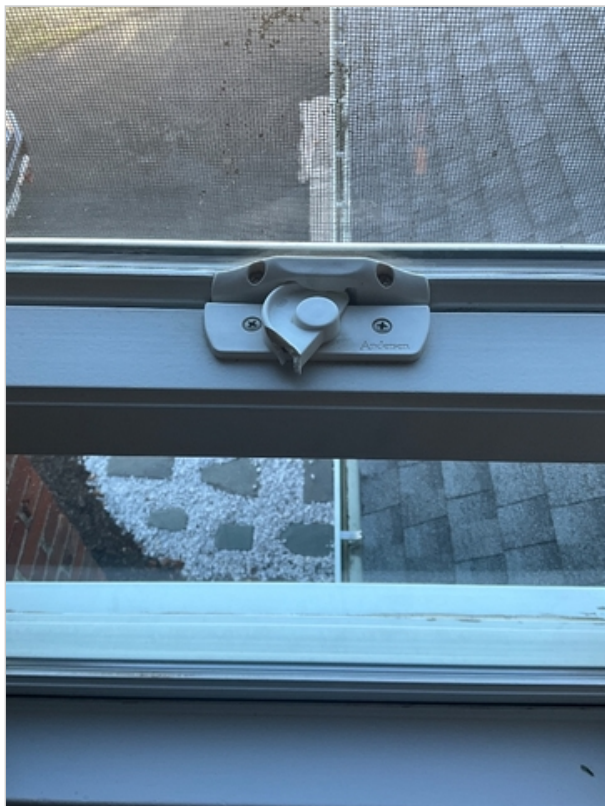
**Photo 217**

Broken hardware on some windows.

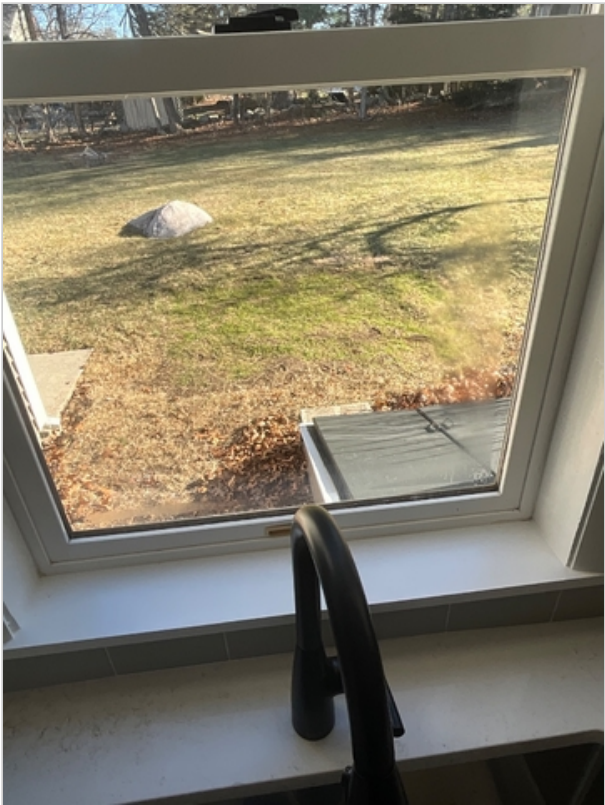
**Photo 220**

**One of the windows in the structure had a broken thermal seal.** A window with a defective thermal seal will show a slow but gradual "fogging" effect, and the insulation value of the window is marginally reduced. HomeTeam recommends having the affected window(s) repaired or replaced and further assessed.

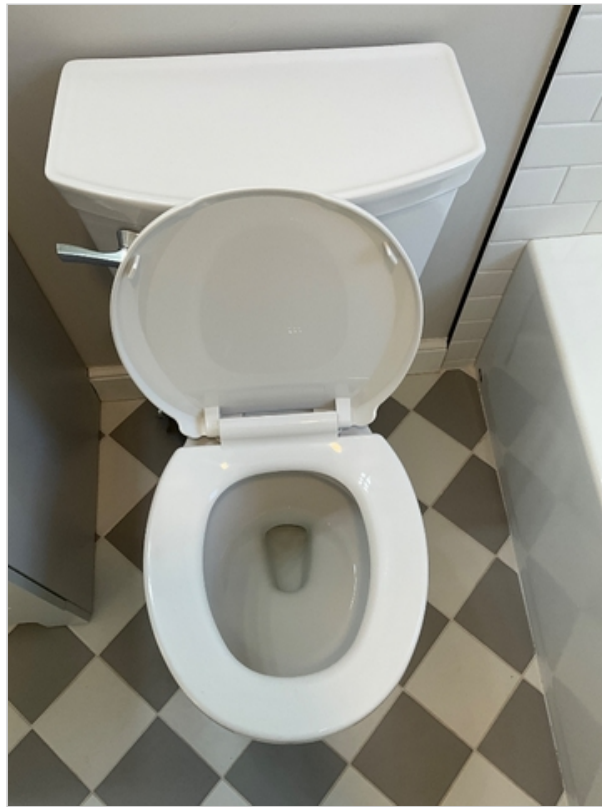
**Photo 259**

The toilet in the 1st floor bathroom is loose. Failure to secure the toilet may lead to leakage around the wax ring.

The toilet should be secured.

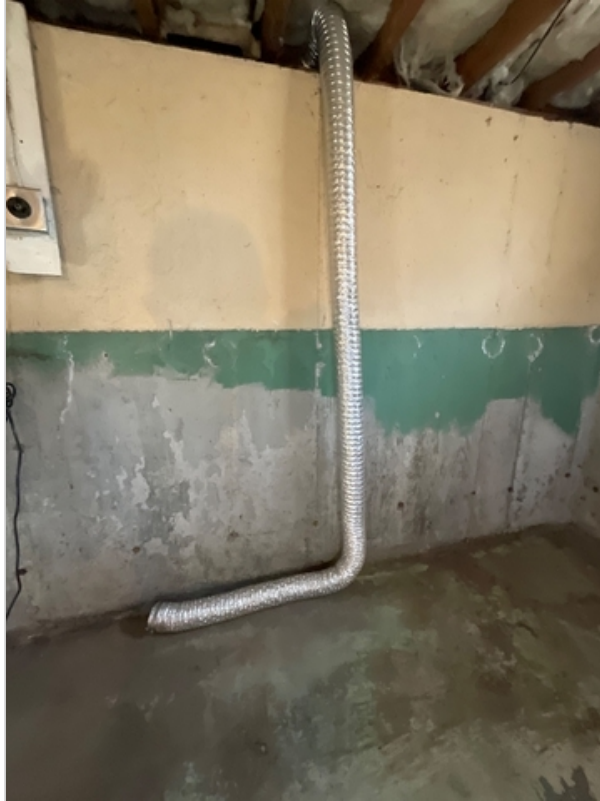
**Photo 302**

**HomeTeam recommends using a rigid metal (tin/aluminum) dryer hose venting system.** The aluminum foil type accordion hose vents tend to collect moisture and dryer lint resulting in overheating.

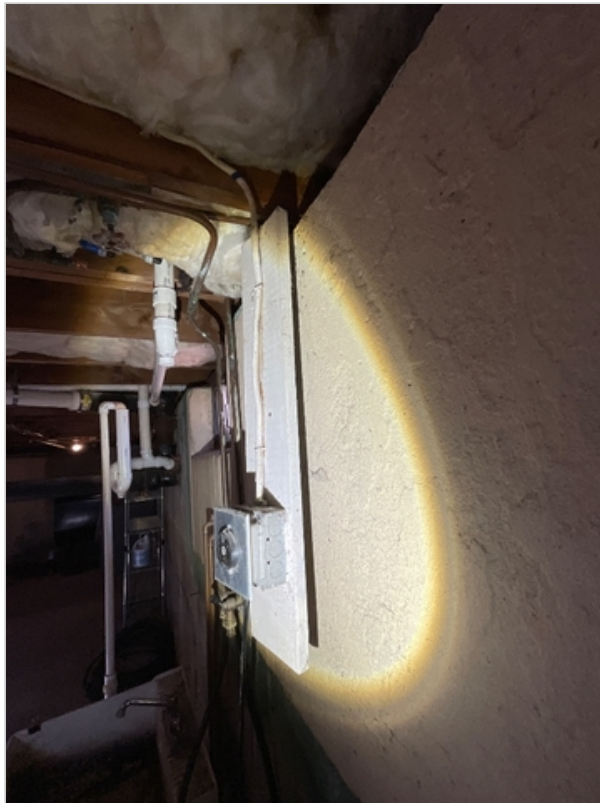
**Photo 303**

**A loose outlet was observed in the basement.** This could be a shock hazard due to exposed electrical contacts. The affected outlet(s) should be replaced by a qualified contractor.
