# HomeTeam<sup>®</sup>

### *HOME INSPECTION REPORT*

File Number: **MI0111111**  
Address of Inspection: **123 Main  
Street**

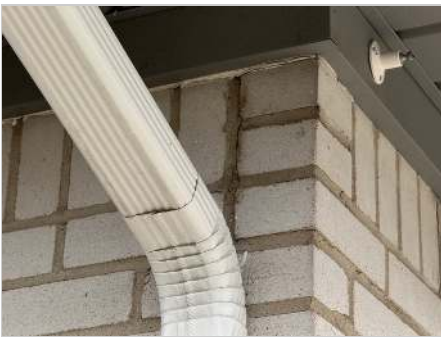
**Photo 73**

Cracks were observed on the exterior brickwork in multiple areas of the home. Tuck pointing and sealing cracks will help prolong the life of the brick and help prevent water penetration.

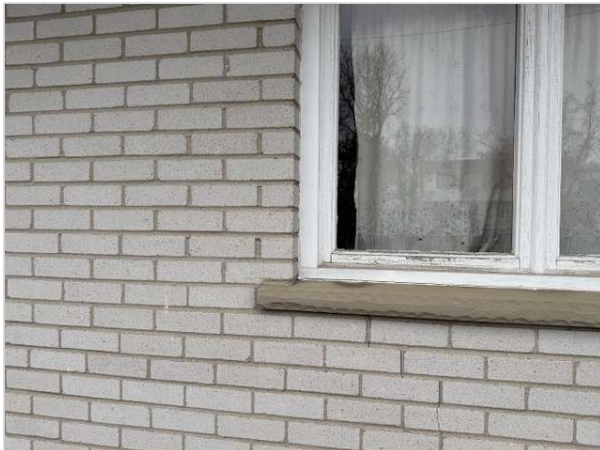
**Photo 82**

The caulking on the exterior of the home was cracked or missing in one or more areas. The caulking should be replaced to ensure the exterior of the home remains weather and watertight.

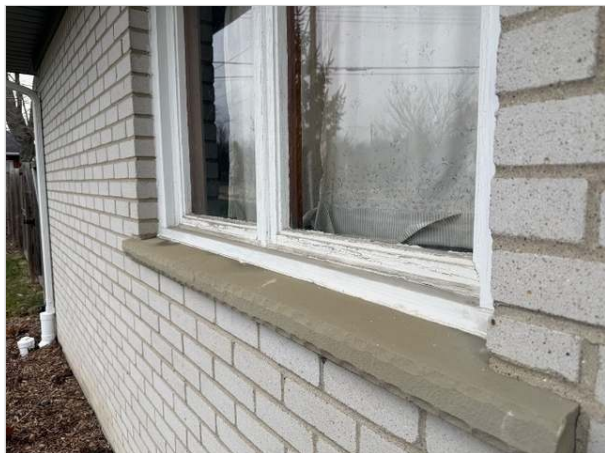
**Photo 83**

Peeling paint was noted in multiple areas of the home. To maintain the integrity and longevity of the exterior surfaces and materials, it is advisable to scrape and repaint all affected areas.

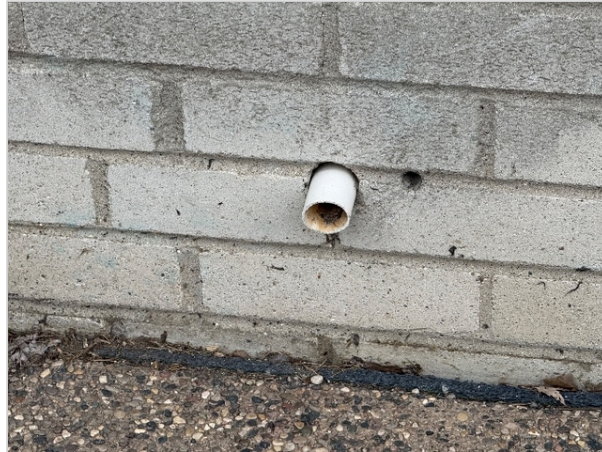
**Photo 85**

Sealing is needed around various siding penetrations. Proper sealing is recommended to help prevent moisture and pest intrusion.

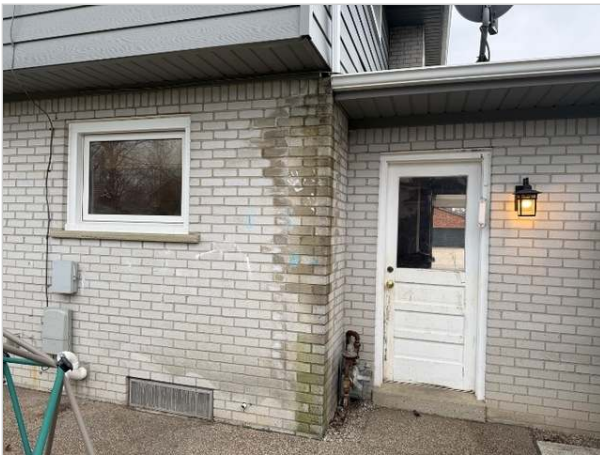
**Photo 86**

The downspout serving the upper roof was not properly aligned with the lower gutter at the left rear corner of the home. As a result, roof runoff is discharging directly onto the adjacent brick wall rather than into the gutter system. Evidence of moisture staining and organic growth was observed on the brick in this area, indicating prolonged water exposure. Corrections are recommended to properly align and secure the downspout to direct water into the gutter system and help reduce the potential for continued moisture-related deterioration of the exterior wall.

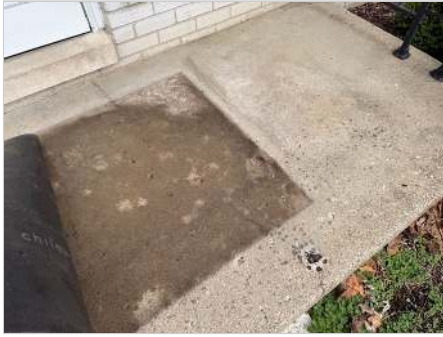
**Photo 88**

Cracks were observed in the concrete porch cap at the time of the inspection. Monitoring and sealing of the cracks are recommended to help prevent moisture intrusion and further deterioration.

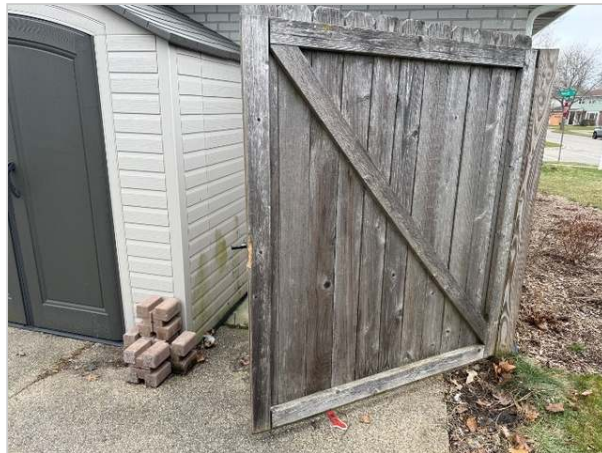
**Photo 91**

The fence gate on the left side of the home was damaged and was difficult to open and close. Repair or replacement is recommended to restore proper operation.

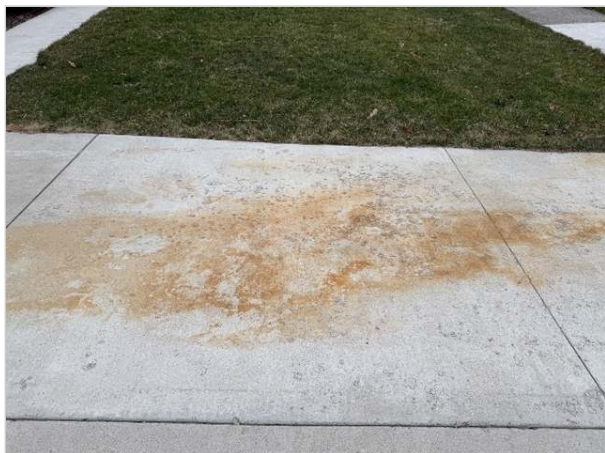
**Photo 92**

The surface of the driveway showed signs of deterioration at the time of the inspection. Deterioration can worsen over time and may lead to an uneven or damaged surface. Repairs or resurfacing may be necessary to maintain durability and function.

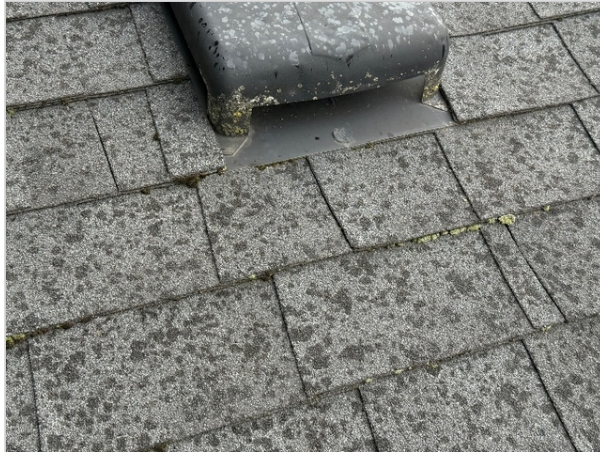
**Photo 95**

There was moss noted on the roof. Moss and algae can hold moisture on the shingles. Preventive maintenance is recommended to prevent premature wear to the roofing materials.

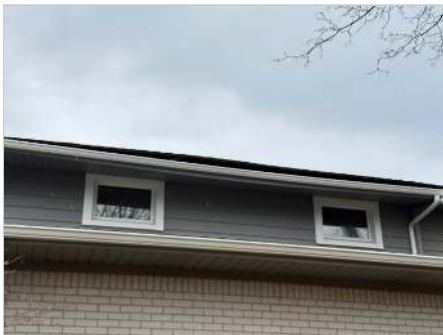
**Photo 96**

The soffit along the right side of the second-floor roof was sagging and partially detached, with open sections allowing direct visibility into the attic space. This condition can allow moisture, pests, and cold air to enter the attic and may contribute to insulation disturbance or reduced energy efficiency. Repair and securement of the soffit is recommended to restore proper enclosure of the roof structure.

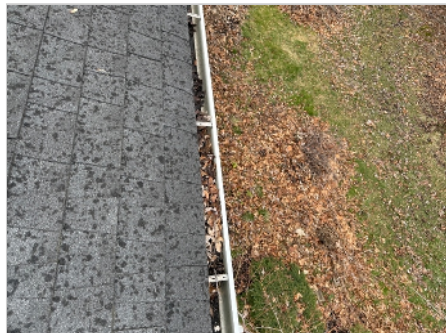
**Photo 102**

The gutters need to be cleaned. Clogged gutters can cause roof drainage water to back up and cause damage to the structure, soffit and fascia. Keeping gutters clean will help move water away from the foundation which could lead to basement water problems.

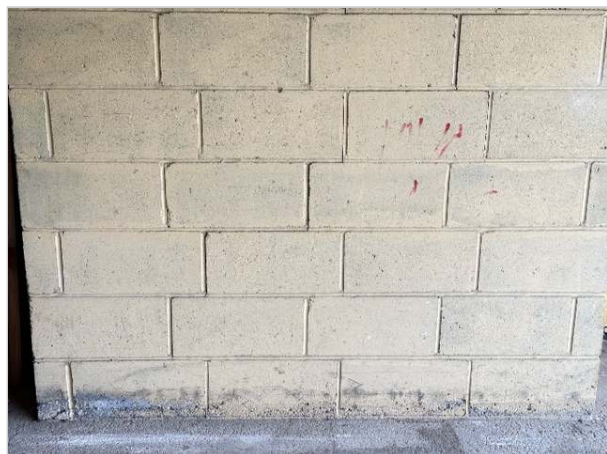
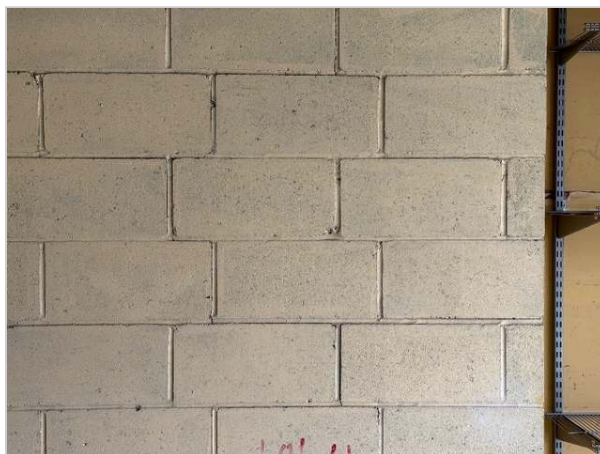
Cracking was observed in the concrete block chimney structure visible within the garage. This condition should be monitored and repaired as needed to help prevent further deterioration. Evaluation and repair by a qualified chimney contractor is recommended.

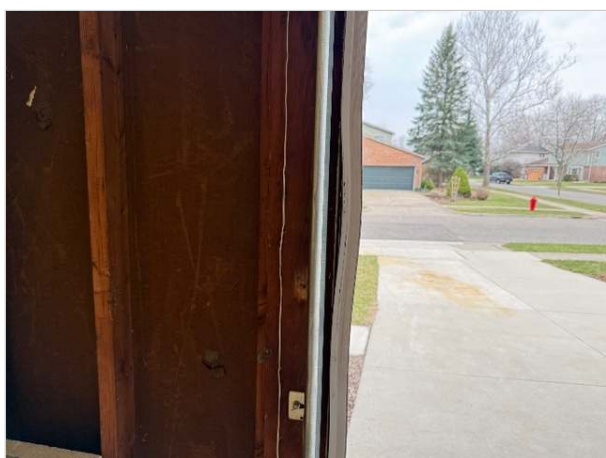
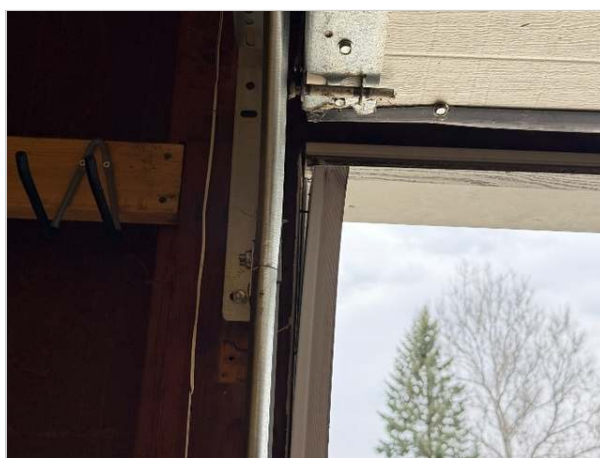
The weather stripping around the garage doors was loose and poorly installed. This condition can allow air, moisture, and pests to enter the garage. Repair or replacement is recommended to improve the seal and overall performance of the doors.

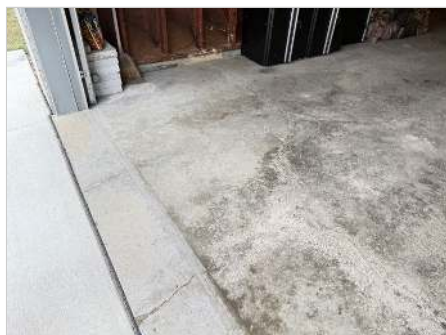
**Photo 109**

Cracks and settlement were observed in the garage floor. Addressing these issues is recommended to prevent further deterioration and reduce potential tripping hazards, which may be the homeowner's responsibility. Due to the limited timeframe of the home inspection, it is not possible to determine whether the cracks will worsen or if additional settlement will occur.

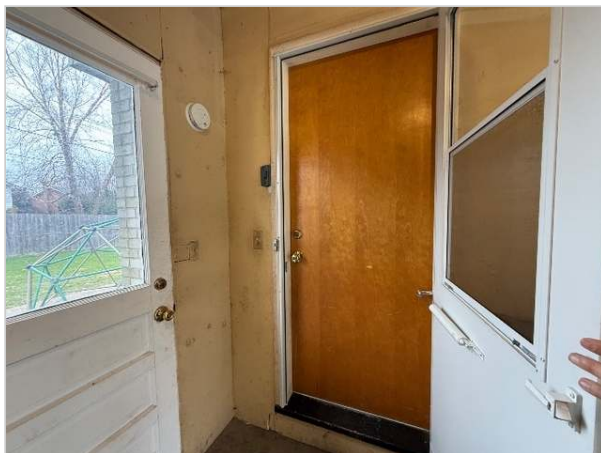
**Photo 112**

The door leading from the garage to the house does not appear to be fire rated. Some municipal regulations as well as certain lenders may require the installation of a fire rated door. Corrections are recommended.

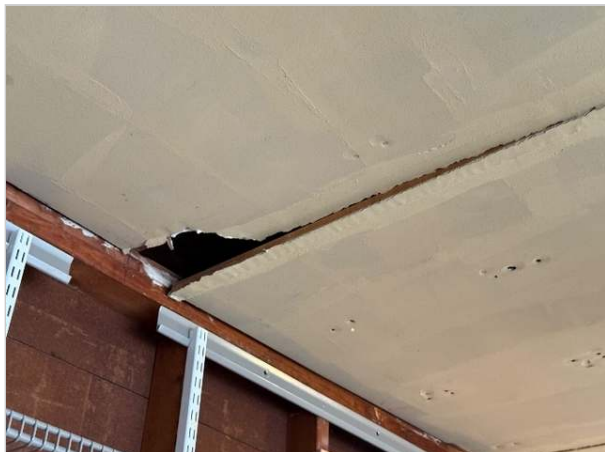
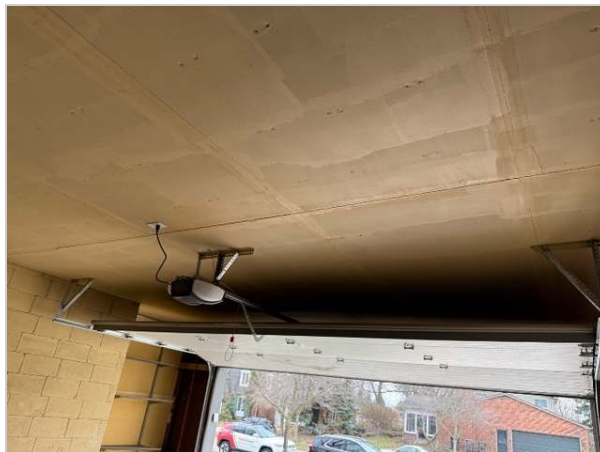
The finish on the garage ceiling/walls is designed to provide a barrier between the garage and living space in the event of a fire. One or more openings were noted in the garage ceiling or walls. Repairs should be made to maintain the integrity of this important safety feature.

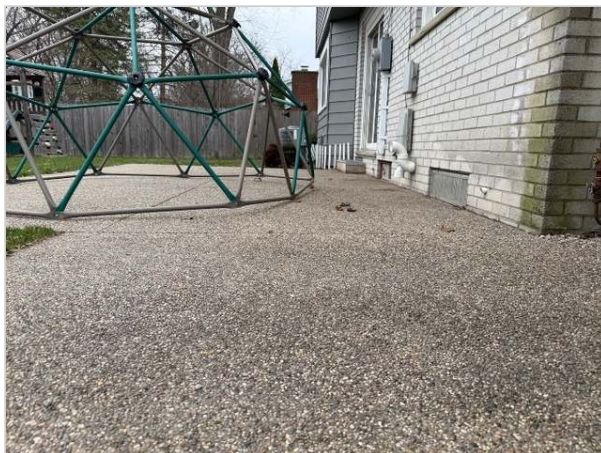
**Photo 115**

The concrete patio slopes towards the foundation. This increases the chance for water penetration, as described in the grade notes within this report. Correcting this slope is recommended.

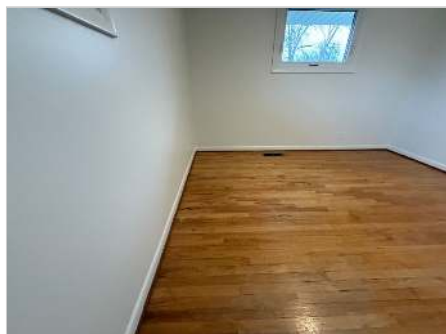
**Photo 116**

Sloping was observed in portions of the second-floor flooring. No indications of structural concerns were noted in the areas below at the time of the inspection. Variations in floor level can occur over time due to typical settling or construction methods. Monitoring is recommended, and further evaluation may be considered if changes in the condition are observed or concerns arise.

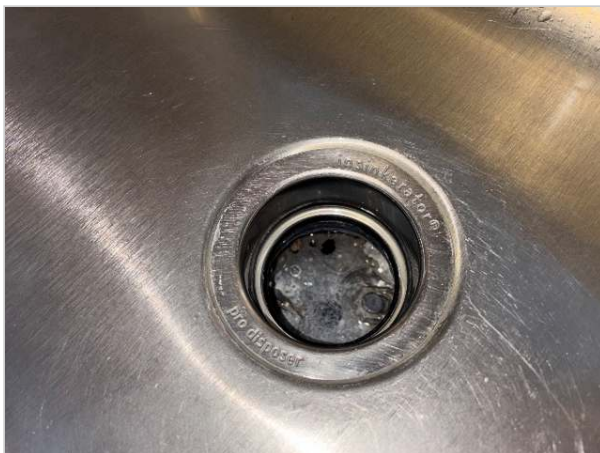
**Photo 119**

The disposal splash guard was deteriorated or missing. Replacing or repairing the splash guard can prevent larger objects falling into the disposal or debris being expressed from the disposal.

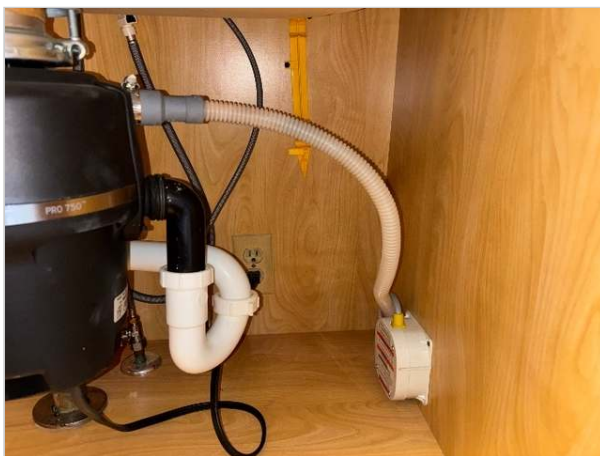
**Photo 120**

The dishwasher drain should be installed with a high loop above the drain to prevent waste water from entering into the drain line from the disposal in the event of a back up. Corrections are recommended.

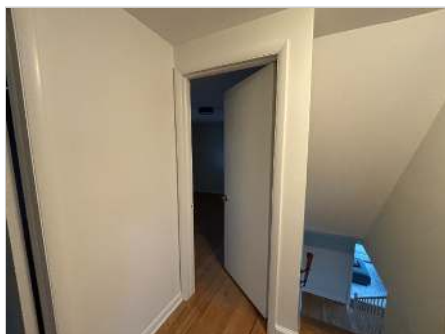
Rear right bedroom

One or more interior doors would not latch. Adjustments are recommended for privacy.

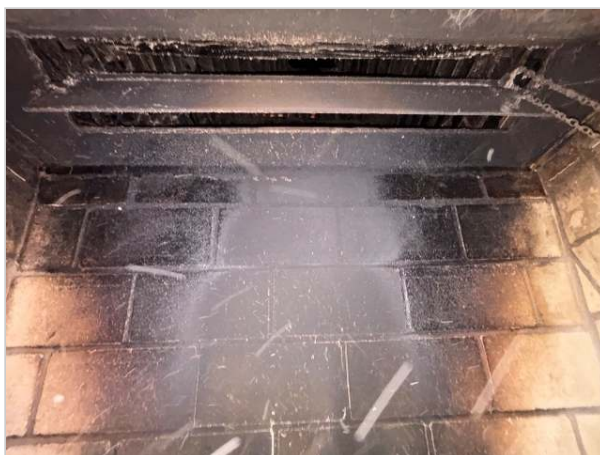
**Photo 126**

There was creosote build up inside the chimney which has limited our ability to observe the walls of the chimney. Due to this condition you should have the chimney cleaned as there could be defects that are not visible. Further evaluation is recommended.

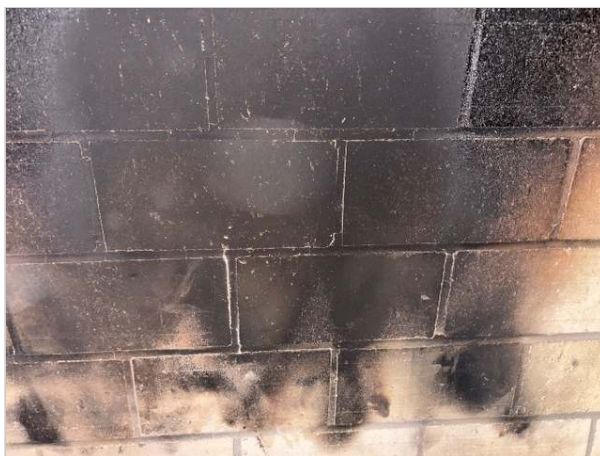
**Photo 127**

Cracks were present in the firebox of the fireplace located in the living room. Generally, firebox cracks are acceptable

unless they are wide enough to fit a quarter into. The bricks and mortar inside the firebox are designed to act as a heat and spark shield and should be free of any voids. The firebox should be repaired and further assessed by a qualified chimney and fireplace service.

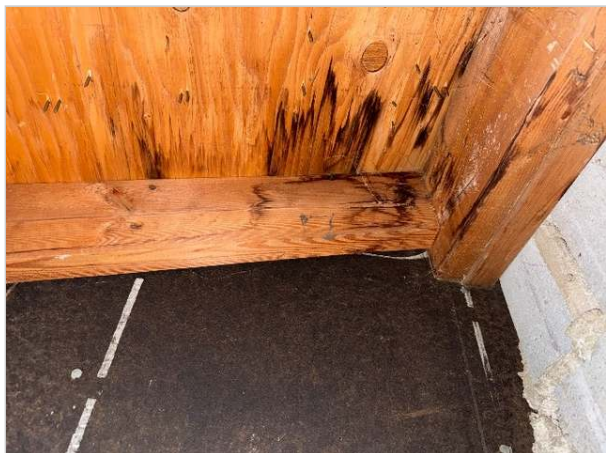
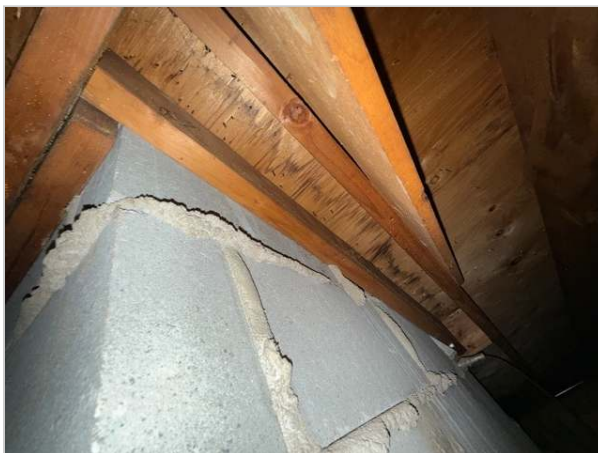
Water stains were noted in the attic, in one or more areas. While these areas appeared dry at the time of the inspection, water stains can result from various issues that may not be immediately visible. It is advisable to consult with the seller regarding any known past problems. Further evaluation would be needed to determine the cause of the stains and assess any potential ongoing issues.

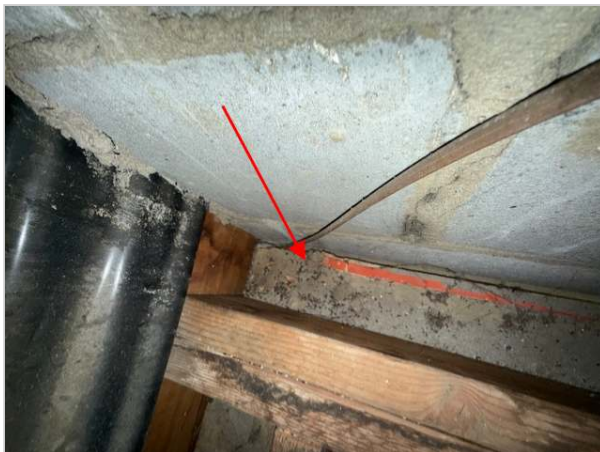
Attic above garage

Mouse droppings were noted in one or more places on the property. Further evaluation would be needed to determine how they are entering the home or if they are active.

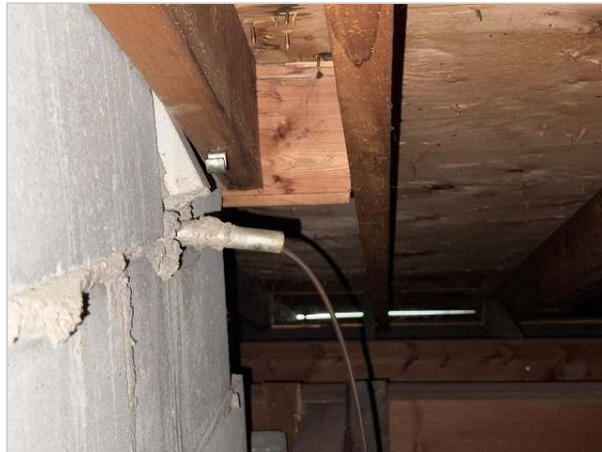
Front of home above garage visible from garage attic

A gap was observed at the roof edge where the roof covering meets the gutter. From within the attic, this area was open to the exterior. Openings at the roof edge can allow moisture intrusion, air leakage, and entry by pests. Correction by a qualified roofing contractor is recommended.

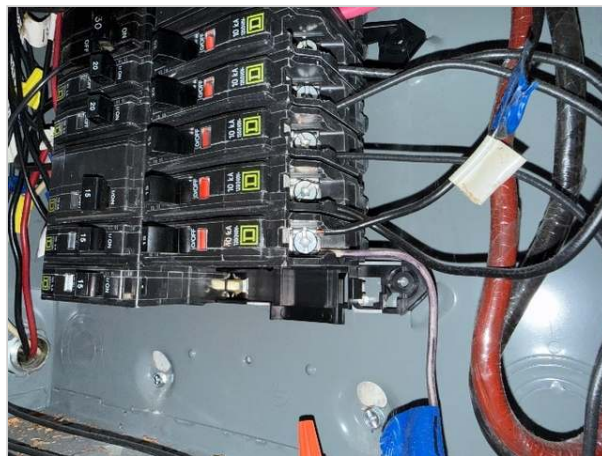
**Photo 142**

A Square D circuit breaker with two conductors connected at a single terminal (commonly referred to as a “double tap”) was observed in the electrical panel. Some Square D breakers are designed and listed to accommodate two conductors under a single terminal, depending on the specific model and labeling. No deficiencies were confirmed at the time of inspection. If there are any concerns regarding compatibility or installation, consultation with a qualified electrician is recommended.

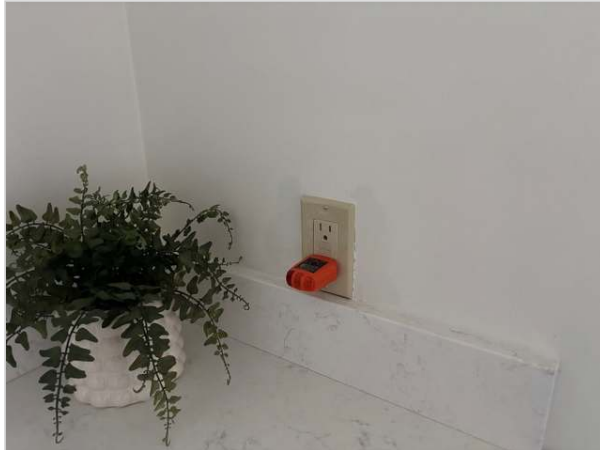
Bedroom bathroom

GFCI receptacles in one or more areas were non functional and would not reset when tested. Corrections are recommended to ensure proper protection exists for the circuit or receptacle.

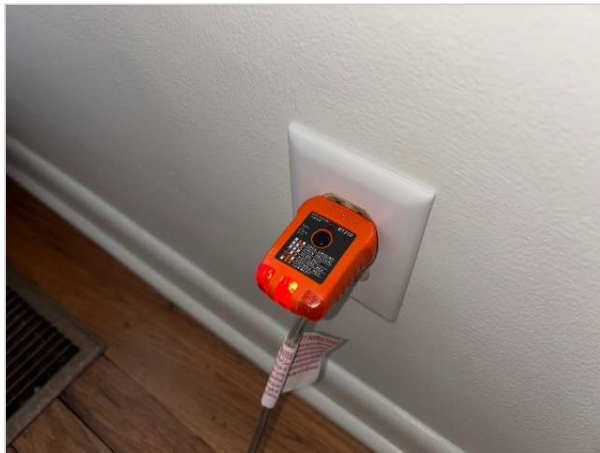
Living room

Reverse polarity was noted at one or more receptacles on the property. Reversed polarity refers to improper wiring of a circuit or receptacle. Reversed polarity is generally easily corrected by an electrician who can perform minor wiring adjustments at the receptacle. It is important that this correction be made for the safe use of the outlet and those items powered off the receptacle.

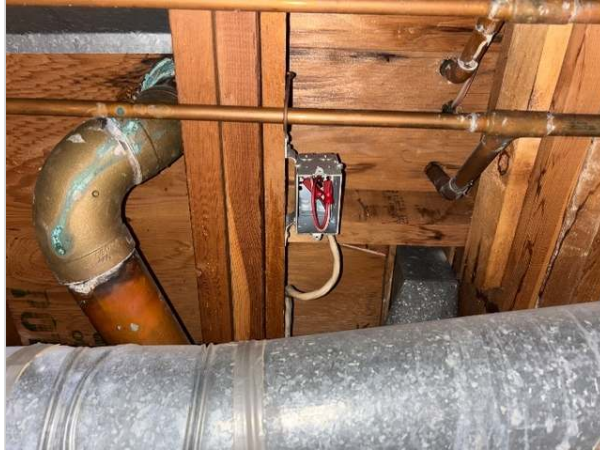
**Basement**

One or more uncovered junction boxes were noted on the property. Electrical connections should be housed within approved, covered junction boxes, including receptacles and outlets. Corrections are recommended.

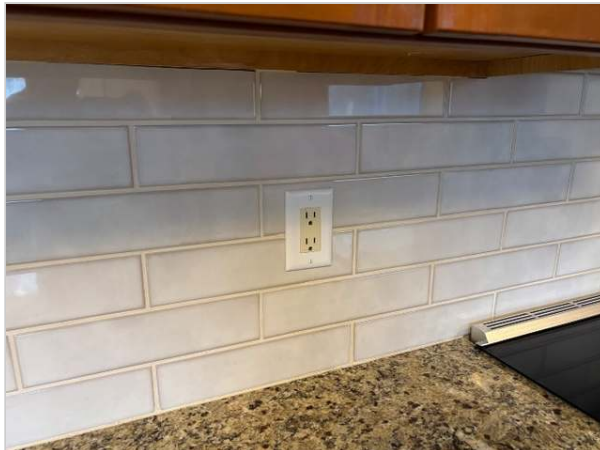
**Kitchen**

Loose outlets were noted in one or more areas of the property. Loose or broken outlets/receptacles should be replaced to prevent injury.

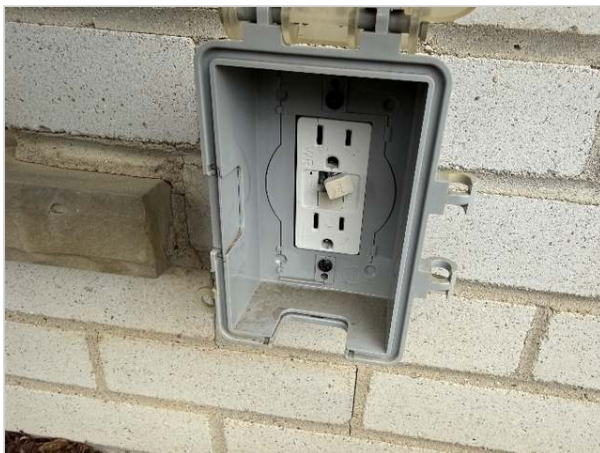
**Photo 149**

The GFCI outlet on the front exterior of the home was found to be in a failed condition at the time of the inspection and did not operate when tested. Replacement is recommended to restore proper function and safety.

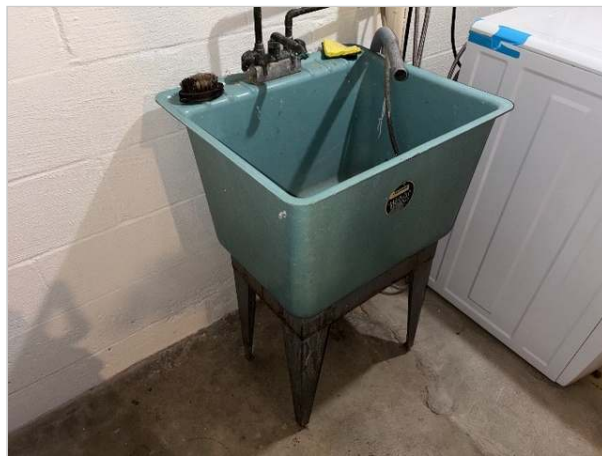
Utility tub

Loose plumbing fixtures were noted in one or more areas of the home. Corrections are recommended to prevent damage to the plumbing or the fixtures which may lead to leaks or water damage.

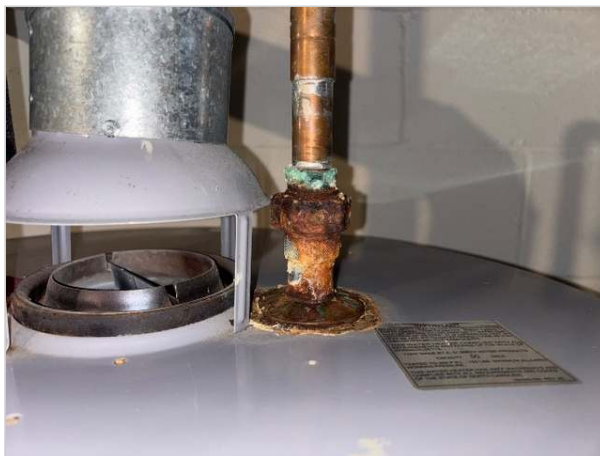
**Photo 162**

There was corrosion at the fittings above the water heater. Although there were no leaks at this time, this is an

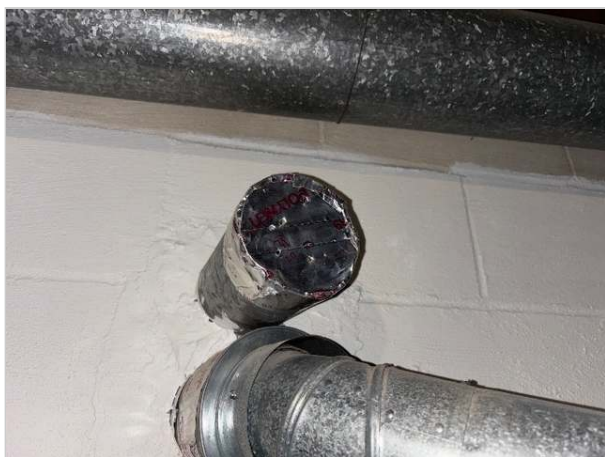
**Photo 163**

The vent pipe may not be sealed properly. Carbon monoxide could be expelled into the home when the exhaust vent is damaged or not properly installed. Corrections are recommended.

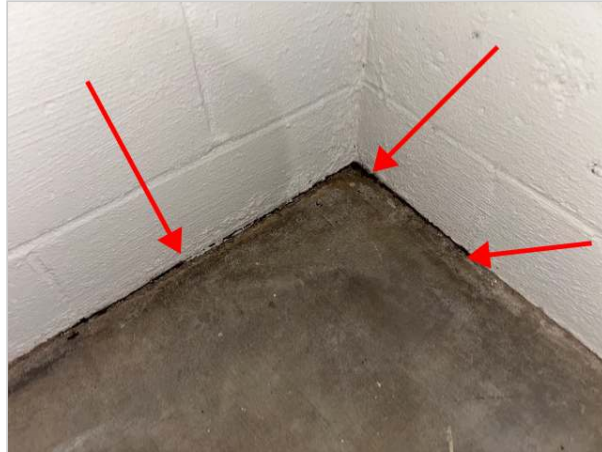
**Photo 166**

Water stains were noted in the basement, in one or more areas. While these areas appeared dry at the time of the inspection, water stains can result from various issues that may not be immediately visible. It is advisable to consult with the seller regarding any known past problems. Further evaluation would be needed to determine the cause of the stains and assess any potential ongoing issues.

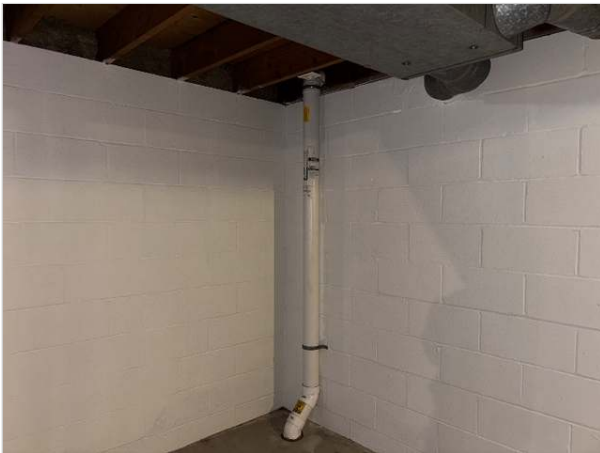
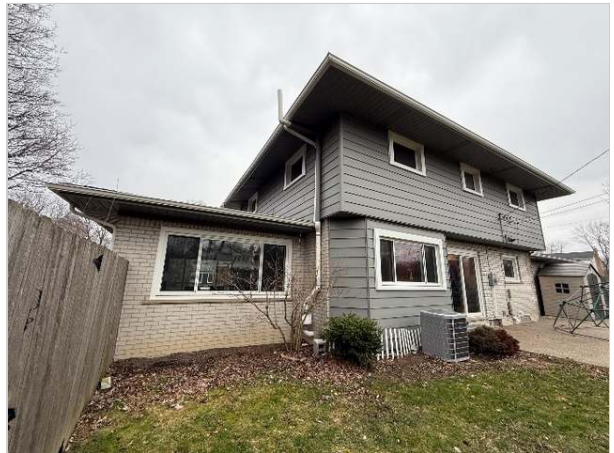
There is a radon mitigation system located in the basement. The Radon system appeared to be non functional. Further evaluation is recommended.

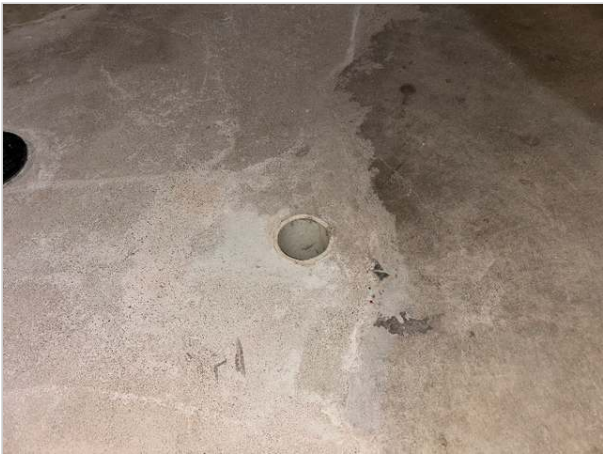
Photo 169

An uncovered floor drain was noted in the basement. A cover should be installed to eliminate possible trip hazards or debris falling into the drain.
