### *HOME INSPECTION REPORT*

On Sunday, January 01, 2000 The HomeTeam Inspection Service made a visual inspection of 123 Sample Drive, Boulder , CO 80302. Enclosed please find a written, narrative report of our findings in accordance with the terms of our Inspection Agreement. Although general maintenance items may have been addressed verbally at the time of the inspection, they may not be included in the enclosed report.

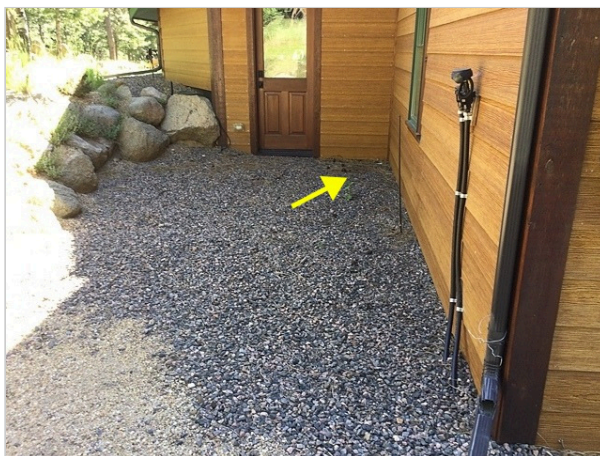
**Photo 5**

**The grading around the structure appears to be insufficient to carry water away from the foundation.**

HomeTeam recommends having the soil regraded on the right side of the structure and further assessed at the time of regrading.

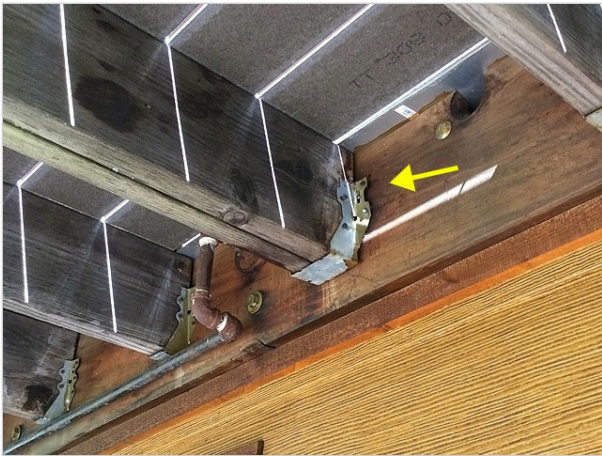
**Photo 38**

A few of the joist hangers on the middle deck appear to be coming loose. Recommend repairs by a qualified contractor.

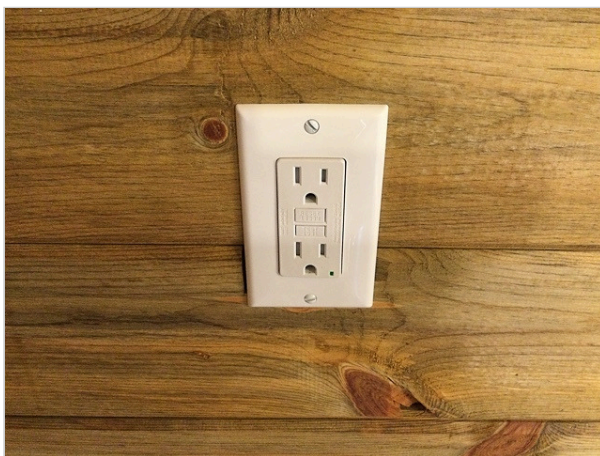
**Photo 57**

**The GFCI outlet located in the detached garage loft is defective** and should be replaced.

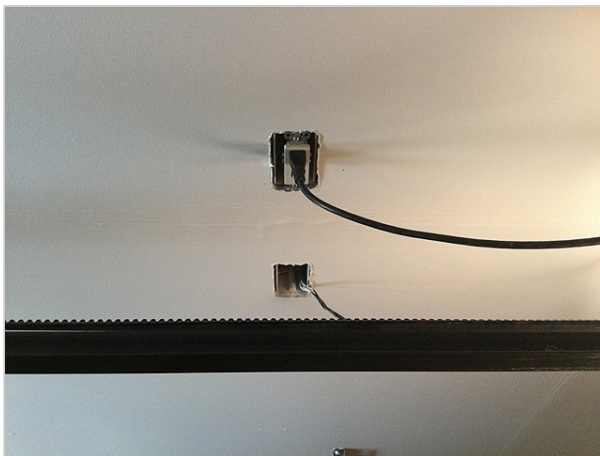
**Photo 58**

**A missing outlet cover was observed in the garage.** All switch and outlet boxes should be properly covered to avoid a shock hazard. Electrical repairs should be performed by a qualified electrician.

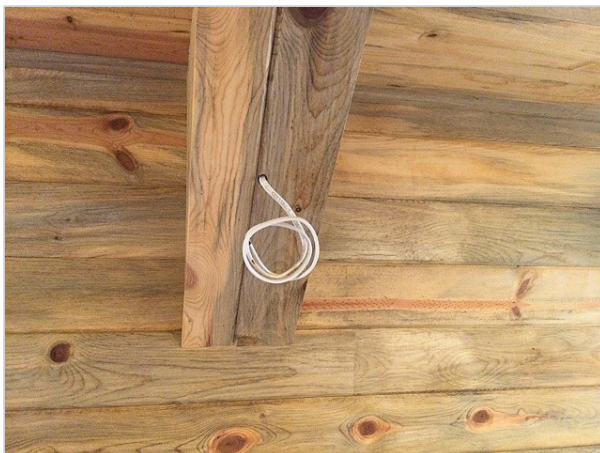
**Photo 59**

**Exposed or un-terminated live wires were observed in the detached garage loft.** The wires should either be disconnected at the source or properly terminated in an approved, covered electrical box. Consult with a qualified electrician for repair and further assessment.

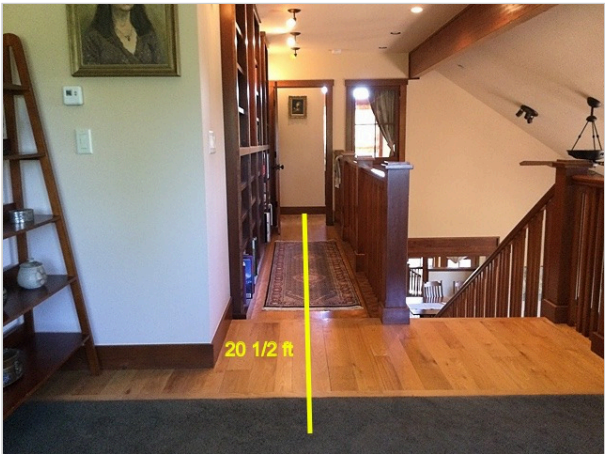
**Photo 66**

Per Colorado state law, carbon monoxide detectors are required to be installed within 15 feet of all sleeping areas. No carbon monoxide detectors were observed installed within 15 feet of the sleeping areas on the upper level.

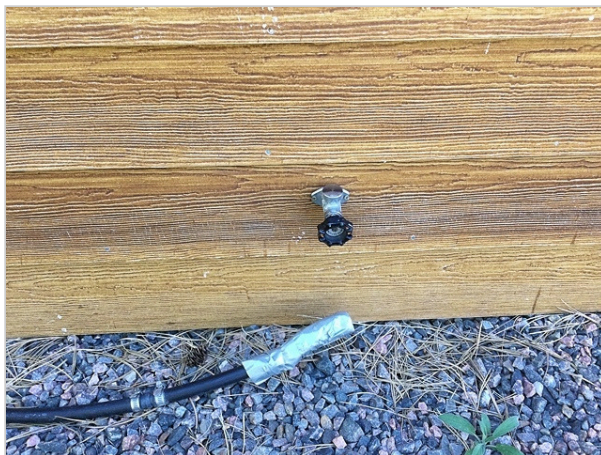
**Photo 72**

An exterior hose bib did not function when tested. During winter months and times of colder temperatures, homeowners often turn off hose bibs from the interior to prevent pipes from freezing and bursting. Due to the possibility of uncontrollable leaks at the faucet handle if activated, HomeTeam does not activate shutoff valves. Once temperatures remain safely above freezing the client should check the hose bibs for proper operation.

rear hose bib

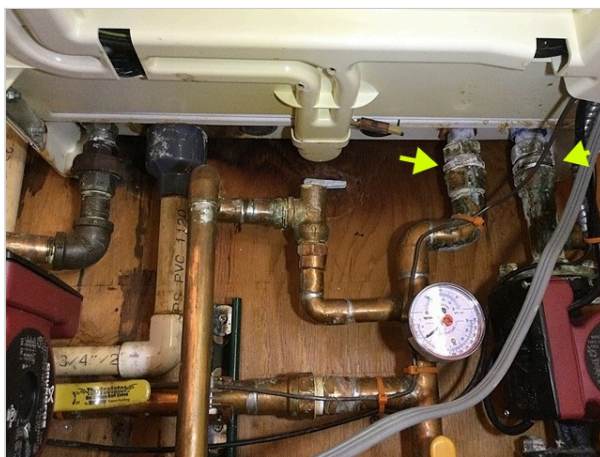
**Photo 89**

Corrosion was observed on the water pipes for the water heater. No water leaks were observed at the time of the inspection.

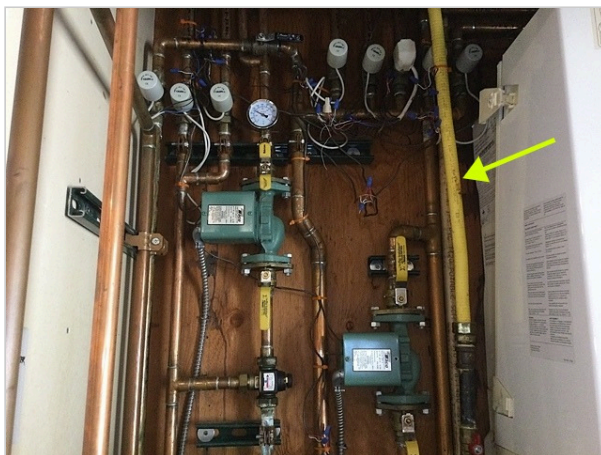
**Photo 95**

A bonding or grounding device is recommended to be verified and/or installed on the CSST (Corrugated Stainless Steel Tubing) natural gas system in order to reduce the chances of a natural gas leak or fire. Bonding is provided primarily to prevent a possible electric shock to people who come in contact with the gas piping and other metal objects connected to the CSST system. Nearby lightning strikes can also result in an electrical surge and can potentially puncture a hole in the CSST. Additional information regarding this type of condition can be found at: <http://csstsafety.com/>

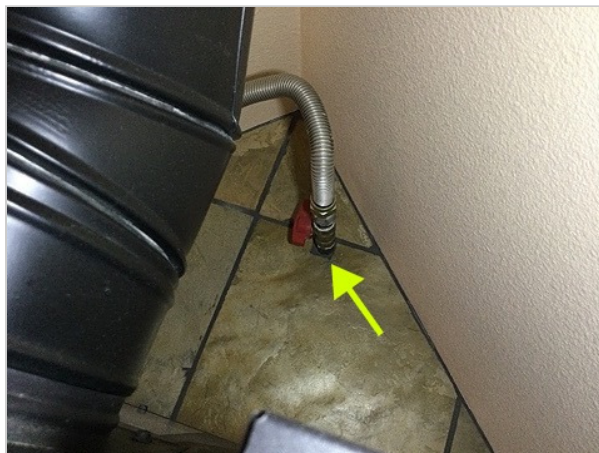
**Photo 102**

gas valve

**The gas valve to the primary bedroom fireplace was turned off at the time of inspection and the fireplace could not be tested. Recommend seller disclosure.**

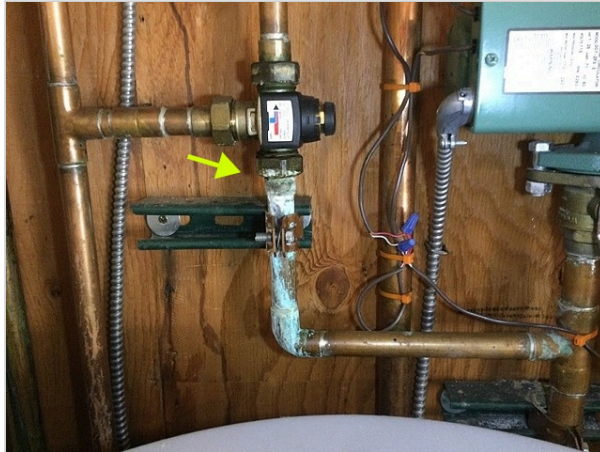
**Photo 107**

Corrosion was observed on the water distribution pipes for the hydronic heating system. No water leaks were observed at the time of the inspection.
