### HOME INSPECTION REPORT

File Number: **6549**

Address of Inspection: **123 Sample Drive**

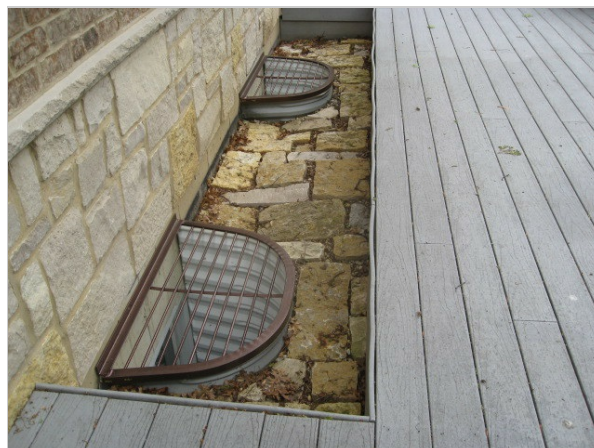
- ***We recommend monitoring the area in back by the house, between the sections of deck, to ensure water does not pool in this area.***

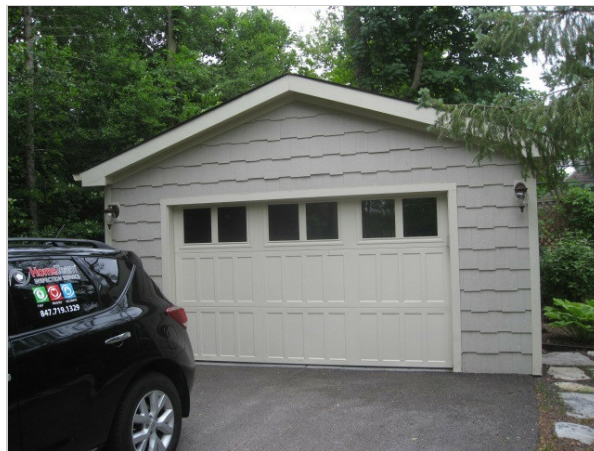
- *There was a car and storage in the detached garage that obscured some areas from visual inspection.*

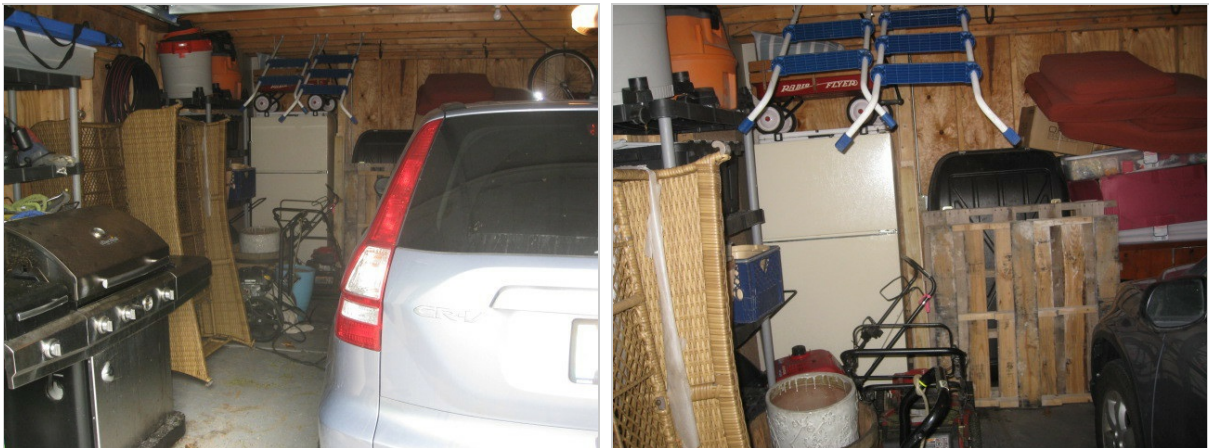
- *There was a car and storage in the attached garage that obscured some areas from visual inspection.*

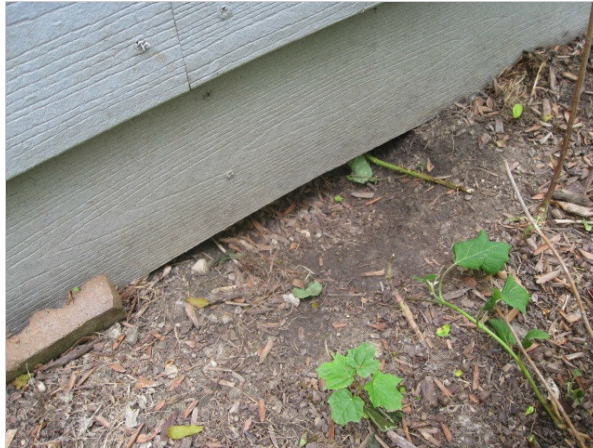
- ***There were signs of animal activity under the deck that should be corrected.***

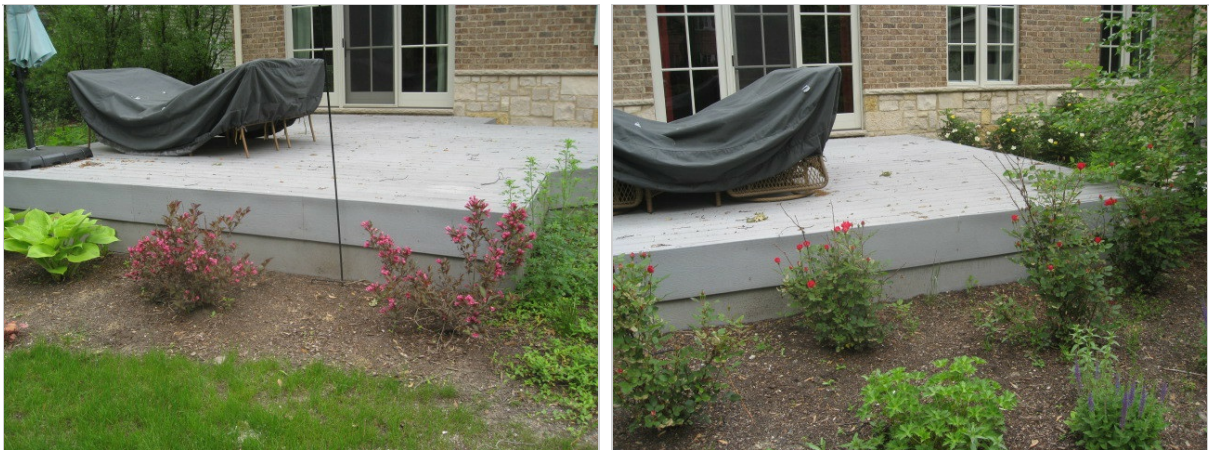
- ***There was no railing for the deck and we recommend that one be installed.***

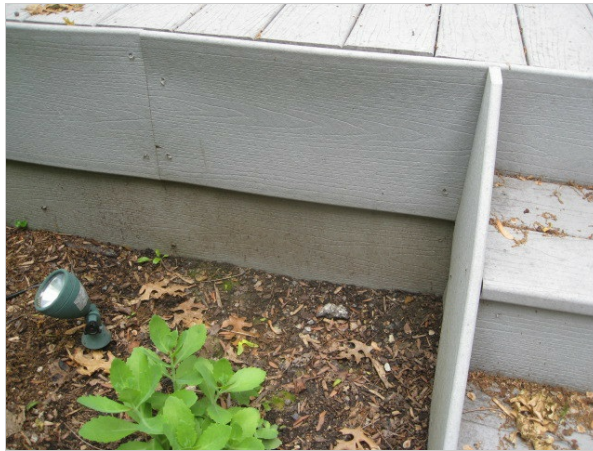
- ***We were unable to view the support structure under the deck due to the wood deck skirt around the outside perimeter of the deck.***

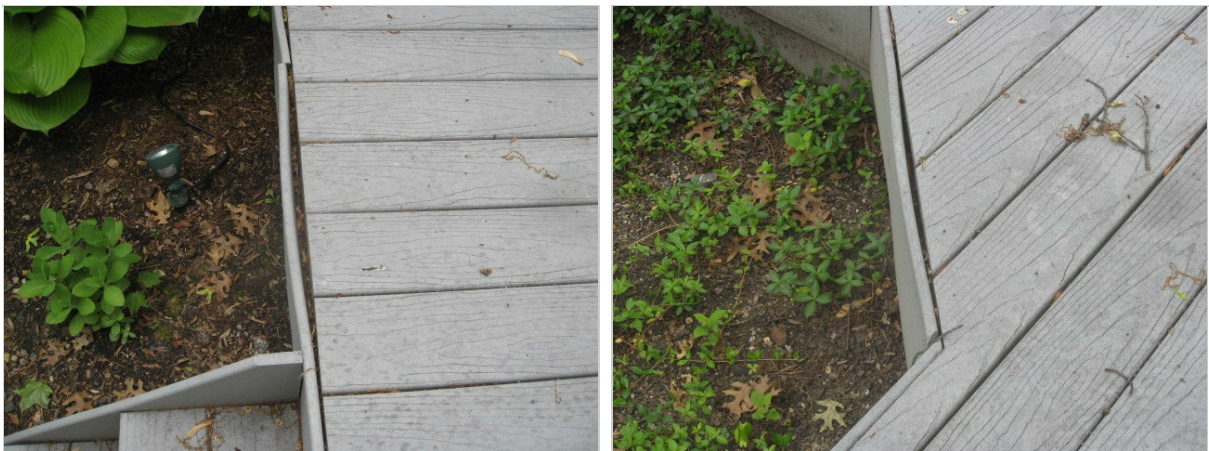
- ***There was movement and gaps along the outside trim boards for the deck that should be monitored for action.***

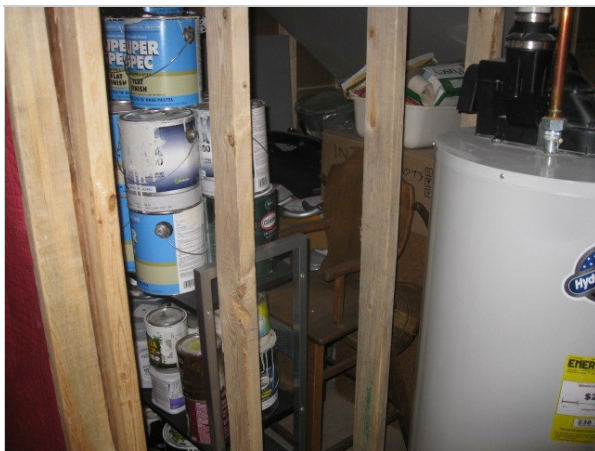
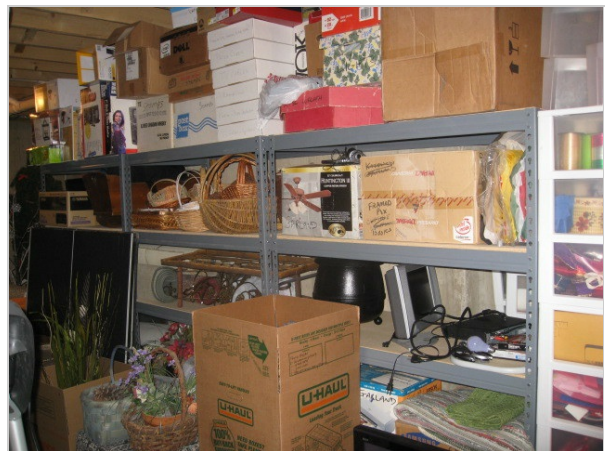
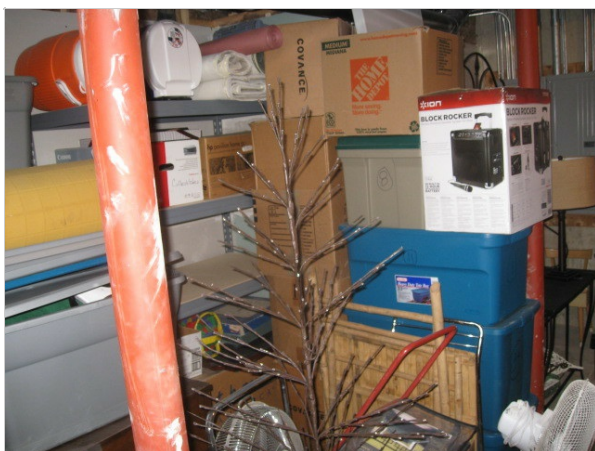
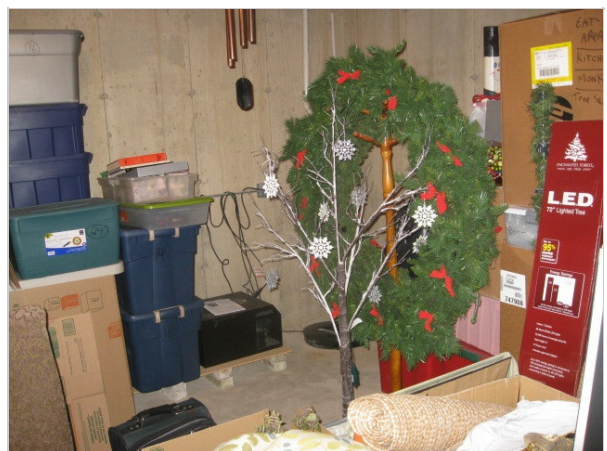
- ***There was storage throughout the utility room in the basement that obscured some areas from visual inspection.***

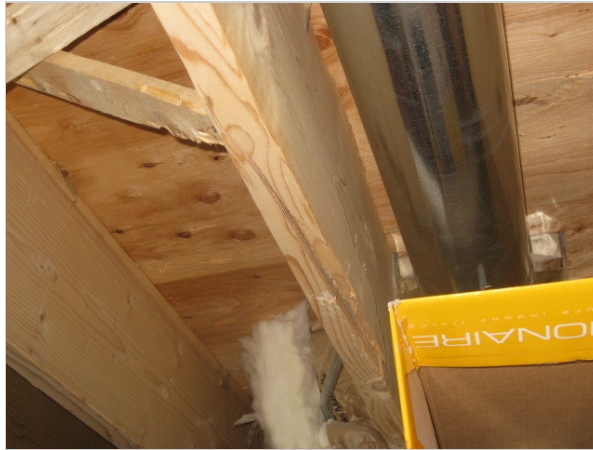
- ***There was a cracked floor joist in the front center section of the basement utility room that should be monitored and repaired as necessary.***

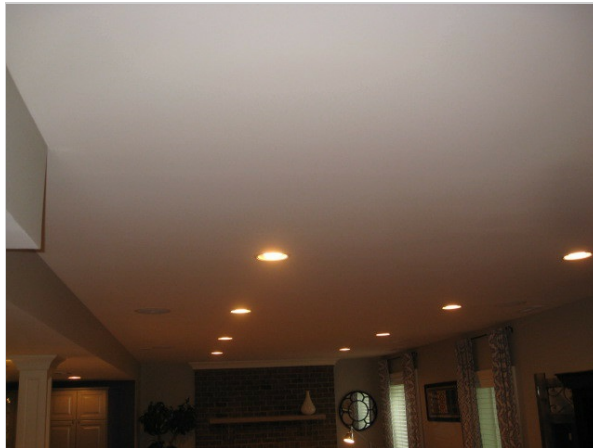
- ***Most of the basement ceiling was finished, which restricts a clear view of the floor joists. As a result, we were not able to see the entire floor structure during the inspection.***

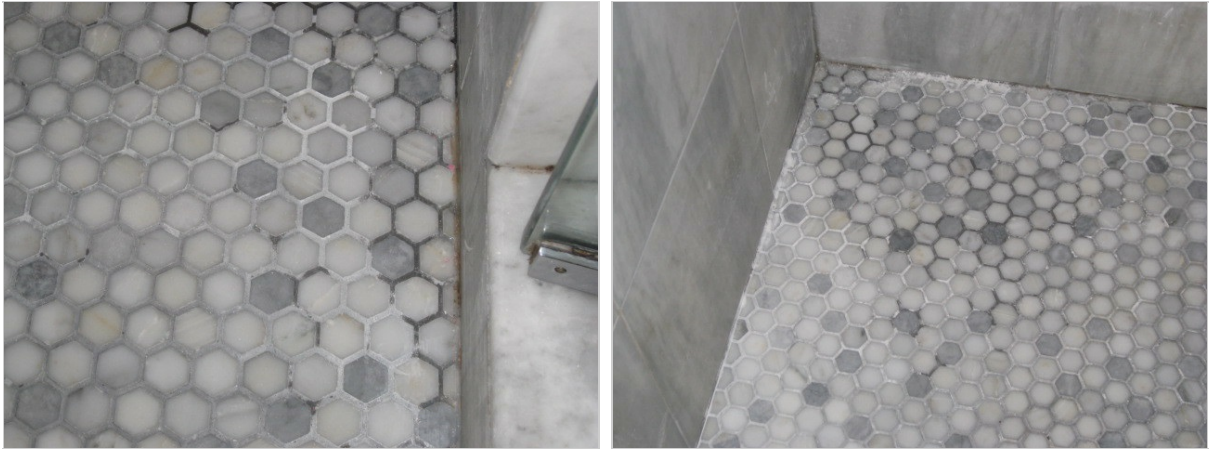
- ***There was quite a bit of mildew on the master bathroom shower floor that should be cleaned and corrected.***

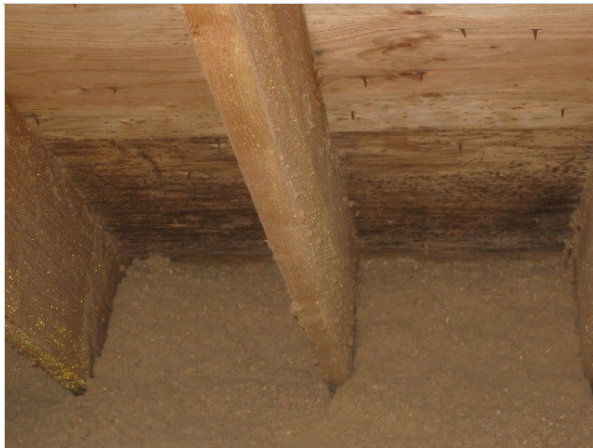
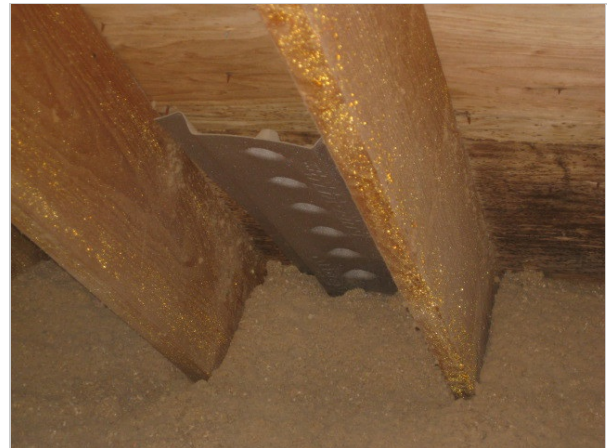
- ***There was darkened sheathing, with possible light mold growth, in the right front section of the attic that should be further evaluated and treated as necessary.***

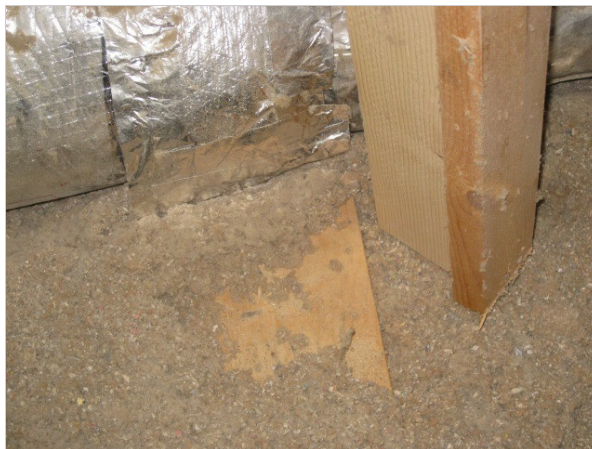
- ***One of the support columns on the far left side of the attic space was completely loose and needs to be secured.***
