### HOME INSPECTION REPORT

File Number: **xxxx**  
Address of Inspection: **123 Sample Drive**

**John Doe**  
**123 Sample Drive**  
**Anytown, NC**

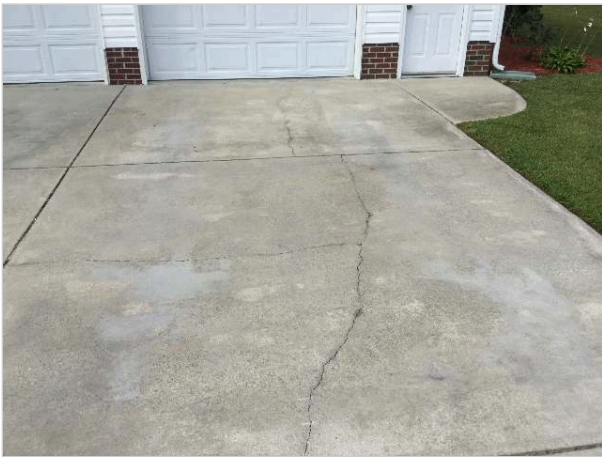
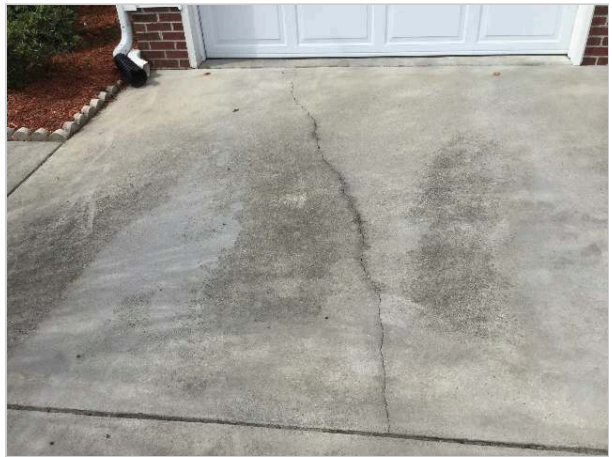
***The driveway has several cracks with slight separation. Freezing moisture here may create further cracks and spalling. Have a qualified contractor seal these cracks.***

1. The driveway has several cracks with slight separation. Freezing moisture here may create further cracks and spalling. Have a qualified contractor seal these cracks.

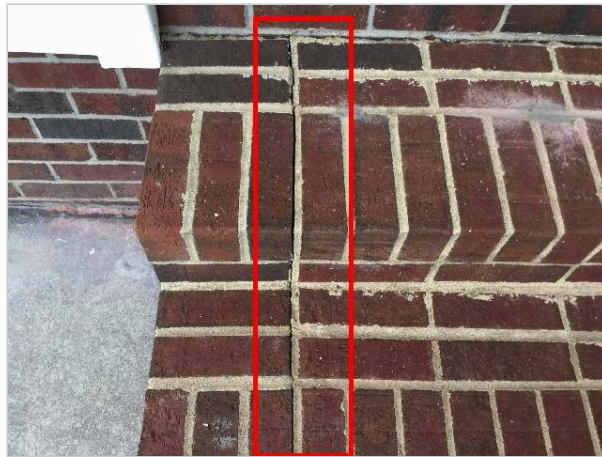
***The rear brick steps have missing mortar in places. This can allow water to enter the steps, freeze, expand, and cause further damage. Have a qualified contractor re-point the mortar as required.***

1. The rear brick steps have missing mortar in places. This can allow water to enter the steps, freeze, expand, and cause further damage. Have a qualified contractor re-point the mortar as required.

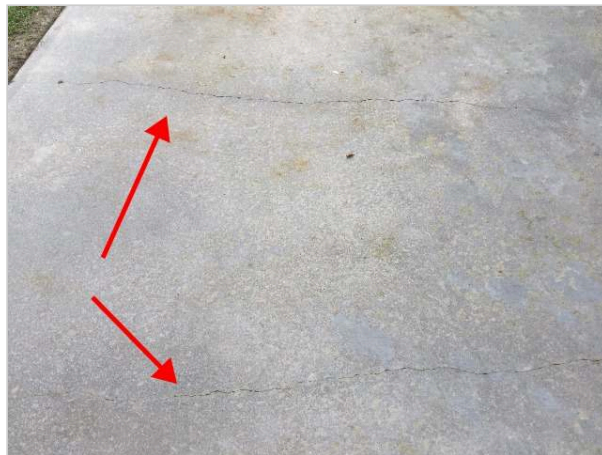
***There is cracked concrete on the patio. Cracked concrete can spall further in freezing conditions. Recommend having a concrete contractor repair the area.***

1. There is cracked concrete on the patio. Cracked concrete can spall further in freezing conditions. Recommend having a concrete contractor repair the area.

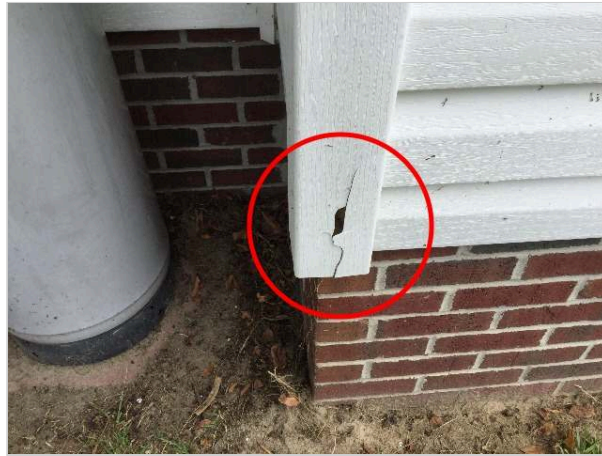
***There is one area on the left side of the home where the vinyl siding is damaged, apparently by lawn equipment. If left, this can allow moisture to penetrate and damage structural components. Have a qualified contractor evaluate and repair as required.***

1. There is one area on the left side of the home where the vinyl siding is damaged, apparently by lawn equipment. If left, this can allow moisture to penetrate and damage structural components. Have a qualified contractor evaluate and repair as required.

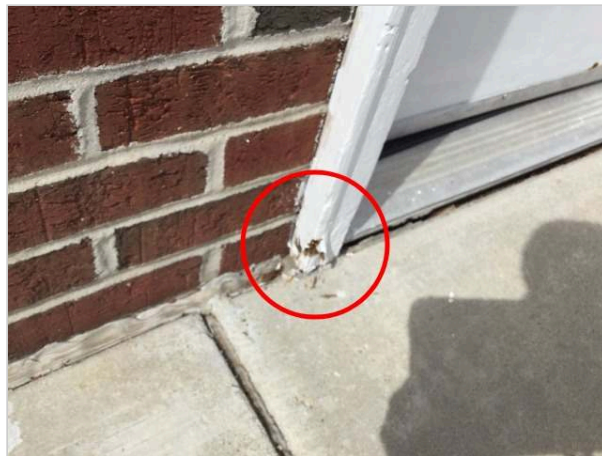
***At the garage walk-in door the lower frame is rotted. If left, this conditions can lead to structural damage. Have a qualified contractor repair the frame as required.***

1. At the garage walk-in door the lower frame is rotted. If left, this conditions can lead to structural damage. Have a qualified contractor repair the frame as required.

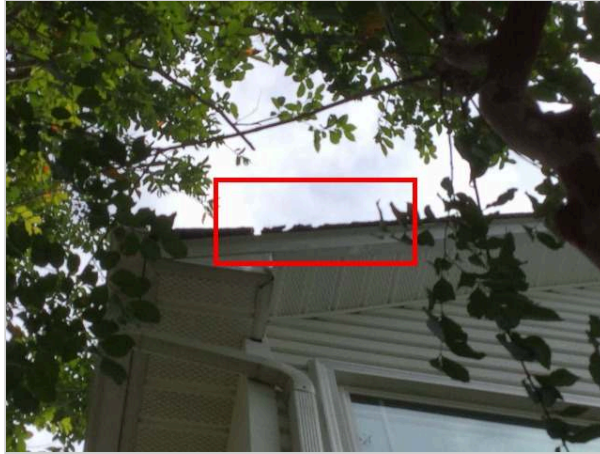
***On this roof, several shingles appeared to be in poor condition at the rear left corner of the home. Broken, loose and/or cracked shingles can allow the infiltration of water and lead to damaged structural components. Have a qualified contractor to evaluate and repair as required.***

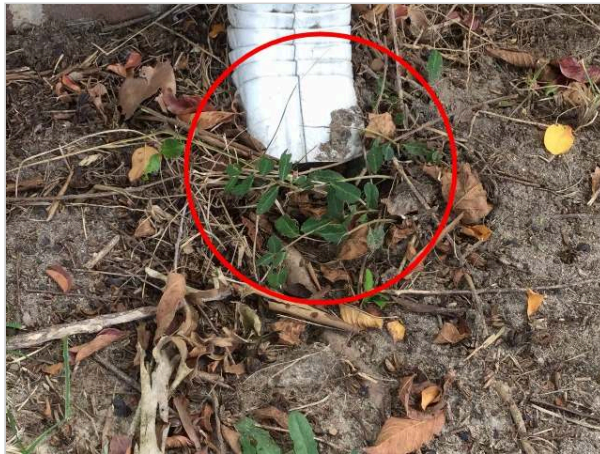
***At the back porch, the gutter downspout is partially underground. This may interfere with proper drainage. Have a qualified contractor repair as required to configure this downspout for proper drainage moving water away from the foundation.***

1. At the back porch, the gutter downspout is partially underground. This may interfere with proper drainage. Have a qualified contractor repair as required to configure this downspout for proper drainage moving water away from the foundation.

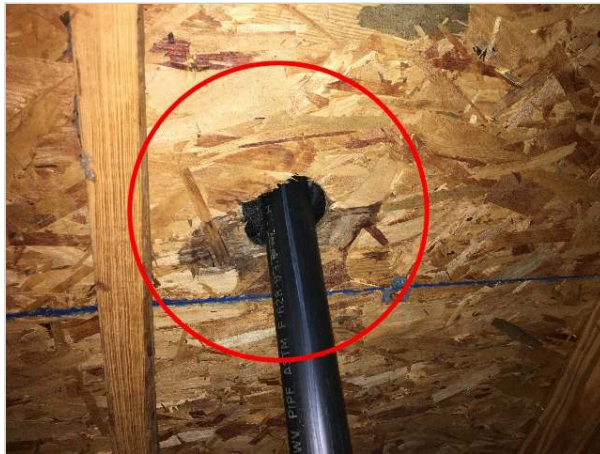
Area over bonus room

***In the attic there is evidence of moisture staining to the roof sheathing at the plumbing vent. If the roof is actively leaking, this can lead to further damage to structural components. Have a qualified roofing contractor evaluate and repair as required.***

1. In the attic there is evidence of moisture staining to the roof sheathing at the plumbing vent. If the roof is actively leaking, this can lead to further damage to structural components. Have a qualified roofing contractor evaluate and repair as required.
2. On this roof, several shingles appeared to be in poor condition at the rear left corner of the home. Broken, loose and/or cracked shingles can allow the infiltration of water and lead to damaged structural components. Have a qualified contractor to evaluate and repair as required.

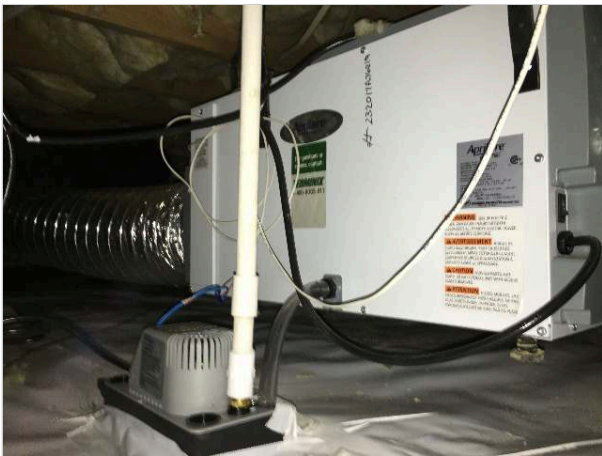
***In this sealed crawl space, there is a dehumidifier operating. A DH unit is beyond the scope of this inspection. There is evidence of a past problem with microbial growth on the wood floor structure that now appears to be dormant. It appears the DH unit, the sealed vents and the new vapor barrier were in response to this past problem. It is critical that the DH unit be kept operating in this sealed environment. Ask for seller disclosure on the past issues including the microbial growth and if the area was evaluated by a qualified contractor for any required mitigation. If necessary, have a qualified industrial hygienist evaluate and advise.***

1. In this sealed crawl space, there is a dehumidifier operating. A DH unit is beyond the scope of this inspection. There is evidence of a past problem with microbial growth on the wood floor structure that now appears to be dormant. It appears the DH unit, the sealed vents and the new vapor barrier were in response to this past problem. It is critical that the DH unit be kept operating in this sealed environment. Ask for seller disclosure on the past issues including the microbial growth and if the area was evaluated by a qualified contractor for any required mitigation. If necessary, have a qualified industrial hygienist evaluate and advise.

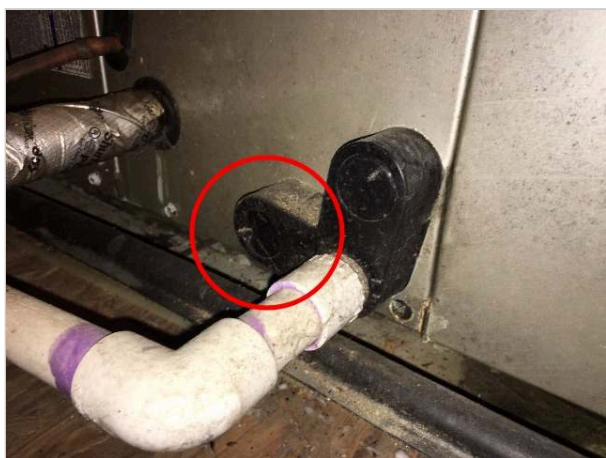
Attic

***In the attic and crawl space, both HVAC indoor units have no secondary condensate drain. If the primary drains become inoperable, condensate can spill over the primary pan and cause corrosion and damage in the units. Secondary drains are essential for proper functioning of these units. Have a qualified HVAC contractor evaluate and repair as required.***

1. In the attic and crawl space, both HVAC indoor units have no secondary condensate drain. If the primary drains become inoperable, condensate can spill over the primary pan and cause corrosion and damage in the units. Secondary drains are essential for proper functioning of these units. Have a qualified HVAC contractor evaluate and repair as required.
2. The insulation on the upstairs HVAC outdoor unit refrigerant line set is damaged. This could adversely affect the efficiency of the system. Have a qualified HVAC contractor repair the insulation as necessary.

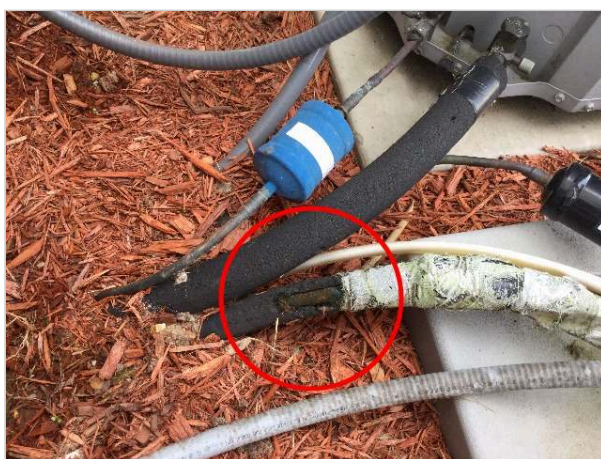
***The insulation on the upstairs HVAC outdoor unit refrigerant line set is damaged. This could adversely affect the efficiency of the system. Have a qualified HVAC contractor repair the insulation as necessary.***

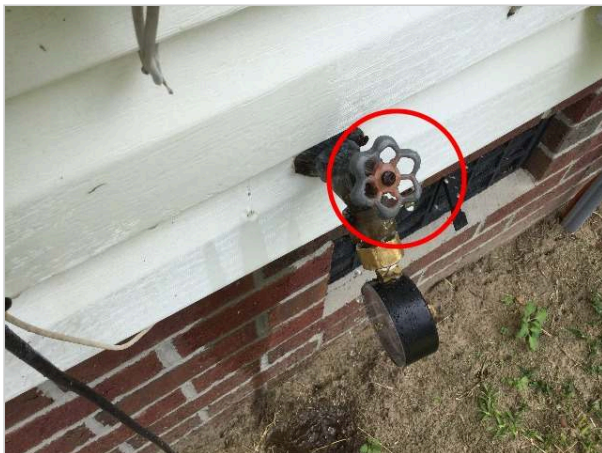
***The left outdoor faucet leaks from the valve stem when turned on. If left, this valve could fail completely and run large amounts of water. Have a qualified plumbing contractor repair or replace this faucet.***

1. The left outdoor faucet leaks from the valve stem when turned on. If left, this valve could fail completely and run large amounts of water. Have a qualified plumbing contractor repair or replace this faucet.
