On Friday, May 22, 2026 The HomeTeam Inspection Service made a visual inspection of 123 Sample Street, Charlotte, NC 28217. Enclosed please find a written, narrative report of our findings in accordance with the terms of our Inspection Agreement.

HomeTeam Inspection Service
NCHI 3979 / SCHI 49320

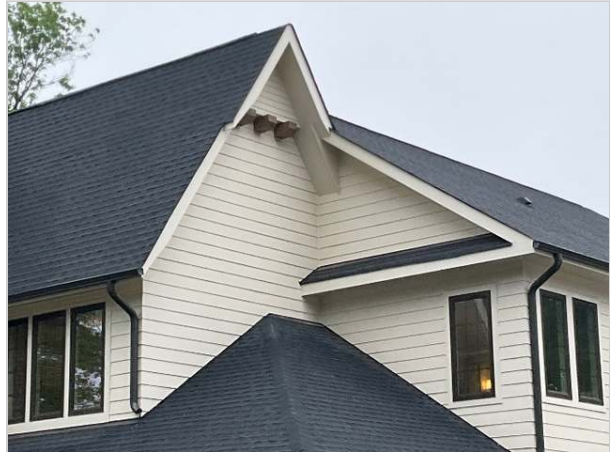
Photo 4

At the exterior, at places the siding is dirty. If not cleaned and repaired as needed this may result in damage to the siding and adjacent wood trim. Have a qualified cleaning contractor clean the siding and repair as needed (Not limited to photos).

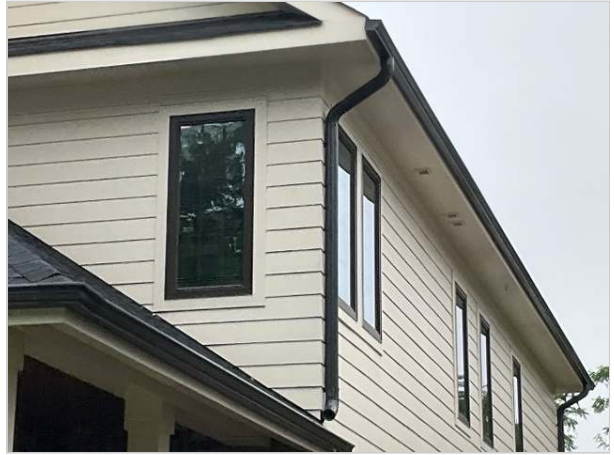
Photo 16

Two gutter downspouts have no splash guards. If not repaired the lack of splash pads allows the flow of water to accumulate at the foundation. This can lead to damage at the foundation. Have a qualified gutter and downspout contractor install splash pads as required.

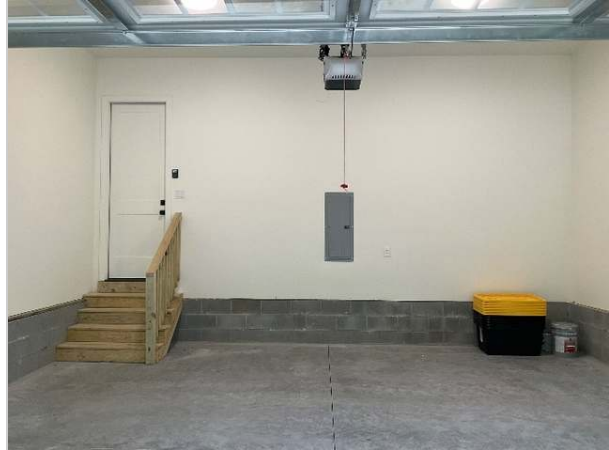
Photo 26

At the garage daylight was observed between the door framing and block foundation wall. If not repaired or sealed this could allow moisture, pests and small animals to enter into the garage. Have the builder repair and or seal this opening.

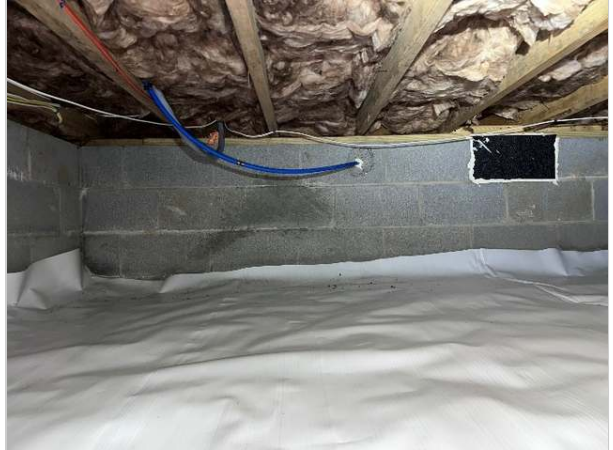
Photo 38

At the rear garage foundation wall a crack was observed. This crack was also visible on the opposite side in the crawlspace. If not evaluated and repaired this crack can worsen resulting in additional damage to the foundation and adjacent areas. Have a qualified structural engineer evaluate and advise.

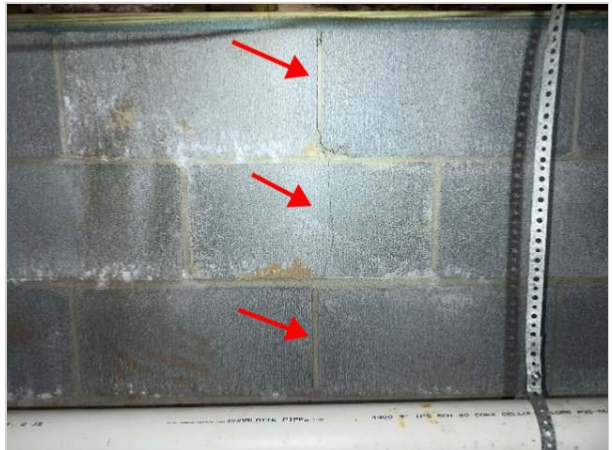
Photo 40

From Inside Crawlspace

There is evidence of efflorescence on the inside of the block foundation walls. Efflorescence is caused by moisture entering from the exterior of the foundation and weeping through. The white residue that is left behind on the inside of the block foundation when drying occurs are mineral deposits. Efflorescence is evidence of water penetration and or elevated moisture levels. If not evaluated and repaired water intrusion and or elevated moisture levels can damage the foundation and adjacent structural components. Have a qualified contractor evaluate and make appropriate repairs to prevent future water penetration (Not limited to photos).

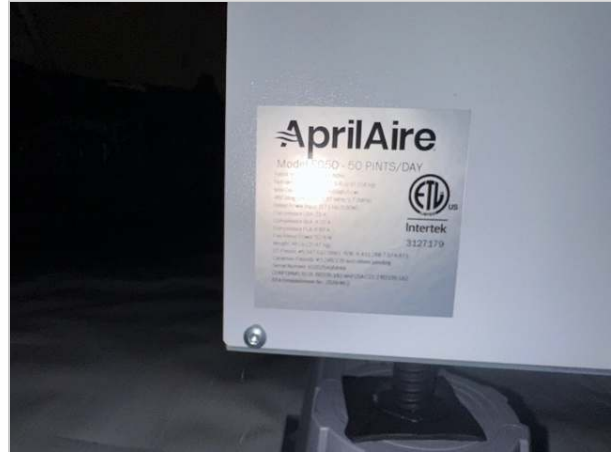
Photo 46

In the crawl space, there is evidence of possible microbial growth on the floor structure. This is often evidence of higher than normal moisture levels in the area. If not mitigated high moisture levels (above 18%) can lead to the growth of harmful mold, mildew, fungus and make the wood more susceptible to wood destroying insects and rot. At the time of this inspection moisture meter readings indicated that the wood moisture content was below 18% (9.2%). Moisture levels in crawl spaces can be cyclical. Therefore it is recommended that a qualified contractor evaluate the condition of the crawl space regularly and repair / mitigate conditions when necessary (Not limited to photos).

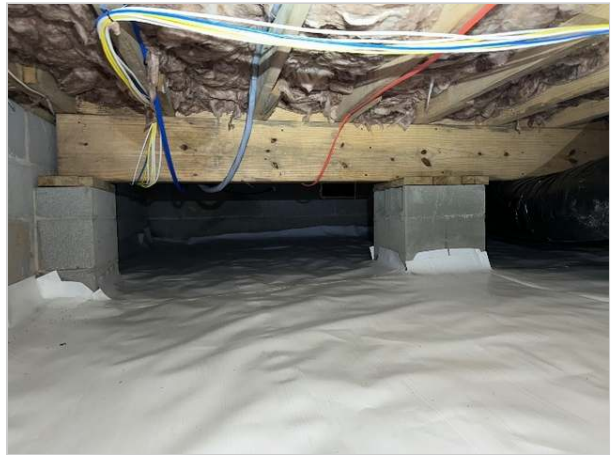
Photo 52

At one support pier there appears to be missing and or inadequate support between the top of the pier and the floor structure. Additionally, it appears that a supplemental post was added without adequate footing or support. If not evaluated and repaired this may result in damage to the floor structure. Have the builder evaluate and make repair as needed to ensure proper support (Not limited to photos).

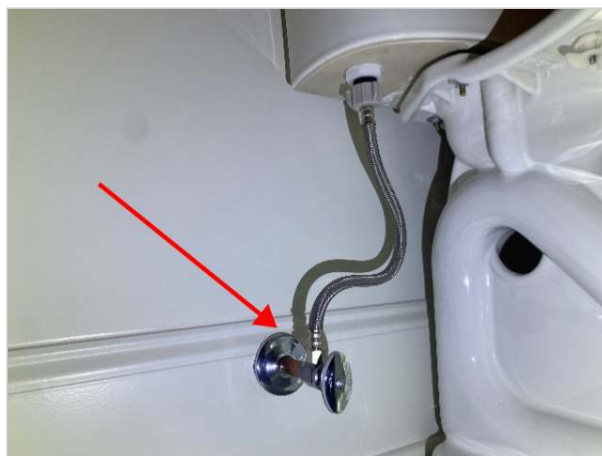
Photo 64

Second Floor Hallway Bathroom Toilet

Water pressure is generally on the lower limits of normal. If not repaired low water flow/pressure makes multiple fixture and appliance use inefficient. Have a licensed plumbing contractor evaluate and make appropriate adjustments.

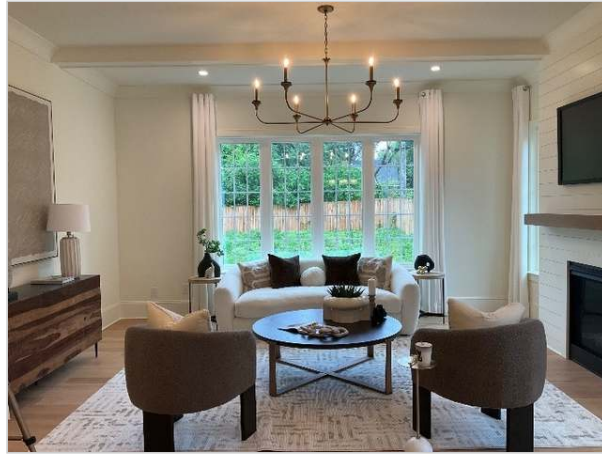
Photo 71

At numerous places the floors are noisy and squeaky. If not repaired this may continue to worsen possibly resulting in damage to the flooring. Have the builder or a qualified general contractor evaluate the flooring and floor structure of this home and repair as needed to ensure proper function (Not limited to photos).

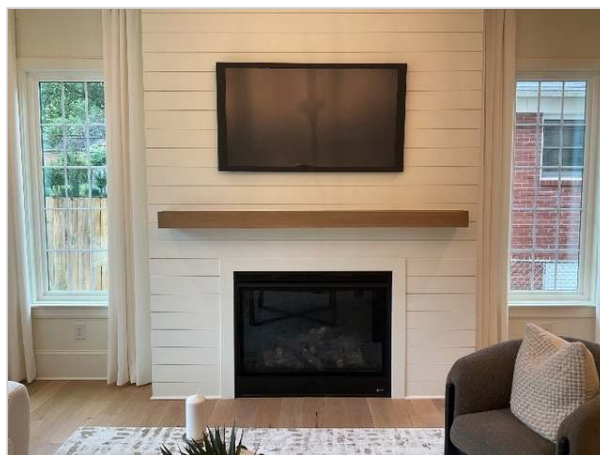
Photo 87

The living room fireplace was not operational at the time of the inspection. Have the present owner demonstrate its function or have a qualified fireplace contractor evaluate and make appropriate repairs.

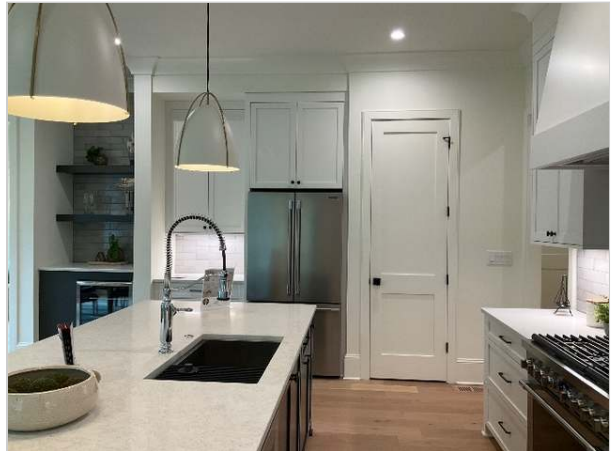
Photo 91

The kitchen cabinets near the gas range appear to be separating from the wall and are loose. Gaps were observed in the caulk and grout. If not repaired this will continue to worsen. Have the builder ensure that these cabinets are adequately secured to the walls and make repairs to ensure proper function.
