HOME INSPECTION REPORT

On Saturday, January 1, The HomeTeam Inspection Service made a visual inspection of 123 Sample Street, Oro Valley, AZ 85737. Enclosed please find a written, narrative report of our findings in accordance with the terms of our Inspection Agreement.

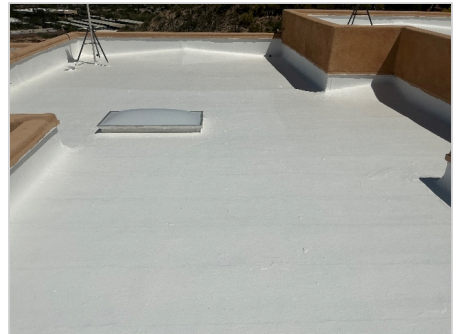
Photo 14

Center left to the rear

> **Excessive leaves and/ or other debris observed on roof.** This debris can trap moisture on roof and cause deterioration of the roofing material. Suggest that this debris be removed by a qualified party and that this issue be monitored in the future.

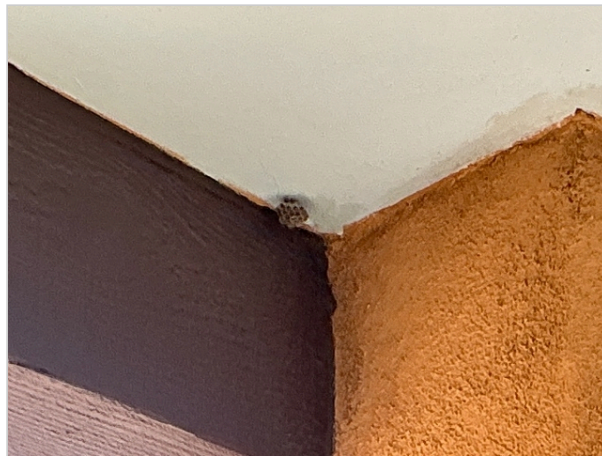
Photo 31

Front left patio

> **A few under-eave area(s) found with evidence of prior moisture intrusion.** Suggest repair by a qualified roofing professional to fix moisture intrusion and assess damage to sheathing.

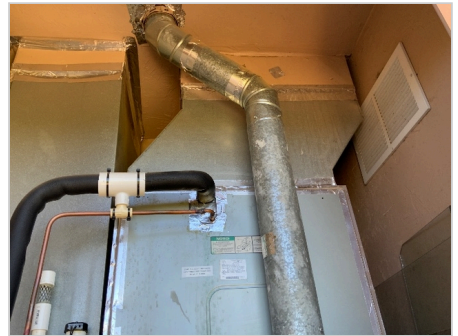
Photo 53

The furnace flue pipe is not sealed where it enters the chimney, possibly leading to exhaust gases entering the structure. In order to ensure proper venting of the flue gases, the chimney should be properly sealed around the flue pipe. Consult with a qualified contractor for repair.

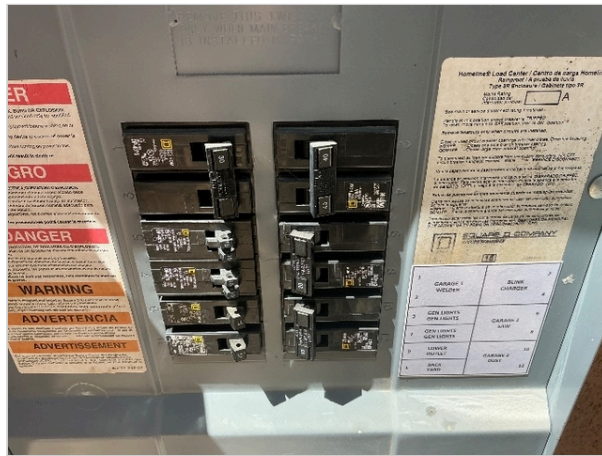
Photo 83

> **At least one breaker observed to be in "Off" position. Breaker was not marked so inspector unable to determine usage for circuit. Suggest discussion with seller to provide input as to what breaker is powering.**

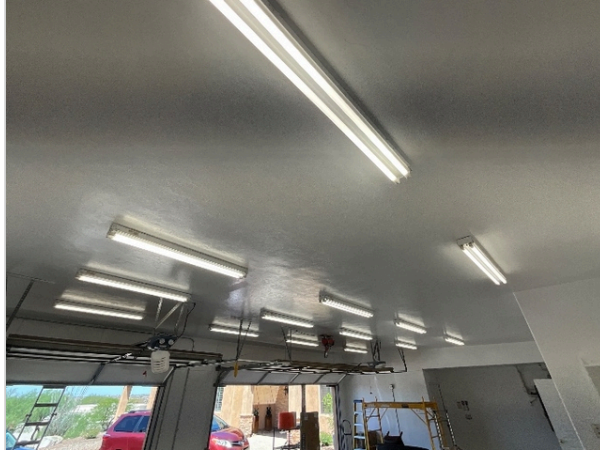
Photo 90

1. > Multiple light fixture(s) with exposed bulb(s) observed. HomeTeam suggests that these bulbs be covered with a light fixture or globe to prevent possible breakage. Consult a qualified party for these repairs.
2. Evidence of amateur wiring was observed on exterior of home.

All garage ceiling lights with exposed bulbs

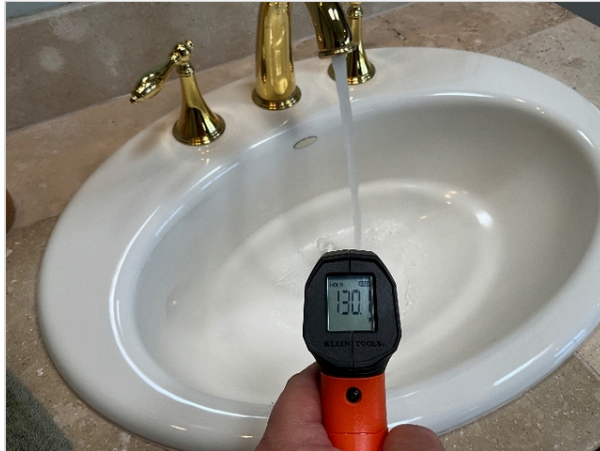
Photo 105

Note- The hot water temperature is high and may pose a risk of burning. HomeTeam recommends adjusting the hot water temperature by turning down the water heater thermostat.

Measured water temperature

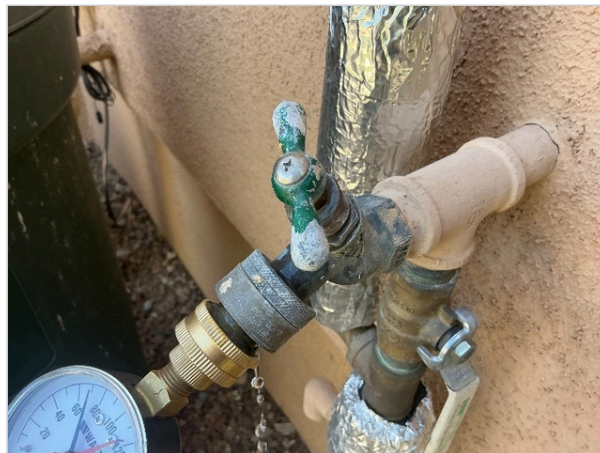
Photo 112

Note: Cross connections observed on at least one hose bib (missing vacuum breaker). Cross connections are a possibility wherever supply plumbing and solid or liquid waste could come together and contaminate potable water with waste to create a serious health issue. Home inspection standards require the inspector to look for and call out any cross connections observed.

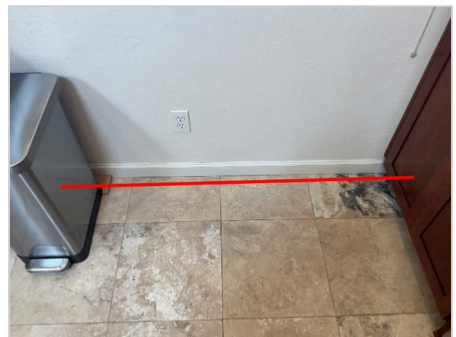
Photo 157

Kitchen tiles

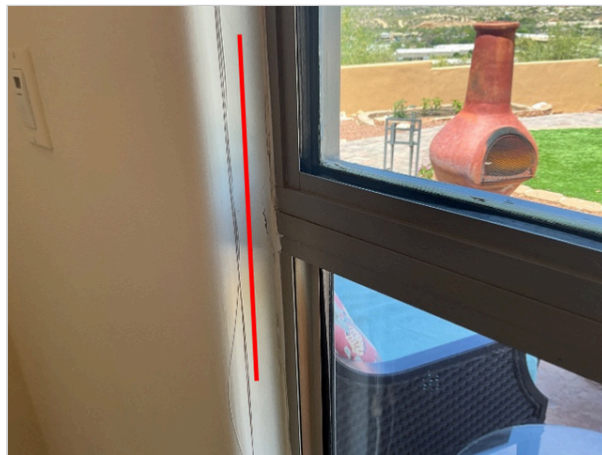
Photo 158

> **Area(s) observed between drywall and window frames that were not properly sealed.** Suggest caulking and painting (as required) to improve aesthetics and protect drywall.

Living room window left side middle

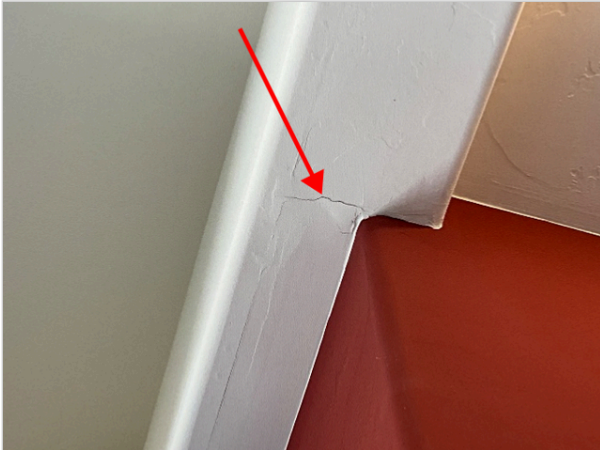
Photo 159

Note- One area(s) observed with settlement cracking in drywall. This type of cracking is typical and can usually be corrected with caulking and paint.

Living room ceiling above fireplace

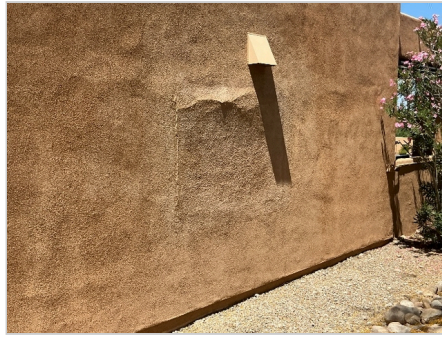
Photo 180

> Holes and damaged siding were noted on the parapet wall of the structure's exterior. This condition does not have any effect on the structural integrity of the building. The areas should be repaired to prevent water or pest intrusion.

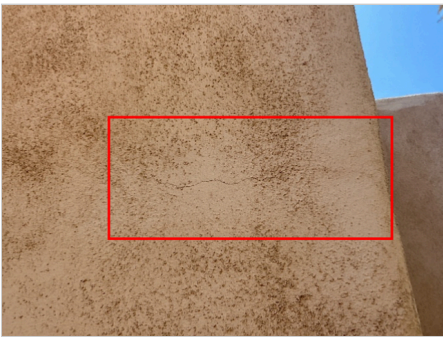
Photo 188

> **Cracked stucco on multiple locations of the structure's exterior.** This condition does not have any effect on the structural integrity of the building. The areas should be repaired to prevent water or pest intrusion.

Rear left

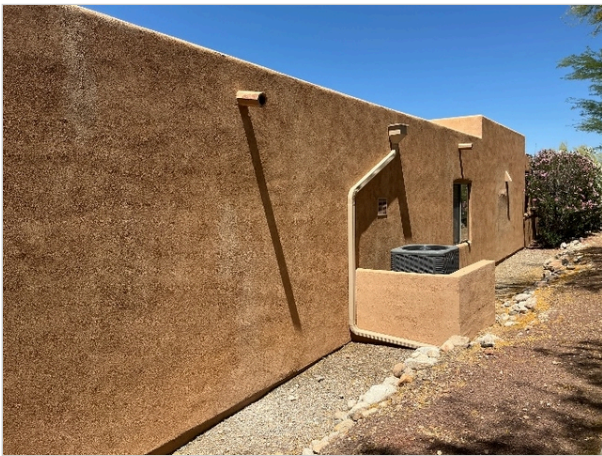
Photo 206

> **Area(s) observed with non-uniform paint.** Suggest correction by a qualified painting professional to protect surface and improve aesthetics.

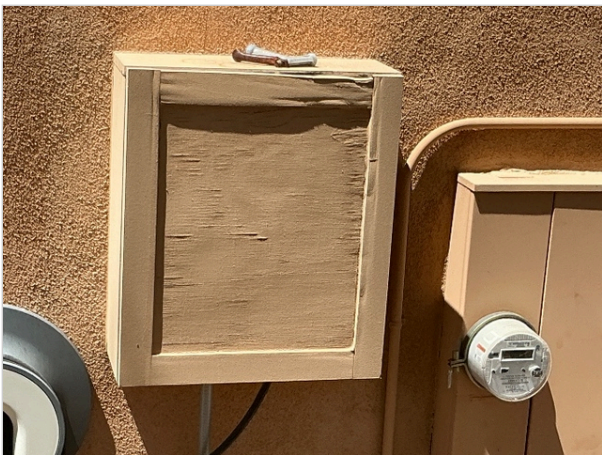
Photo 208

> **Exterior cladding and trim observed with moisture damage.** Suggest area(s) be repaired and sealed to limit further progression of damage.

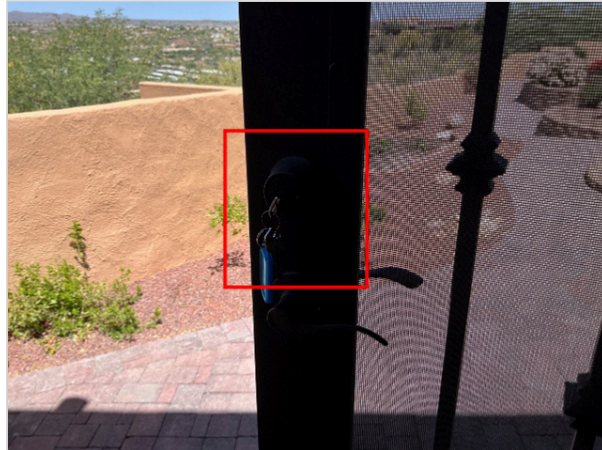
Photo 222

> **One exterior door lock(s) observed with deadbolt lock that requires a key to unlock it from the interior of the structure.** For safety during emergency egress, all exterior doors should be operable without a key from the interior. The affected lock should be repaired or replaced to allow for manual, keyless operation from the interior.

West end hallway bathroom rear patio security door

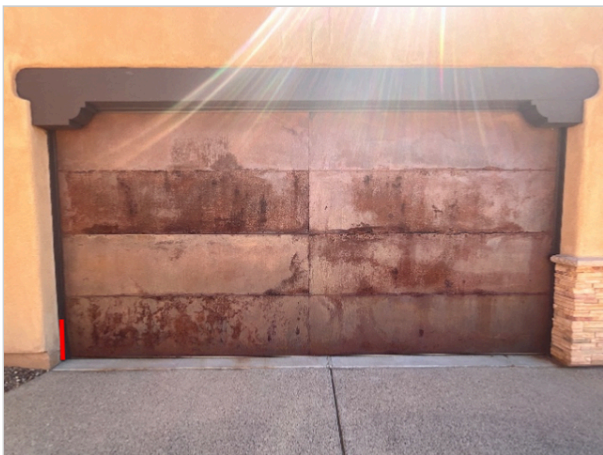
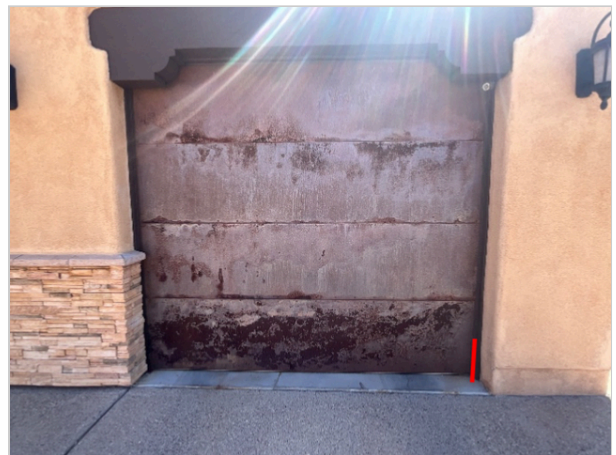
> Weatherstripping at garage door is loose. Suggest repair or replacement to limit intrusion by moisture and pests into garage space.

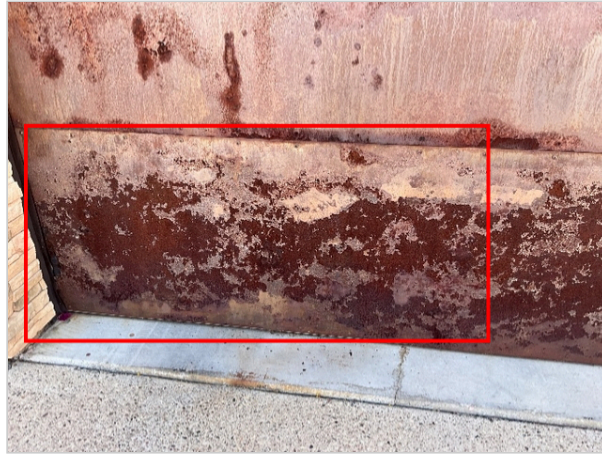
Photo 230

Note: Panel on single car garage door was observed to be damaged at time of inspection, suggest repair or

replacement by a qualified party.

Single car garage door

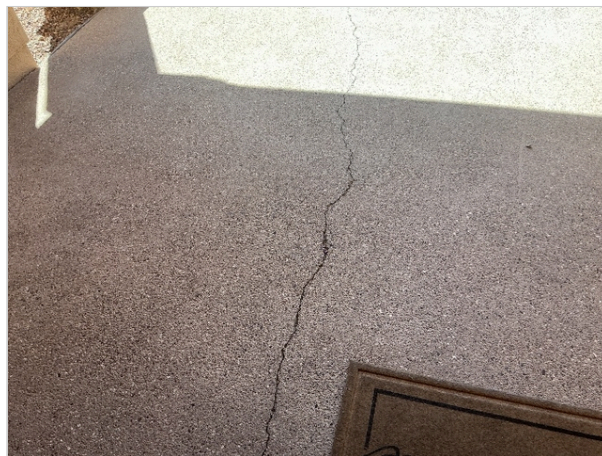
Photo 238

> **Crack(s) observed in concrete garage, driveway, or walkway.** Cracks that have separated and/ or have experienced upheaval at crack itself are of greater concern than those that have not. Suggest filling with epoxy or caulking to limit moisture intrusion and monitoring for further movement.

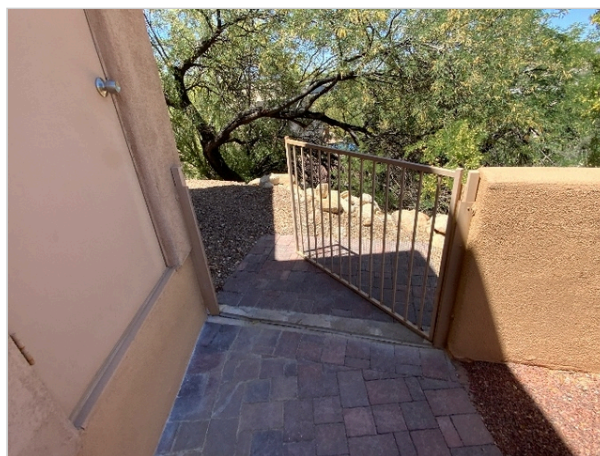
Photo 278

> Doors from house to pool area lack alarms, auto-close, and/ or locking features to prevent or alert access by small children to pool area. HomeTeam suggests that these preventive measures be investigated should small children be in the home for any length of time (supervised or unsupervised).
