# HomeTeam<sup>®</sup>

*HOME INSPECTION REPORT*

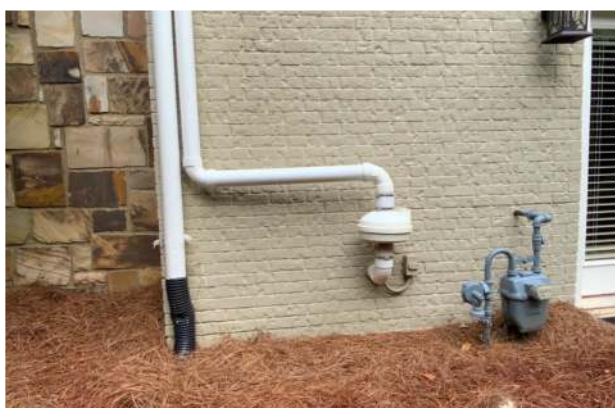
Photo 1

A radon mitigation system is installed in the structure. This system depends on an operable fan and a sealed ventilation system. HomeTeam recommends periodically checking to ensure the system is providing a low-pressure environment to help reduce radon buildup in the structure.

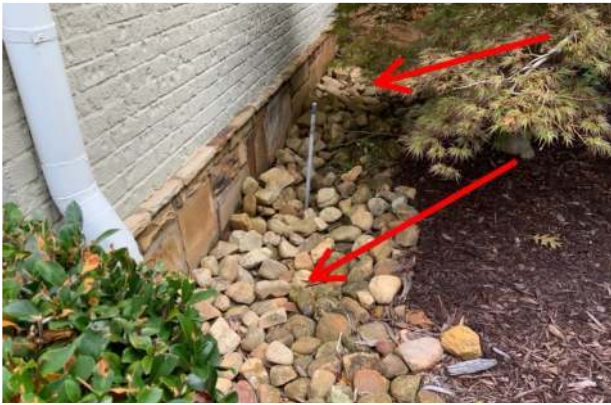
**Photo 8**

The grading around the structure appears to be insufficient to carry water away from the foundation. HomeTeam recommends having the soil regraded on the front of the structure and assessed at the time of regrading.

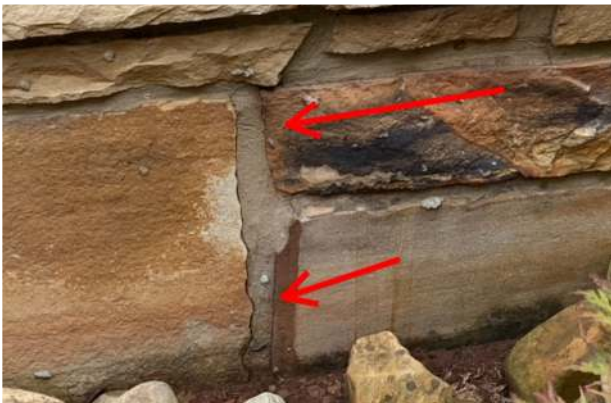
**Photo 9: Back of garage**

Cracks were present on the stone work of the structure. The cracks were located on the front. The cracks are common and do not usually have any structural significance. No structural concern was noted. All cracks should be monitored for significant changes in characteristics. The cracks should be sealed to prevent water intrusion behind the brick.

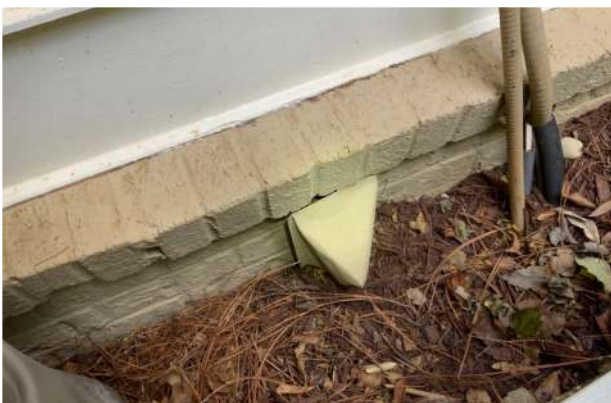
**Photo 11**

Vent damage was noted

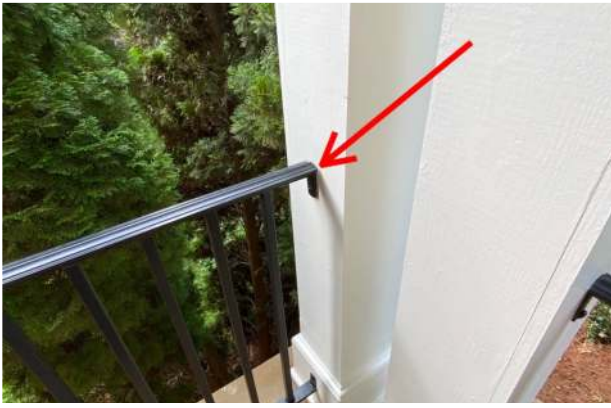
Photo 14

The handrail on the porch in the front is loose or otherwise not secure. The handrails should be repaired by a qualified contractor.

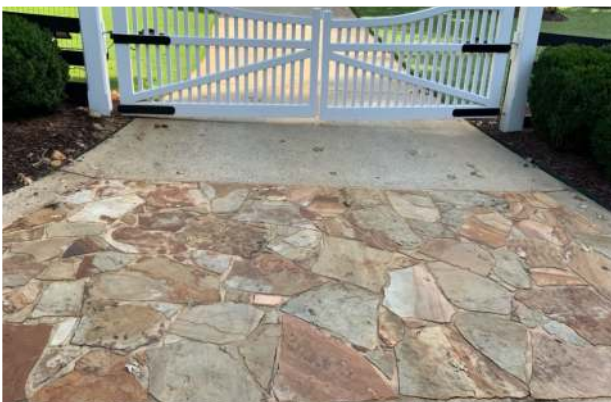
Photo 23

A concrete driveway is present in the front of the structure. Cracks and spalling were observed on the driveway. Surface defects in driveways develop and progress with age and are considered normal as long as they do not create a safety hazard. Sealing defects may help slow the rate of deterioration.

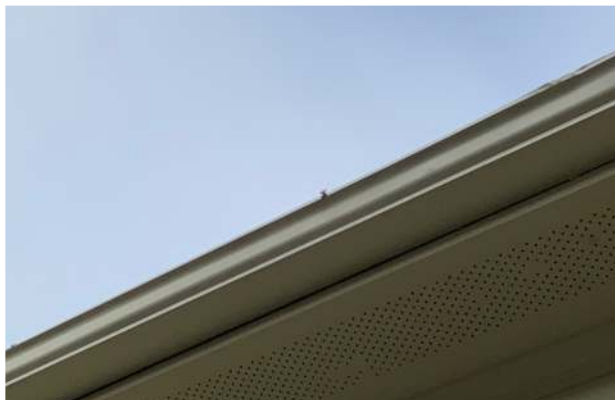
**Photo 27: Front of structure**

A loose gutter mount was observed at the time of the inspection. This is a common condition and is caused by expansion and contraction, along with the freeze thaw cycles that we experience in this area. The mounts should be re-secured and the underlying fascia checked for damage.

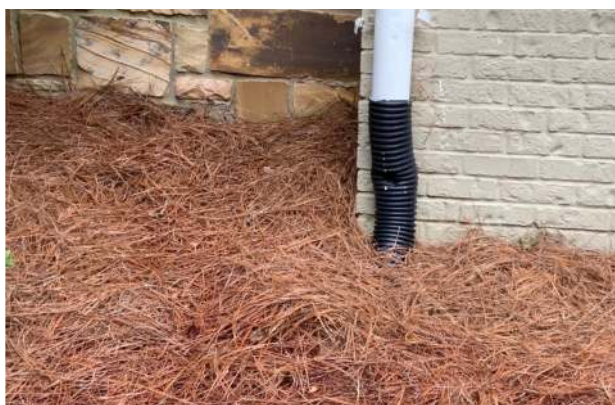
**Photo 28**

Some of the downspouts around the structure are draining into the ground with corrugated tubing and may not have a conclusive termination point. HomeTeam recommends ensuring termination points for all downspouts is far enough from the structure and configured in such a way as to ensure water flows away from the foundation during periods of rain. Diligence should be maintained to monitor that the corrugated tubing is not obstructed preventing water flow away from the structure.

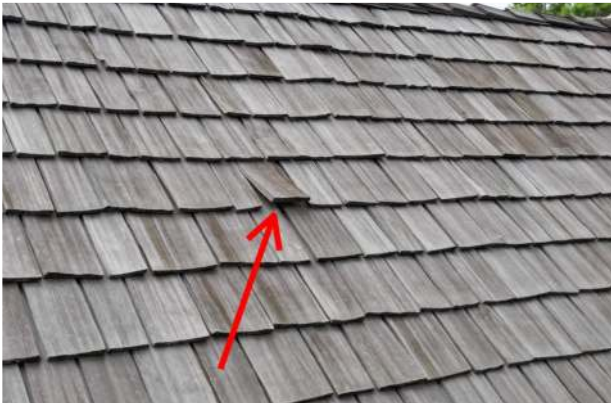
Photo 63

Curled roof shingles have been observed, suggesting that the roof may be nearing the end of its lifespan. It is recommended to have it assessed by a professional roofer.

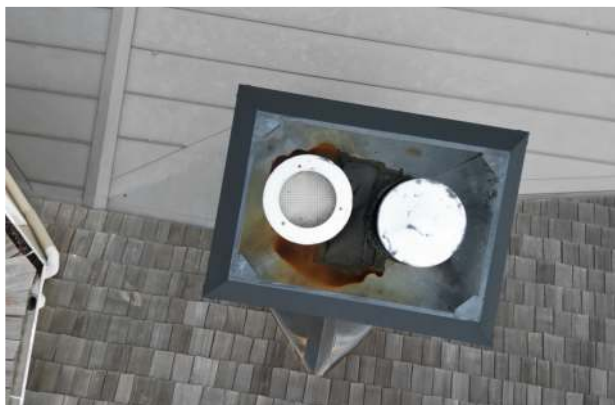
Photo 69

The metal flue chase cap is rusted. Over time, this may lead to water intrusion. No points of visible water intrusion were evident, although our view was limited. As a maintenance item, the rust should be removed and the metal cap painted and sealed to help prolong the life of the cap and reduce the potential for water intrusion.

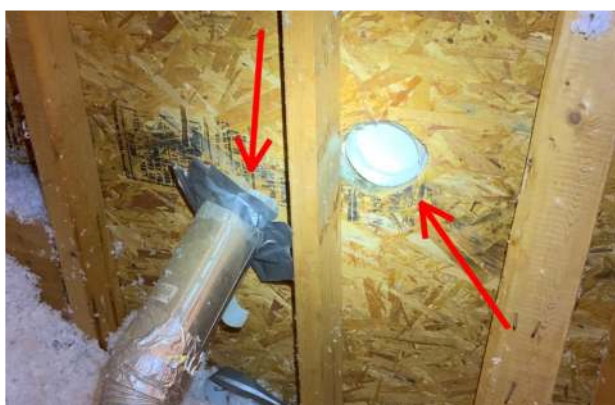
Photo 102

**The bathroom exhaust fan is discharging into the attic.** Excessive moisture can build up in the insulation, creating a condition for mold growth. A duct should be installed from the fan exhaust to an exterior vent.

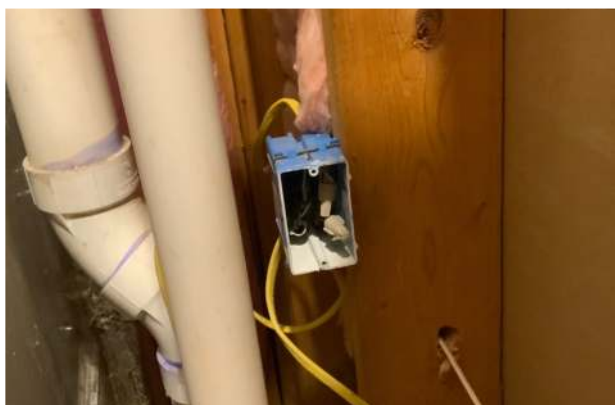
**Photo 138**

**Exposed or un-terminated live wires were observed in the basement.** The wires should either be disconnected at the source or properly terminated in an approved, covered electrical box. Consult with a qualified electrician for repair and assessment.

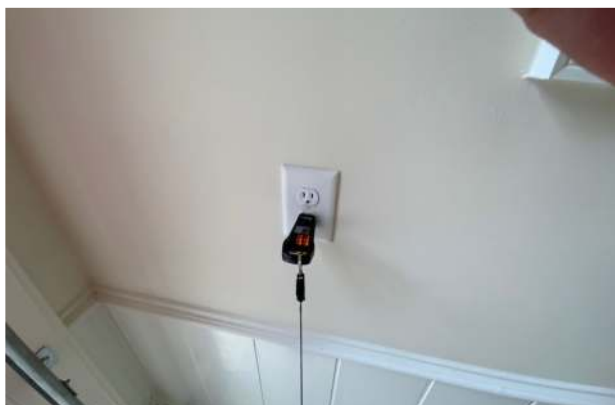
**Photo 139: Single stall garage**

The The structure in the indicated areas lacks GFCI protection.

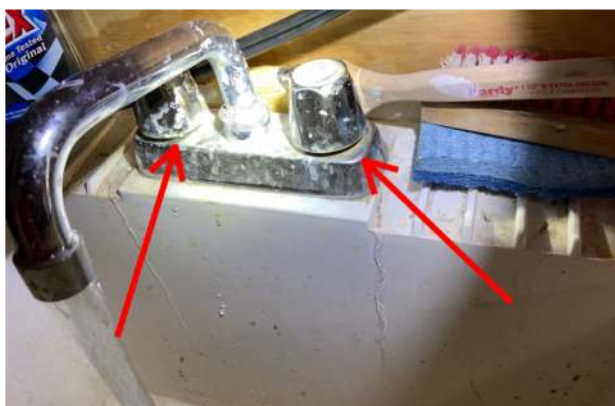
**Photo 143**

A leak was observed at the utility sink faucet. The faucet should be repaired or replaced.

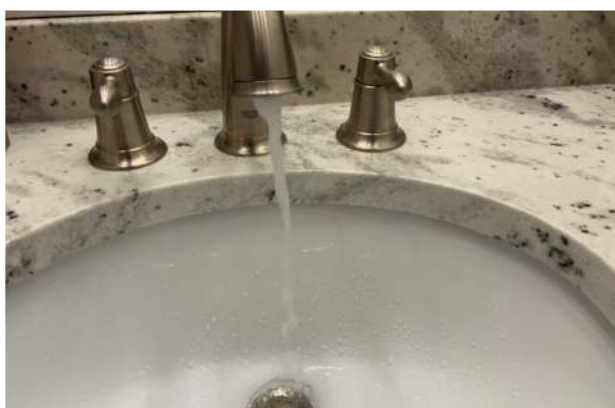
**Photo 145**

Minimal hot and cold water in **Front en suite bath**, It may be shut off at the supply line. Home inspector can not turn on main supply lines.

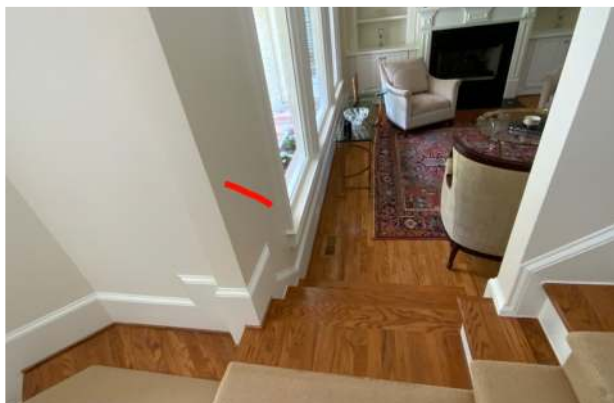
Photo 155

An appropriate handrail was not present on the stairs **going to the second floor**. Adding a handrail may improve safety.

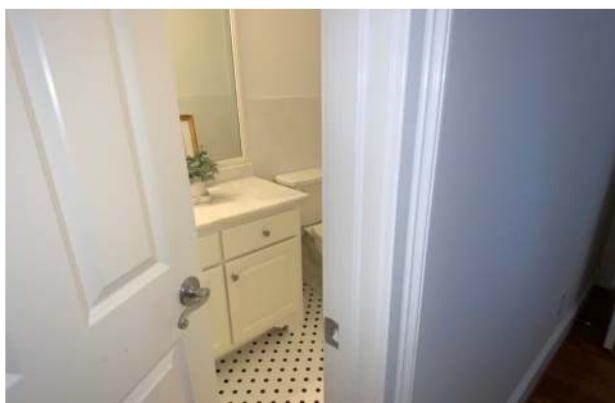
**Photo 159: Left front en suite bath door**

One or more doors were observed to bind against the frame or adjacent surfaces, making them difficult to open and close. Evaluation and repair of the door, frame, and/or hardware are recommended to restore proper operation.

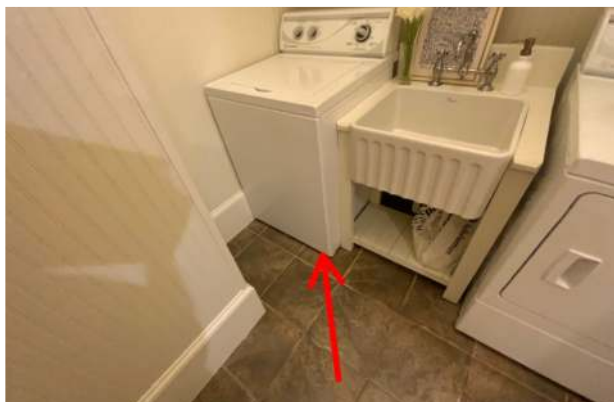
**Photo 188**

The washing machine does not have a pan or floor drain underneath it to catch possible leaks and drain them away safely. As a precaution, HomeTeam recommends placing a moisture detector near the washing machine to monitor for possible leaks. Monitoring for leaks is the best way to prevent possible water damage.

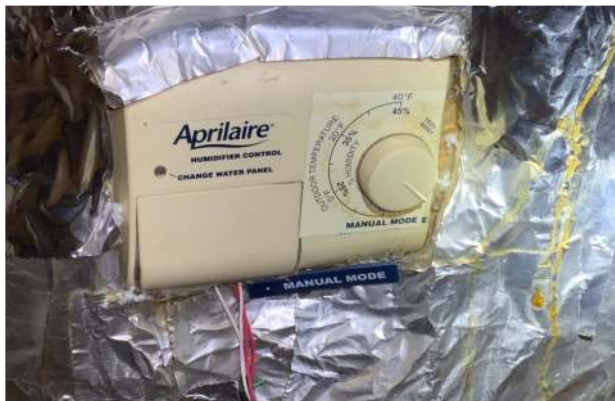
**Photo 192**

Humidifiers can lead to indoor air quality issues if not properly maintained. It is recommended to have your humidifier evaluated by a qualified HVAC professional.

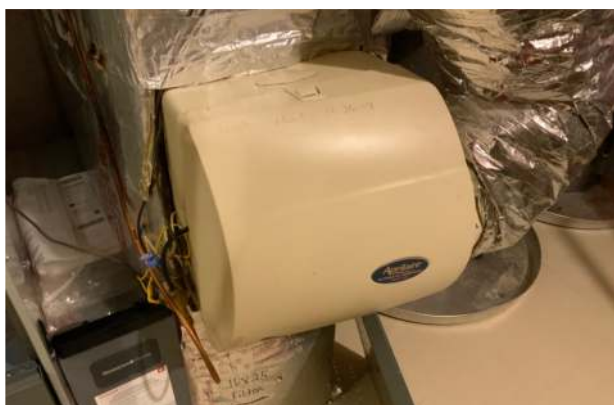
Photo 196

Humidifiers can lead to indoor air quality issues if not properly maintained. It is recommended to have your humidifier evaluated by a qualified HVAC professional.

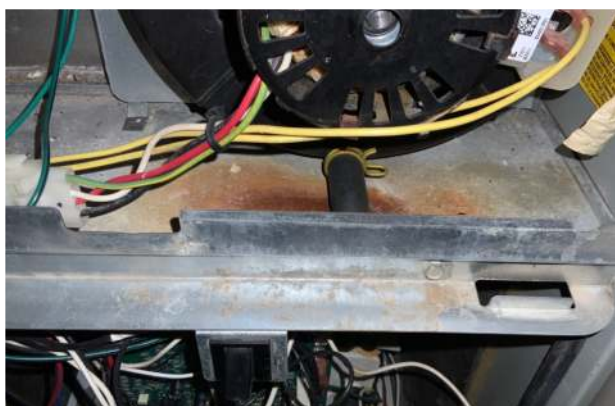
**Photo 202**

Rust noted in heating system should be evaluated by qualified HVAC contractor

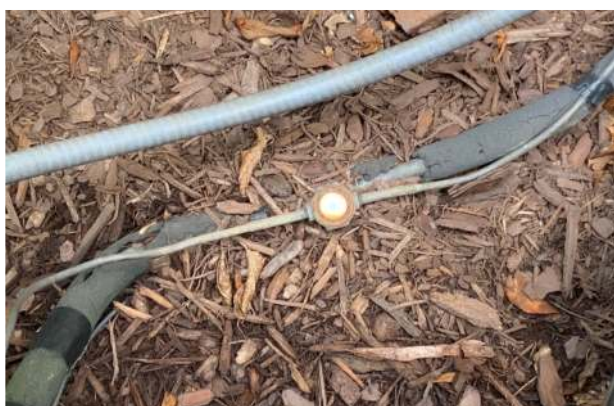
Photo 221

The insulation on the air conditioning line set is damaged **in and around multiple areas of the property**. This could affect the efficiency of the system and should be replaced.
