**HomeTeam**<sup>®</sup>  
INSPECTION SERVICE

RE: 123 Sample Drive, Fort Myers, FL 33908

# SUMMARY

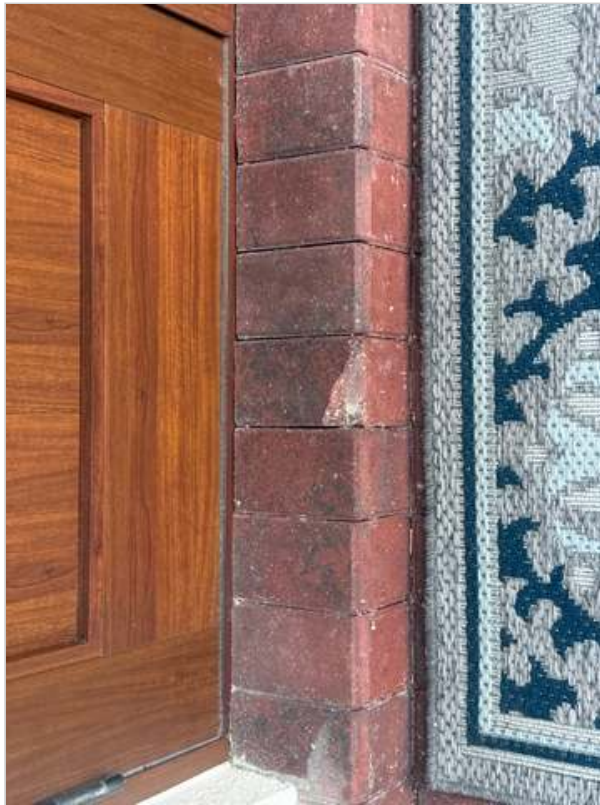
There was noted to be a chipped brick paver at the front entry. This condition is considered to be cosmetic in nature.

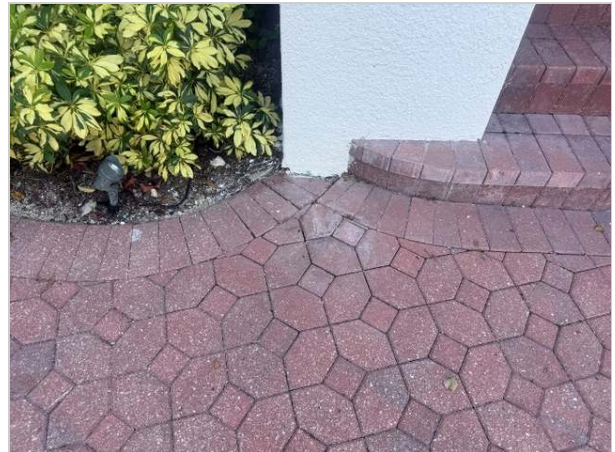
The brick pavers were settling/lifting in a few areas. This condition should be further assessed and corrected as needed to prevent trip hazards.

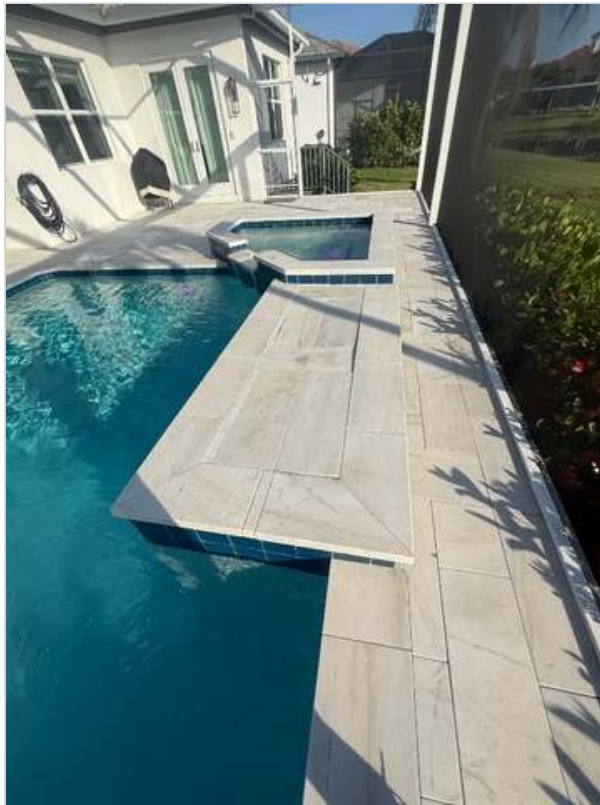
The brick pavers were settling on the lanai. This condition should be further assessed and corrected as needed to prevent trip hazards.

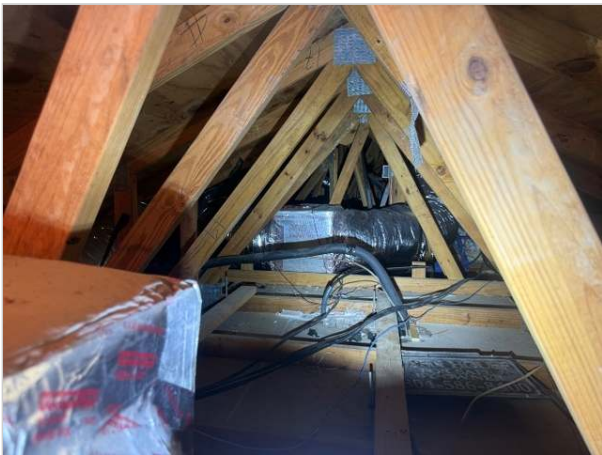
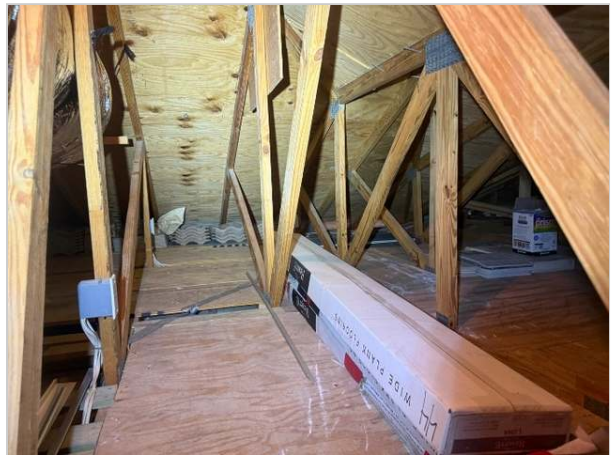
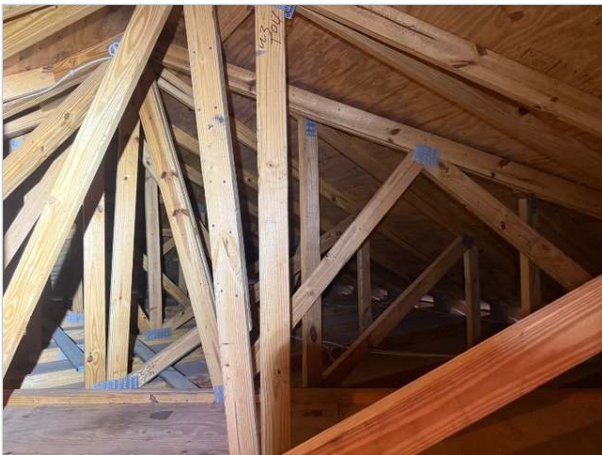
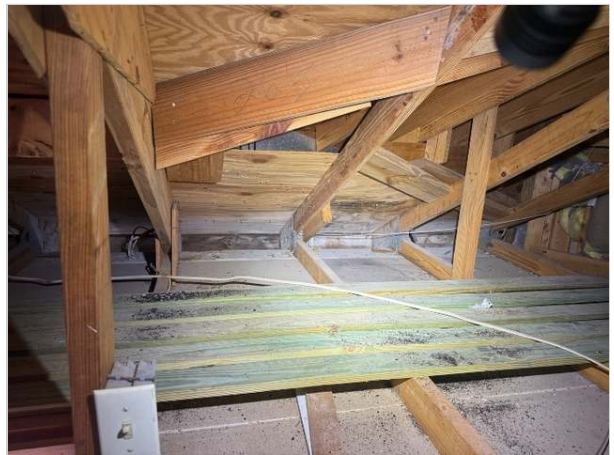
There was noted to be moisture staining over the garage in the attic. These areas were dry at the time of the inspection.

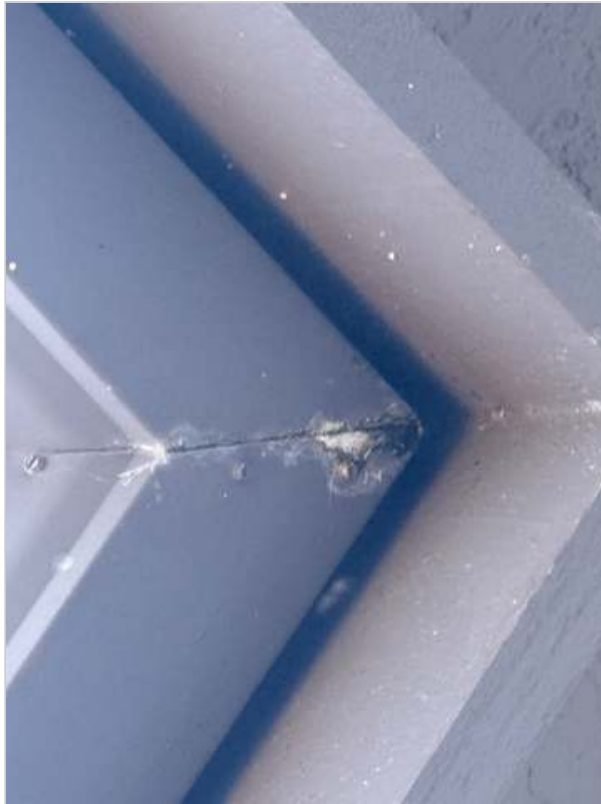
The gutters were in need of sealing at the corners.

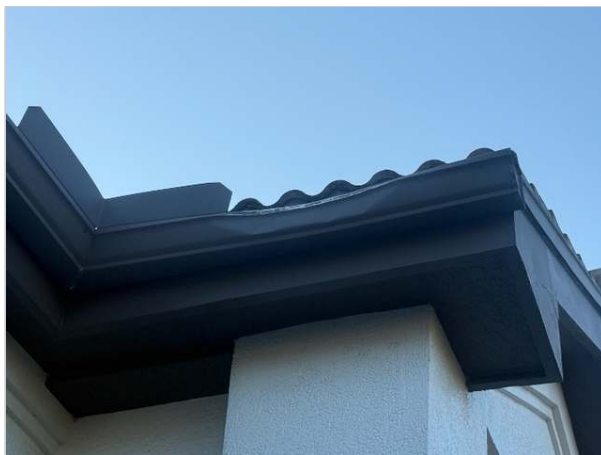
At the front left of the home, the gutter was damaged and in need of repair or replacement.

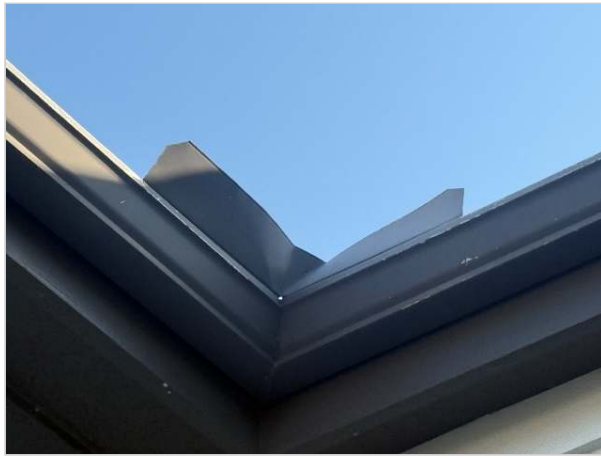
There was a damaged rain guard at the right of the home, in need of repair.

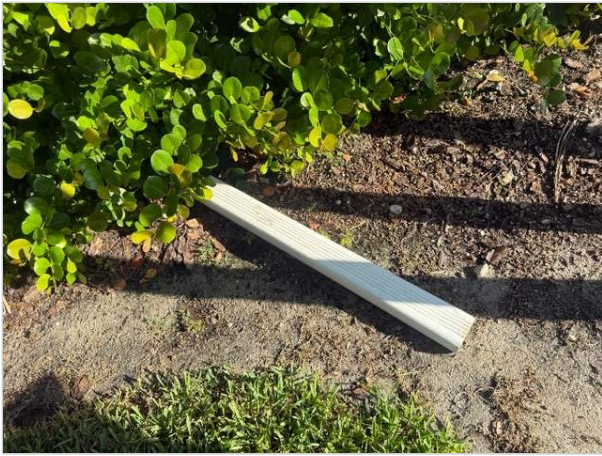
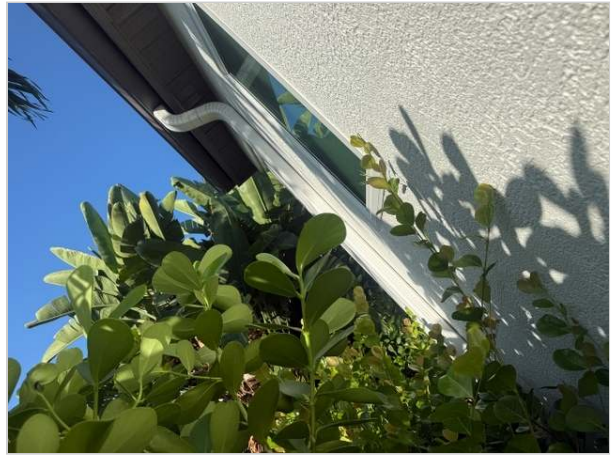
The gutter downspout extension was not attached and in need of repair.

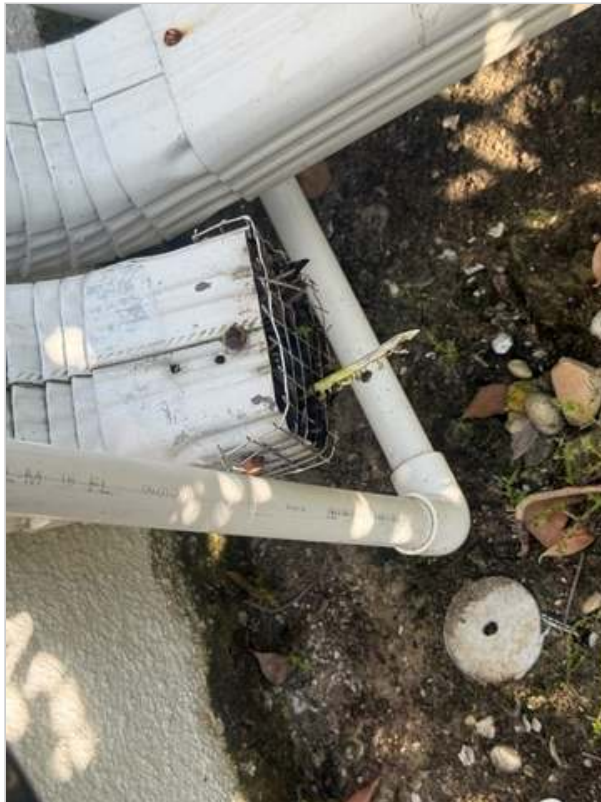
There was debris in the gutter downspout, in need of clearing.

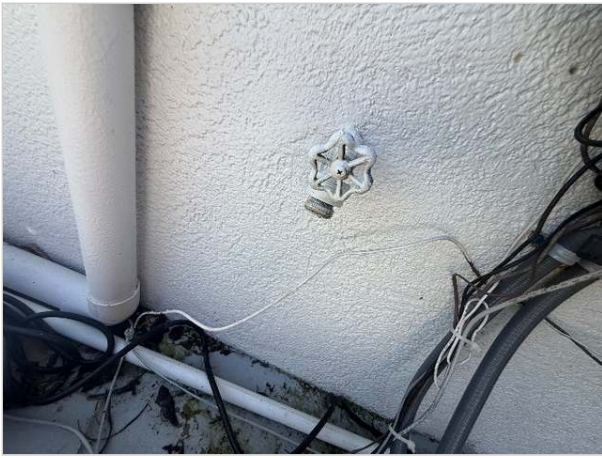
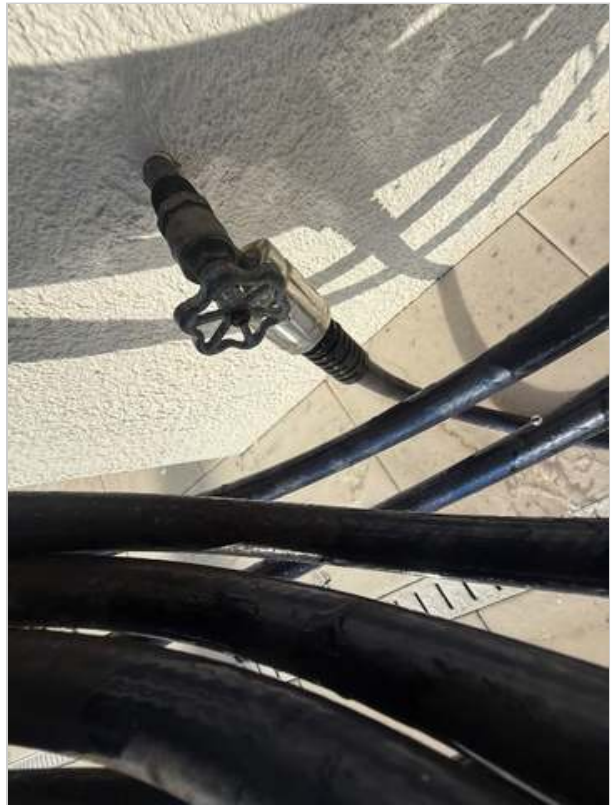
The hose bibs on the exterior of the house were LEAKING and in need of repair.

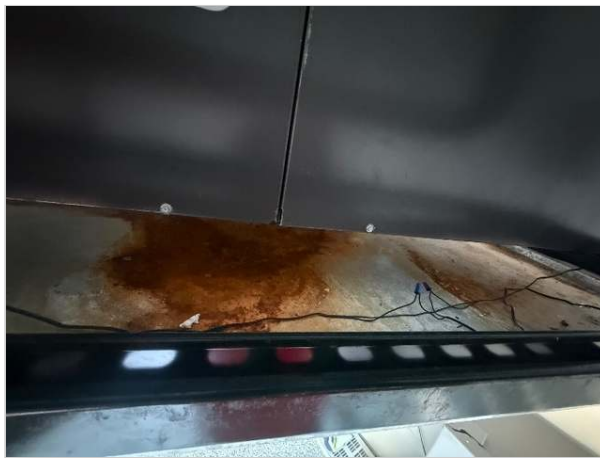
There was corrosion to the air handler drain pan. Please note that, since no dismantling is done, it was not possible to determine if there was corrosion to the interior of the unit. This condition should be further assessed and corrected as needed by a licensed HVAC technician.

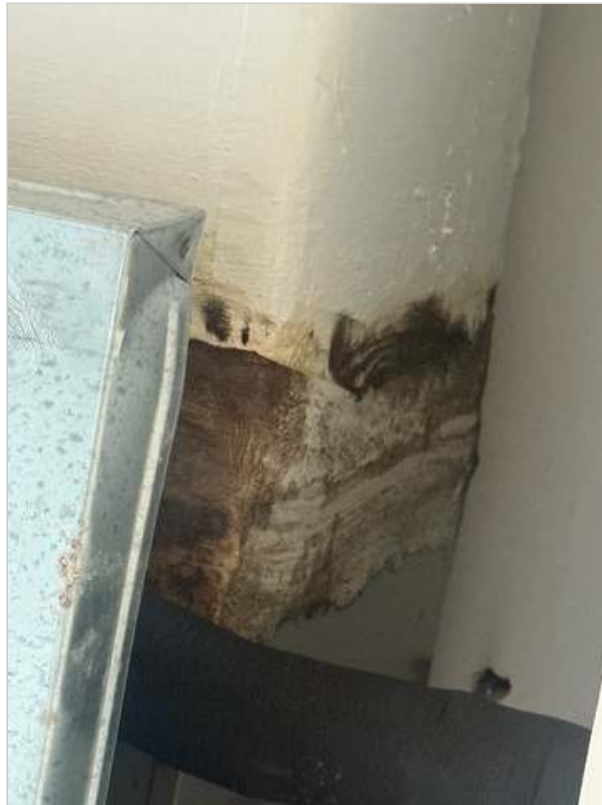
The air handler was in need of sealing on the back of the unit.

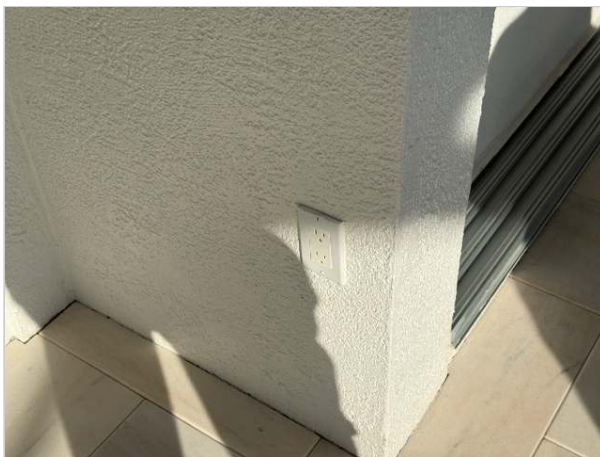
The waterproof cover plate on the outlet at the lanai was missing and in need of replacement for safety purposes.

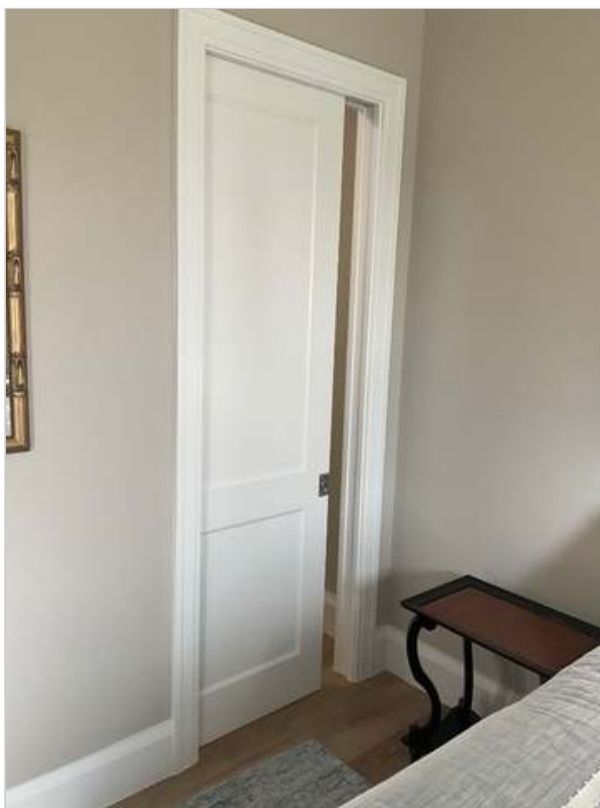
The left rear guest bedroom closet pocket door is catching at the opening and in need of an adjustment.

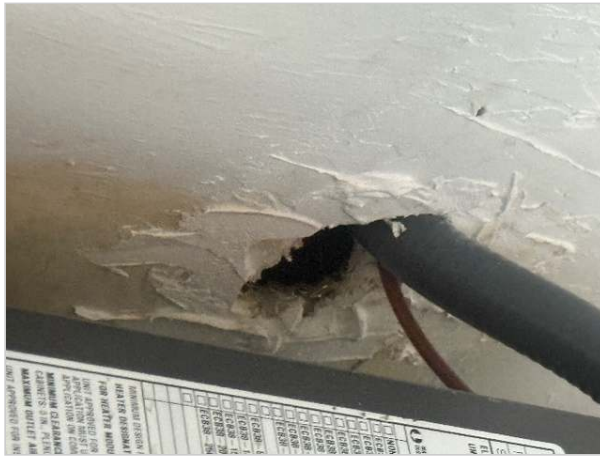
The ceiling was in need of sealing at the air handler, in the garage.

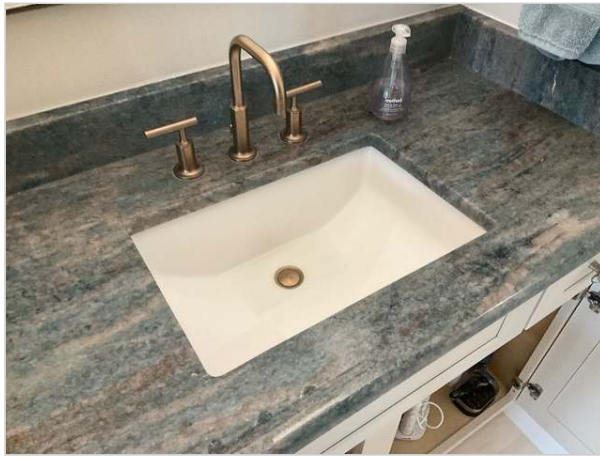
In the master bathroom, the drain stopper for the right sink was in need of adjustment or repair in order to function properly.

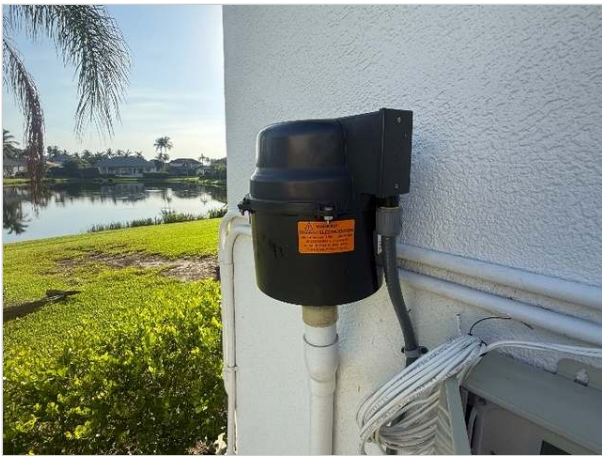
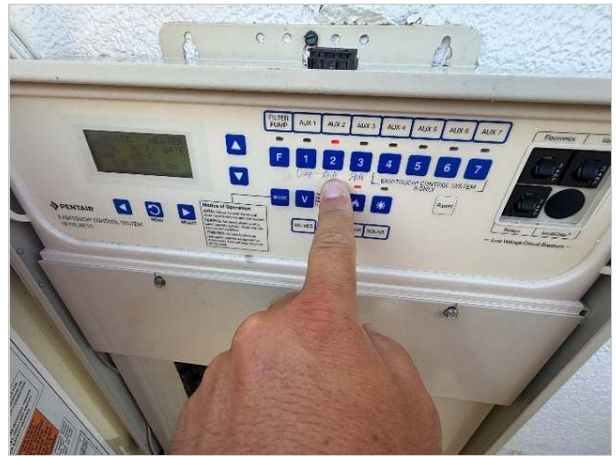
The spa blower was nonfunctional and in need of repair or replacement. This condition should be further assessed and corrected as needed by a qualified pool technician.

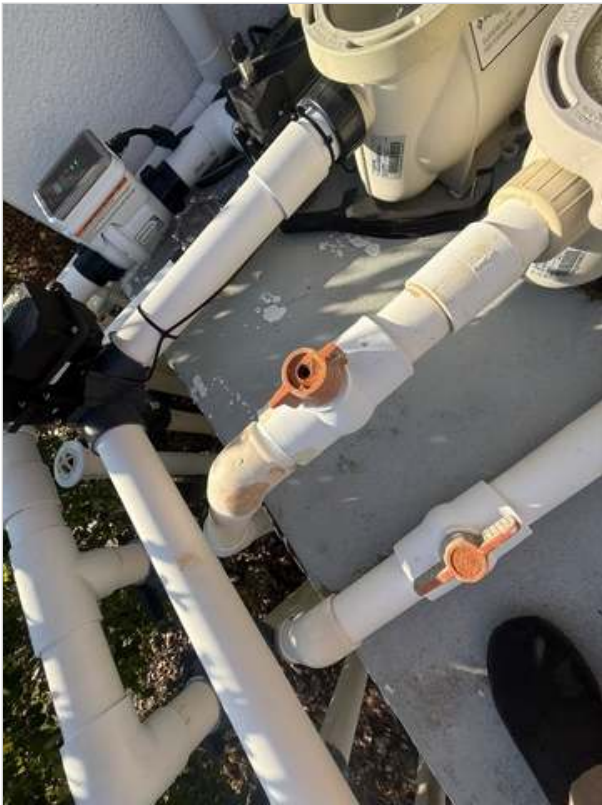
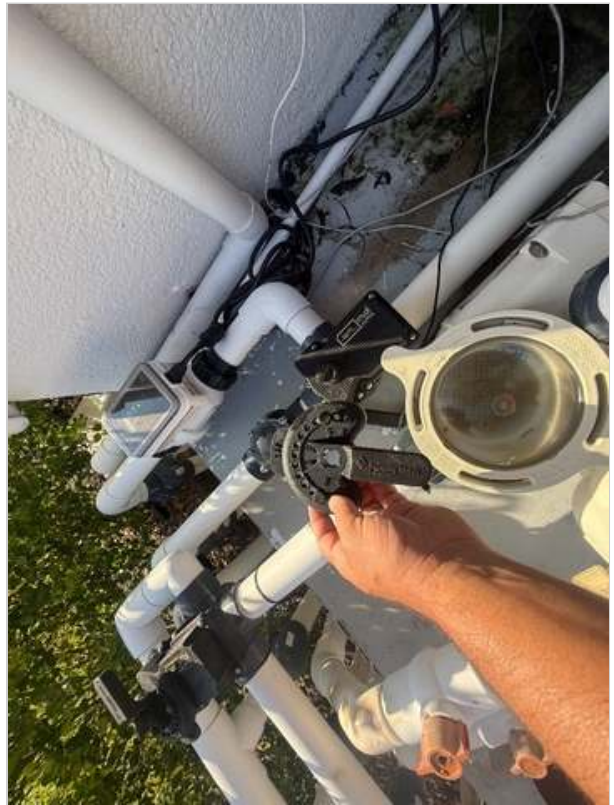
There were two damaged valve handles at the pool equipment, in need of replacement by a qualified pool technician.

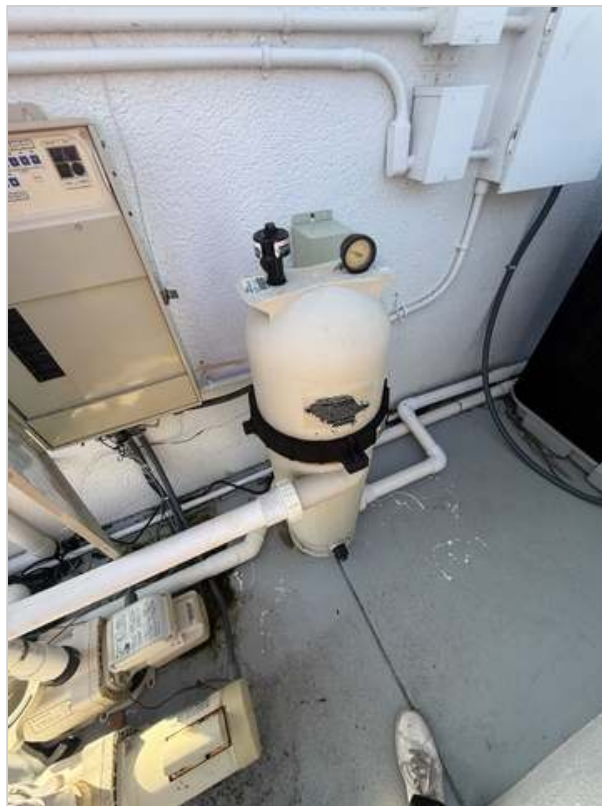
There was minor corrosion to the pool pump. Please note that, since no dismantling is done, it was not possible to determine if there was corrosion to the interior of the unit. This condition should be monitored and corrected as needed by a qualified pool technician.

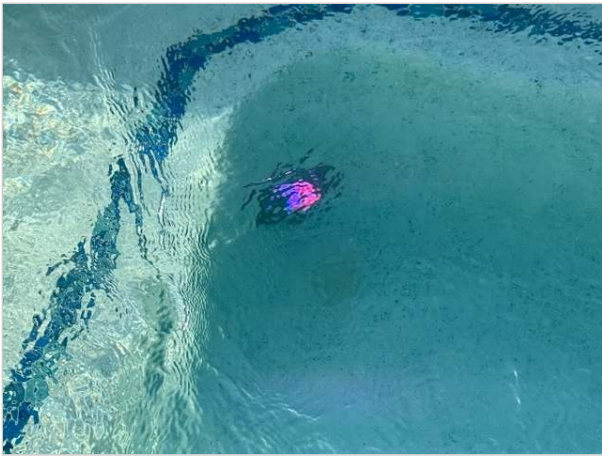
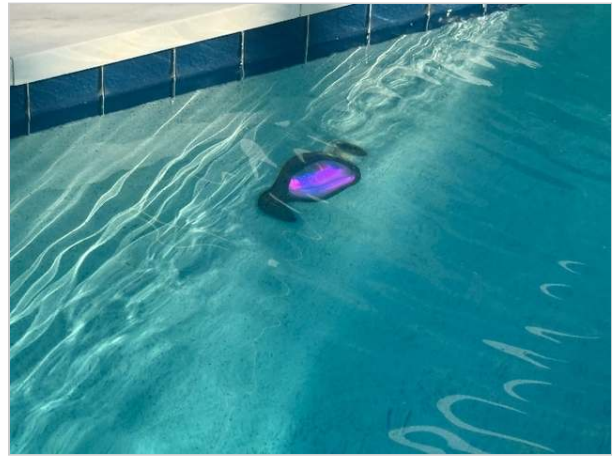
The pool and spa lights were functional at the time of the inspection.

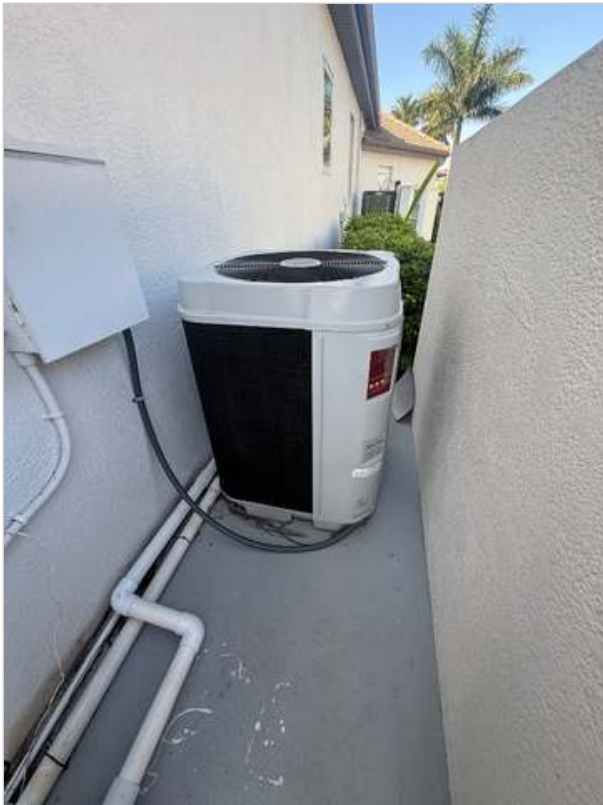
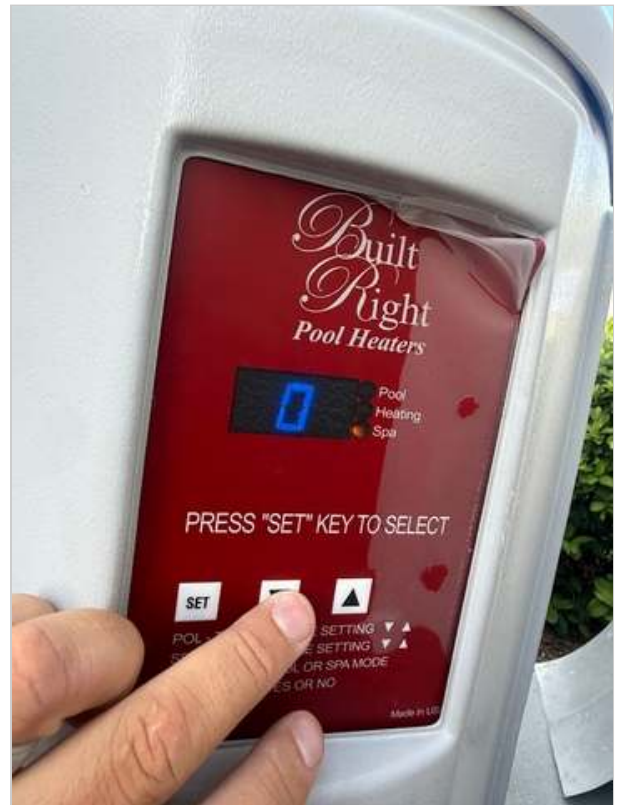
The Built Right pool heater displayed 'LOC' and, as a result the heater could not be tested at the time of the inspection.
