**HomeTeam**<sup>®</sup>  
INSPECTION SERVICE

**123 Sample Drive  
Chattanooga , TN 37409**

## SUMMARY:

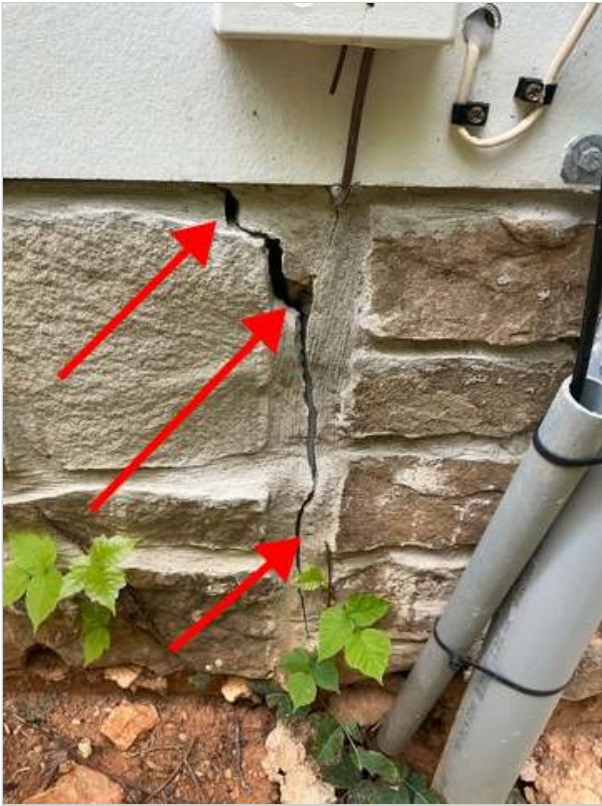
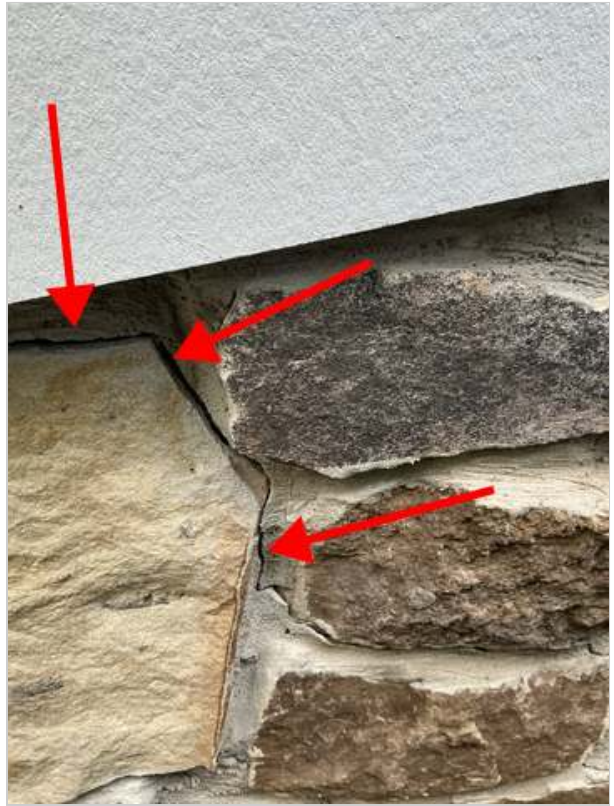
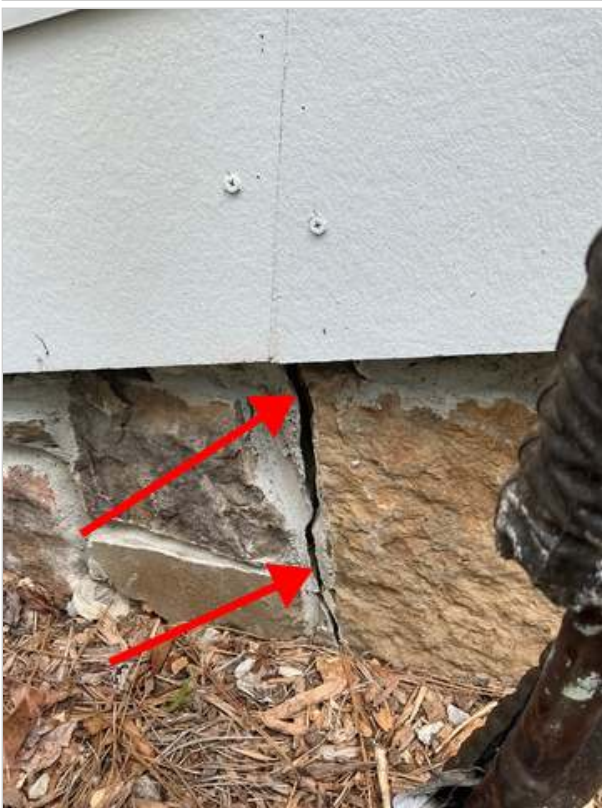
There are a few areas of the stone siding that needs to be sealed to prevent any future damage.

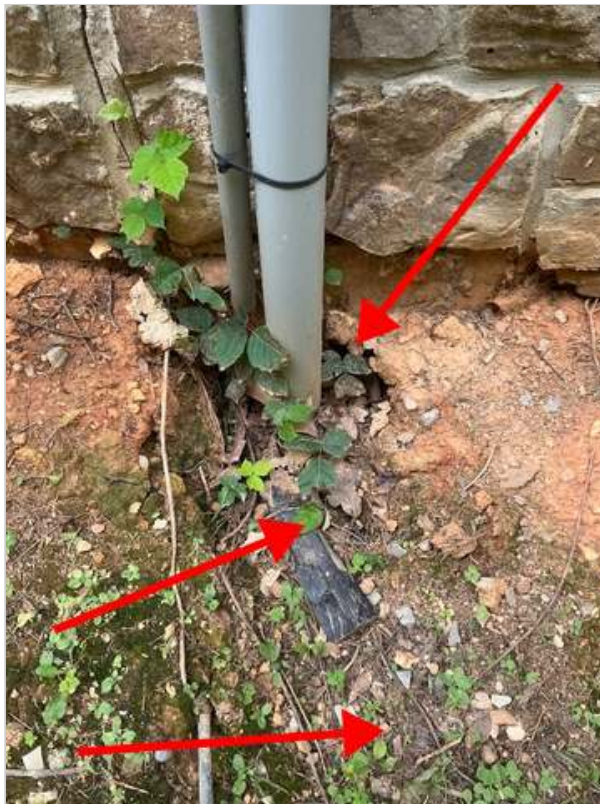
Recommend that the area below the electric meter be filled in to prevent any water from settling against the foundation.

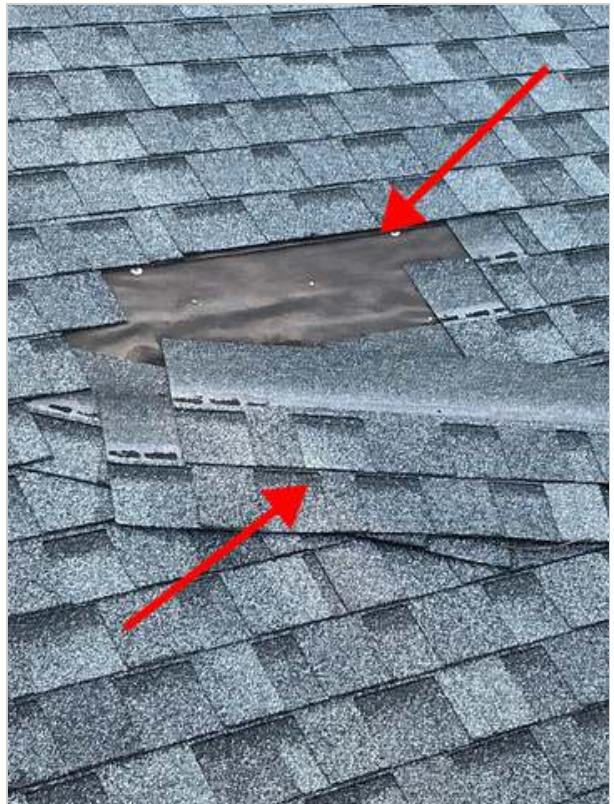
There were loose shingles on the carport roof. Recommend that the shingles be properly secured by a qualified roofing professional.

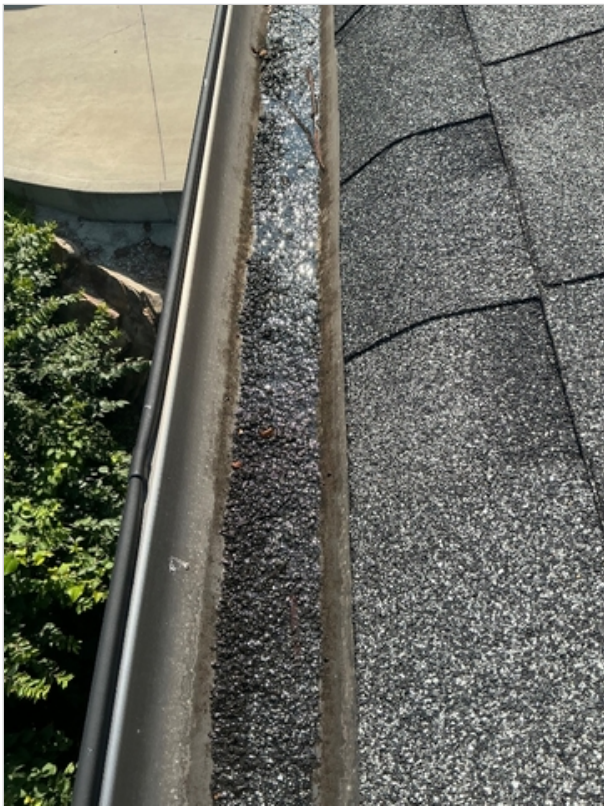
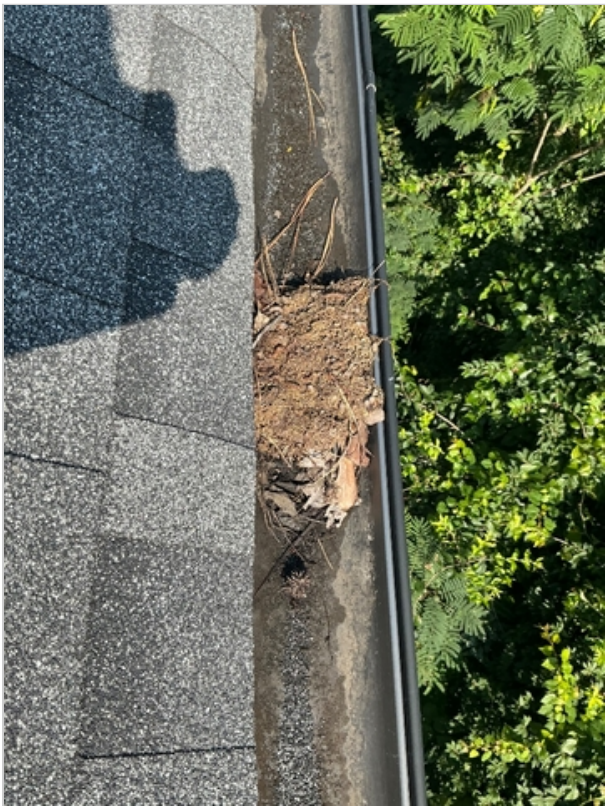
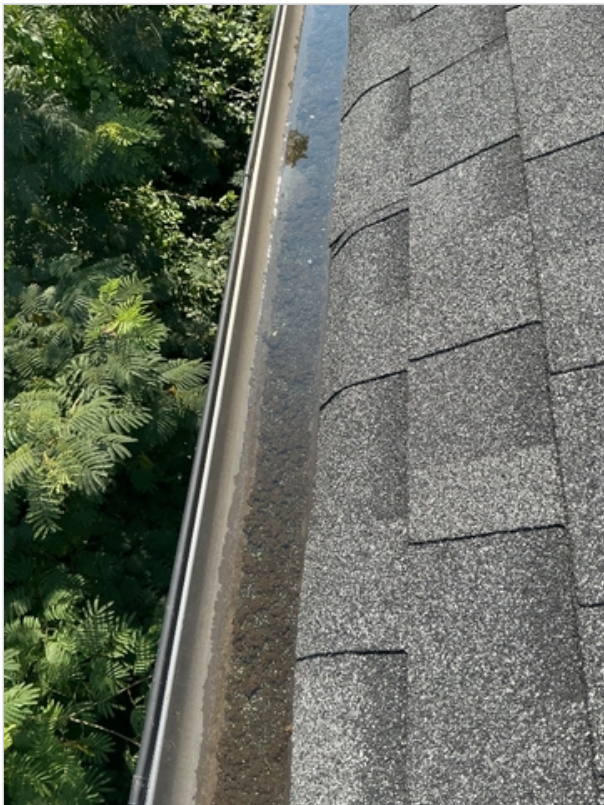
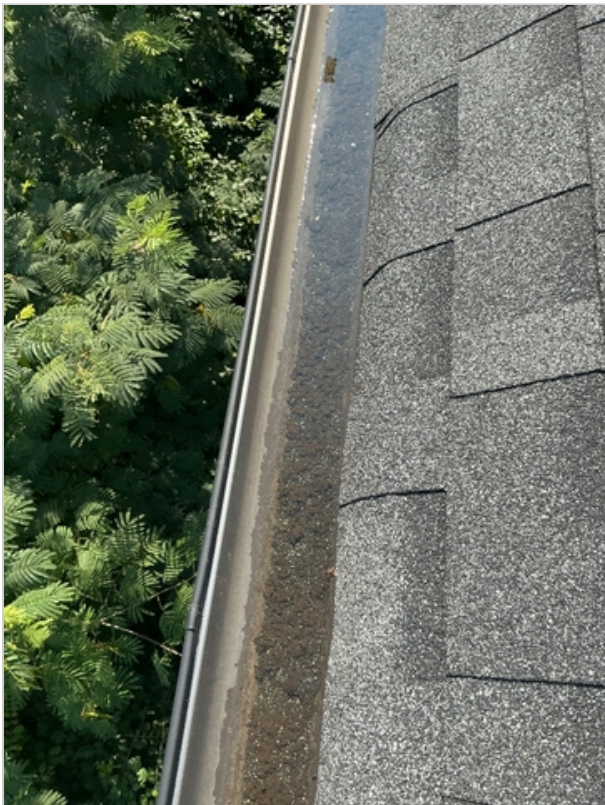
The gutters were stopped up and full of debris and will need to be cleaned out to function properly.

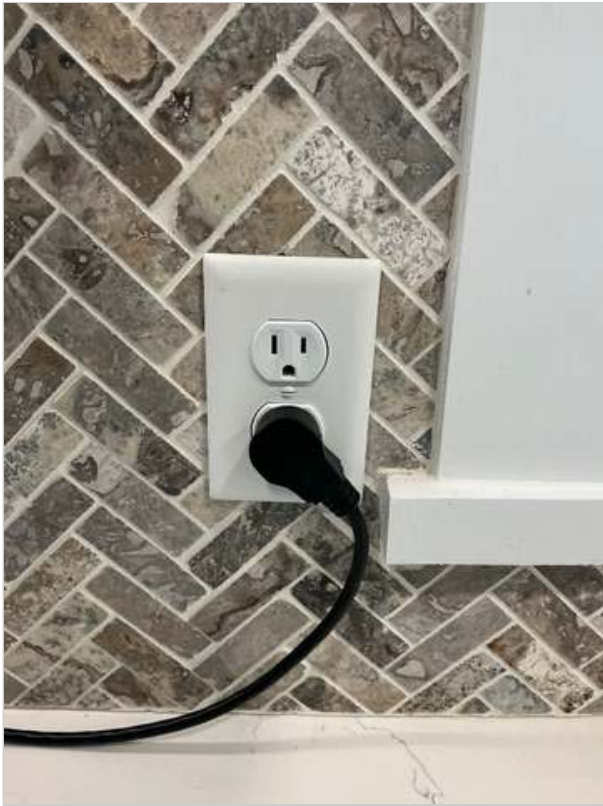
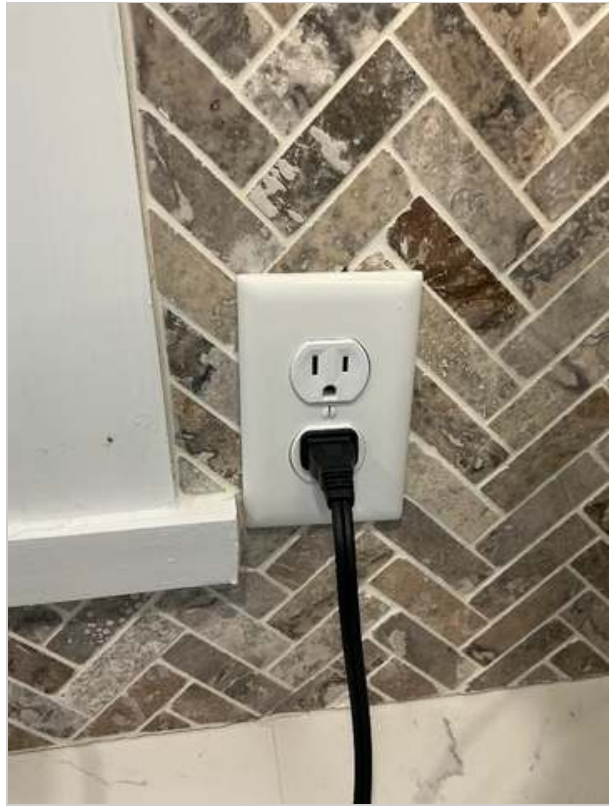
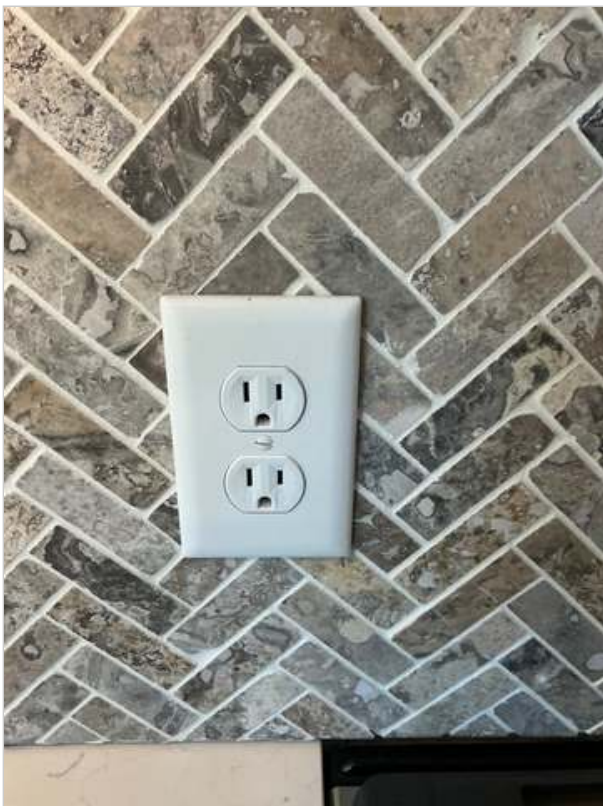
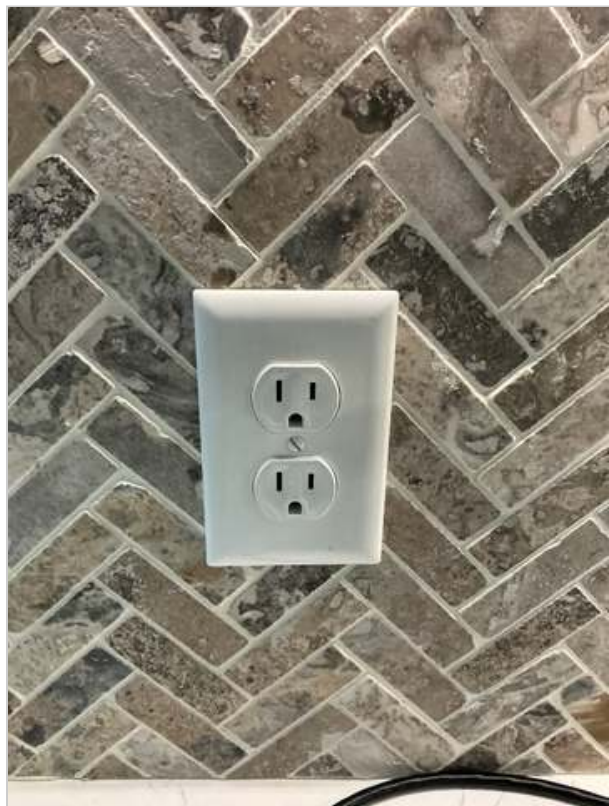
The 2 receptacles to the left and the 2 receptacles to the right of the kitchen sink need to be GFCI protected. Recommend that the receptacles be further evaluated and the necessary repairs be made by a qualified electrical professional

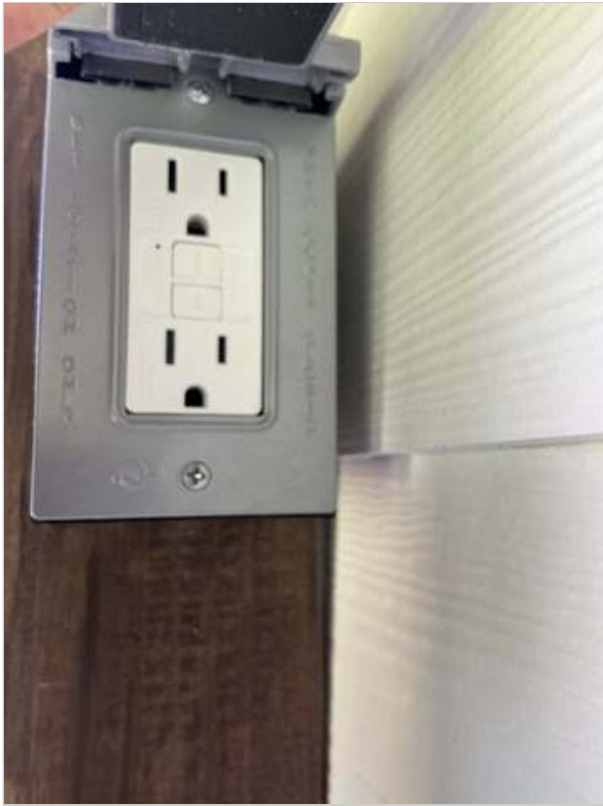
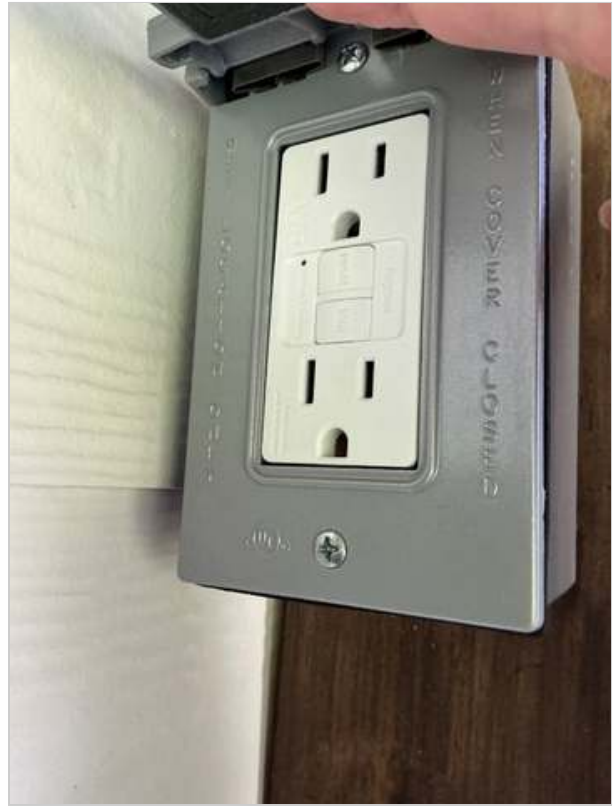
The raised GFCI receptacles located on each front porch were non-functional as a ground fault circuit interrupter. The receptacles were tested by interrupting the current flow with a GFCI testing device and would not trip from the tester or manually. The GFCI receptacles may need to be replaced, for safety. It is recommended that a licensed electrician be consulted to further evaluate and perform any of the necessary repairs.

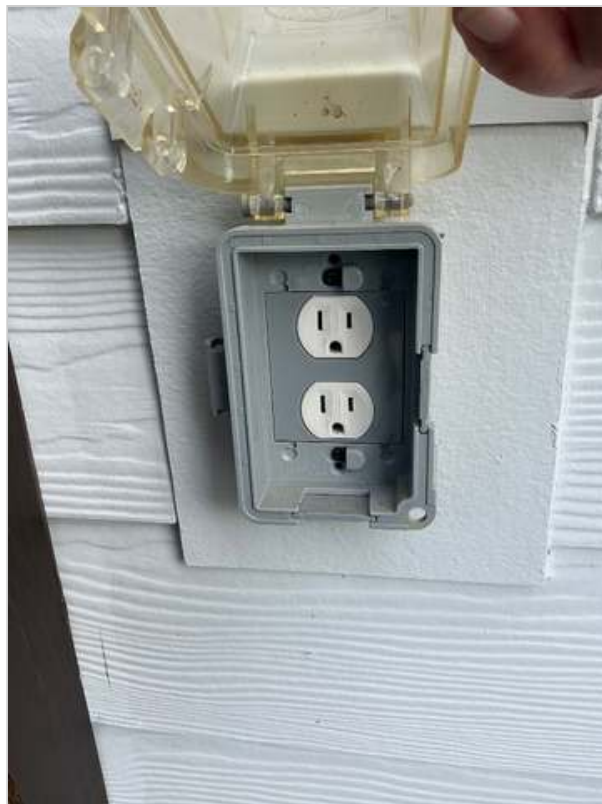
The exterior receptacle on the outside of the left screened porch needs to be GFCI protected for safety. Recommend that the receptacle be further evaluated and the necessary repair be made by a qualified electrical professional.

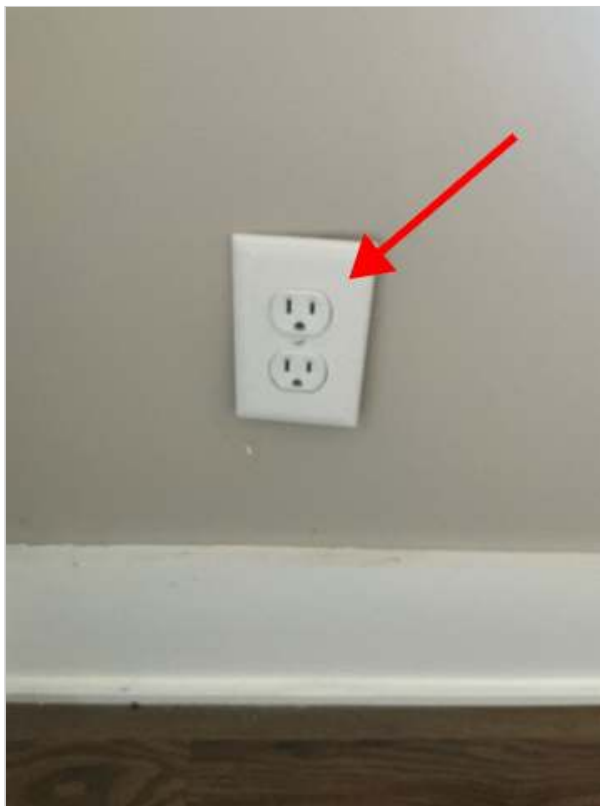
The receptacle to the left of the window in the bonus room is loose. Recommend that the receptacle be properly secured.

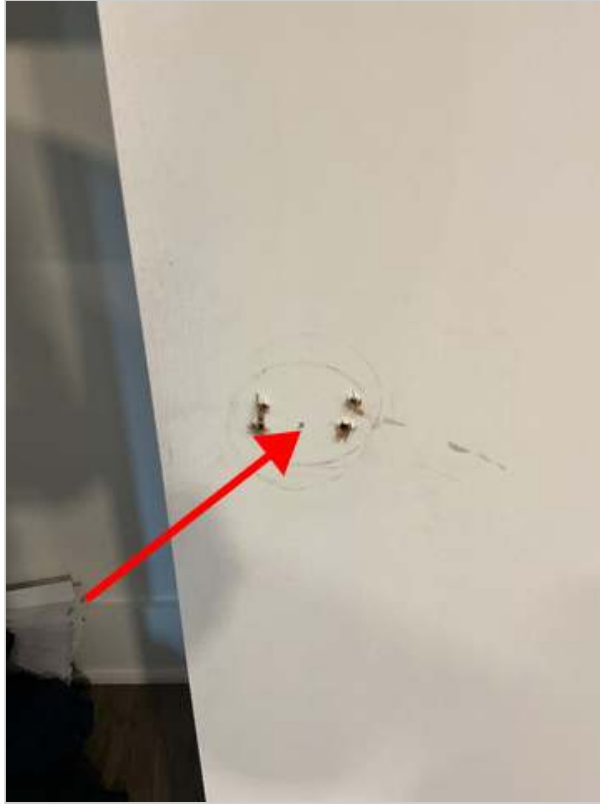
The right closet door in the bonus room is missing a door knob.

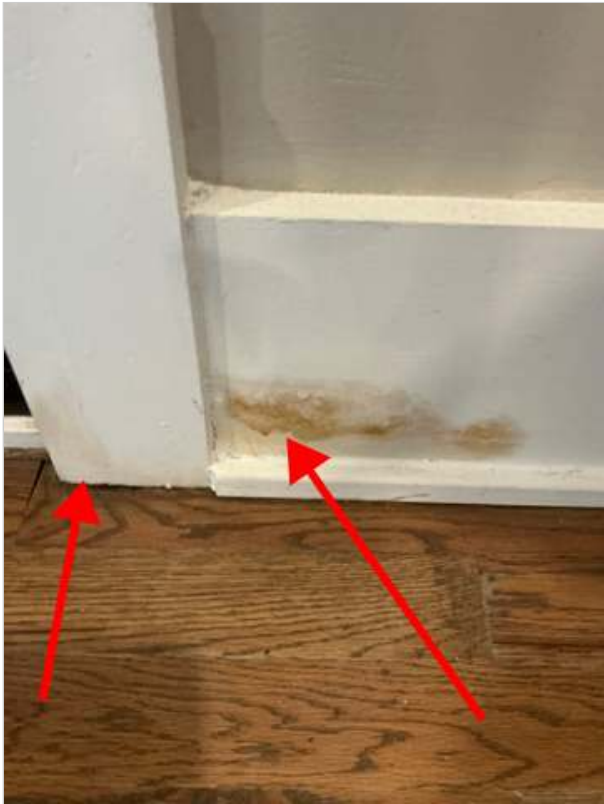
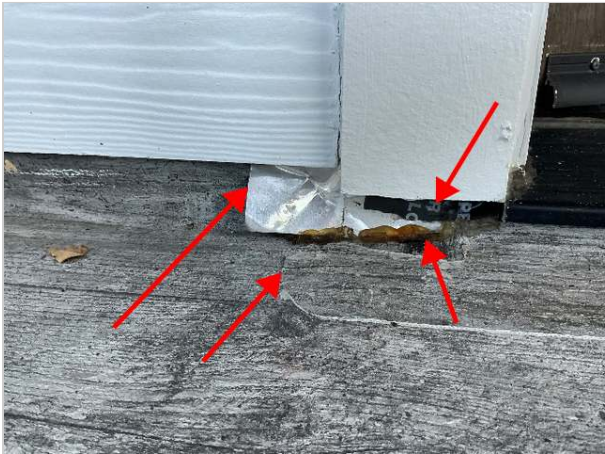
There is an area to the right of the second level master bedroom exterior door that has water damage from an old leak. Recommend that the area be further evaluated and properly sealed to prevent any future water intrusion.

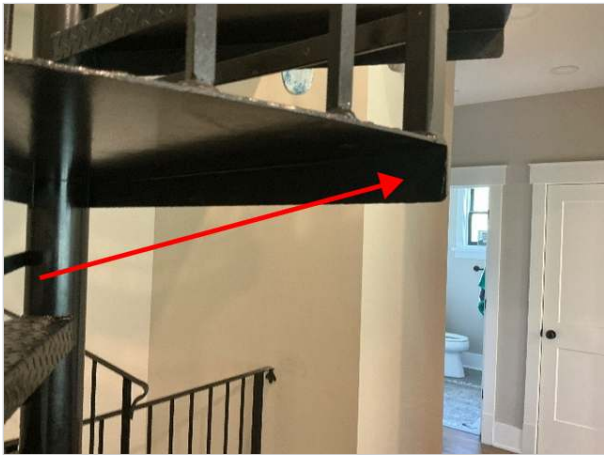
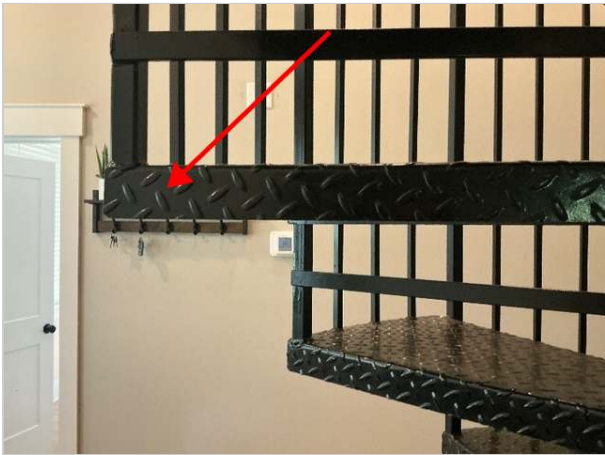
Recommend that the spiral staircase be padded at head level for safety.

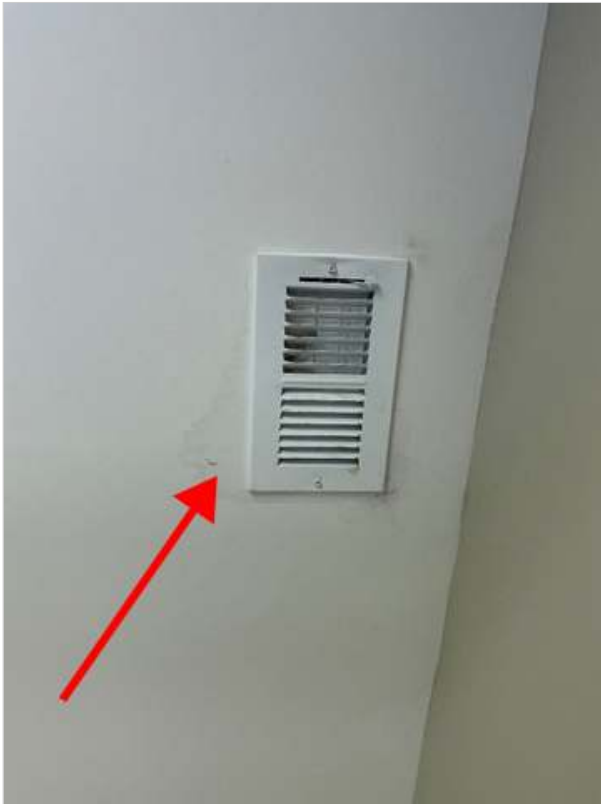
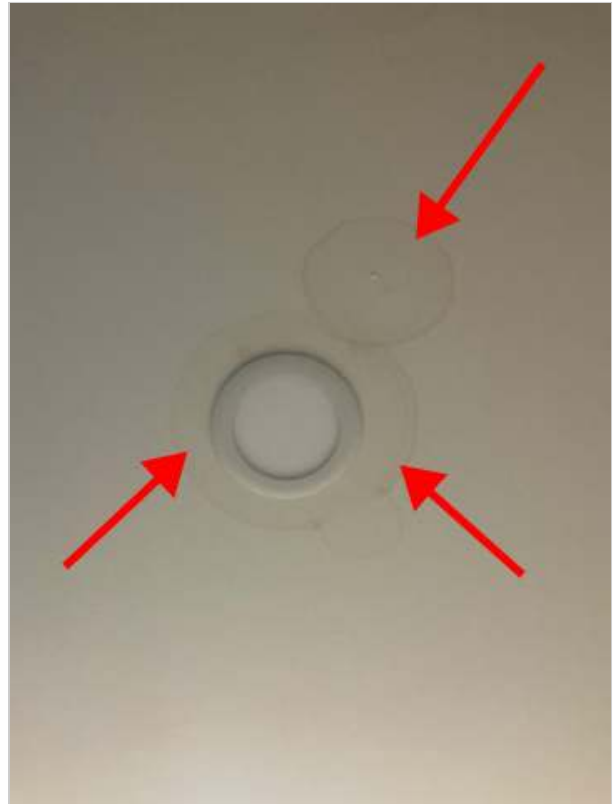
There is an old moisture stain around the air register in the second level bathroom and around the light in the hallway just outside the bathroom. This appears to have come from the ductwork feeding the bathroom register. Recommend that the area be further evaluated by a qualified HVAC professional.

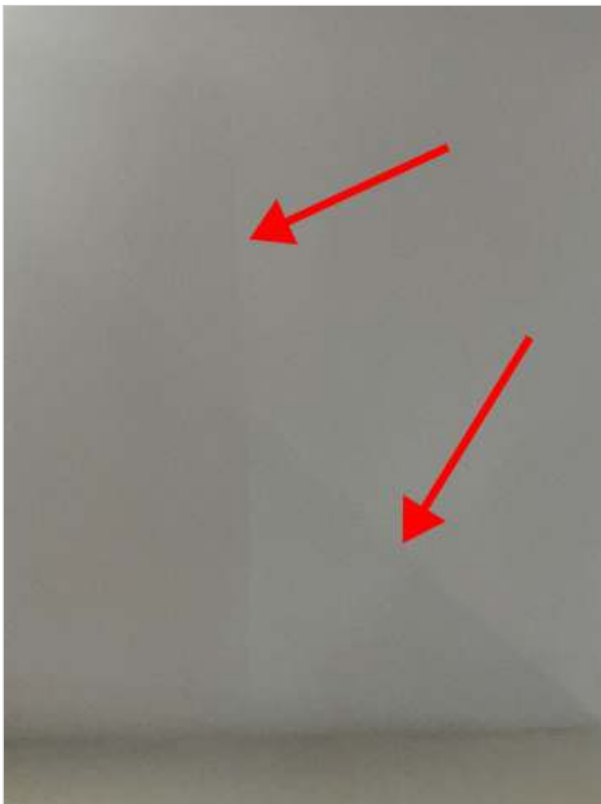
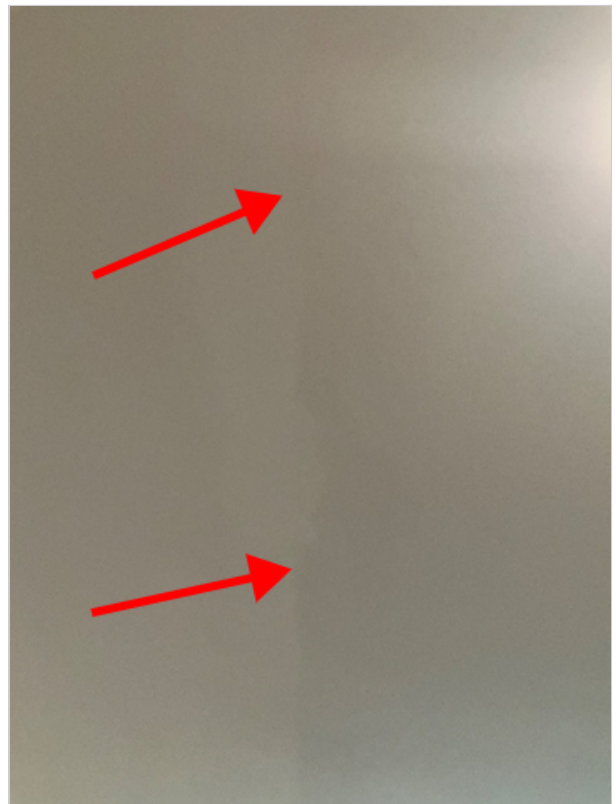
There appears to be a potential old repair/paint job in the living room/kitchen area.

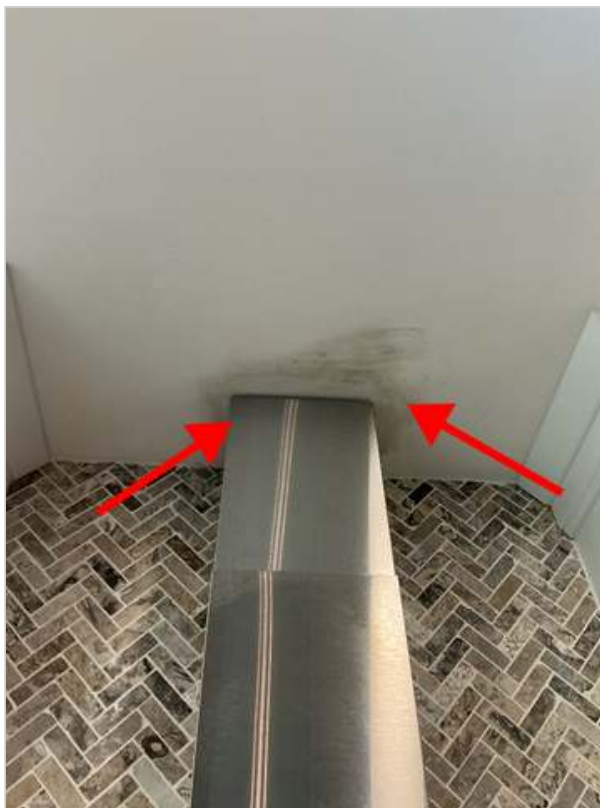
There is a stain on the kitchen ceiling at the top of the range hood. Recommend that the area be further evaluated to confirm that the range hood is venting properly.

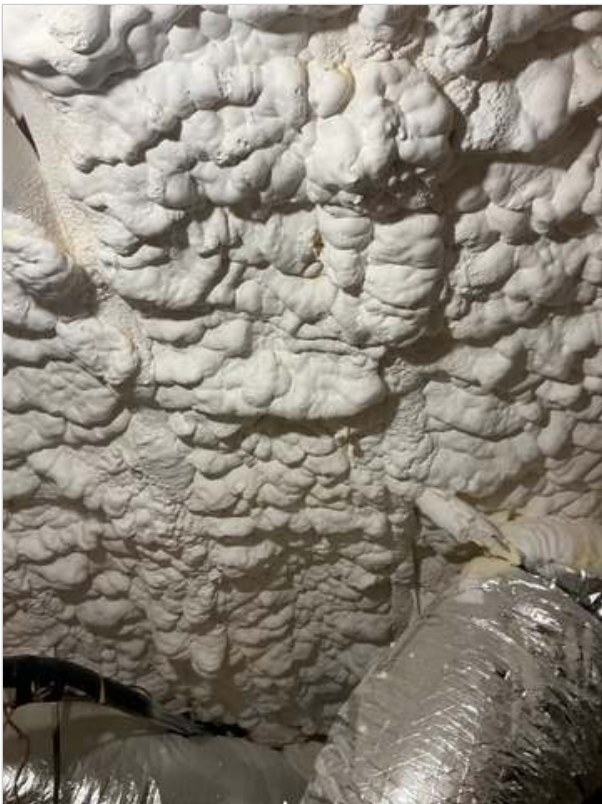
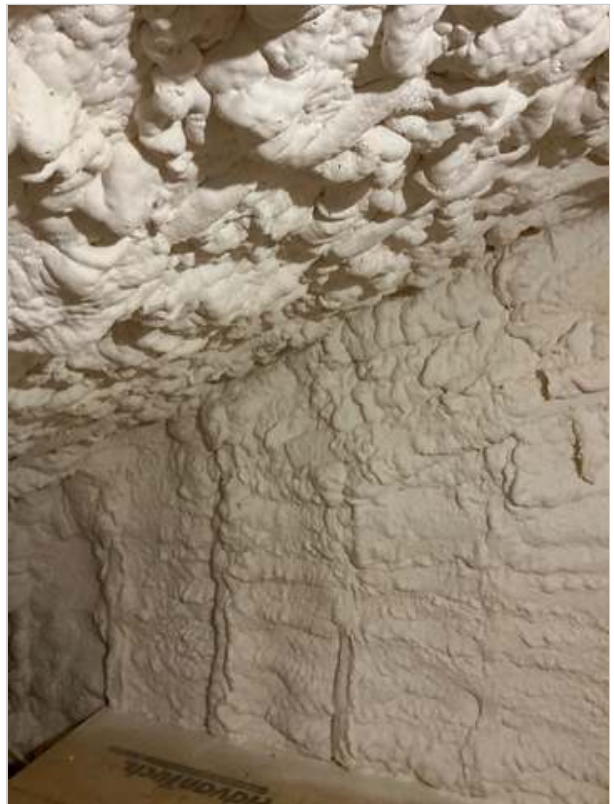
In the attic area it was noticed that the sheathing/decking and rafters was covered with sprayed type insulated material, which restricts the view of the sheathing/decking and rafters. As a result, we were not able to see the entire roof structure during the inspection. Determining the presence of any concealed defects is beyond the scope of the inspection.
