# HomeTeam<sup>®</sup>

### *HOME INSPECTION REPORT*

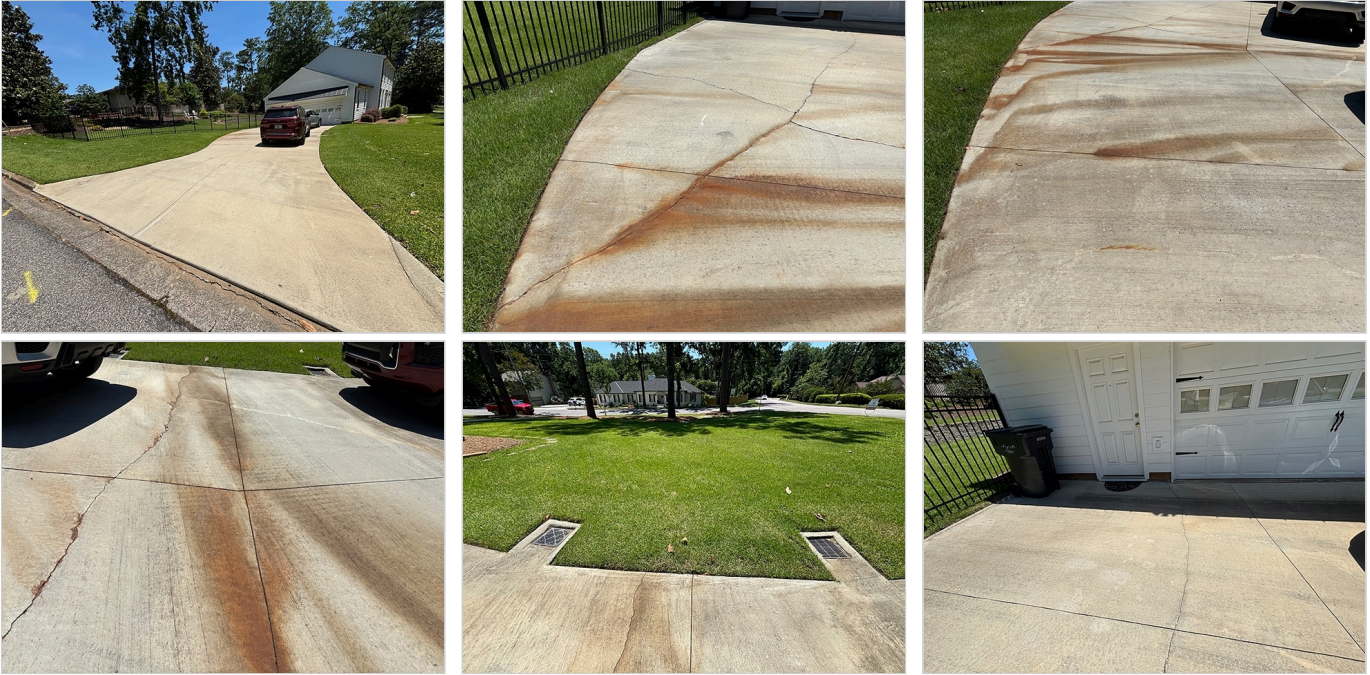
A concrete driveway is present on the left side of the structure. Cracks and spalling were observed on the driveway. Surface defects in driveways develop and progress with age and are considered normal as long as they do not create a safety hazard. Sealing defects may help slow the rate of deterioration.

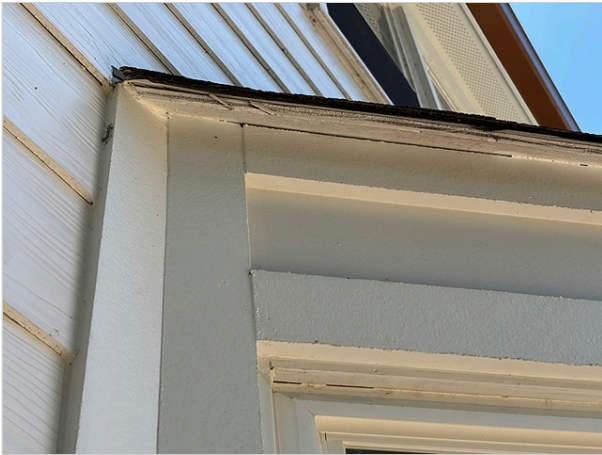
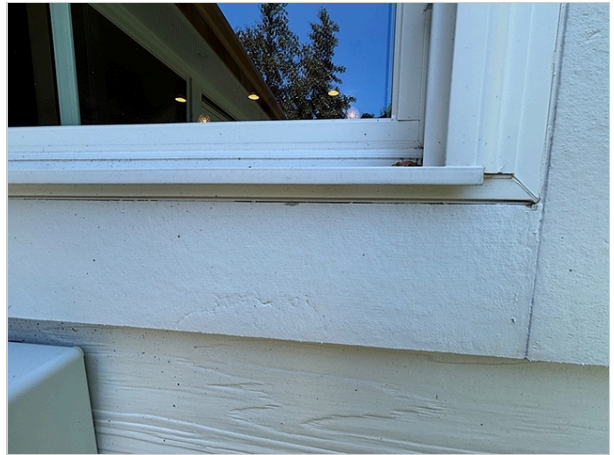
**Caulking is damaged or missing on some areas of the exterior.** The caulking should be repaired or replaced to help prevent water intrusion. **\*\*MAINTENANCE ITEM\*\***

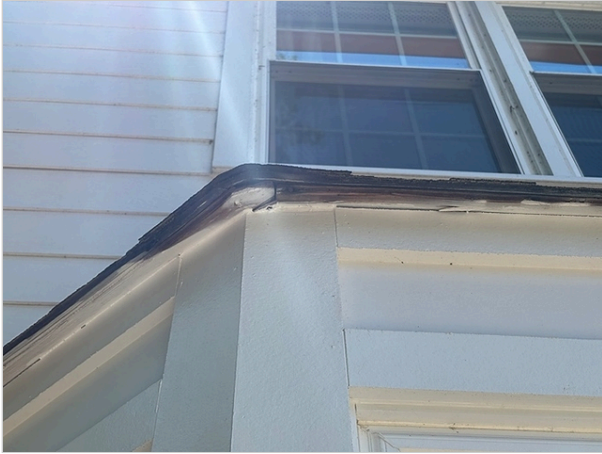
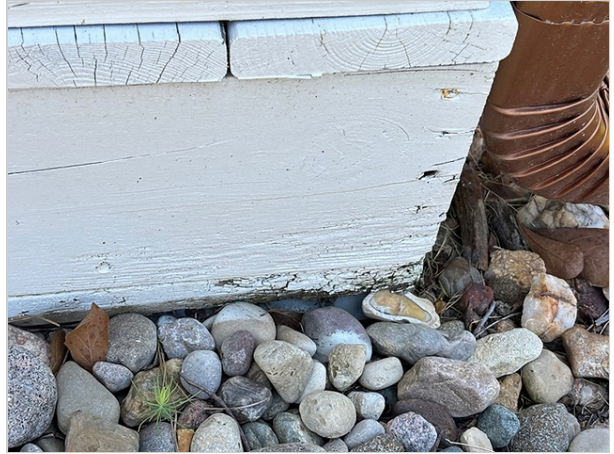
**Rotted wood was present on areas of the exterior.** The areas should be repaired and further evaluated at the time of repair.

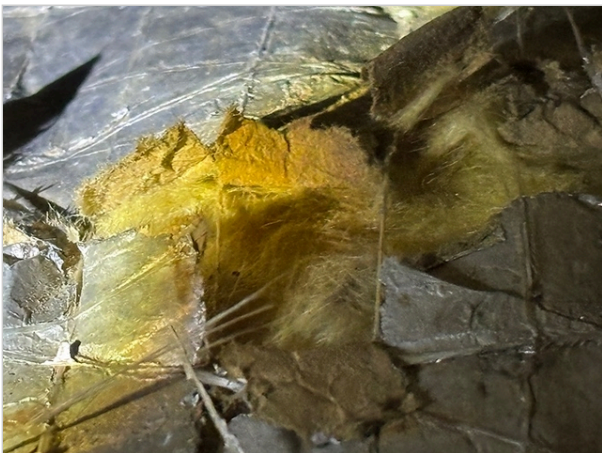
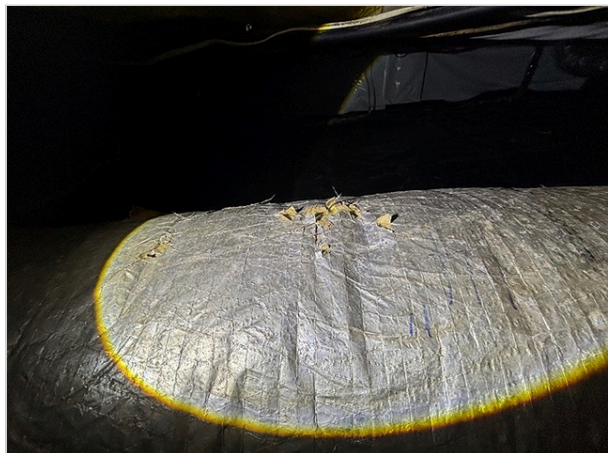
**Some of the insulation, sealant tape, and/or mastic on the ductwork is missing or damaged.** All ductwork should be completely sealed and insulated for maximum efficiency. **\*\*MAINTENANCE ITEM\*\***

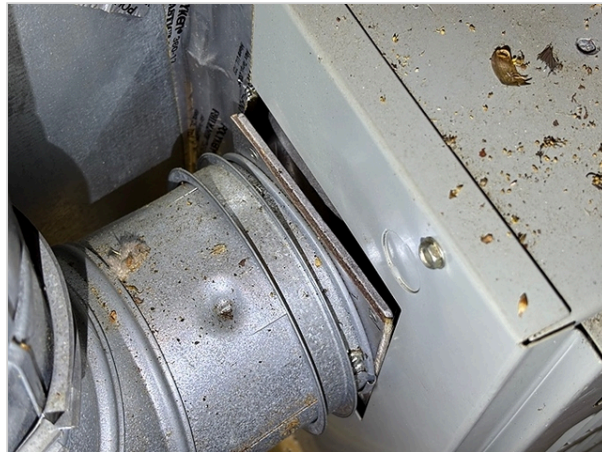
**The furnace flue pipe is not properly sealed.** To prevent noxious fumes from entering the structure, all connections should be properly sealed and supported. Consult with a qualified plumber for repair.

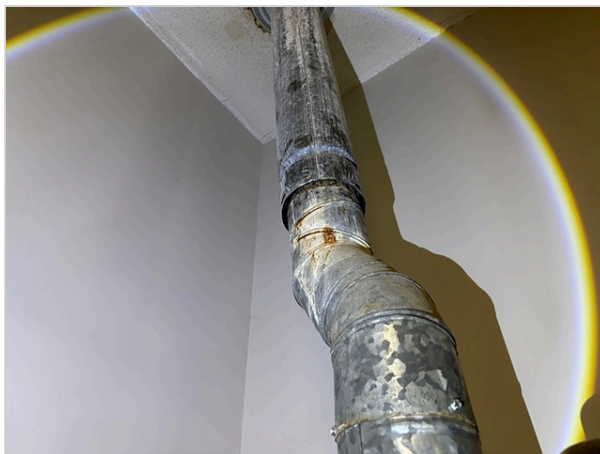
**Flue vents to the hot water heater are not properly connected and risk separation.** The flue vents need to either be seated according to manufacturer recommendations or screwed together to maintain integrity of the flue. Have

assessed and repaired by a qualified professional.

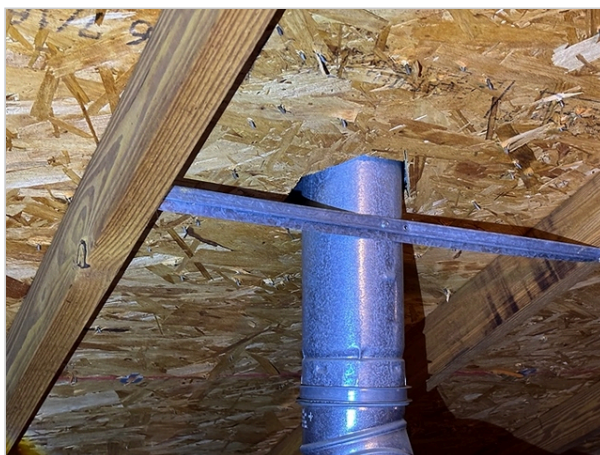
**The furnace vent pipe is too close to combustible material.** A single-walled vent pipe should have 6" of clearance and a double-walled vent pipe should have 1" of clearance. We recommend assessment and repair by a qualified professional for fire safety reasons.

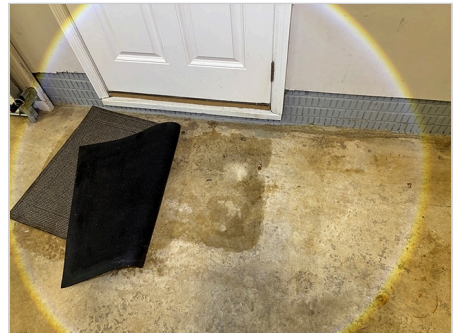
**Evidence of moisture intrusion was present in areas of the garage.** The areas were not dry at the time of the inspection. Many water intrusion problems can be controlled by improving the drainage on the exterior of the structure. It is important that all roof drainage and surface water (ie, from driveway) is directed away from the foundation. Monitor for future water intrusion and repair as necessary.

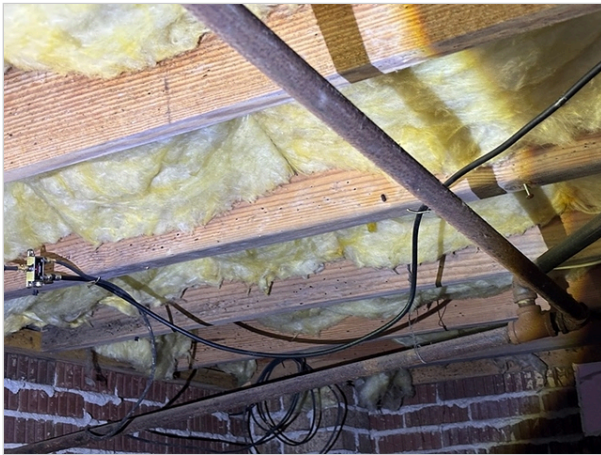
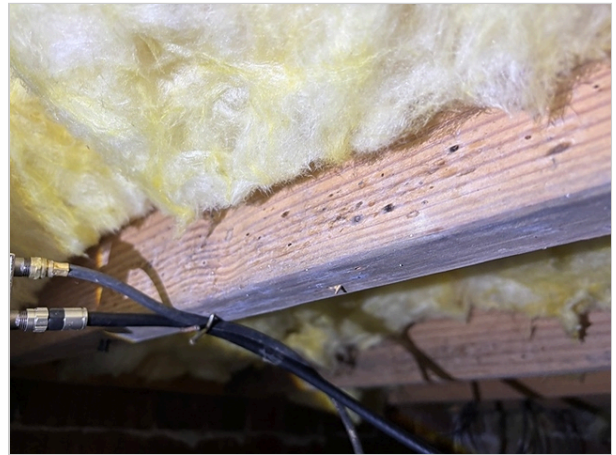
**Microbial growth was found in the crawlspace.** Due to moist conditions that may be present in the crawlspace, this is common but should be evaluated if growth is excessive.

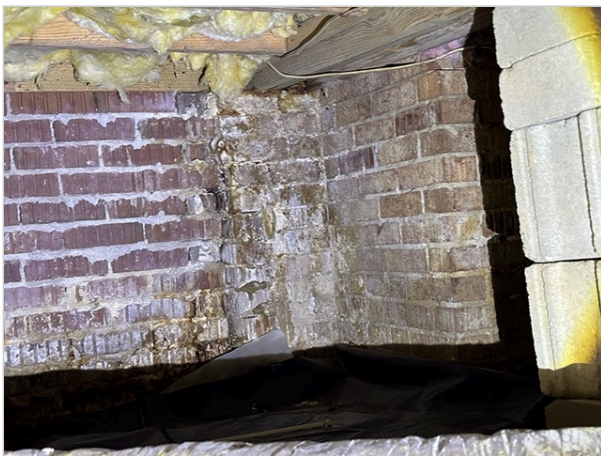
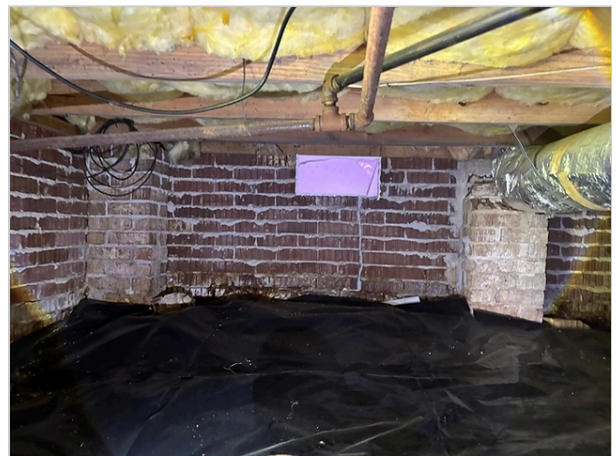
**Evidence of significant previous water intrusion was noted in the crawlspace.** The most common cause of crawlspace water problems is inadequate surface grading and drainage. Many water problems in crawlspaces are a result of improper grading and neglected gutters and downspouts. Masonry and concrete materials are not waterproof unless treated and maintained with waterproof materials.

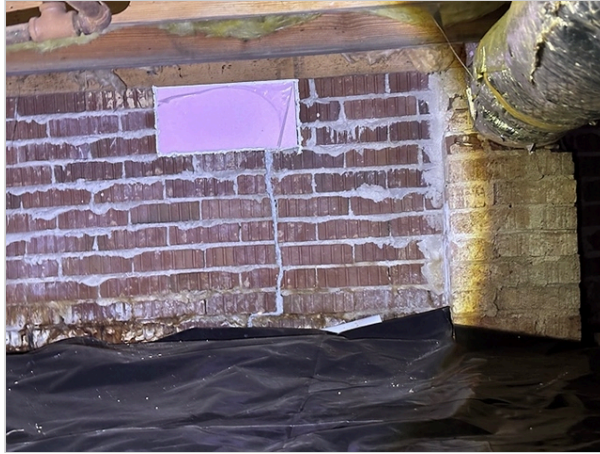
**The foundation appears to have previous repairs.** Recommend further assessment by a certified professional to determine the reason repair was needed and whether the issue has been resolved.

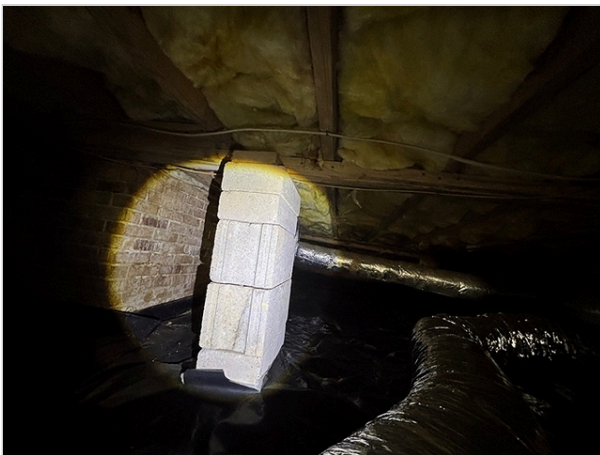
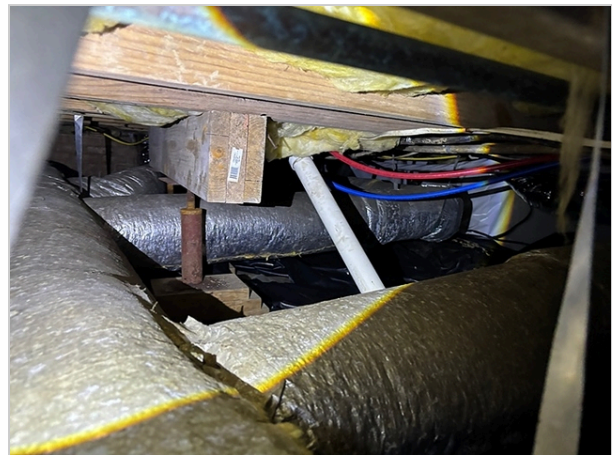
**Some of the piers in the crawlspace appears to be leaning.** This should be assessed and repaired by a qualified contractor.

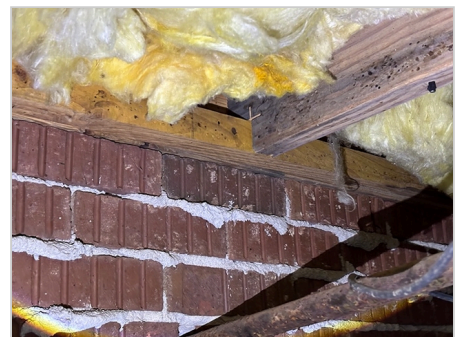
**Some floor joists are cut or damaged and require repair or re-support.** The joists should be repaired and the areas further assessed for any additional required repairs.

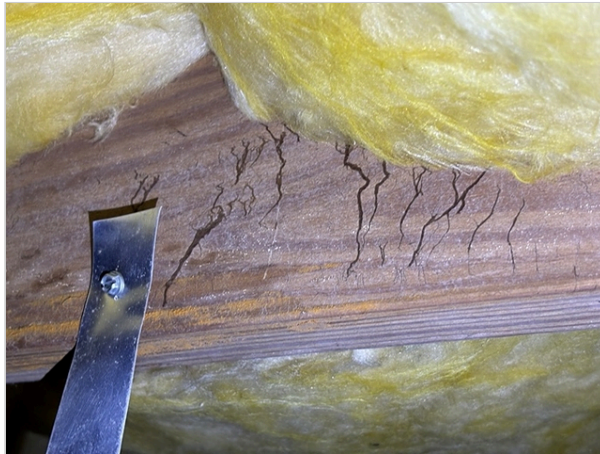
**A substance that has the properties of wood-destroying fungus is present in areas of the crawlspace/attic.** Recommend assessment and repair as required by a qualified professional. <https://naldc.nal.usda.gov/download/12758/PDF>

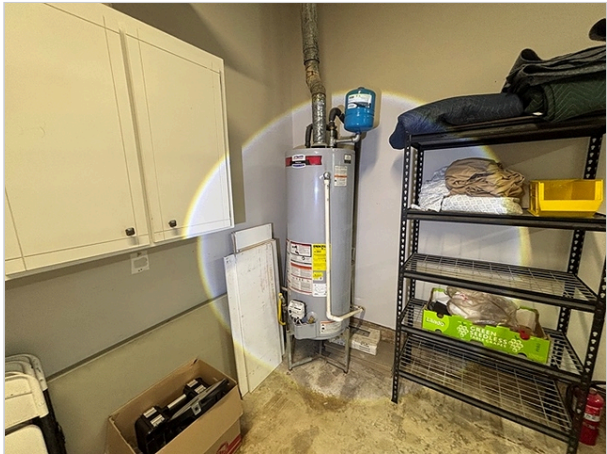
**The water heater in the garage lacks proper protection from vehicle impact. A crash guard or other measure should be added to allow for safer operation.**

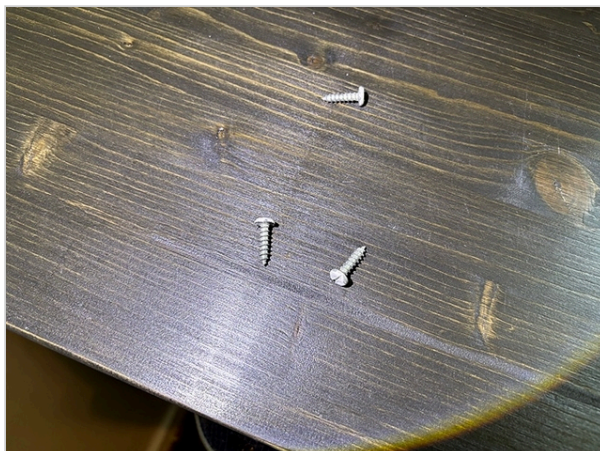
**The screws securing the cover to the electrical panel are pointed and can lead to inadvertent nicking of electrical wires, resulting in a safety hazard.** They should be replaced with blunt screws.

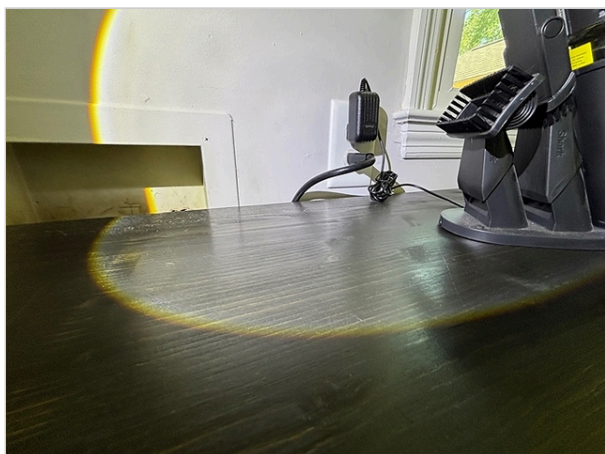
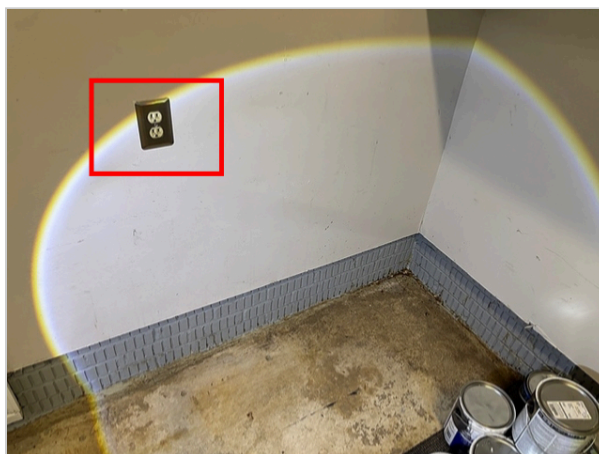
**GFCI protection on some outlets is not present or is defective.** GFCI protection is recommended on all outlets within 6 feet of a water source and any light fixtures or fans above a tub or shower.

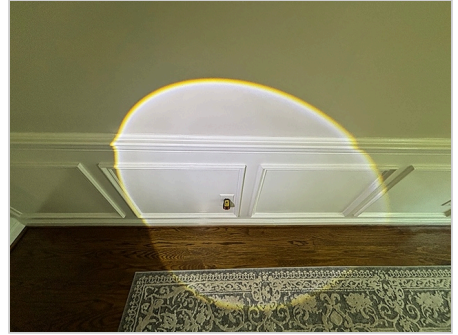
**Outlet(s) in the home were not functional.** Consult with a qualified electrician for repair and further assessment of outlets.

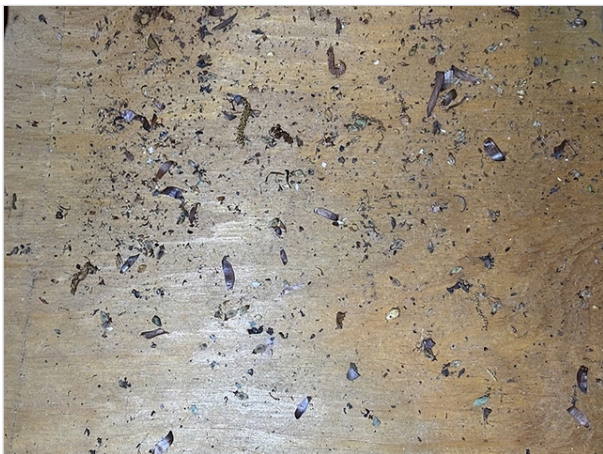
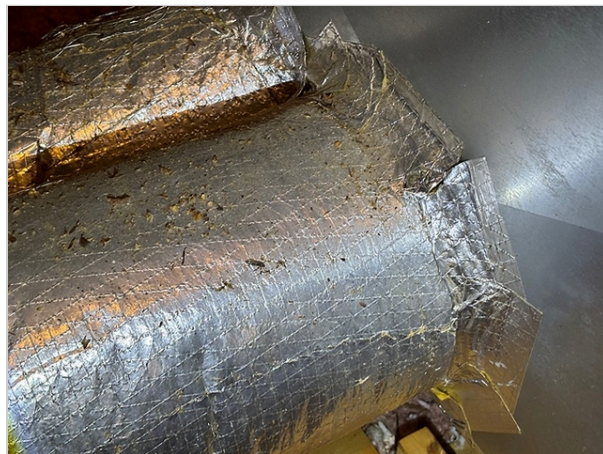
**The attic shows evidence of pest intrusion.** No live pests were visible at the time of the inspection. The client should ensure all openings have been sealed once it is determined the area is completely free of live insects and/or animals.

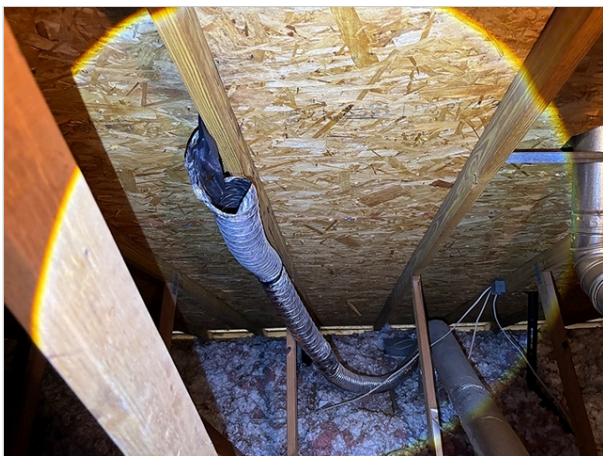
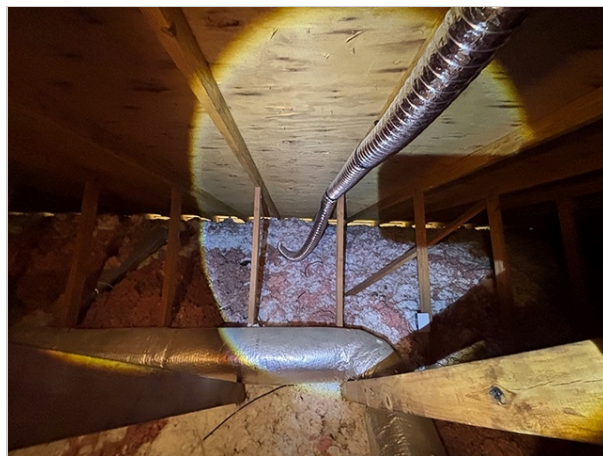
**A plumbing vent terminates in the attic and may be venting sewer gases into the attic space.** The plumbing vent should be capped or repaired so as to vent to the exterior of the structure. Consult with a plumber prior to taking action.

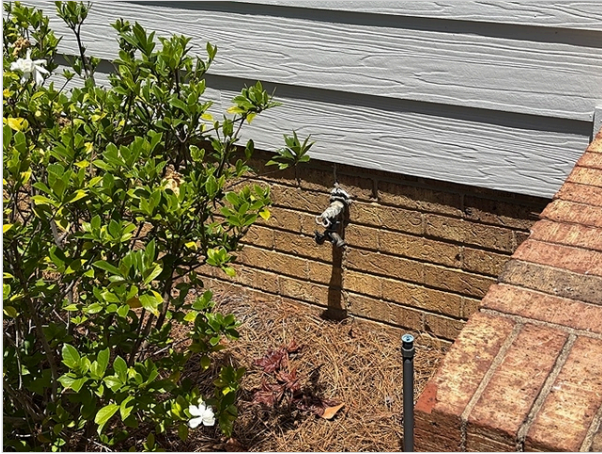
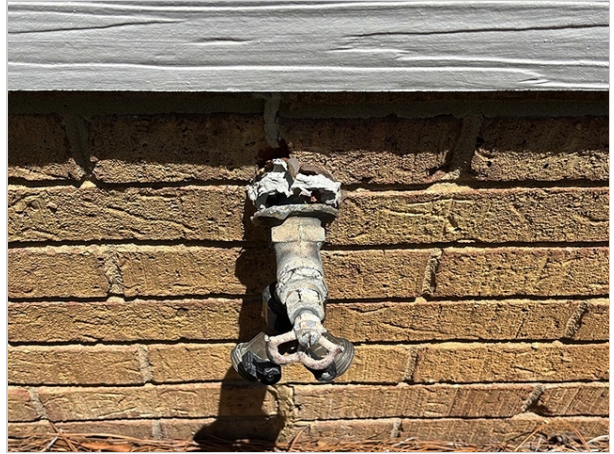
**Some of the hardware/fixtures in wet areas are loose and should be repaired and sealed to prevent water intrusion.**

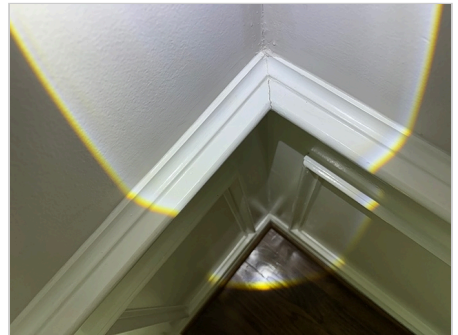
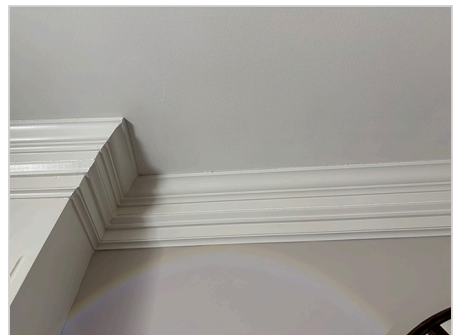
**Some of the caulk/grout was missing from around areas of the interior.** These areas should be sealed to prevent moisture penetration. Failure to keep walls sealed can cause deterioration and extensive moisture damage including microbial growth in the interior walls, which is not always visible at the time of the inspection. **\*\*MAINTENANCE ITEM\*\***

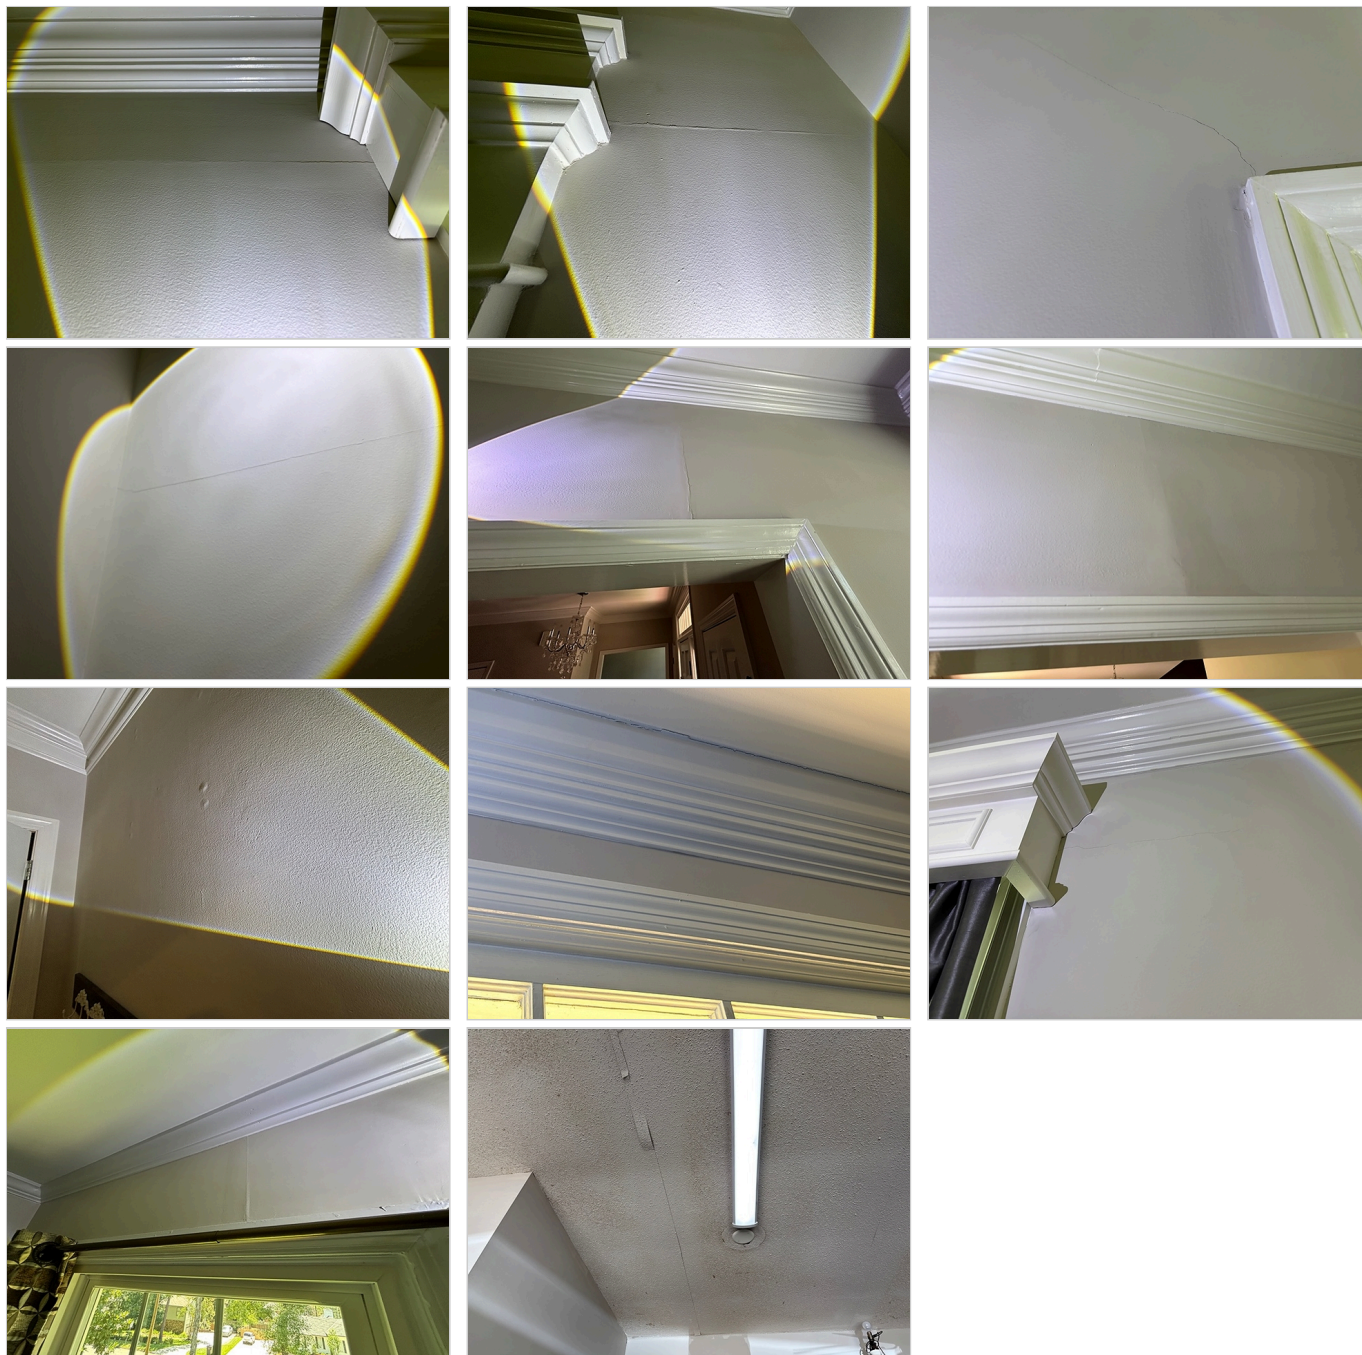
**Cracks were noted in the drywall in some areas of the home.** These are usually cosmetic but should be monitored for water intrusion or further movement.

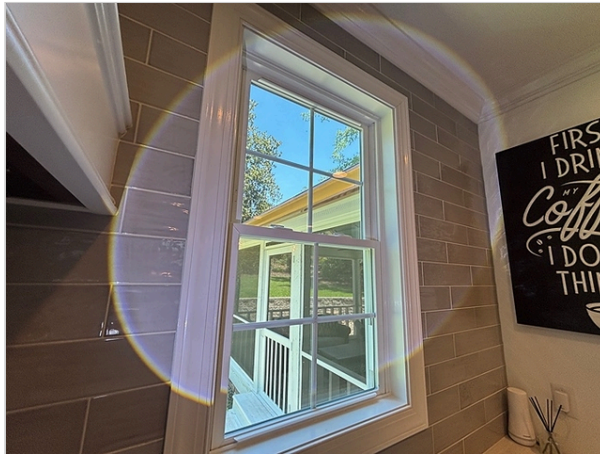
**Some of the caulk/grout was missing from around areas of the interior.** These areas should be sealed to prevent moisture penetration. Failure to keep walls sealed can cause deterioration and extensive moisture damage including microbial growth in the interior walls, which is not always visible at the time of the inspection. **\*\*MAINTENANCE ITEM\*\***

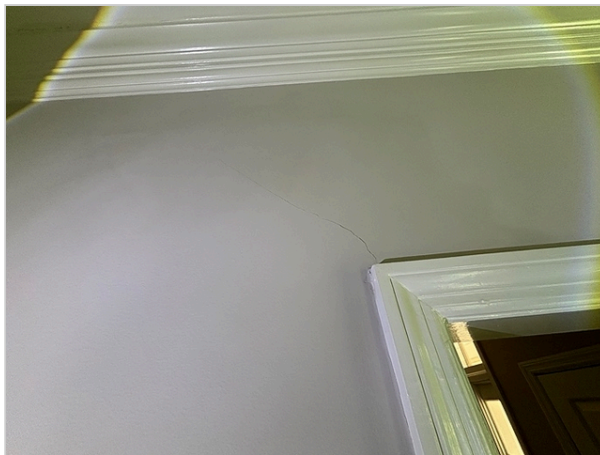
**Cracks were noted in the drywall in some areas of the home.** These are usually cosmetic but should be monitored for water intrusion or further movement.

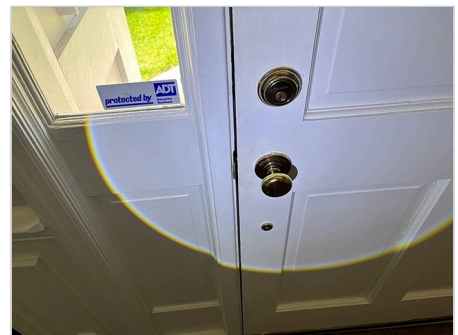
**Exterior doors on the structure have a deadbolt that requires a key to unlock them from the interior of the structure, which may be a safety issue in case of fire.** For safety during emergency egress, all exterior doors should be operable without a key from the interior. The affected locks should be repaired or replaced to allow for manual, keyless operation from the interior.
