### *HOME INSPECTION REPORT*

Address of Inspection: **123 Sample Drive**

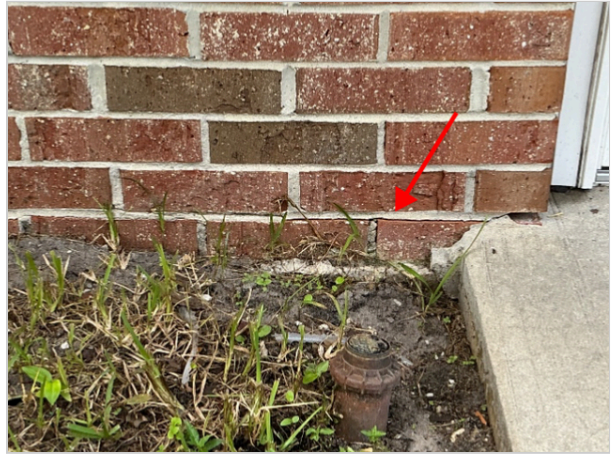
1. Small hairline cracking was observed in the mortar joints of the brick veneer, along with evidence of previous mortar repairs in localized areas. The observed cracking appears minor and is consistent with normal settlement and thermal movement commonly associated with masonry veneer. No significant displacement or other indications of structural concern were observed at the time of the inspection. Recommend monitoring the repaired and cracked areas for signs of continued movement and consulting a qualified masonry contractor if the cracks widen, additional cracking develops, or repairs begin to fail.

Hairline cracking

Previous repairs

Small hairline cracking was observed in the mortar joints of the brick veneer, along with evidence of previous mortar repairs in localized areas. The observed cracking appears minor and is consistent with normal settlement and thermal movement commonly associated with masonry veneer. No significant displacement or other indications of structural concern were observed at the time of the inspection. Recommend monitoring the repaired and cracked areas for signs of continued movement and consulting a qualified masonry contractor if the cracks widen, additional cracking develops, or repairs begin to fail.

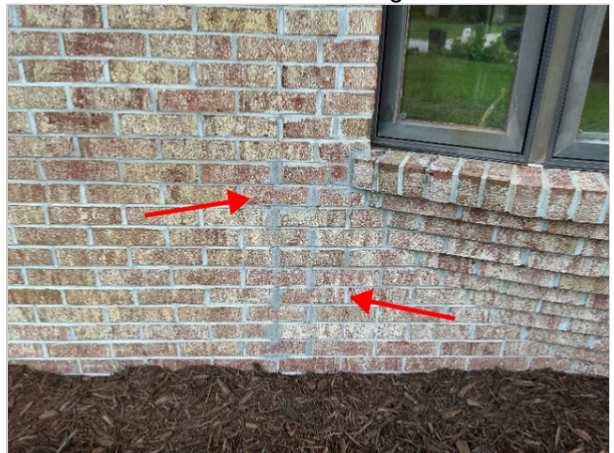
Previous repairs

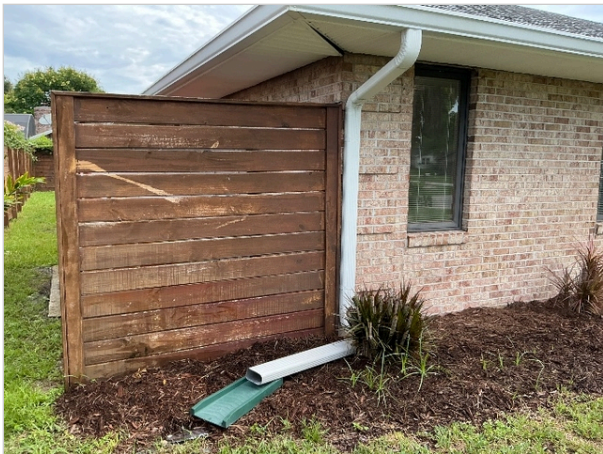
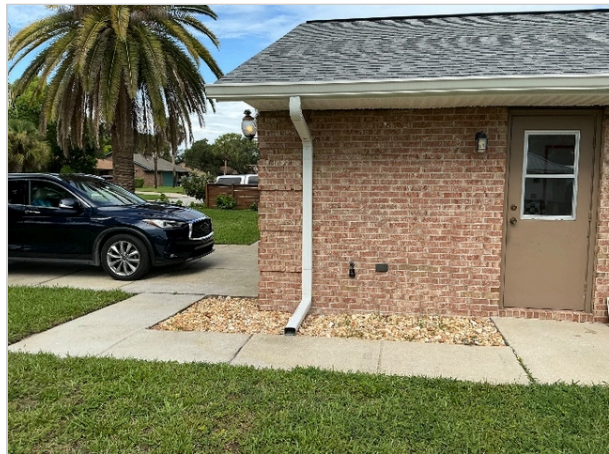
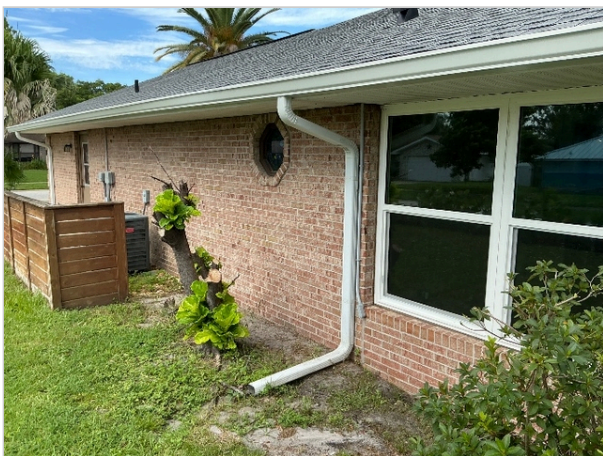
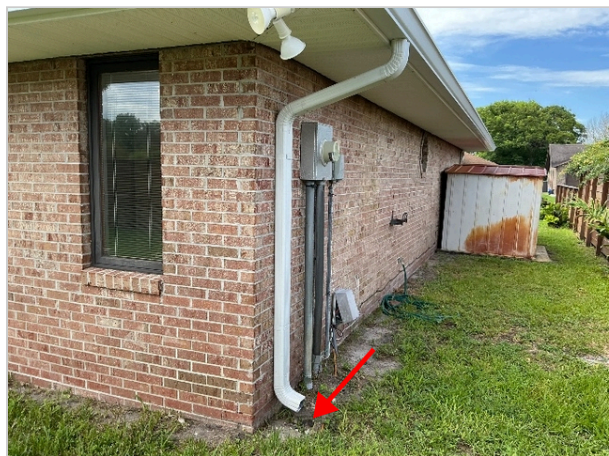
Erosion

**Some of the downspouts around the structure are draining into the ground with no conclusive termination point.** HomeTeam recommends ensuring termination points for all downspouts is far enough from the structure and configured in such a way as to ensure water flows away from the foundation during periods of rain.

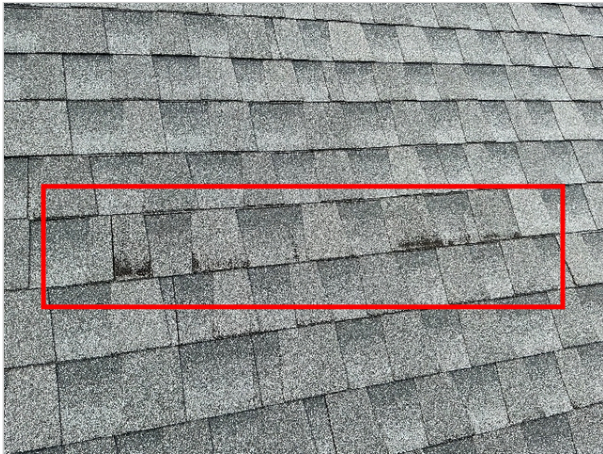
1. Localized granule loss was observed on several asphalt shingles. This condition is most likely the result of normal weathering and aging, although localized mechanical wear or foot traffic may also have contributed. Granule loss reduces the shingles' protective surface and may accelerate deterioration over time. Recommend monitoring the affected areas and having a qualified roofing contractor evaluate the roof to determine if maintenance or localized repairs are warranted.

Localized granule loss was observed on several asphalt shingles. This condition is most likely the result of normal weathering and aging, although localized mechanical wear or foot traffic may also have contributed. Granule loss reduces the shingles' protective surface and may accelerate deterioration over time. Recommend monitoring the affected areas and having a qualified roofing contractor evaluate the roof to determine if maintenance or localized repairs are warranted.

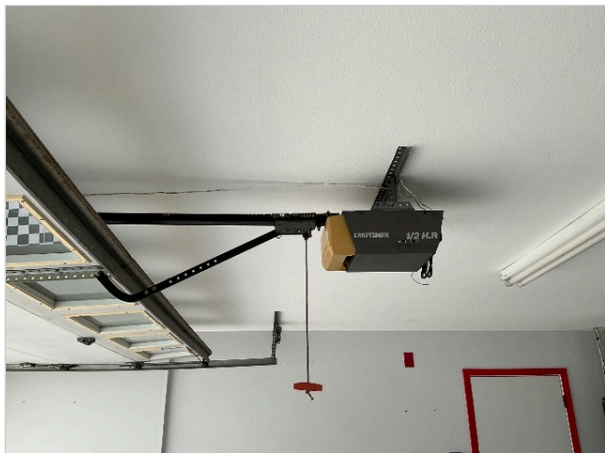
1. The automatic garage door opener did not reverse direction when the door encountered an obstruction during testing. This is a safety hazard that increases the risk of injury or property damage. Recommend discontinuing use of the automatic opener until it has been evaluated, adjusted, or repaired by a qualified garage door service contractor. After repairs, the opener should be tested to verify proper operation of all required safety features.
2. The home lacks GFCI protection.

The automatic garage door opener did not reverse direction when the door encountered an obstruction during testing. This is a safety hazard that increases the risk of injury or property damage. Recommend discontinuing use of the automatic opener until it has been evaluated, adjusted, or repaired by a qualified garage door service contractor. After repairs, the opener should be tested to verify proper operation of all required safety features.

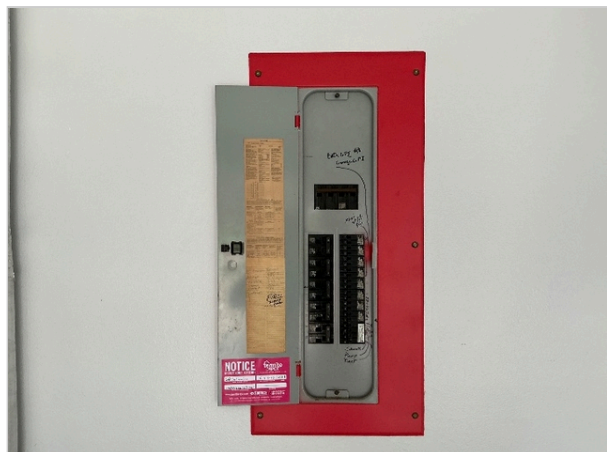
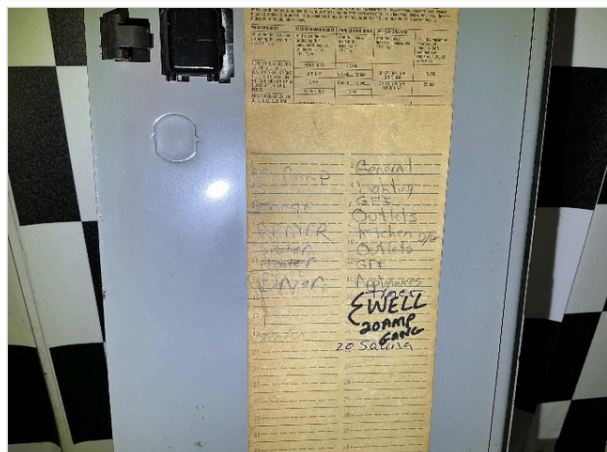
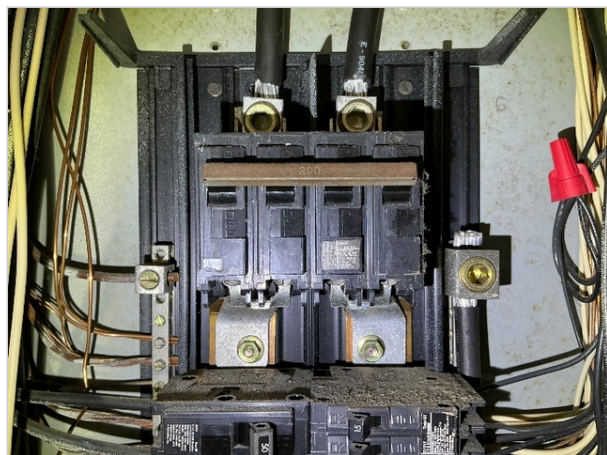
DT - Neutral Bar

1. A double-tap condition exists in the electrical panel (one or more circuit breakers in the electric panel had two attached circuits (wires)).
2. One or more of the tested outlets were not functional.

**The neutral bar in the electric panel had two attached circuits (wires).** Each circuit should have its own dedicated breaker to prevent nuisance tripping and ensure good terminal contact, which may help prevent overheating. This situation is commonly referred to as a "double-tap". An electrician should repair this condition and further assess the panel for any additional required repairs.

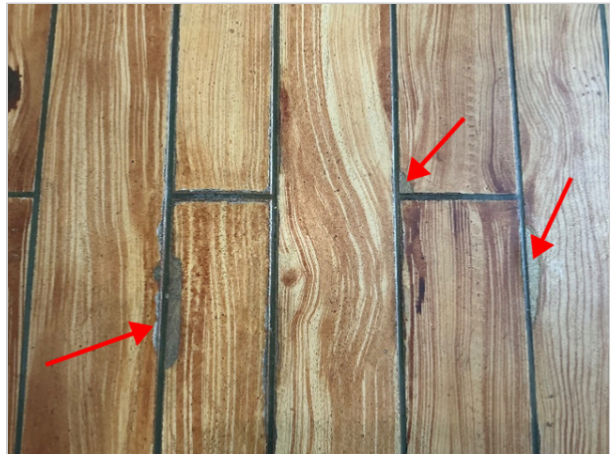
2. Wood-look ceramic tile flooring exhibited localized chips and surface damage in several tiles. The observed damage is primarily cosmetic but may create rough edges and can allow additional deterioration if left unaddressed. Recommend replacing the damaged tiles or performing appropriate repairs as needed to maintain the flooring's appearance and serviceability.

Wood-look ceramic tile flooring exhibited localized chips and surface damage in several tiles. The observed damage is primarily cosmetic but may create rough edges and can allow additional deterioration if left unaddressed. Recommend replacing the damaged tiles or performing appropriate repairs as needed to maintain the flooring's appearance and serviceability.

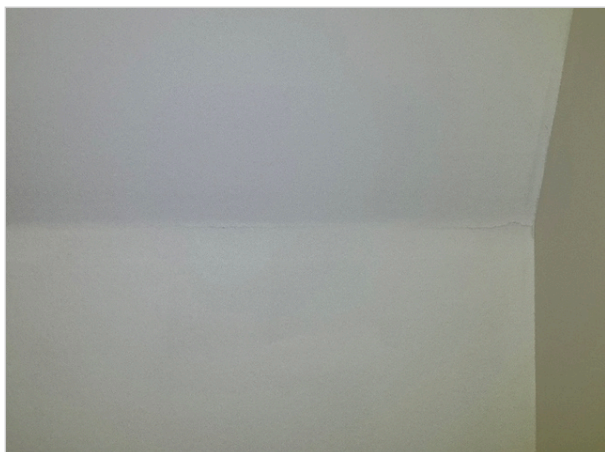
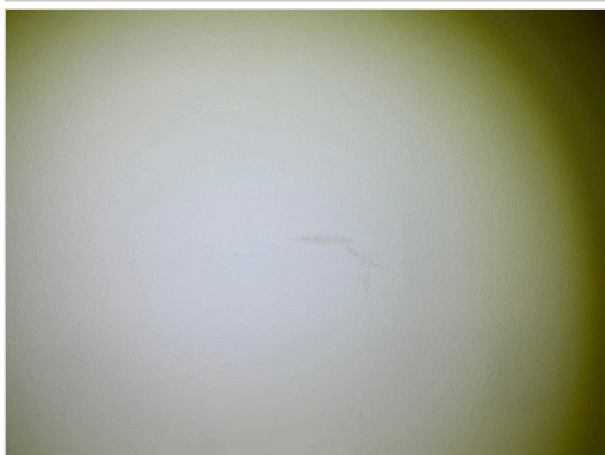
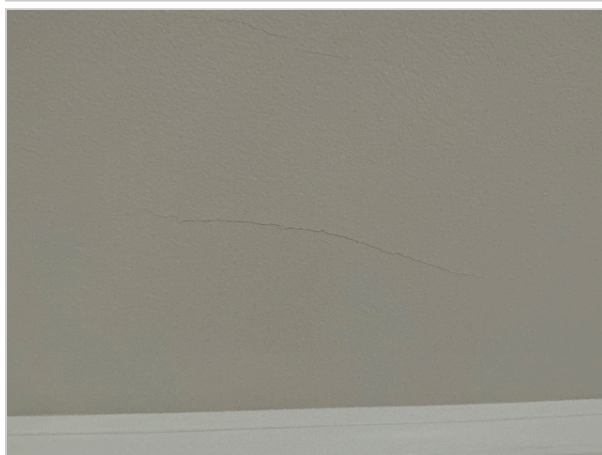
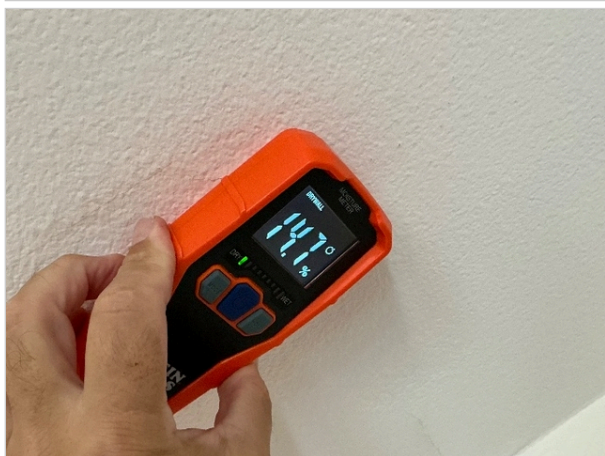
1. Multiple hairline drywall cracks were observed at interior wall and wall-to-ceiling joints. The cracks appear minor and consistent with typical cosmetic movement and/or normal settling. No elevated moisture levels were detected at the time of the inspection (approximately 14.7% using a non-invasive moisture meter), and no visible evidence of active moisture intrusion was observed. Monitor these areas for changes such as widening, displacement, or recurring repairs, and patch and repaint as needed. If significant movement or additional signs of structural distress develop, further evaluation by a qualified contractor is recommended.

Multiple hairline drywall cracks were observed at interior wall and wall-to-ceiling joints. The cracks appear minor and consistent with typical cosmetic movement and/or normal settling. No elevated moisture levels were detected at the time of the inspection (approximately 14.7% using a non-invasive moisture meter), and no visible evidence of active moisture intrusion was observed. Monitor these areas for changes such as widening, displacement, or recurring repairs, and patch and repaint as needed. If significant movement or additional signs of structural distress develop, further evaluation by a qualified contractor is recommended.
