### *HOME INSPECTION REPORT*

On Monday, August 24, 2026 The HomeTeam Inspection Service made a visual inspection of 123 Sample Drive, Pigeon Forge, TN 37863. Enclosed please find a written, narrative report of our findings in accordance with the terms of our Inspection Agreement.

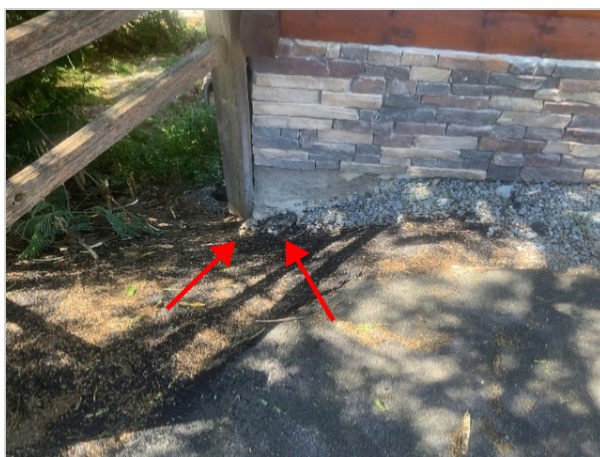
**Photo 1**

1. Exterior - Grading / Erosion Concern Observation: Erosion was observed along the front side of the home at the foundation perimeter. Soil loss is evident at the base of the wall, with exposed areas and uneven grading. Additionally, the downspout termination is discharging water directly adjacent to the foundation, and vegetation/debris buildup is present, which can trap moisture. Recommend: addressing the cause of the erosion and regrading of the soil.

Recommend: addressing the cause of the erosion and regrading of the soil.

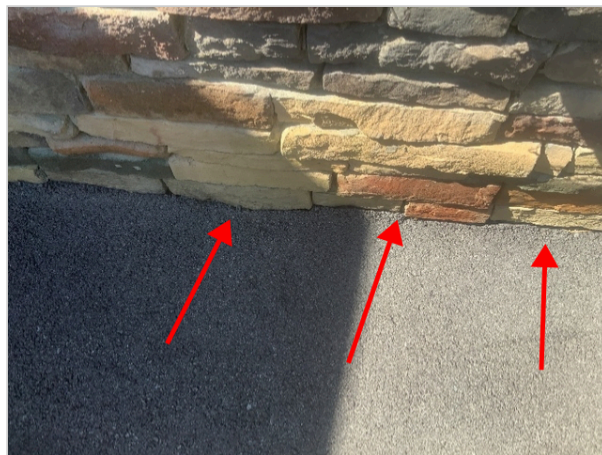
Photo 2

**The exterior caulking between the driveway and the structure is cracked and deteriorated.** The caulking should be re-sealed to help direct rain water away from the structure.

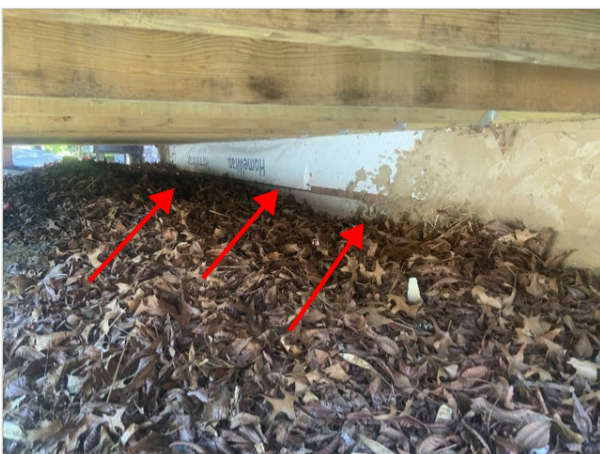
Photo 3

**Missing siding was observed on on the front and right side of the structure.** Consult with a qualified contractor for replacement.

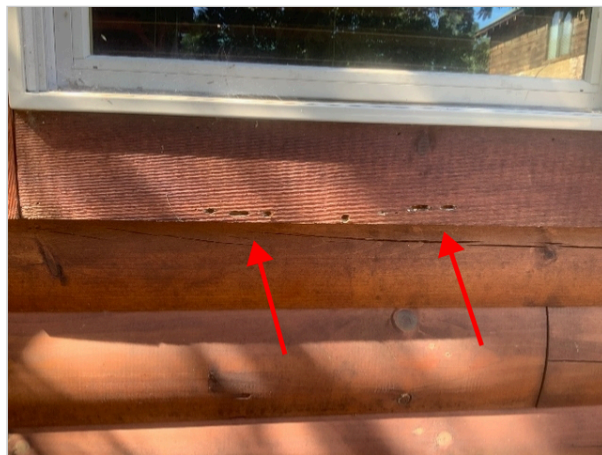
**Photo 6**

Evidence of carpenter bees noted.

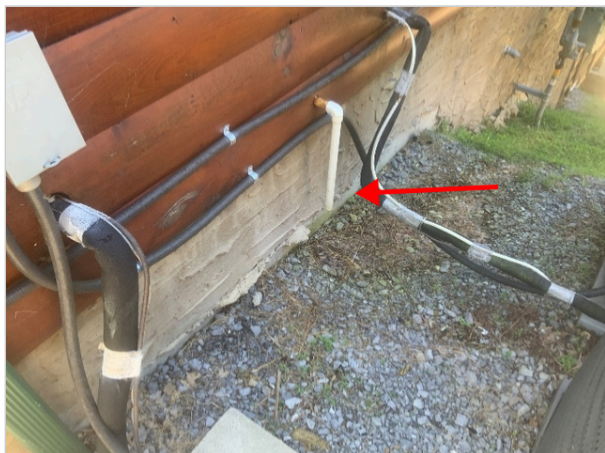
Photo 7

**The condensate line for the HVAC system is discharging adjacent to the foundation.** Condensate water is mildly corrosive and can cause damage to the foundation over time. The condensate drain line should be extended further away from the structure.

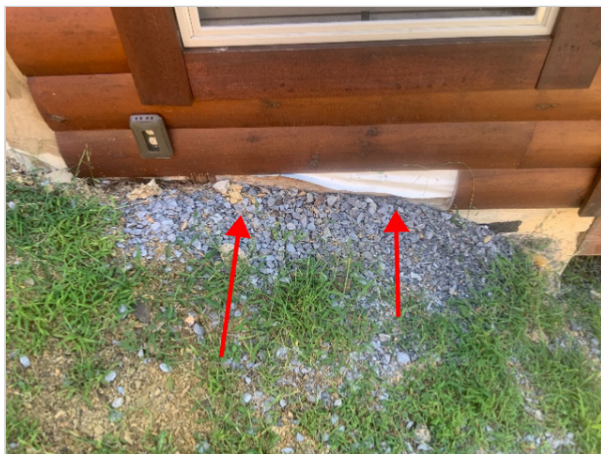
Photo 9

The siding and sill plate are positioned at or below grade level in certain areas of the structure. This configuration poses a heightened risk for moisture intrusion, wood decay, and pest infestation due to direct soil contact. To mitigate these risks, it is recommended to regrade the soil to establish a proper slope away from the foundation and maintain a minimum clearance of 6 inches between the siding/sill plate and the soil. Additionally, inspecting the affected areas for existing damage is advised. Consultation with a licensed contractor is strongly recommended to implement corrective measures and ensure long-term protection of the structure

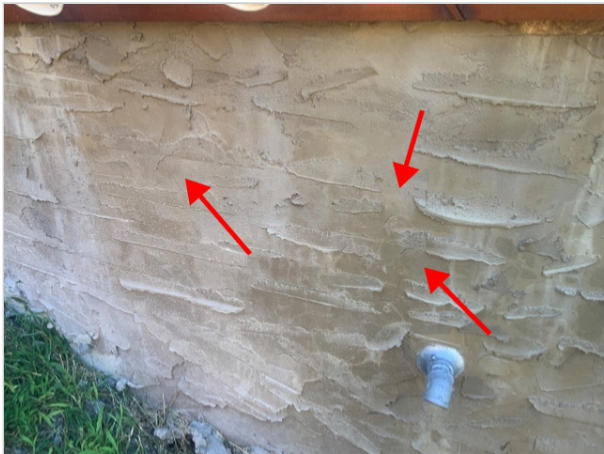
Photo 10

**Cement parging is cracked and should be sealed.** The parging is a covering for the foundation; it is important to keep it sealed in order to prevent further deterioration.

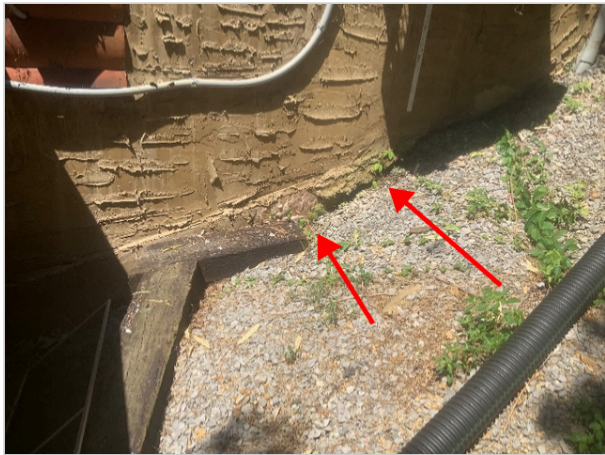
Photo 13

Cement parging was missing and damaged on the left side of the structure. This can lead to potential moisture intrusion into the foundation. This area should be monitored for further moisture.

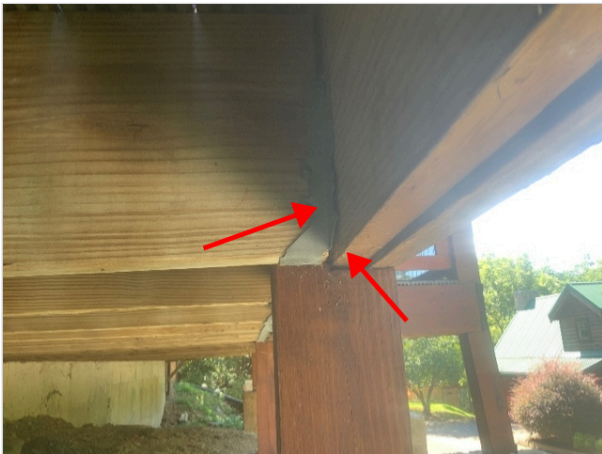
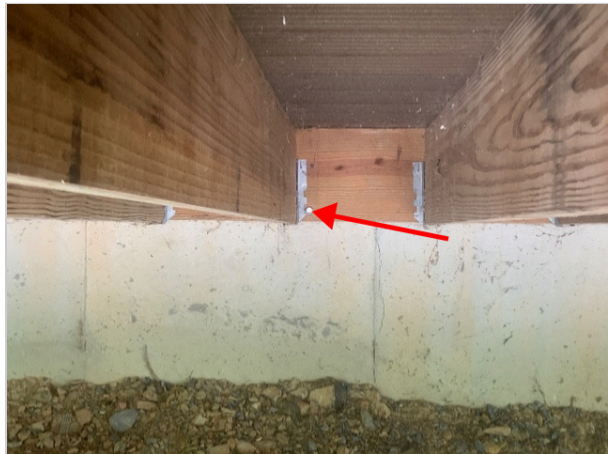
Joists hangers improperly attached. Recommend repair by qualified contractor.

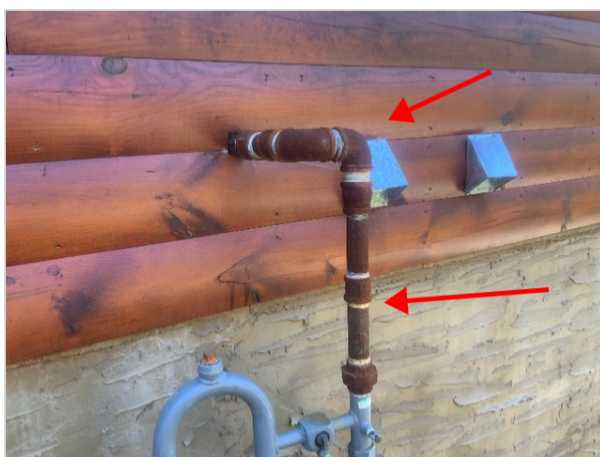
**Photo 19**

There was corrosion noted on the gas line between the meter and the house. Recommend painting to slow the corrosion process.

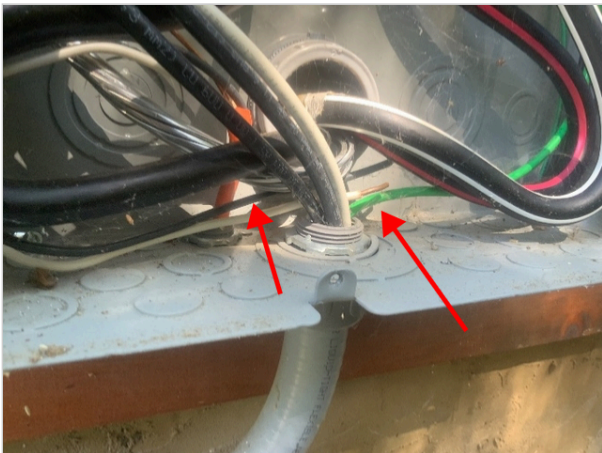
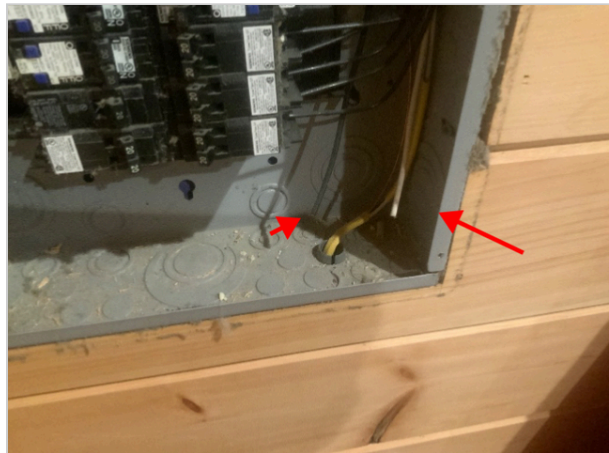
Miscellaneous abandoned wiring in the main disconnect panel and main panel should be evaluated by a qualified electrical contractor to determine whether any wiring is still energized. Improperly terminated, energized wiring is a potential shock/electrocution/fire hazard.

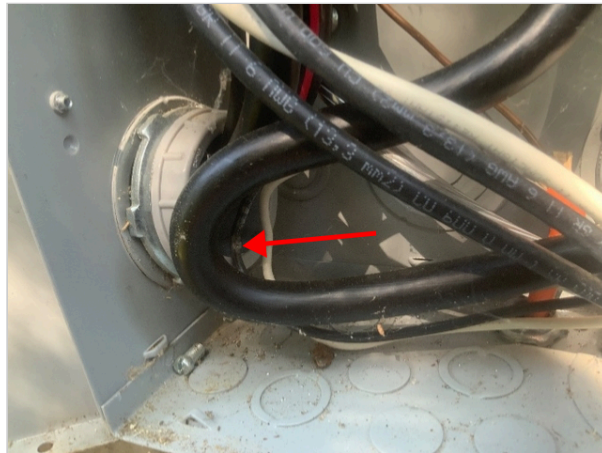
**Photo 23**

Damaged or deteriorated wiring was observed in the main panel. Any such wiring should be repaired or replaced by a qualified electrical contractor to help ensure that safe conditions exist.

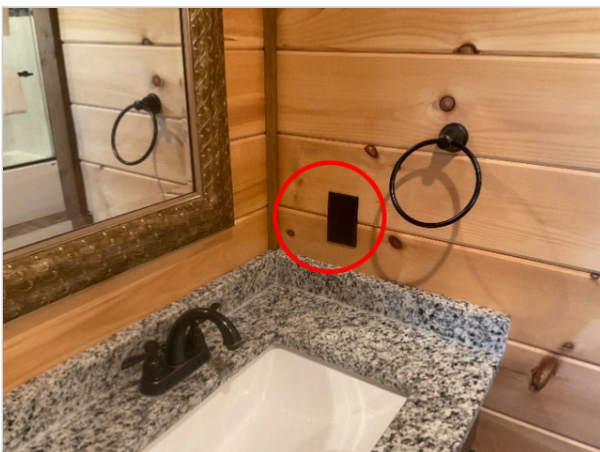
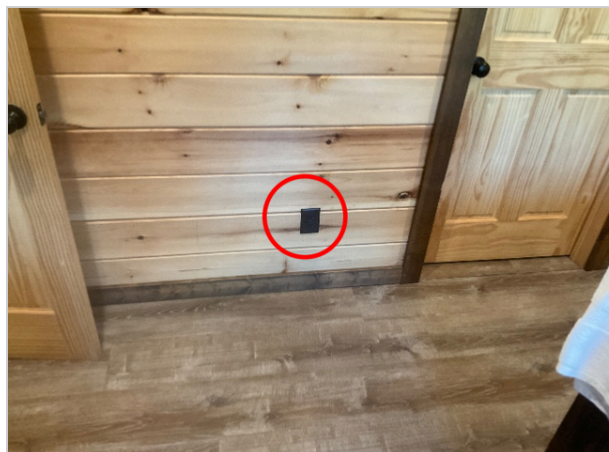
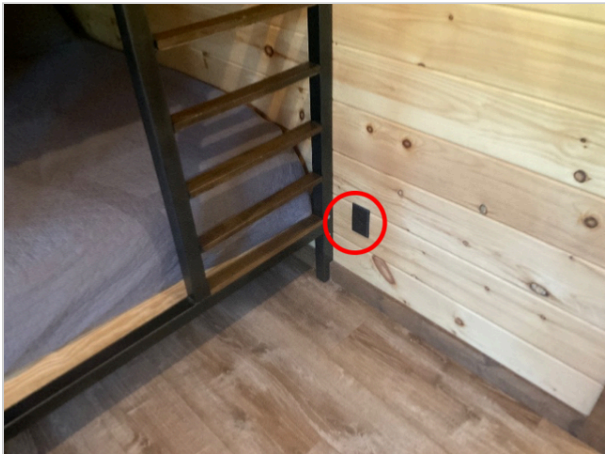
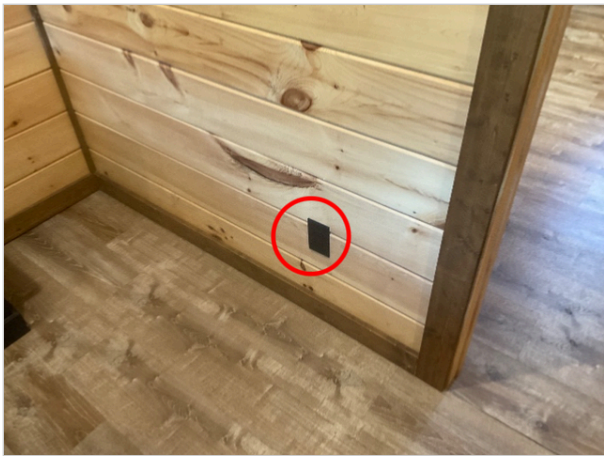
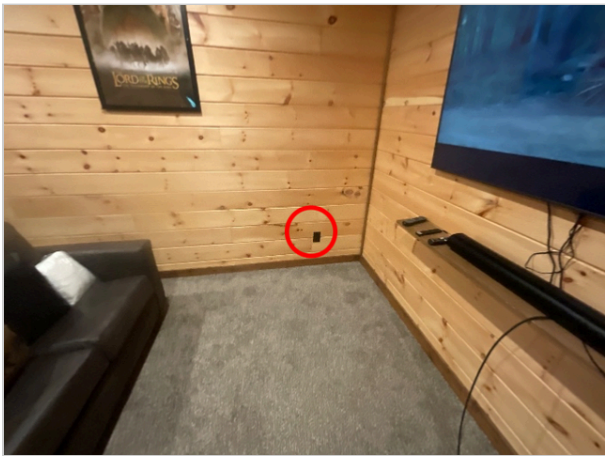
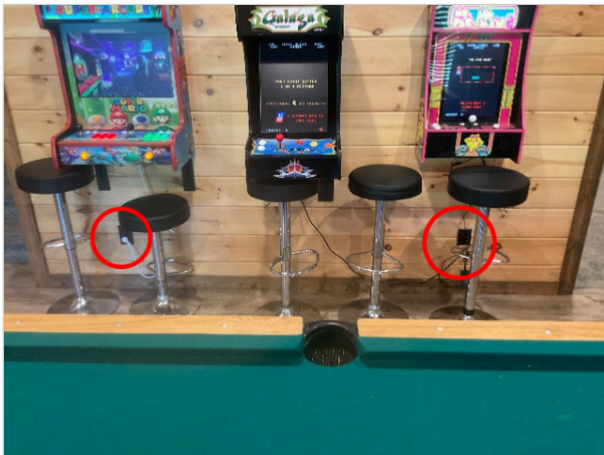
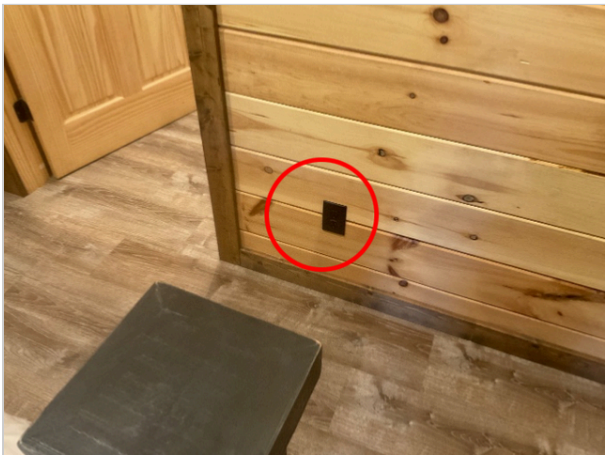
One or more loose outlets were observed. This condition can lead to damage to the outlet as well as to the wiring. Recommend tightening the affected outlets to properly secure them to the structure.

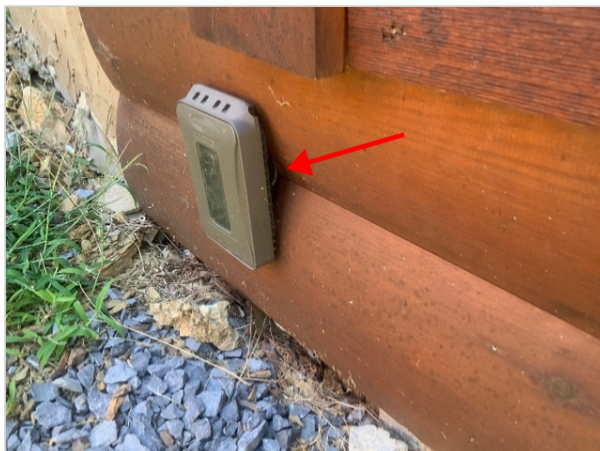
**Photo 32**

**One exterior outlets were not properly covered, potentially allowing rainwater to enter the circuit.** Outlet covers designed for use in wet locations should be installed on all exterior outlets.

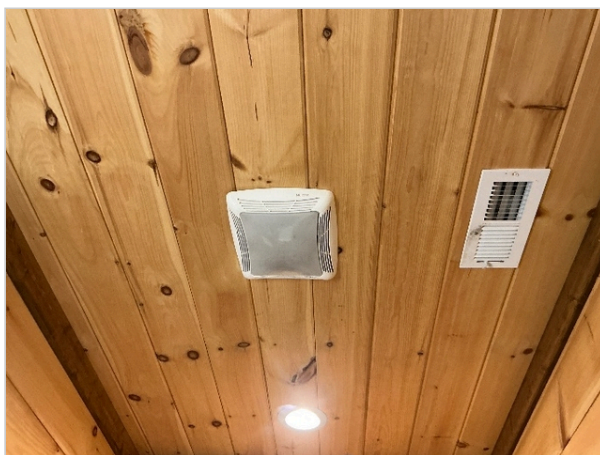
**Photo 33**

A ceiling light fixture in the bathroom did not respond to the switch. The bulb may need to be replaced or there may be a problem with the switch, wiring or light fixture. If after the bulb is replaced this light still fails to respond to the switch, this condition may represent a potential fire hazard and an evaluation and any necessary repairs should be performed by a qualified electrical contractor.

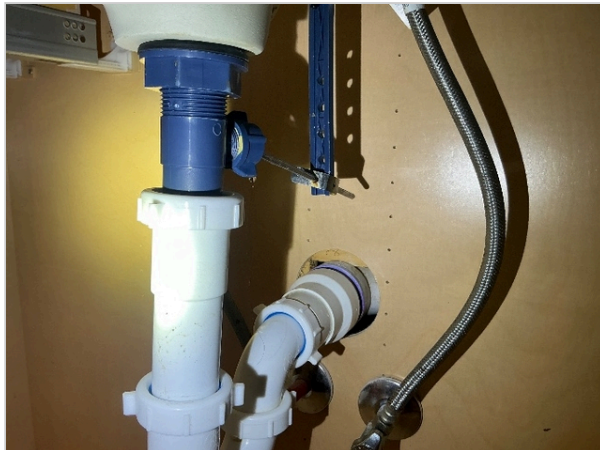
**Photo 38**

**A leak was observed at the drain line to the bathroom sink.** The drain line or seals should be repaired or replaced to prevent water intrusion and should be further assessed at the time of repair.

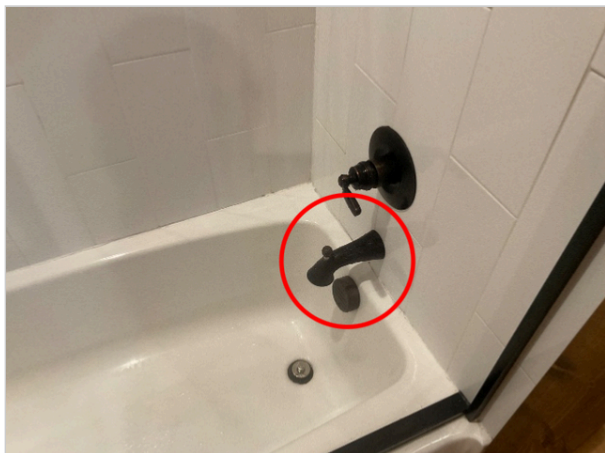
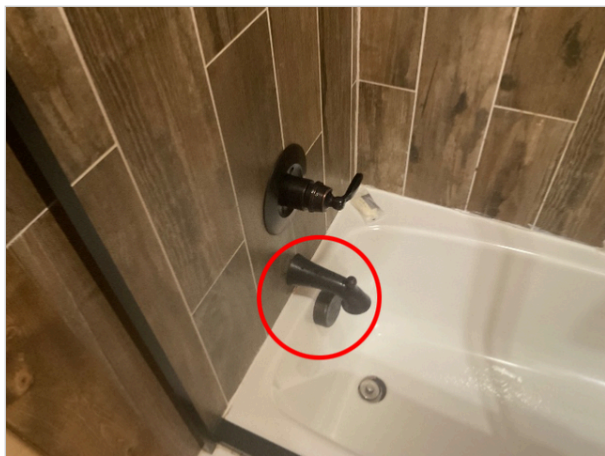
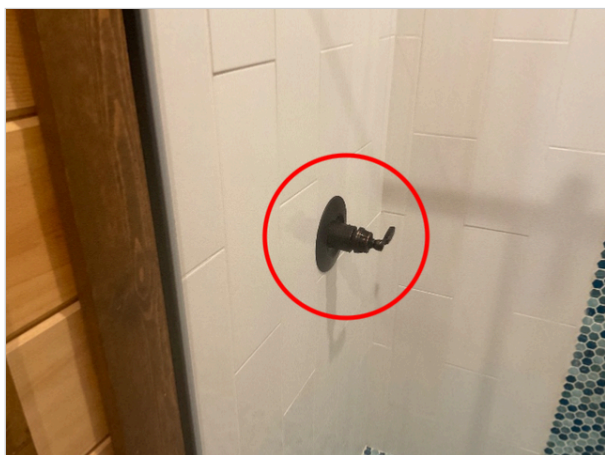
**The faucet in the multiple bathrooms are loose** and should be secured.

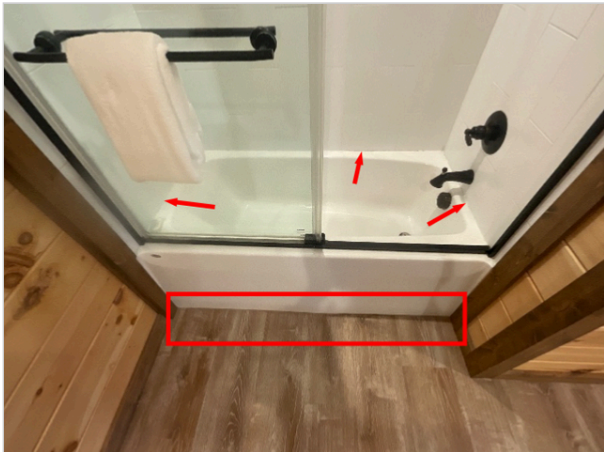
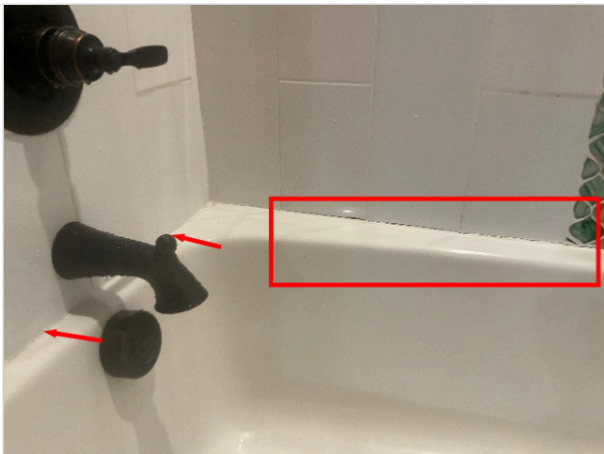
**Some of the caulk and grout was missing from around the tub in multiple bathrooms.** These areas should be sealed to prevent moisture penetration. Failure to keep walls sealed can cause deterioration and extensive moisture damage including mold growth to the interior walls, which is not always visible at the time of the inspection.

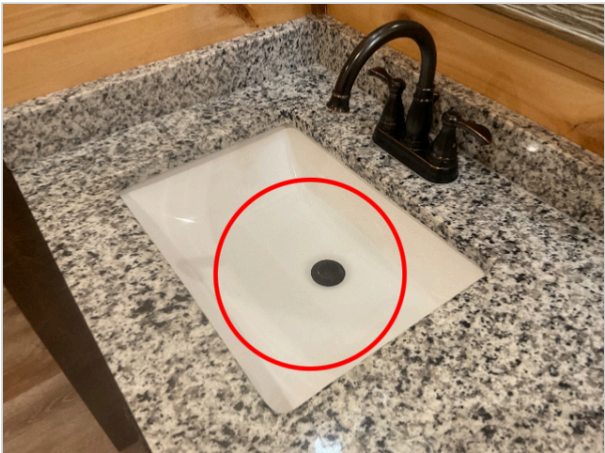
Photo 47

**The basement master left side drains very slowly**, indicating a possible obstruction in the drain line or vent. HomeTeam recommends having the affected line cleared and other lines further assessed at the time of clearing.

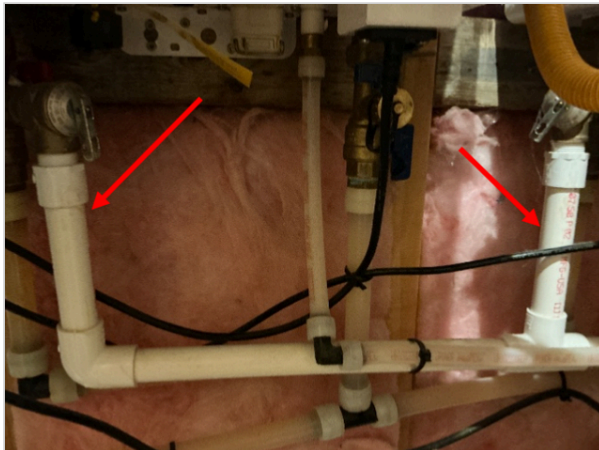
**Photo 50**

**The water heater overflow leg does not terminate properly.** The overflow leg should be repaired/replaced with one that terminates properly.

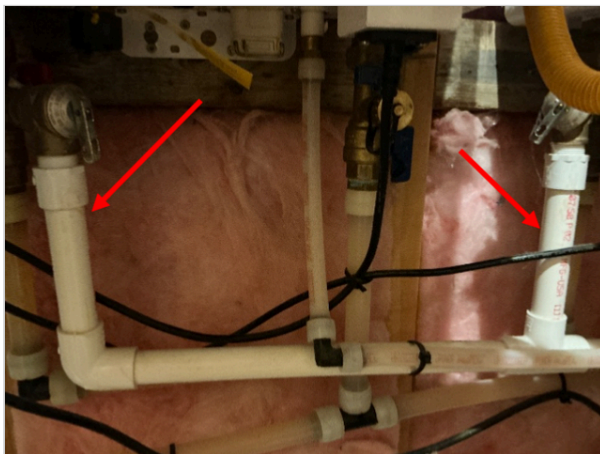
**Photo 52**

**The water heater overflow leg does not terminate properly.** The overflow leg should be repaired/replaced with one that terminates properly.

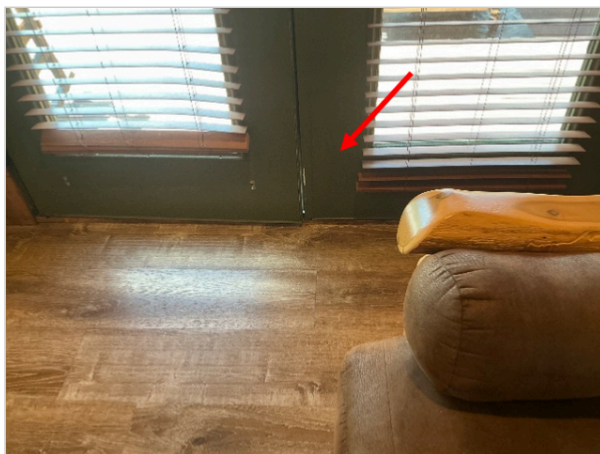
**Photo 56**

**The DOOR SEAL: The seal at the bottom of the exterior door is torn and in need of repair. Recommend replacement of the door seal.**

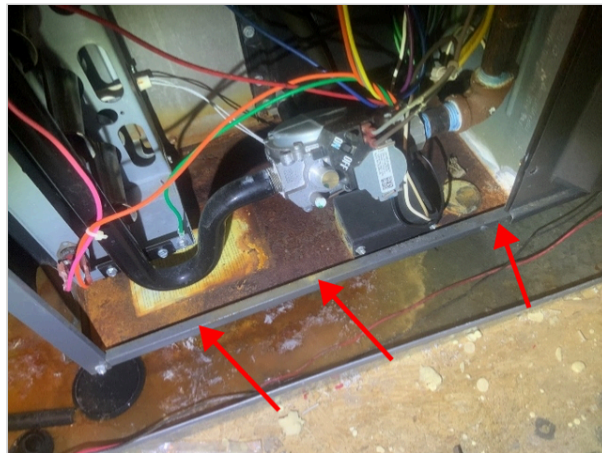
**Photo 68**

Evidence of water was noted inside the furnace compartment. The condition is most likely caused by a condensate leak in the furnace and/or air conditioning condensate drain lines. The water can also be caused by a leaking humidifier if one is installed. Water inside the furnace compartment can damage the furnace cabinet or other operational components and should be repaired. The furnace compartment was dry at the time of the inspection. Consult with a qualified heating contractor to determine the source of the water and correct the issue.

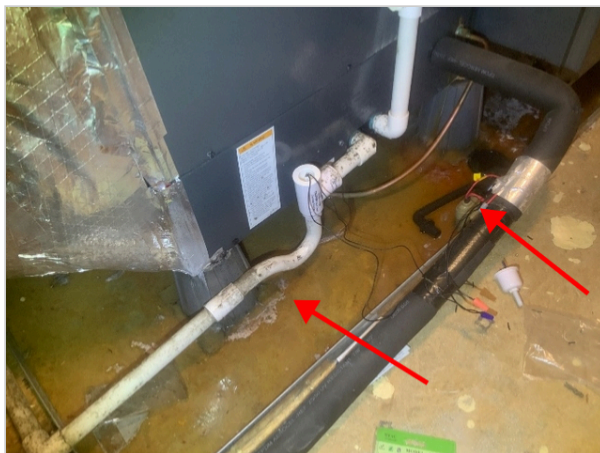
**Photo 69**

**A condensate leak was noted at the air handler . Repairs should be made by a qualified contractor.**

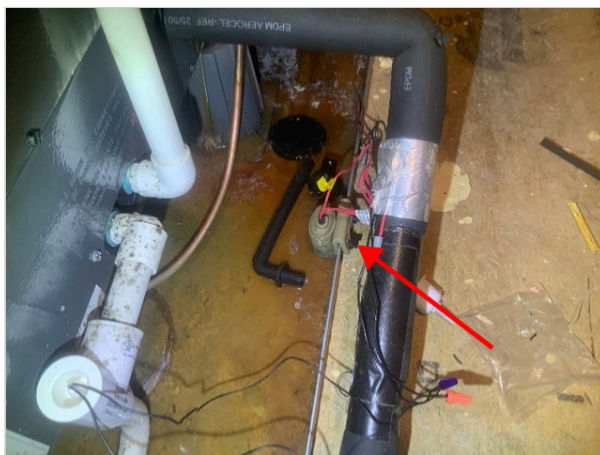
**Photo 70**

**The cutoff switch for the air handler did not function/ was not present when tested.** The cutoff switch should be repaired or replaced to provide the intended safety features for this unit.

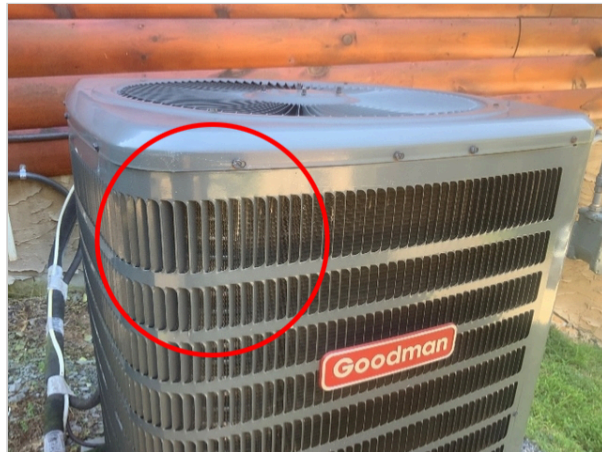
**Photo 76**

**The fins on the outdoor compressor unit are bent.** Combing or straightening the fins may improve the efficiency of the unit by aiding heat transfer.

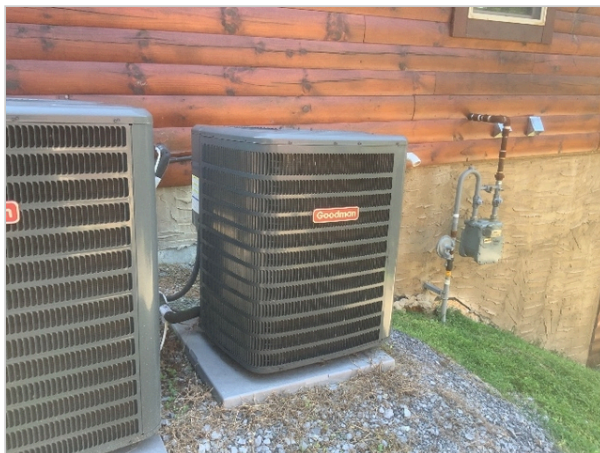
**Photo 77**

**Outdoor condenser not securely fastened.** The exterior condensing unit was observed to wobble when touched, suggesting it may not be properly anchored or supported. The manufacturer requires the unit to be installed level and firmly secured to its pad to prevent vibration, movement, or damage to refrigerant and electrical connections. Recommend evaluation and correction by a qualified HVAC contractor.

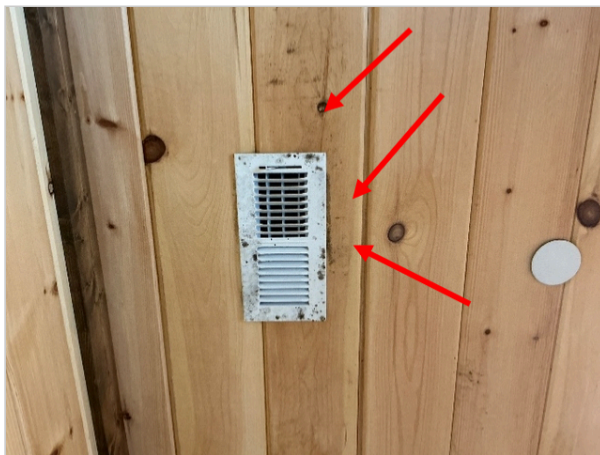
**Photo 80**

**Mold-like growth is visible in the structure.** The EPA has helpful information that may assist the buyer. HomeTeam recommends having the areas tested to determine presence, type and relative concentration of mold spores, and professionally remediated by a reputable mold remediation company, which may include removing and replacing affected segments. A mold remediation company may uncover additional areas or issues requiring repair or remediation. Swab sample taken for analysis.

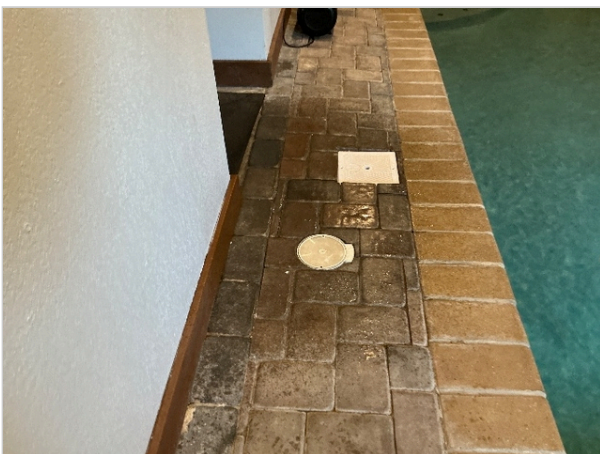
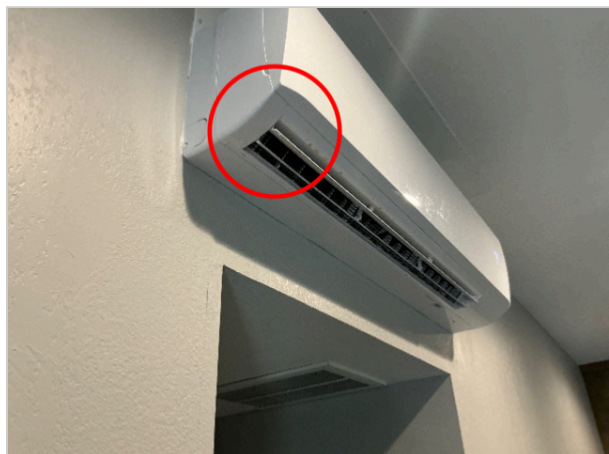
Upon inspection of the HVAC system, it was determined that the **secondary condensate drain** is blocked, which could lead to moisture backup and potential water damage if left unresolved. The secondary drain serves as a backup system in the event that the primary drain becomes clogged or malfunctioning, and its blockage is a significant concern that could compromise the efficiency of the HVAC system and the integrity of the surrounding structure.
