# HomeTeam<sup>®</sup>

## INSPECTION SERVICE

### *HOME INSPECTION REPORT*

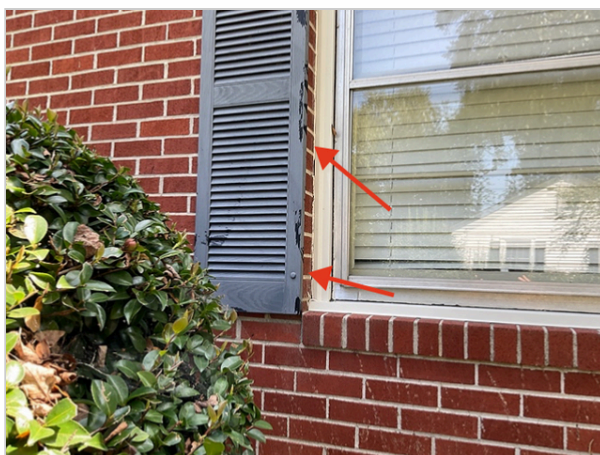
**Photo 5**

**Exterior caulking around the windows is cracked or missing.** The caulking should be repaired or replaced to help prevent water intrusion.

Caulk needs repair around windows

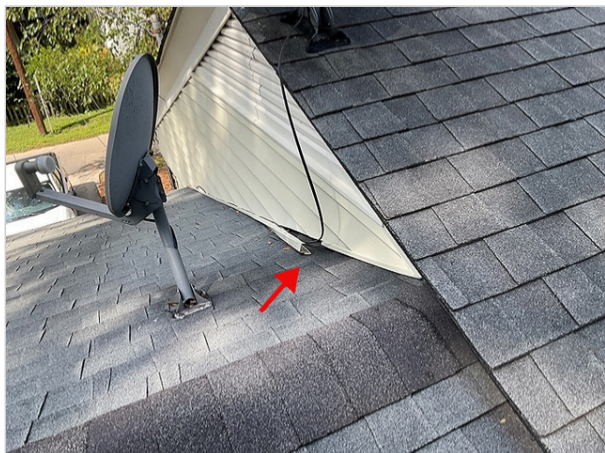
**Photo 6**

**Loose siding was present on the right side of the structure.** The siding should be reattached to prevent water and insect intrusion.

Loose siding over carport transitions

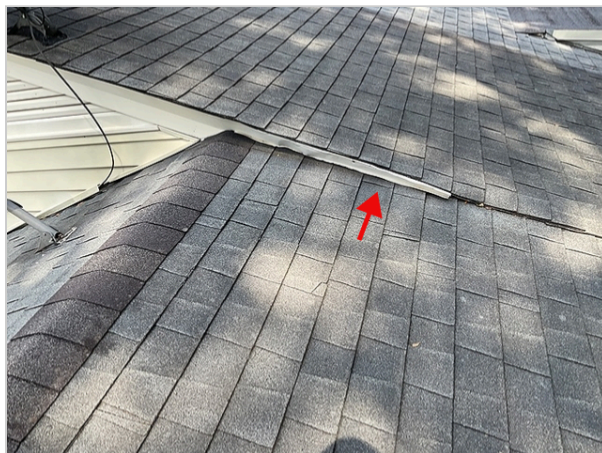
**Photo 7**

Loose siding over carport transitions

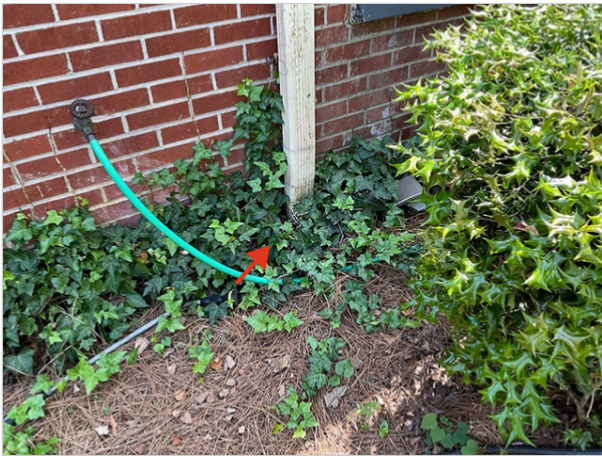
**Photo 9**

**Several downspouts were draining at or too close to the base of the foundation.** To reduce the likelihood of water problems at the base of the structure, all roof drainage should be directed at least six feet from the base of the foundation.

Downspout drains too close to foundation on front of structure

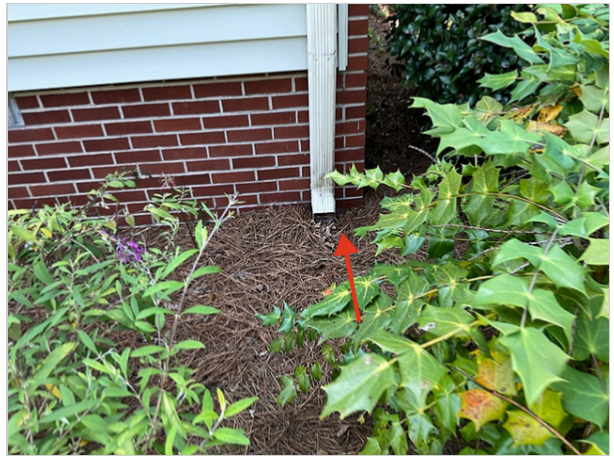
**Photo 10**

Downspout drains too close to foundation

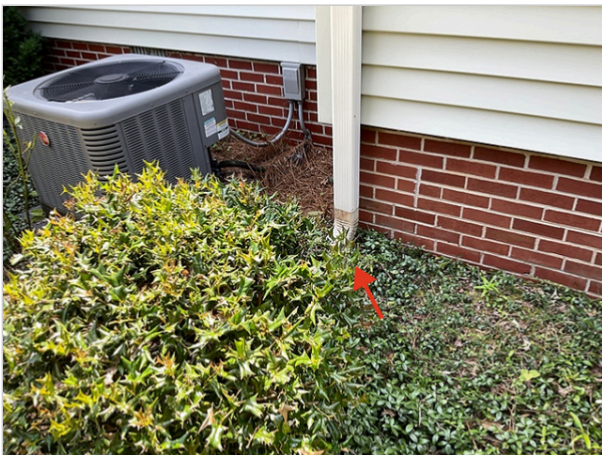
**Photo 11**

Downspout drains too close to foundation

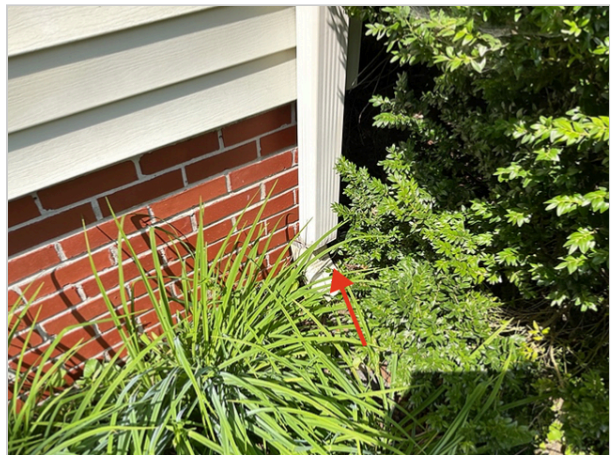
**Photo 12**

Downspout drains too close to foundation

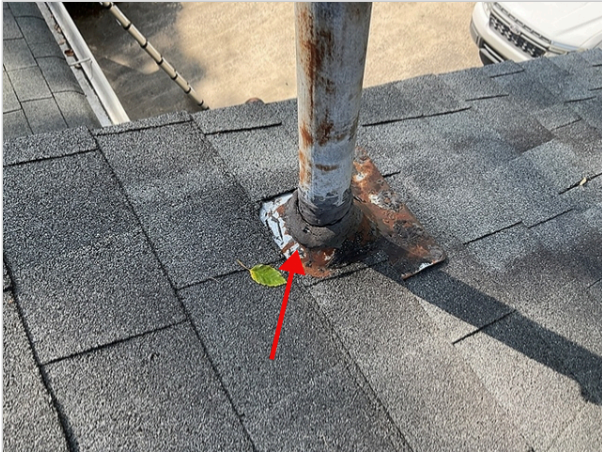
**Photo 22**

Cracked sealant at power mast

**The roof requires routine maintenance to prolong its life.** At the time of the maintenance, the roof should be further assessed for any additional repairs.

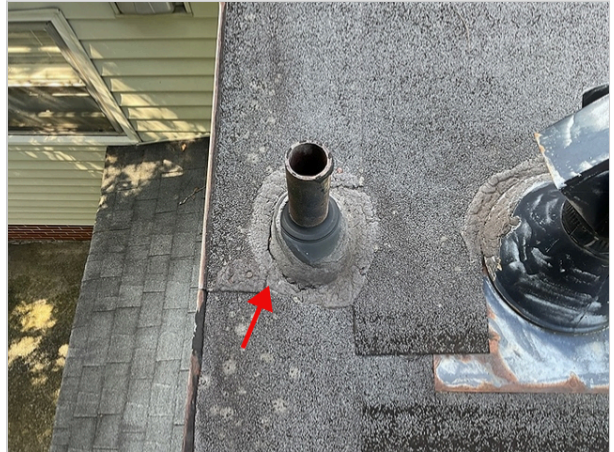
**Photo 23**

Cracked sealant on plumbing boot in rear addition

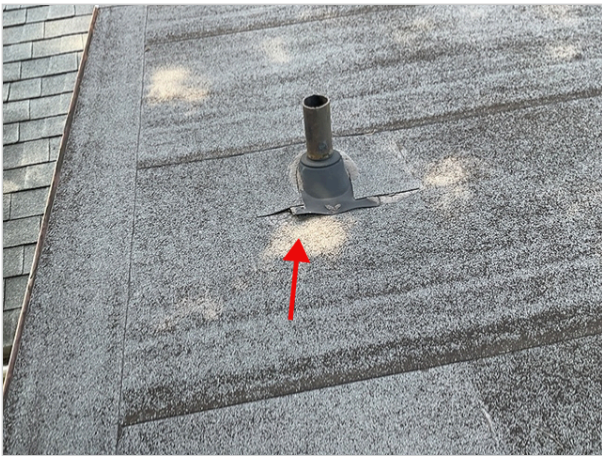
**Photo 24**

Secure plumbing boot on rear

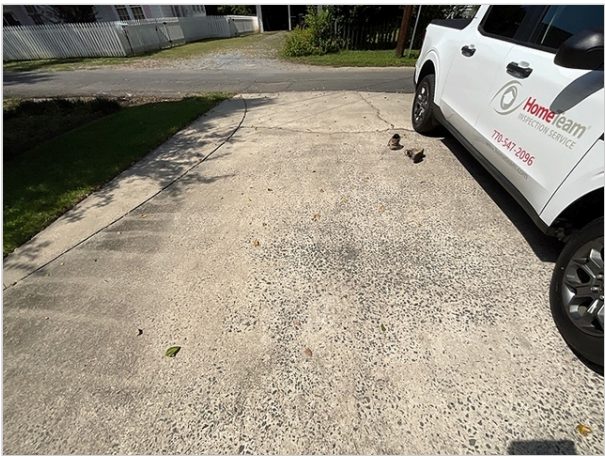
**Photo 28**

A concrete driveway is present in the front of the structure. Cracks and spalling were observed on the driveway. Surface defects in driveways develop and progress with age and are considered normal as long as they do not create a safety hazard. Sealing defects may help slow the rate of deterioration.

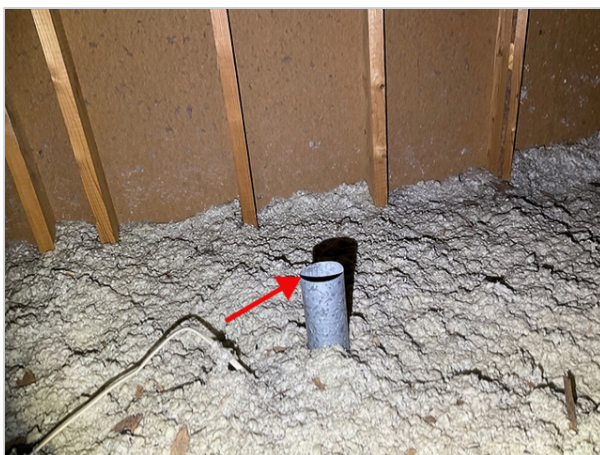
**Photo 43**

**The bathroom exhaust fan is discharging into the attic.** Excessive moisture can build up in the insulation, creating a condition for mold growth. A duct should be installed from the fan exhaust to an exterior vent.

Bathroom bath fan vents into attic

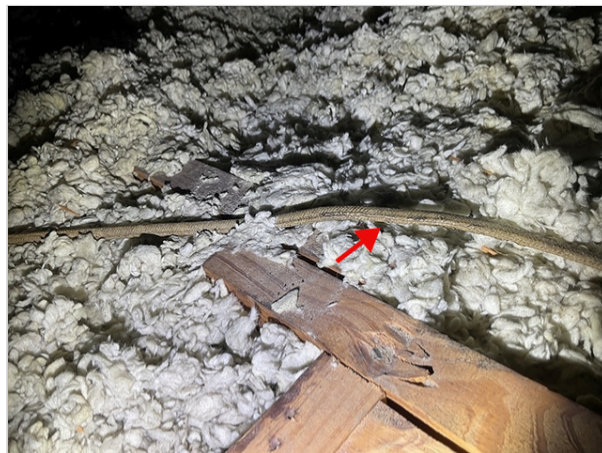
**Photo 45**

Braided cloth NM wiring was present in this home. This is the predecessor for today's polyvinyl chloride (Romex-like) wiring. This wiring's insulating jacket, both external, and the individual jackets covering the conductors themselves become brittle with age, and can be damaged easily, particularly at securement points to studs and joists, in hot attics, and at bend points in the wiring. Typically this form of wiring does not contain an EGC (ground wire). Replacement of this wiring is recommended to be considered due to its age alone. For safety, AFCI breakers are recommended to protect the circuits with braided cloth NM wiring, as the breaker would trip if a damaged section of the wiring were to arc.

Cloth braided wiring

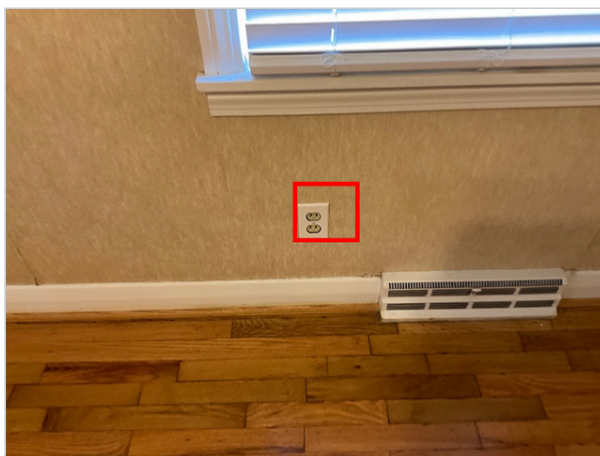
**Photo 46**

Two prong outlets were found in the structure. At the time this structure was constructed, two-prong outlets were the standard construction. Two-pronged outlets were not grounded (open-ground), and are considered to be outdated by today's standards. In many cases, the outlets can be easily upgraded to three-prong type. In cases where the outlets cannot be easily upgraded, the installation of GFCI's in kitchens, baths, garages, basements, outdoor receptacles, and any other high-risk areas, will increase the overall safety of the electrical system. A qualified electrician should be consulted when working on or updating the electrical system in your home.

Two prong outlets in structure

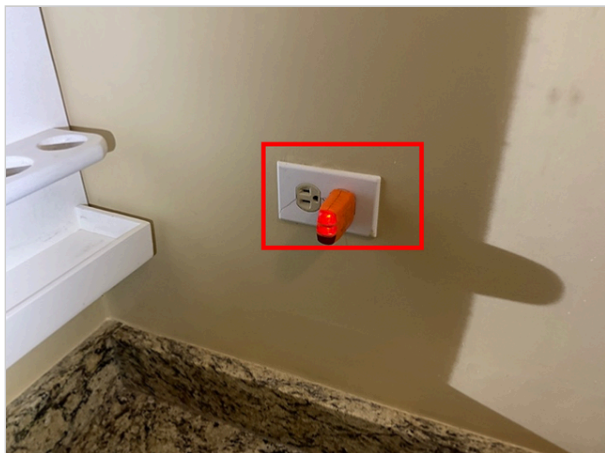
**Photo 47**

**The home lacks GFCI protection.** Electrical repairs should be performed by a qualified electrician.

No GFCI protection in bathroom

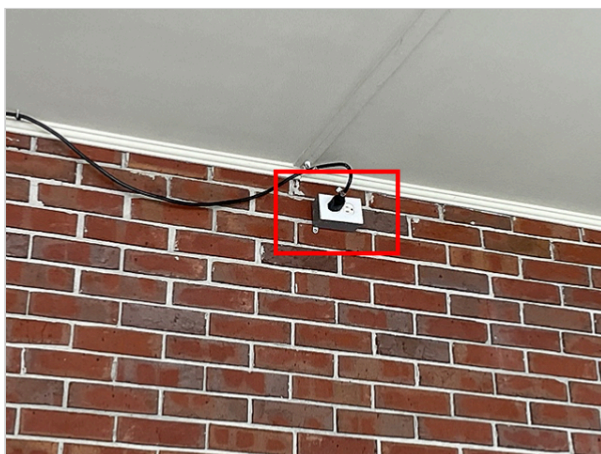
**Photo 49**

**One exterior outlets were not properly covered, potentially allowing rainwater to enter the circuit.** Outlet covers designed for use in wet locations should be installed on all exterior outlets.

No cover on exterior outlet under carport

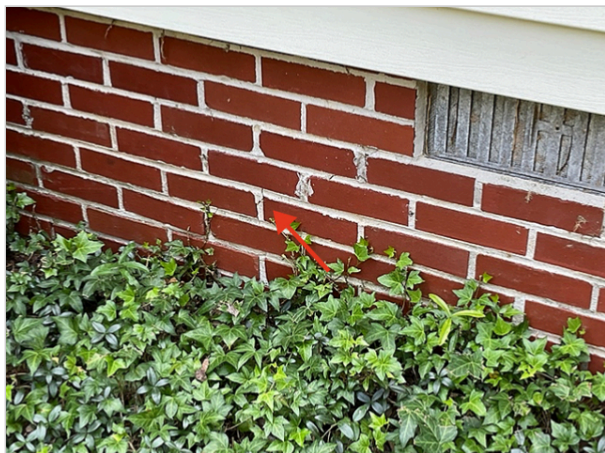
**Photo 50**

Small cracks were observed on the foundation. The cracks were 1/16th-inch or less in width. The homeowner should monitor these cracks for any changes, and if changes are noted, should contact a structural repair company for further analysis. Below-grade cracks are highly susceptible to water intrusion during times of heavy rain. Water staining from previous water intrusion was not visible. HomeTeam recommends sealing these cracks if a watertight basement is desired.

Small crack in foundation on left side of structure

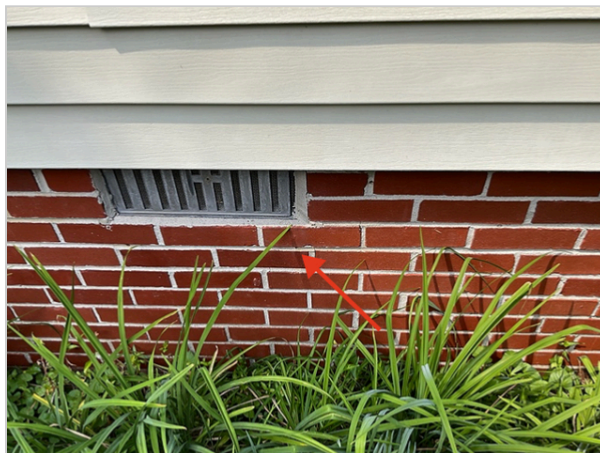
**Photo 51**

Small crack in foundation on rear of structure

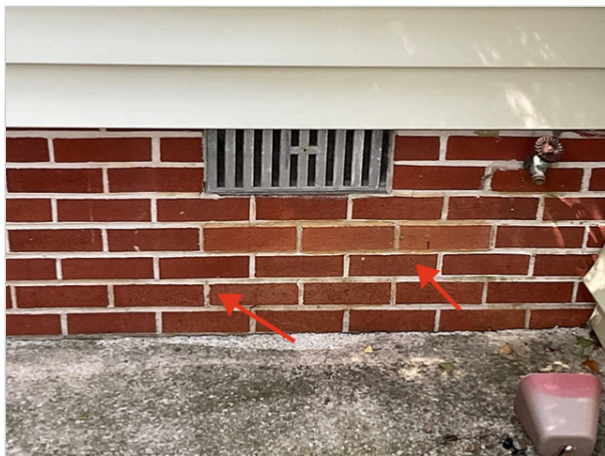
**Photo 52**

Small crack in foundation on rear of str

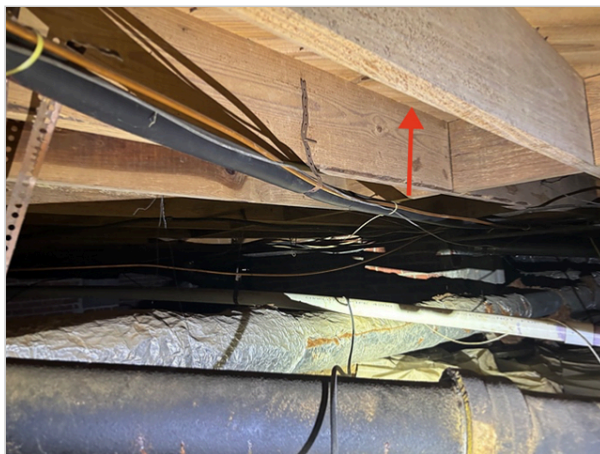
**Photo 63**

living space above the crawlspace and may assist in preventing moisture intrusion.

No insulation on subfloor in crawl space

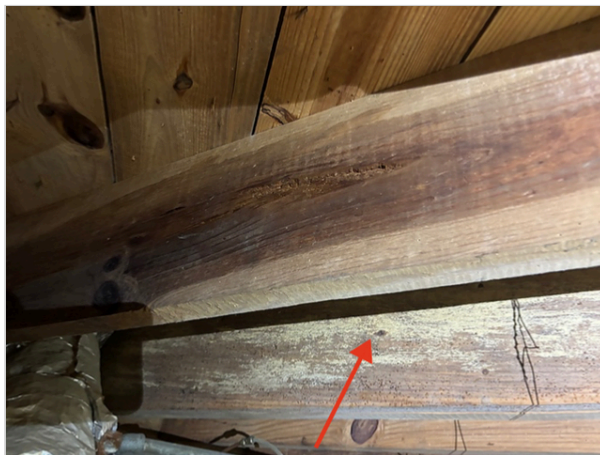
**Photo 64**

**Mold-like growth is visible in the structure.** The EPA has helpful information that may assist the buyer. HomeTeam recommends having the areas tested to determine presence, type and relative concentration of mold spores, and professionally remediated by a reputable mold remediation company, which may include removing and replacing affected segments. A mold remediation company may uncover additional areas or issues requiring repair or remediation.

Mold like growth in crawl space

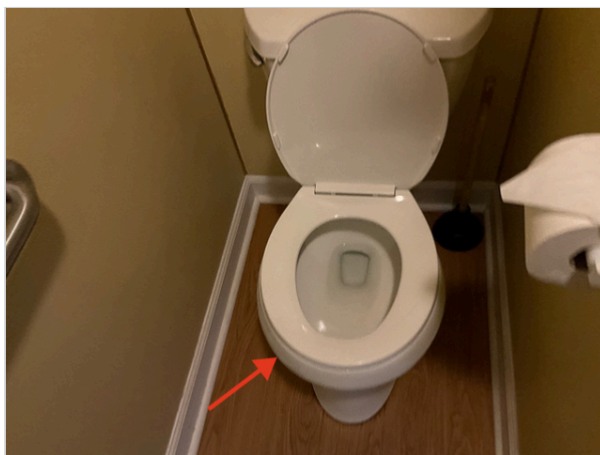
**Photo 68**

**The toilet in the master bath is loose.** Failure to secure the toilet may lead to leakage around the wax ring. The toilet should be secured.

Loose toilet in primary bathroom

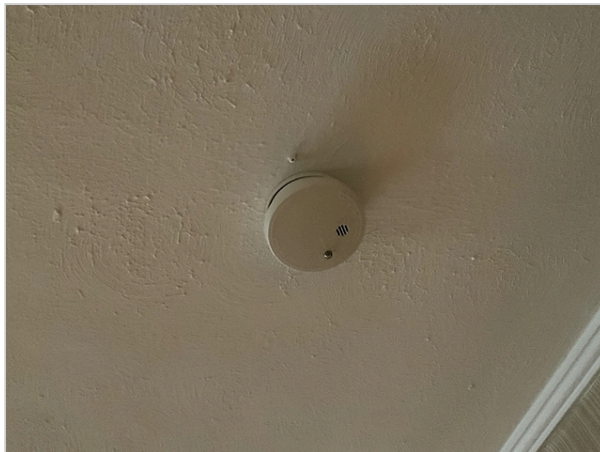
**Photo 80**

Carbon monoxide detectors were not present in the house. Carbon Monoxide detectors should be used whenever there are gas appliances in the home.

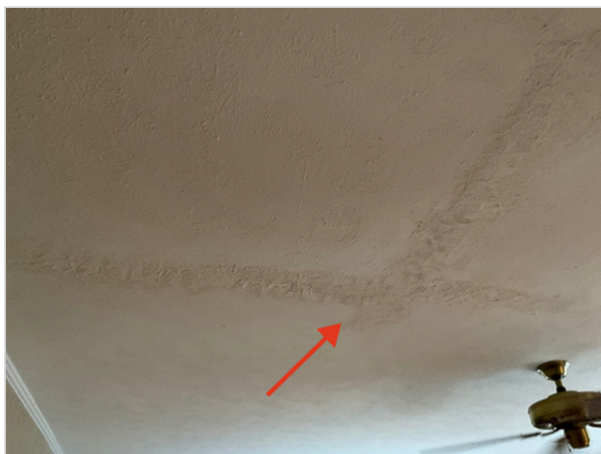
**Photo 83**

Previous repair in bedroom
