# HomeTeam<sup>®</sup>

### *HOME INSPECTION REPORT*

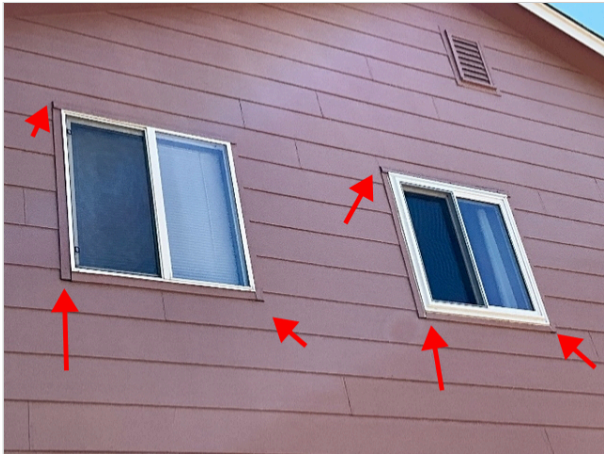
**One or more areas of window trim showed signs of water damage**, including discoloration, swelling, and/or deterioration of the material. This condition may be caused by prolonged moisture exposure due to leaks, condensation, or failed sealing. We recommend further evaluation and appropriate repair or replacement by a qualified contractor. It is also advised to identify and correct the source of moisture to prevent recurrence.

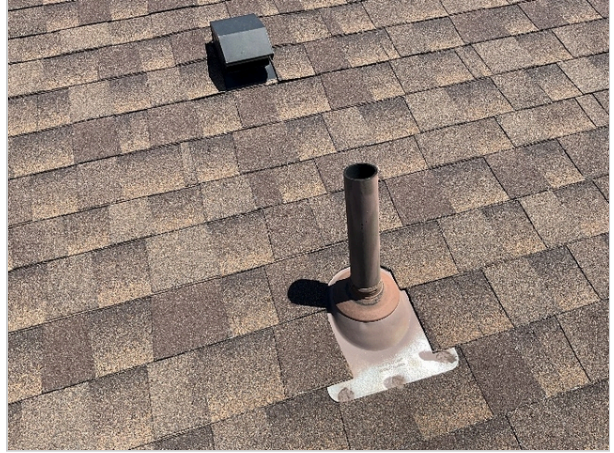
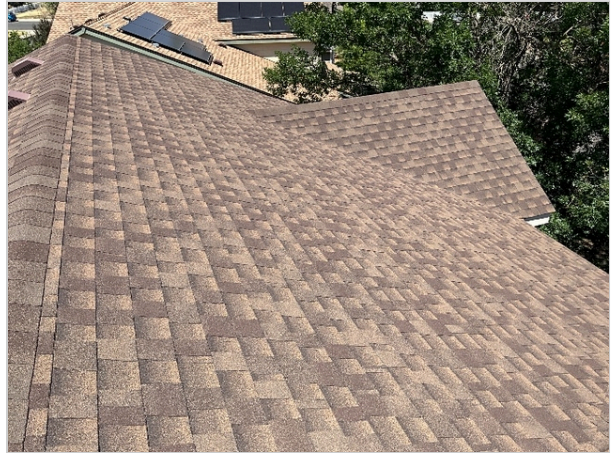
**One or more popped nails were noted on the roof** at the time of the inspection. A popped nail can be identified by a lifted corner on a shingle. The heating and cooling of the roof will often cause roofing nails to lift under the shingles, causing the corner to lift. While it is not likely that the condition is causing a leak, the nails should be reset and sealed to prevent wind from getting under the shingle and possibly lifting the shingle off the roof. Consult with a qualified roofer for repair.

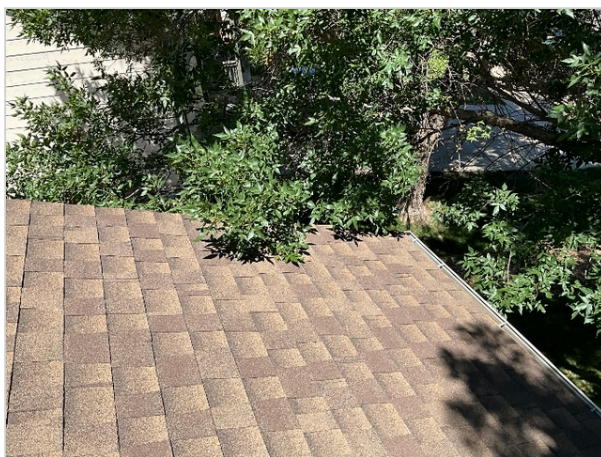
**Tree branches were hanging over or making contact with the roof.** The trees should be cut back away from the roof to avoid damage to the roofing material.

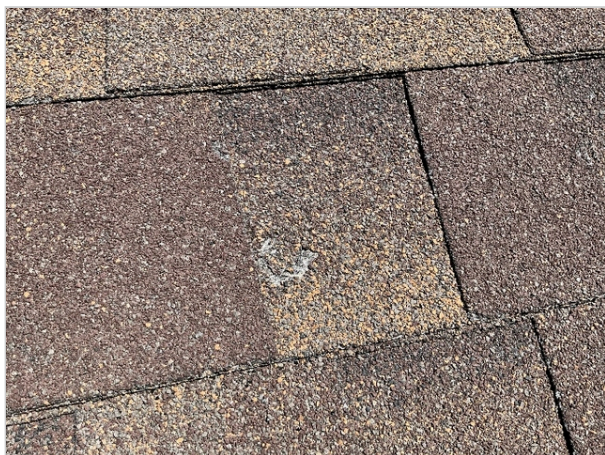
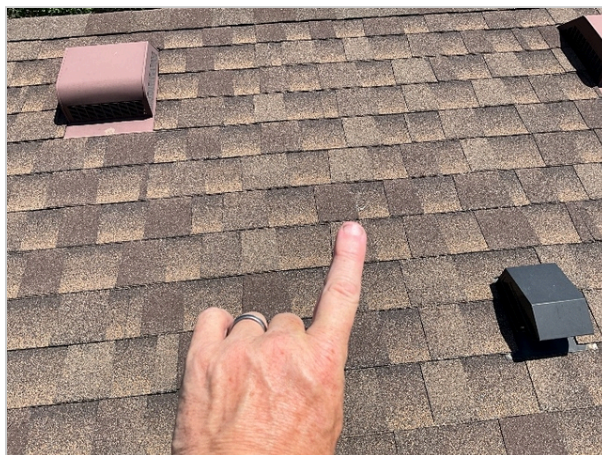
**Widely scattered hail impact marks were observed on the roof covering.** The impacts appeared limited and sporadic, and no widespread functional damage was observed at the time of the inspection. **HomeTeam**  
**Recommends:** Documenting the current condition for future reference, monitoring the roof for changes over time, and consulting a qualified roofing contractor if concerns arise or if an insurance evaluation is desired.

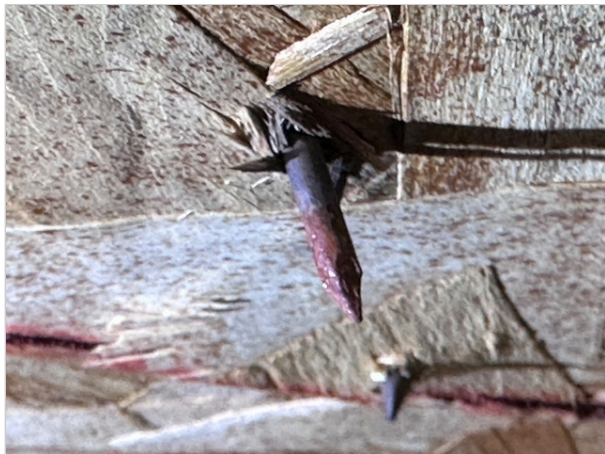
**Rust was observed on roofing nails in the attic, and the upper layer of attic insulation exhibited signs consistent with elevated humidity.** The source of the excess moisture could not be determined at the time of the inspection. Bathroom or laundry exhaust fans discharging into the attic are common causes, although no definitive source was identified. Attic ventilation appeared generally adequate but may benefit from improvement. **HomeTeam Recommends:** Have a qualified contractor evaluate the attic to identify and correct the source of the elevated humidity. Verify that all bathroom and laundry exhaust fans discharge to the exterior of the home rather than into the attic, and improve attic ventilation as needed to help reduce the potential for future moisture-related damage.

**Rusted Roofing Nails**

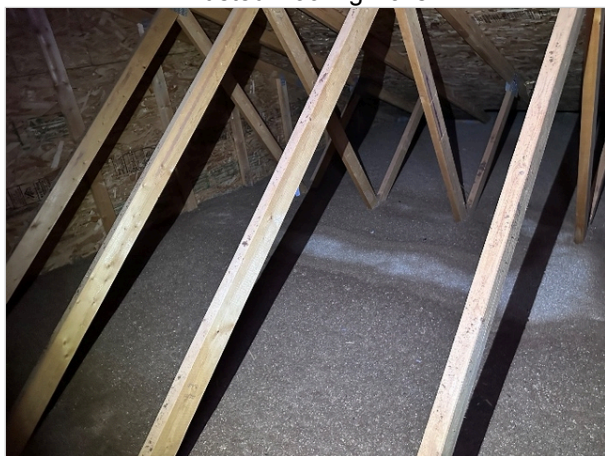
**Humidity affected insulation**

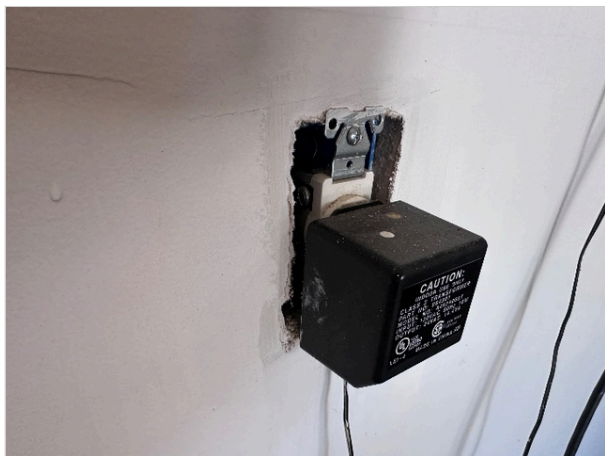
**Missing switch or outlet covers were observed in the garage.** All switch and outlet boxes should be properly covered to avoid a shock hazard. Electrical repairs should be performed by a qualified electrician.

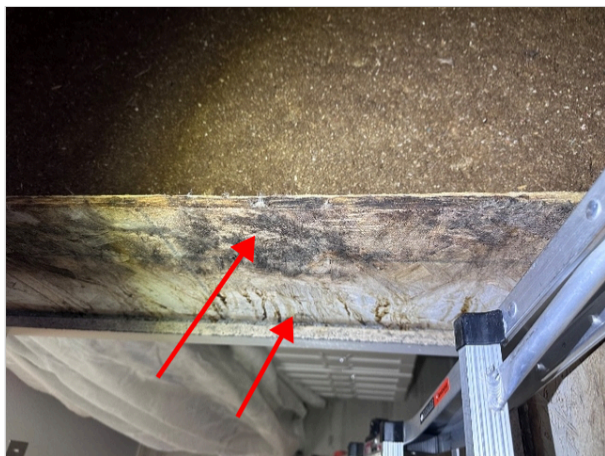
**The primary bathroom does not have an exhaust fan, and a mold-like substance was observed around the attic access scuttle in the adjoining closet, which may be related to elevated moisture levels. HomeTeam recommends having the mold-like substance evaluated and cleaned as needed, and installing a properly vented bathroom exhaust fan to help reduce moisture accumulation and improve ventilation.**

Black Substance and evidence of dripping

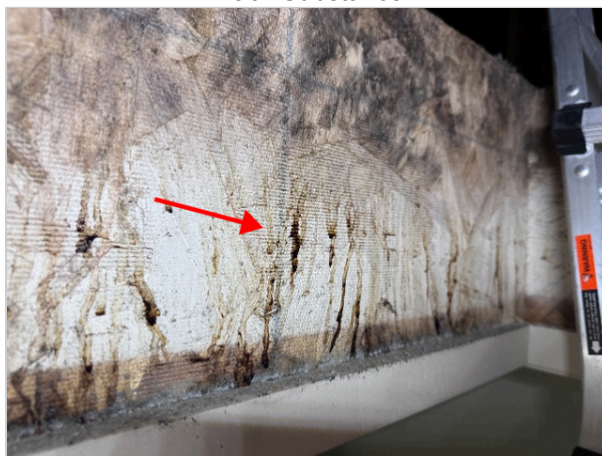
Drips in attic scuttle are evidence of moisture

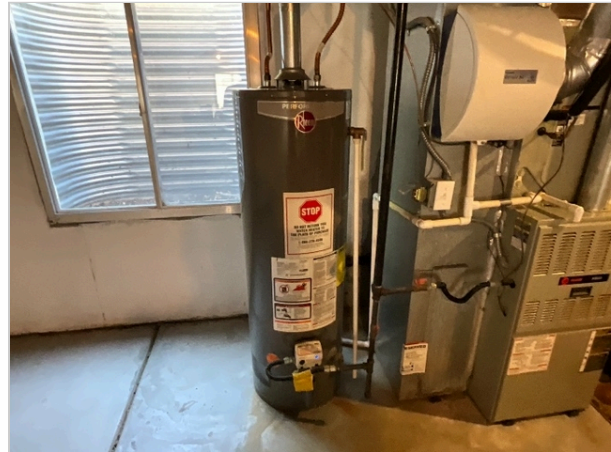
**Water heater does not have an expansion tank** or overpressure valve. Water heaters are recommended to have a way to absorb water expansion through heating without triggering the T & P Valve. Water expansion can cause damage to the plumbing and water heaters. HomeTeam recommends evaluation by a qualified Plumber.

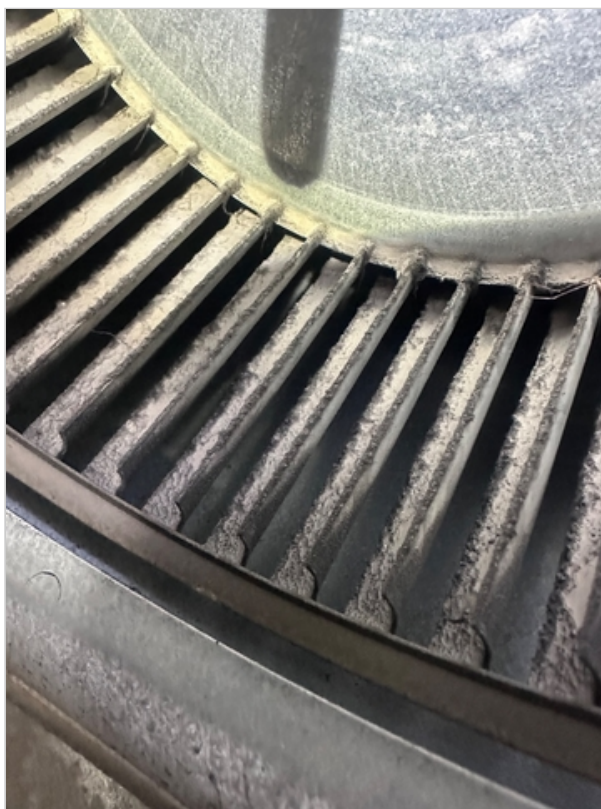
Because of its condition and performance at the time of the inspection, **the furnace requires cleaning and servicing by a professional HVAC technician**. At that time, the technician will test refrigerant levels, service the equipment to improve its performance, and perform other tests beyond the scope of the home inspection to assess and identify any additional areas that may require attention.

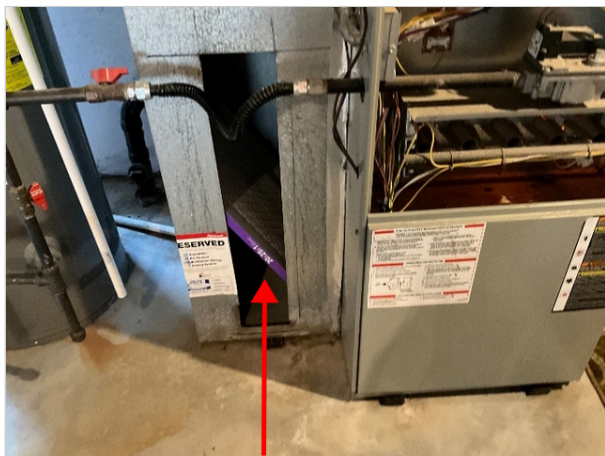
1. White residue was observed on the roof surface beneath the HVAC flue.
2. The furnace requires cleaning and servicing by a professional HVAC technician due to its condition and performance at the time of the inspection.
3. HVAC filter was installed incorrectly and was not effectively filtering the air

Incorrect Installation
