### *HOME INSPECTION REPORT*

On Wednesday, August 5, 2026 The HomeTeam Inspection Service made a visual inspection of 123 Sample Drive, Brambleton, VA 20148. Enclosed please find a written, narrative report of our findings in accordance with the terms of our Inspection Agreement.

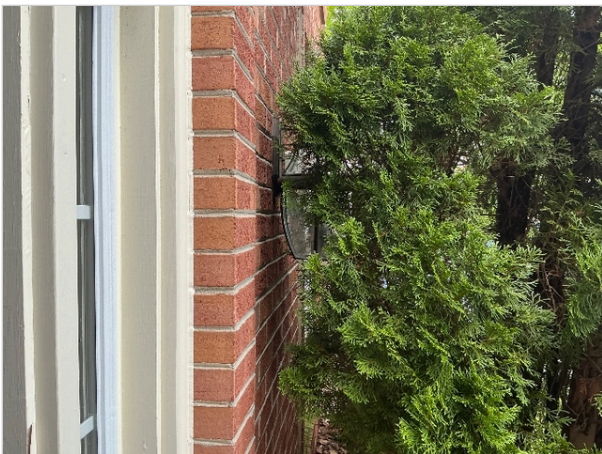
**Photo 6**

**Extensive plant and/or tree overgrowth was observed against the structure.** HomeTeam recommends trimming or removing this growth to prevent possible damage including insect infestation, moisture buildup, and impact damage to the roof and structure.

Maintain Trimming of Shrubs near front entrance

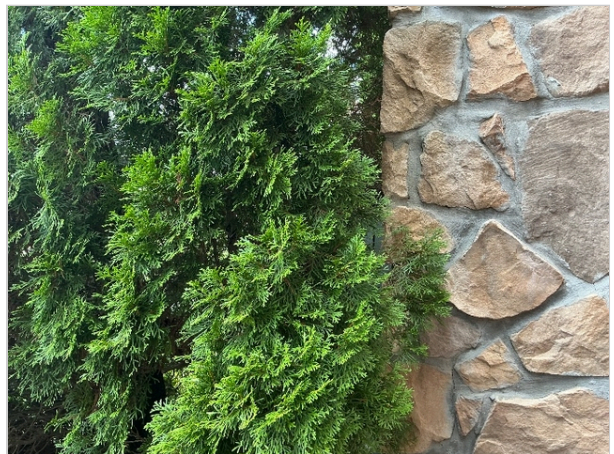
**Photo 7**

Overgrowth of Shrubs near adjacent unit

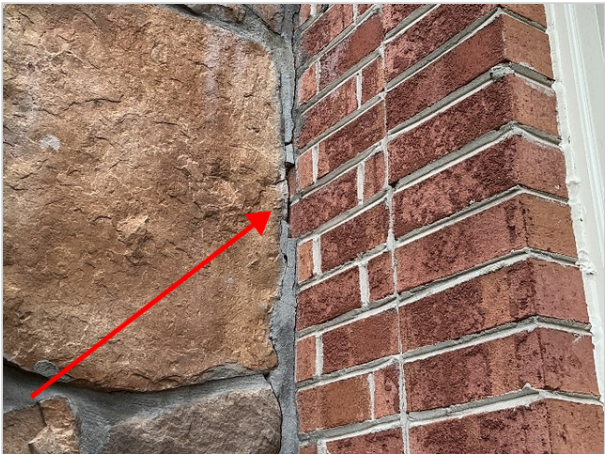
Photo 8

Some cracking and mortar noticed on stone cladding where adjacent unit meets brick at front of subject unit

Cracking of Mortar where adjacent unit meets brick cladding

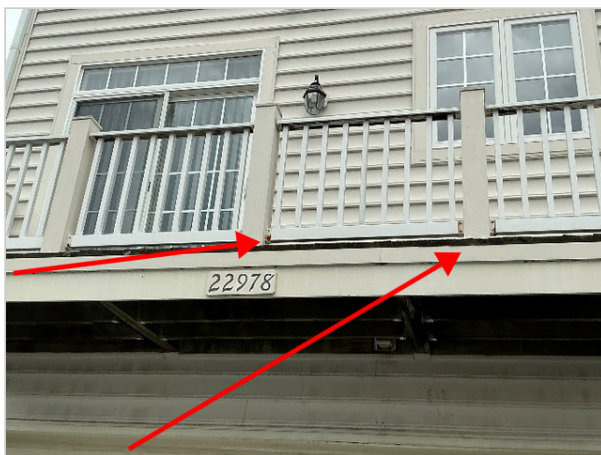
Photo 11

Bracket supports on balcony/deck are beginning to rust. Recommend replacement of brackets.

Brackets for Deck Railing

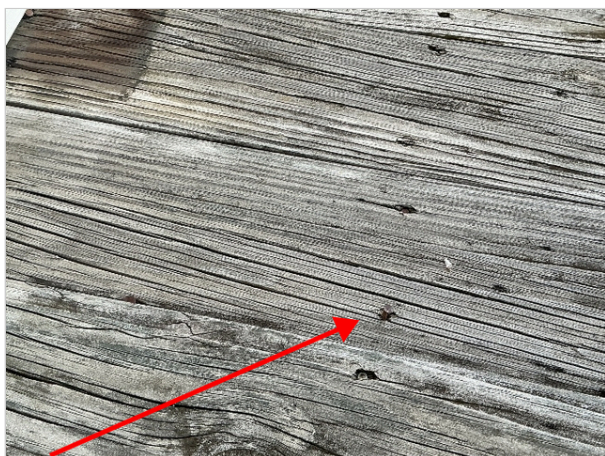
Photo 12

**Multiple loose boards were present on the deck.** All loose decking should be properly secured. Deck also showing signs of deterioration. As noted above, the deck should be regularly cleaned and sealed.

Loose nailing on Deck Surface

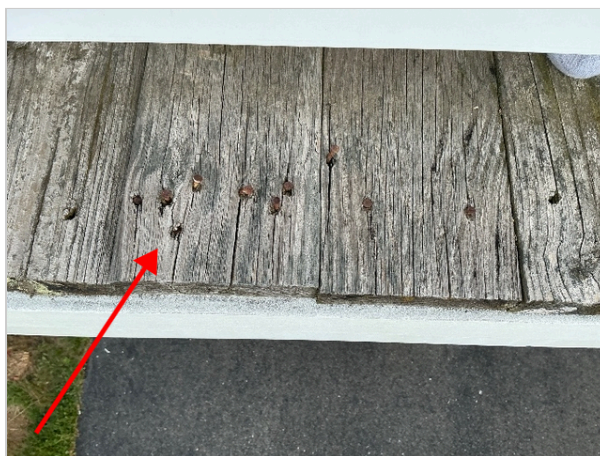
Photo 13

Nails near Deck Edge

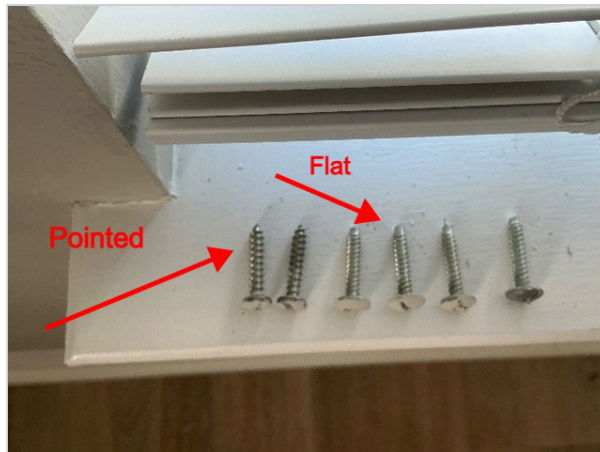
Photo 41

Two of the metal screws securing the face plate to the electrical panel had pointed tips. Recommend replacing these for safety reasons.

Electrical Panel Screws

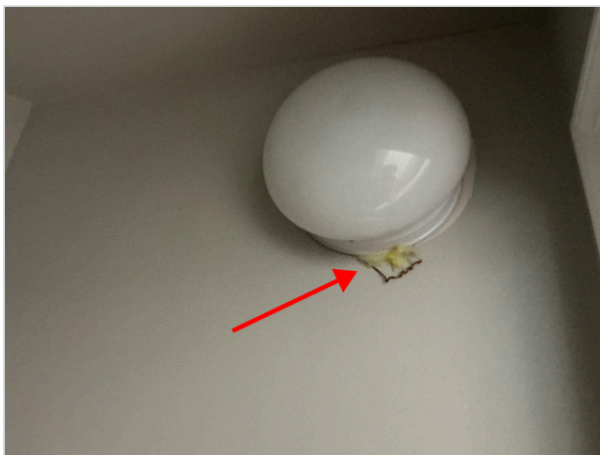
**Photo 43**

Storage room, and basement under stairs light does not work. A wire is also showing behind the light. Licensed electrician should inspect for safety.

**Light in storage closet in basement under staircase**

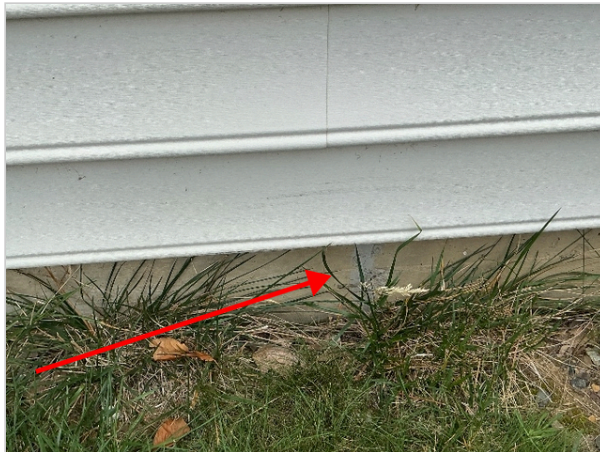
**Photo 44**

Small cracks were observed on the foundation. The cracks were 1/16th-inch or less in width. The homeowner should monitor these cracks for any changes, and if changes are noted, should contact a structural repair company for further analysis. Below-grade cracks are highly susceptible to water intrusion during times of heavy rain. Water staining from previous water intrusion was not visible. HomeTeam recommends sealing these cracks if a watertight basement is desired.

Minor repair to foundation.

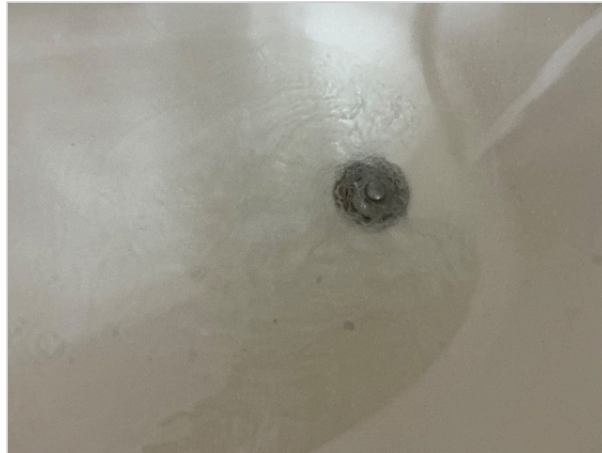
**Photo 59**

Drain plug in third floor hallway bathroom appears to be broken. Tub still drains properly, but requires the plug to be removed.

Third floor hallway bathroom bathtub

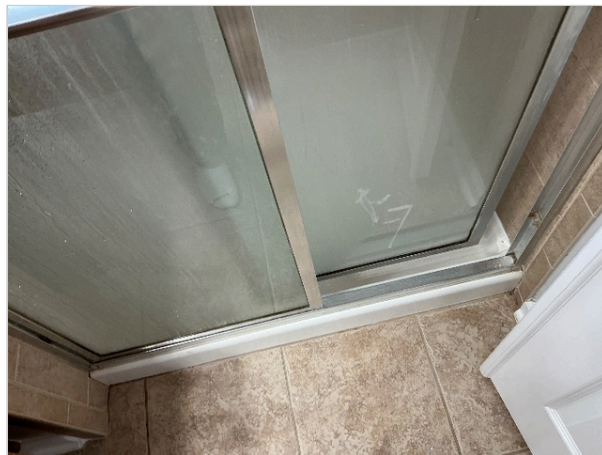
**Photo 60**

Sliding glass door in third floor third bedroom bathroom hanging. Does not appear to be properly seated.

Bathroom of third floor third room

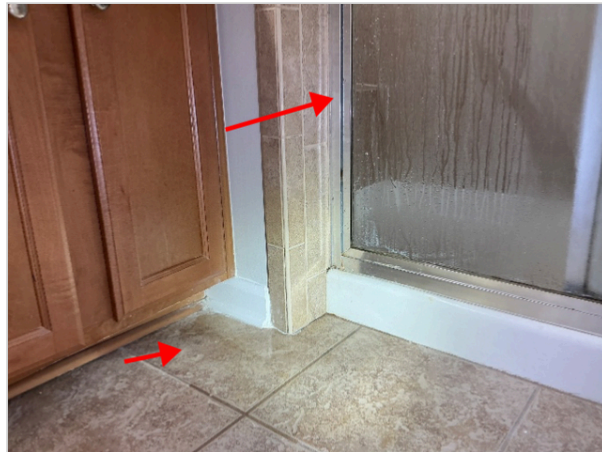
**Photo 61**

Water escaping from sliding glass door in the bathroom of the third bedroom. Leaking water can get into structure and cause mold issues.

Shower in the bathroom of the third floor third bedroom

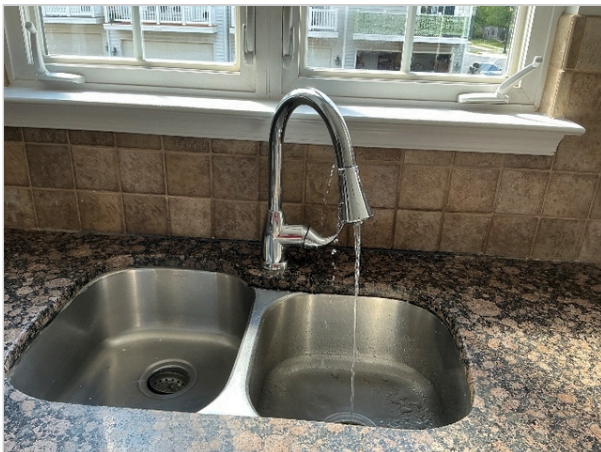
**Photo 62**

Kitchen sink appears to be leaking. Both the faucet and the line beneath the sink show signs of leaks. Plumbing should be repaired by a licensed plumber to prevent damage.

Kitchen faucet

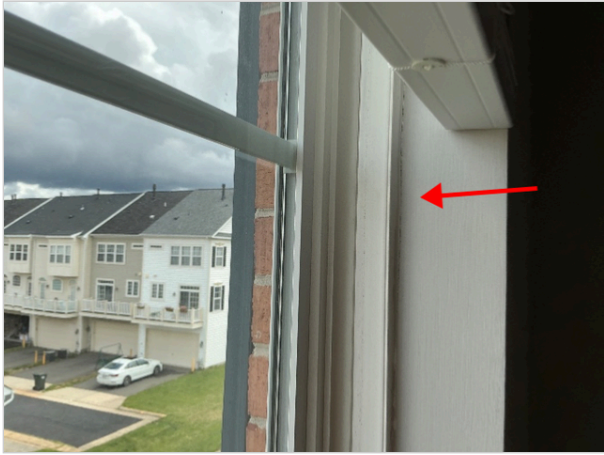
Photo 73

Cracking noticed caulking around the window. This is a maintenance item to help prevent moisture from entering the house.

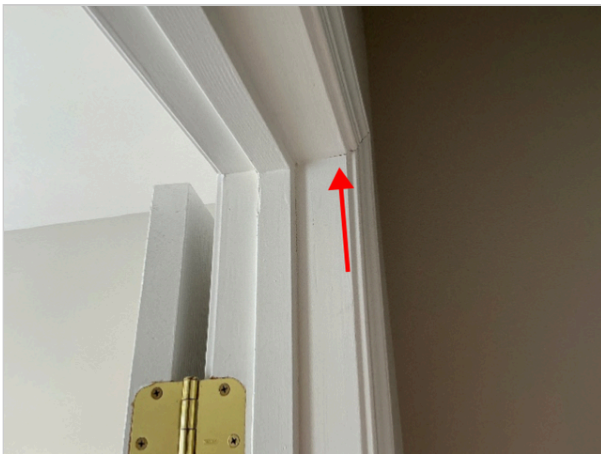
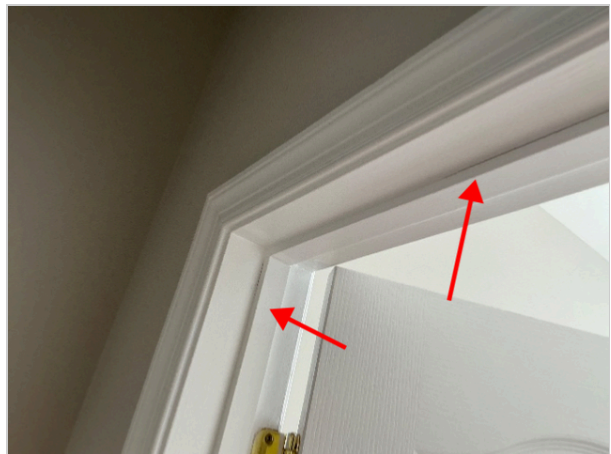
Cracking in door frame of closet and bedroom two.

Bedroom two closet

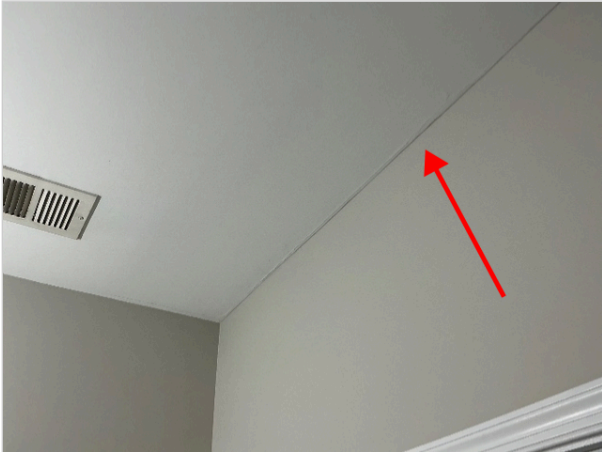
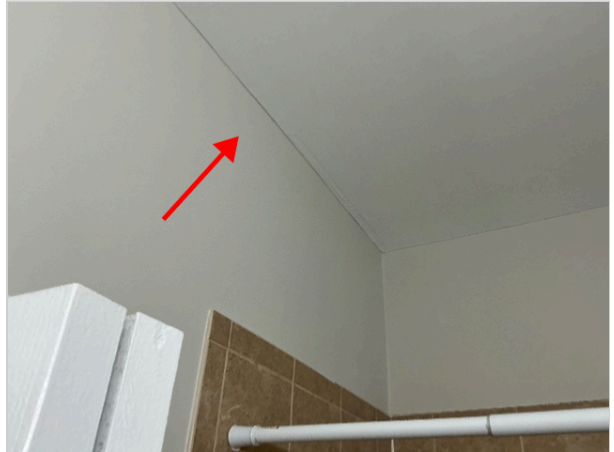
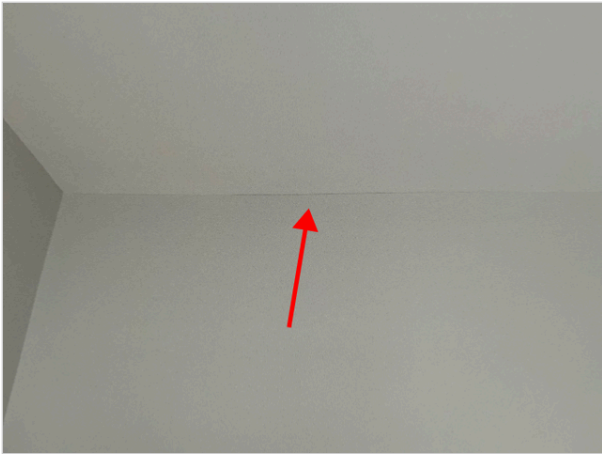
Cracking noticed in ceiling up third floor ceiling . Cracking can be signs of house settlement overtime.

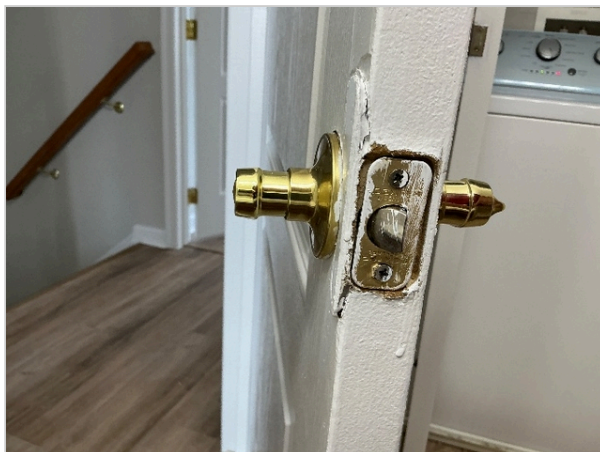
**Photo 84**

Door latch and the door to third floor hallway bathroom appears to be broken.

3rd Floor Bathroom door

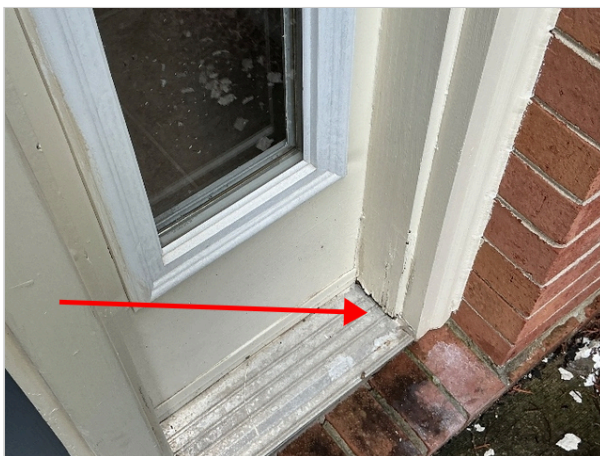
Photo 85

**The base of the door frame to the front of the home was damaged from apparent moisture exposure.** The door frame should be repaired and the surrounding area should be further assessed at the time of repair for any additional damage.

Exterior Door Frame

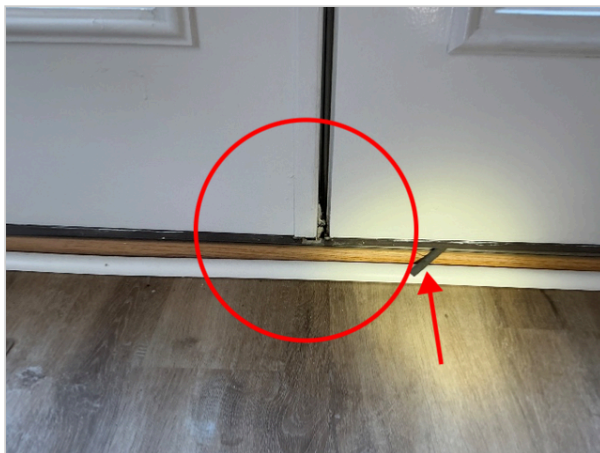
**Photo 88**

Weather seal around living room exterior door needs to be repaired. Moisture can enter the house through broken weather seal.

Living room exterior door

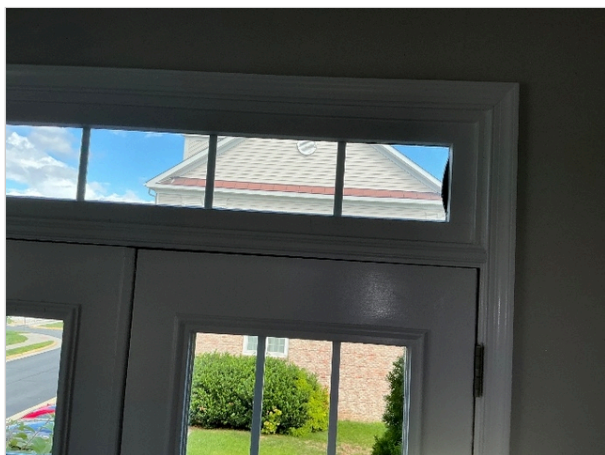
**Photo 89**

Sealing in window appears to be broken. This is an area of moisture could potentially into the home if not repaired.

Window above living room exterior door

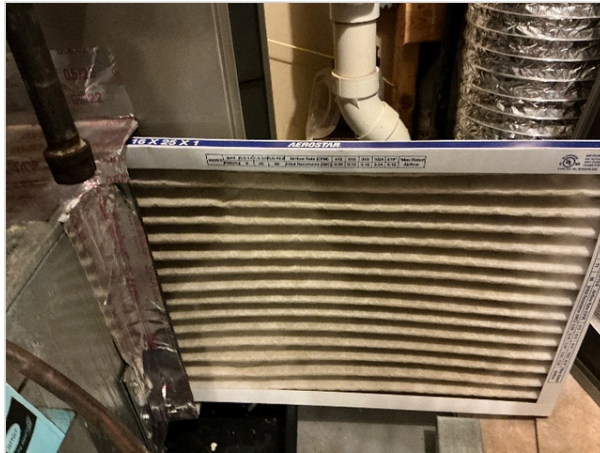
**Photo 117**

**The air filter is somewhat dirty** and should be replaced. Prolonged operation of an HVAC system with a dirty filter can cause internal damage to the compressor valves that may not be observable during the inspection; operating with a dirty filter may also damage the air handler. HomeTeam recommends having the HVAC system cleaned and serviced for this reason. Also, the filter was not the correct type and size for the unit.
