### *HOME INSPECTION REPORT*

Monday, July 13, 2026

**John Smith**  
**123 Sample Drive,**  
**Savannah, GA 31410**

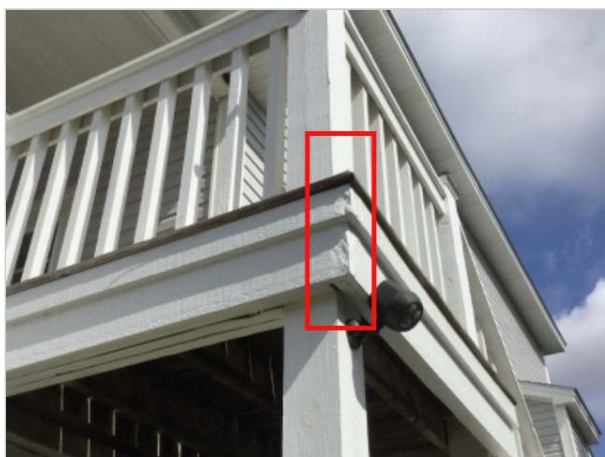
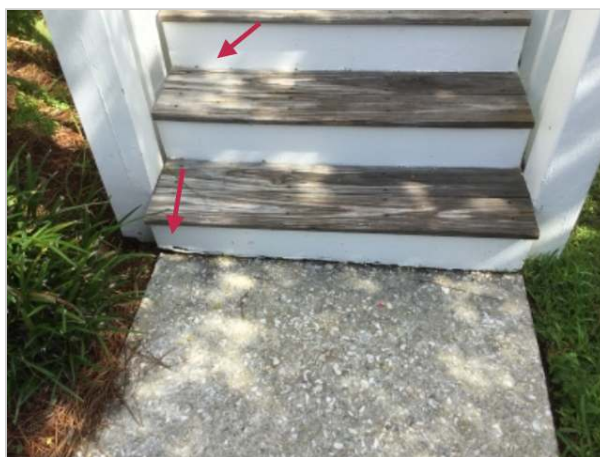
There is wood rot and water damage on the trim around the front steps in a couple of areas.

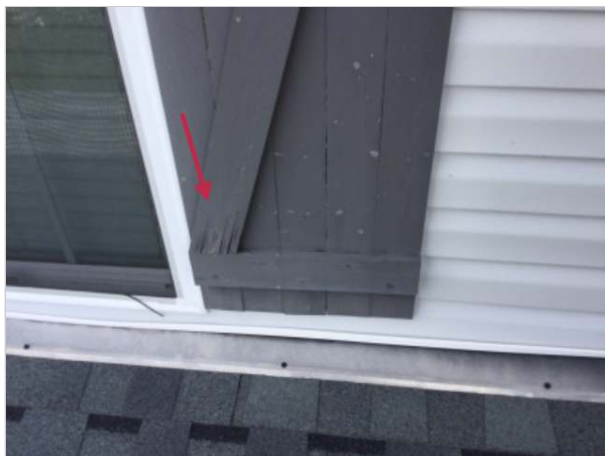
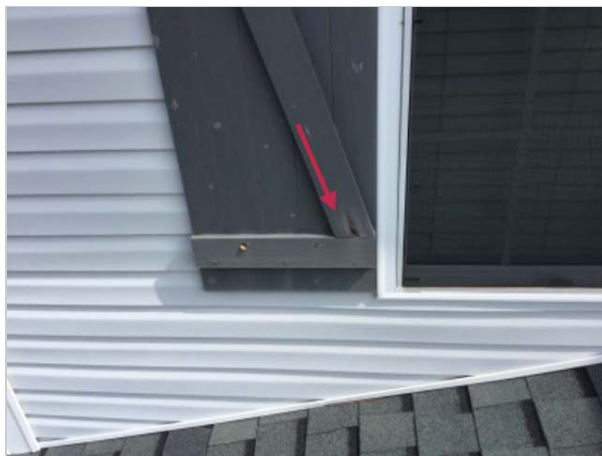
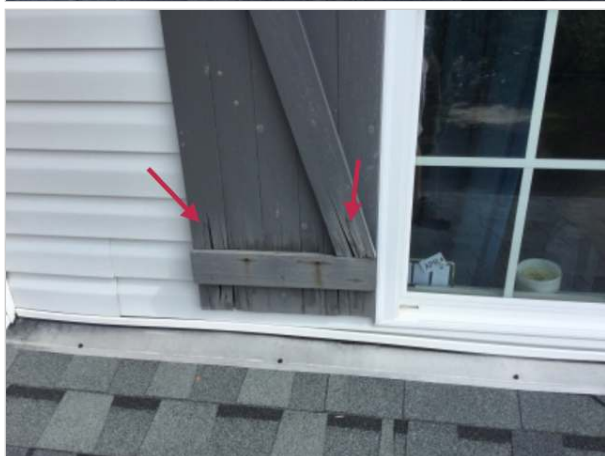
There is wood rot and water damage on a few of the front shutters.

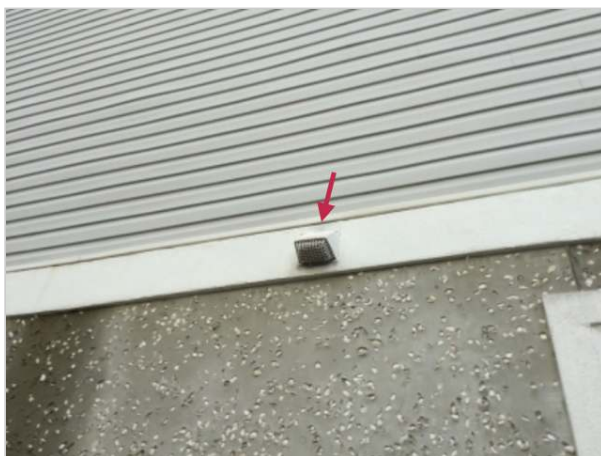
The dryer vent cover on the left side of the home needs cleaning.

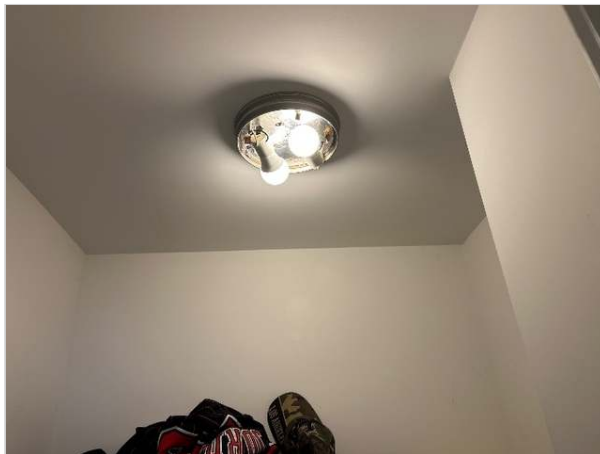
The closet light in the back right bedroom is missing a globe.

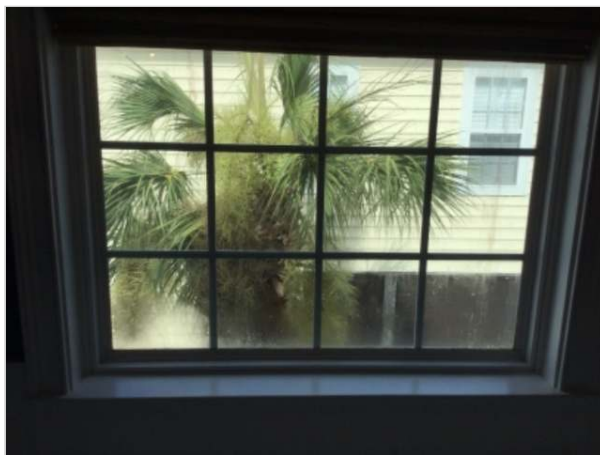
Master bathroom fixed window

The master bedroom fixed window had a defective thermal seal. A defective thermal seal can be identified when fogging is observed between the panes of glass. A defective thermal seal does not affect the performance of the window. Repair of the thermal seal can be accomplished by replacing the affected glass panel.

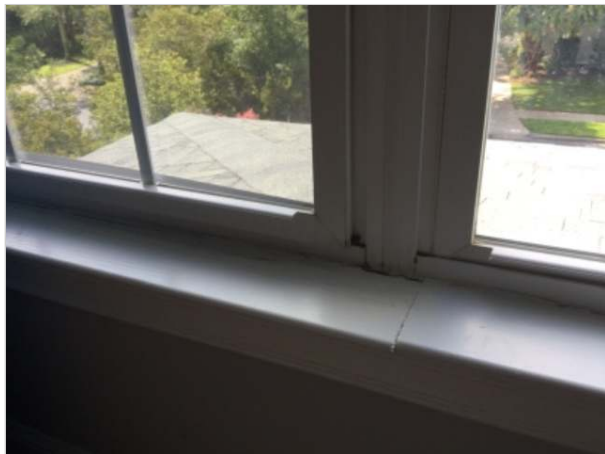
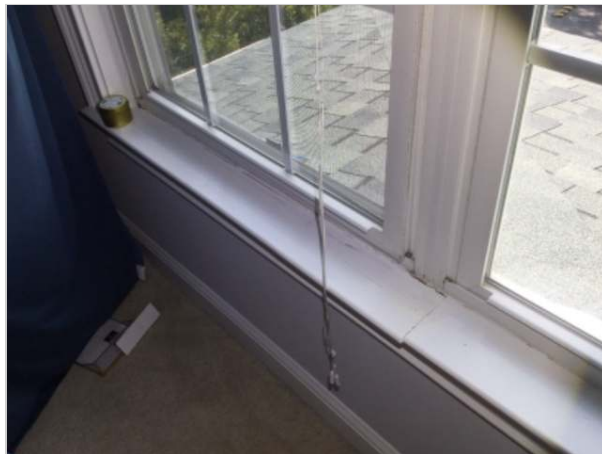
The left window in the second level front right bedroom is not connected to the tension bar which leaves the window open. There is water damage on the sill.

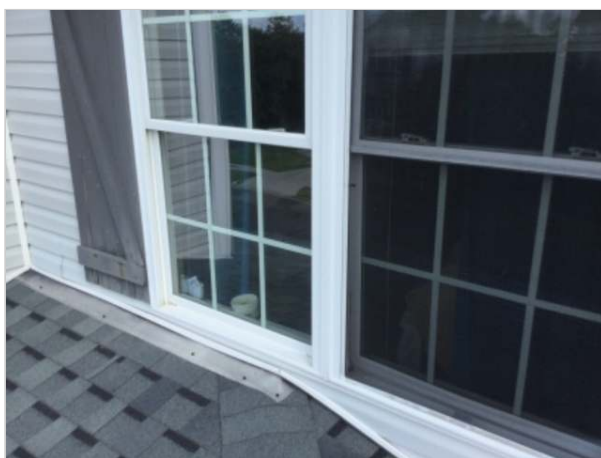
One or more window screens were missing or damaged at the time of the inspection.

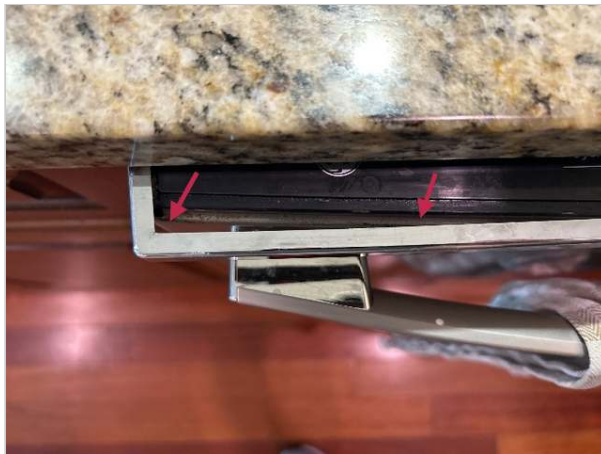
A piece of the trim on the dishwasher is loose.
