### *HOME INSPECTION REPORT*

On Sunday, May 3, 2026, HomeTeam Inspection Service of Northeast Orlando made a visual inspection of 123 Sample Drive, Saint Cloud, FL 34771. Enclosed is a written, narrative report of our findings in accordance with the terms of our Inspection Agreement. Although maintenance items may have been addressed verbally at the time of the inspection, they may not be included in this report.

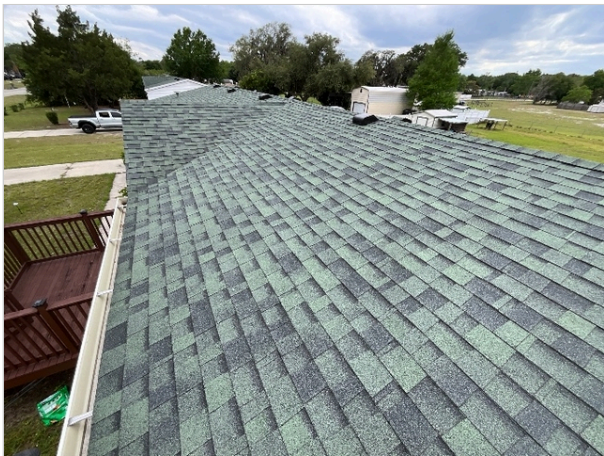
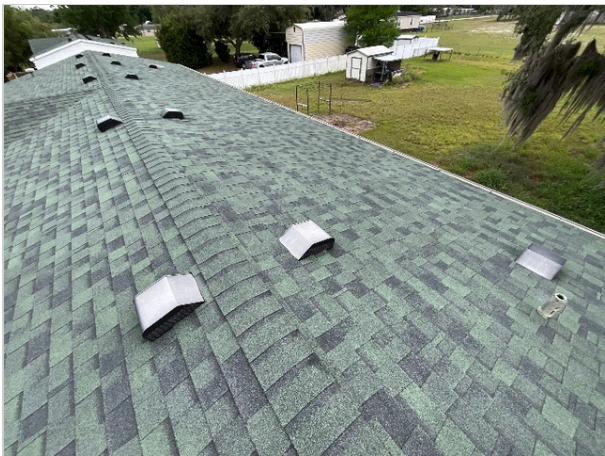
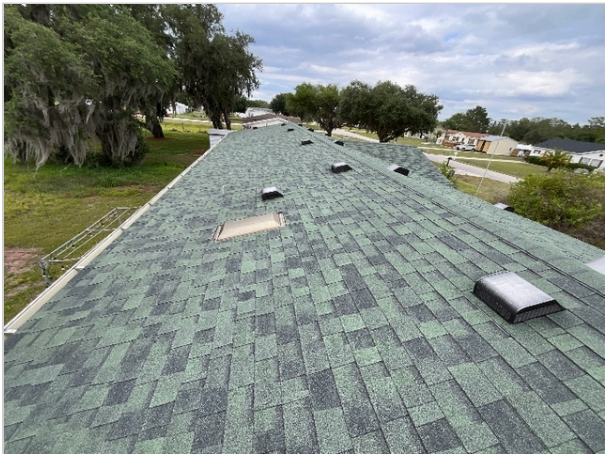
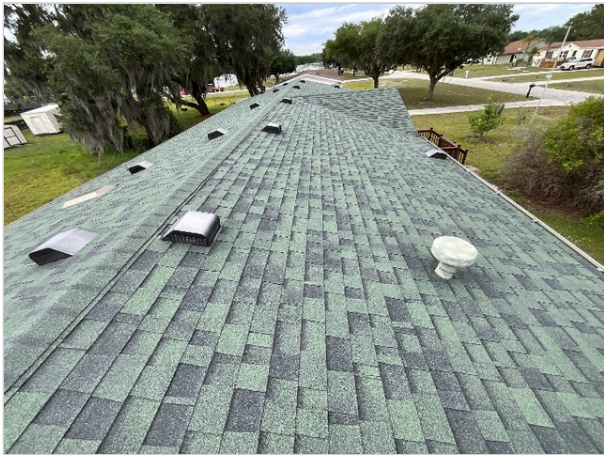
One or more exposed nail heads were observed on the roof. HomeTeam recommends a qualified individual seal the exposed nail heads to prevent water intrusion.

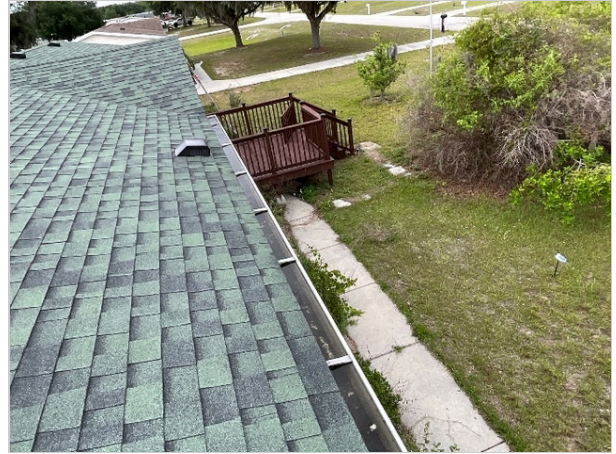
**Standing water was present in the front gutter.** This condition could cause the gutter to overflow in the affected area during periods of heavy or extended rain. This condition can lead to the gutters gradually pulling away from the fascia and possible water damage to fascia that may not be apparent. The gutters should be cleaned and adjusted for proper flow as appropriate, and the underlying fascia assessed and repaired as necessary.

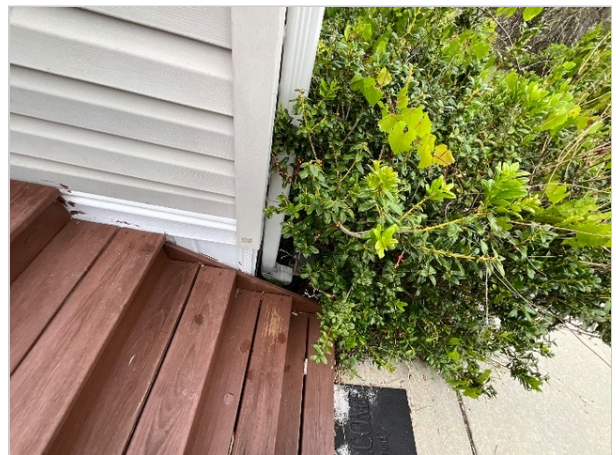
Downspout drainage was at or too close to the foundation. To prevent moisture issues, HomeTeam recommends redirecting roof drainage at least six feet away from the foundation.

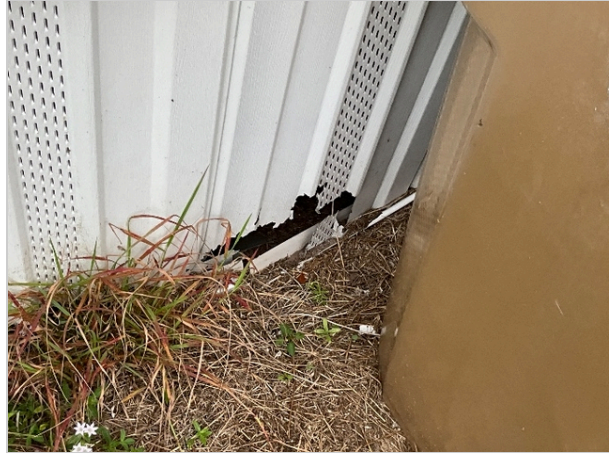
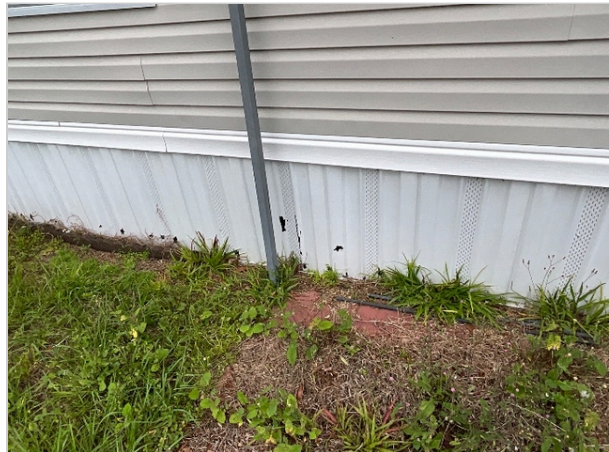
The vinyl skirting was damaged in several areas. This can allow pests into the crawl space area. HomeTeam recommends a qualified individual replace the damaged skirting.

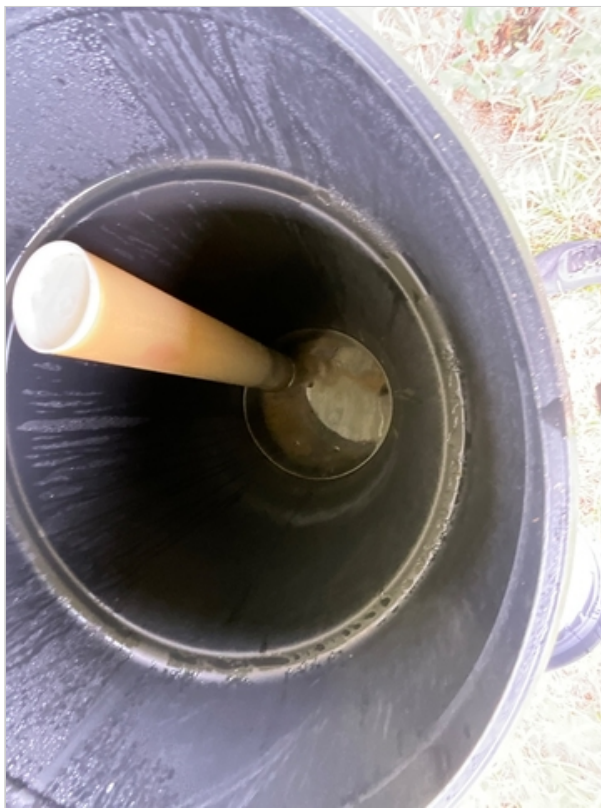
Empty salt tank

The water softener was leaning to the front. HomeTeam recommends a qualified individual ensure the water softener is properly seated and secured.

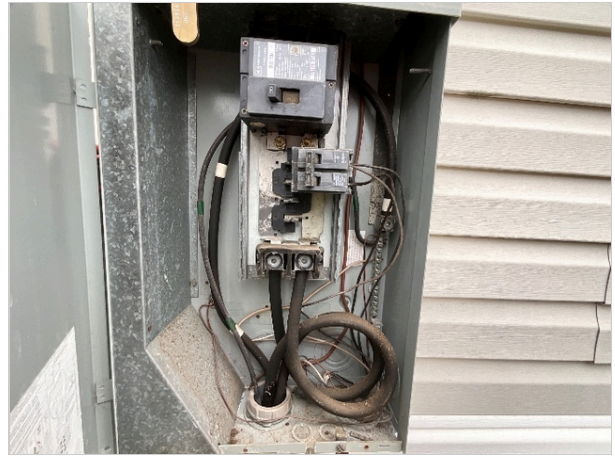
A circuit breaker in the electric panel had two attached circuits (wires). Each circuit should have its own dedicated breaker to prevent nuisance tripping and ensure good terminal contact, which may help prevent overheating. This situation is commonly referred to as a "double-tap". An electrician should repair this condition and further assess the panel for any additional required repairs.

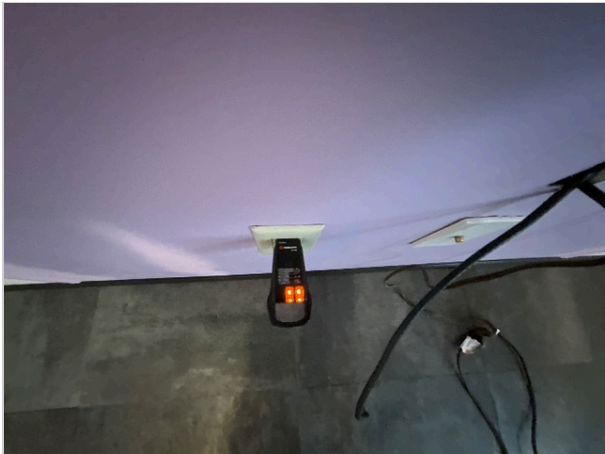
One or more GFCI receptacles were faulty. HomeTeam recommends consulting a qualified individual to assess the affected components for repair or replacement.

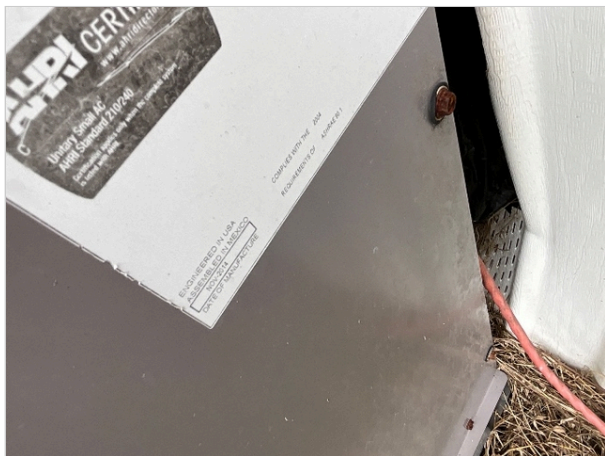
The air conditioner is nearing the end of its design life. The system was not functional at the time of the inspection.

The hvac disconnect switch cover was broken. HomeTeam recommends replacing the cover.

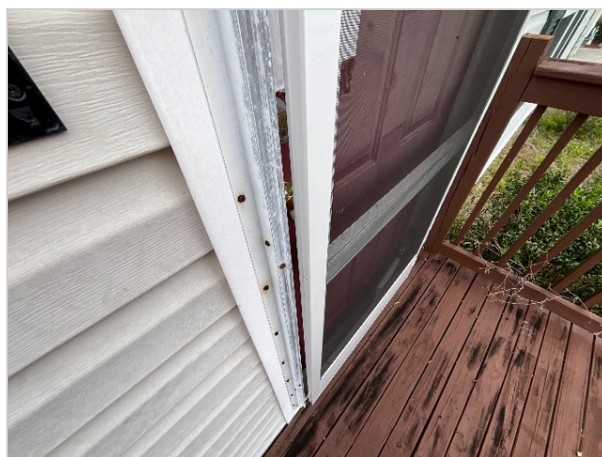
There were multiple holes in the screens throughout the home which can allow pests in the home. HomeTeam recommends a qualified individual replace the screen.

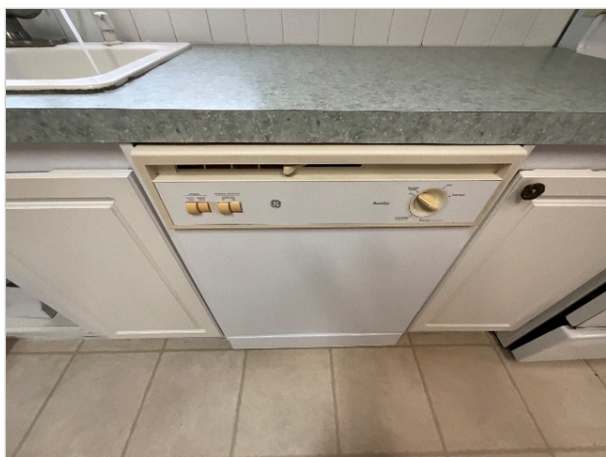
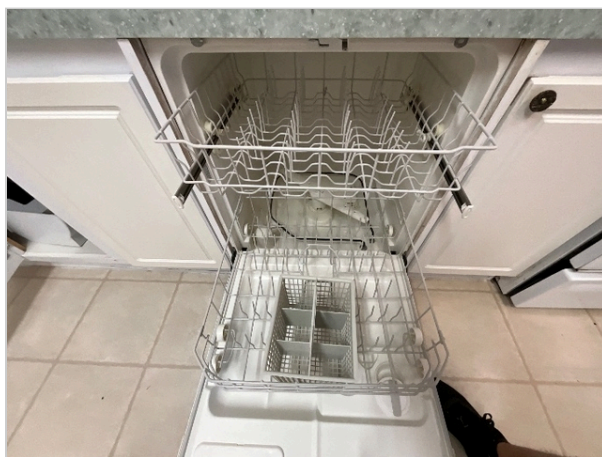
The dishwasher was inspected and actuated but water would not come into the system. HomeTeam recommends a qualified individual connect the dishwasher to the required services and test the appliance for functionality.

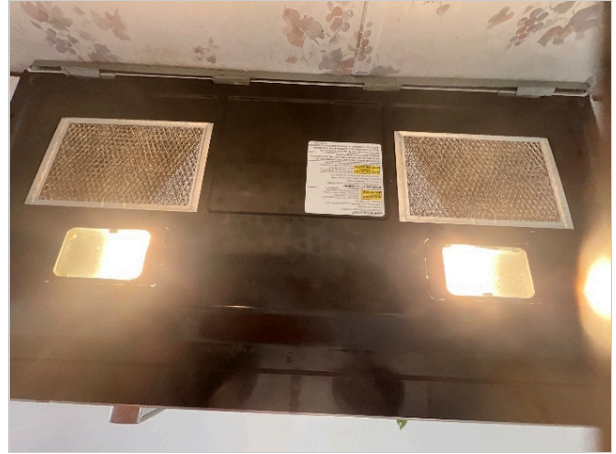
The vent was making a screeching sound when actuated. HomeTeam recommends a qualified individual evaluate and repair the vent.

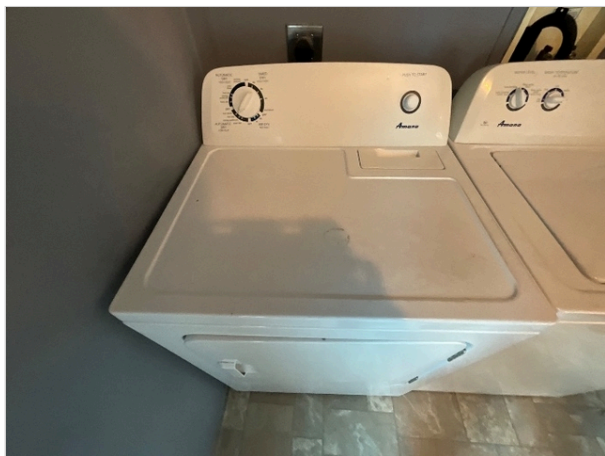
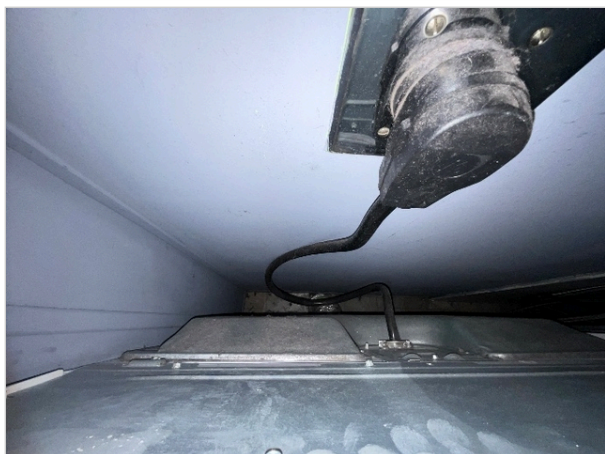
The dryer vent flaps were damaged. HomeTeam recommends a qualified individual replace the cover.

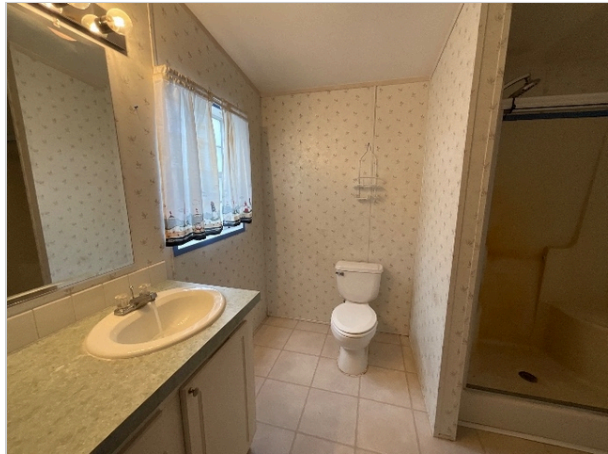
The toilets were not secured properly to the floor. This could compromise the seal of the wax ring and increase the risk of leaks. HomeTeam recommends a qualified individual tighten the toilets to ensure proper stability and prevent potential water damage.

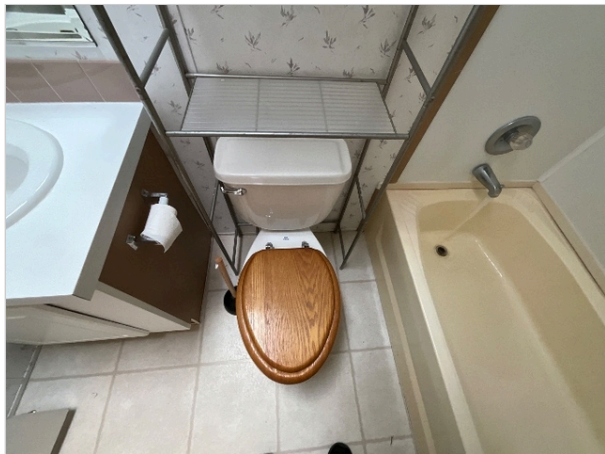
The hallway tub faucet was slightly pulled out from the wall. This can allow water behind the wall. HomeTeam recommends a qualified individual secure the faucet to the wall.

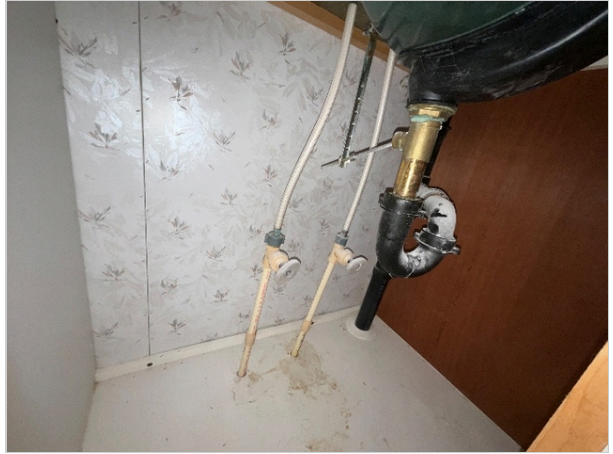
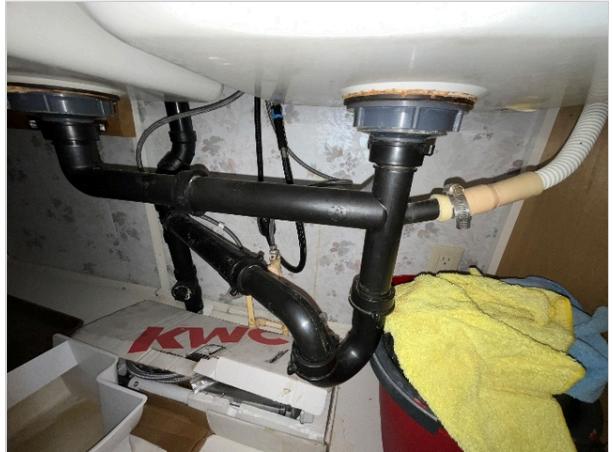
The hallway bathroom sink was leaking from the cold knob when it was actuated. HomeTeam recommends a qualified individual seal the knob.

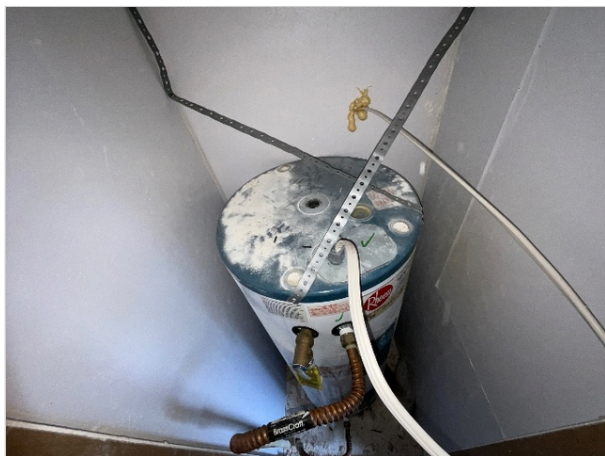
The water heater may be past its design life. This is an informational note only to help give an idea of future budgeting considerations. The unit was functional unless noted otherwise. Please note that since codes change, it is possible the configuration for a water heater's flue and/or discharge may need to be altered at the time of a future replacement.
