*HOME INSPECTION REPORT*

On 06-22-2026 14:00:00 The HomeTeam Inspection Service made a visual inspection of 123 Sample Drive, Painesville OH 44077. Enclosed please find a written, narrative report of our findings in accordance with the terms of our Inspection Agreement.

## HOUSE- BASEMENT- ATTACHED GARAGE

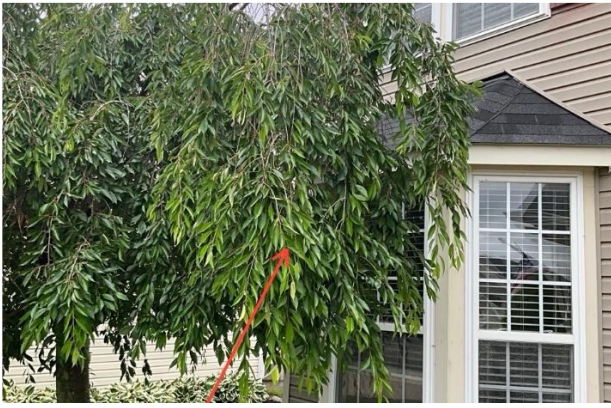
**Extensive plant and/or tree overgrowth was observed against the home.** HomeTeam recommends trimming or removing this growth to prevent possible damage including insect infestation, moisture buildup, and impact damage to the roof and home.

Photo 9: Overgrowth in front yard

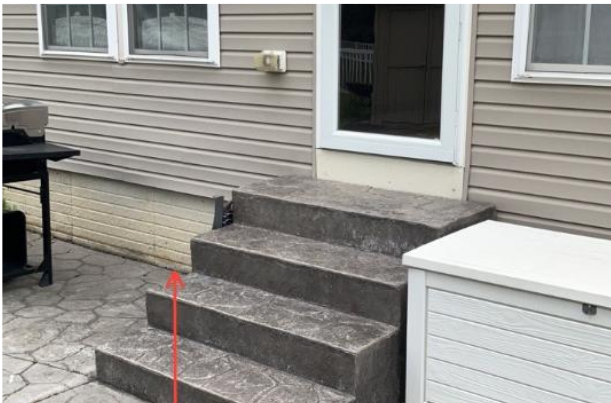
**There were no handrails on the steps in the back.** Adding a handrail may improve the safety of the stairs.

Photo 10: Missing handrail

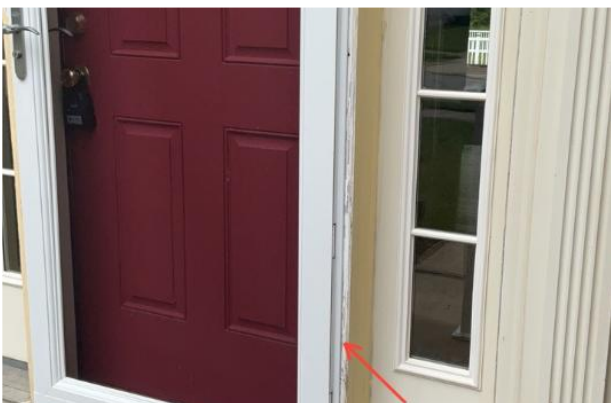
**Peeling paint was present on the exterior of the home.** In order to preserve the life of the exterior surfaces and materials, all areas should be scraped, sealed, and painted after any damaged wood is repaired. This is a routine maintenance item.

Photo 11: Peeling paint around front door

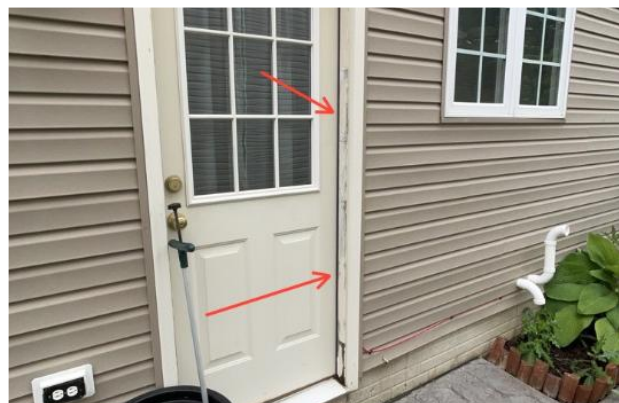
Photo 12: Peeling paint around mandoor

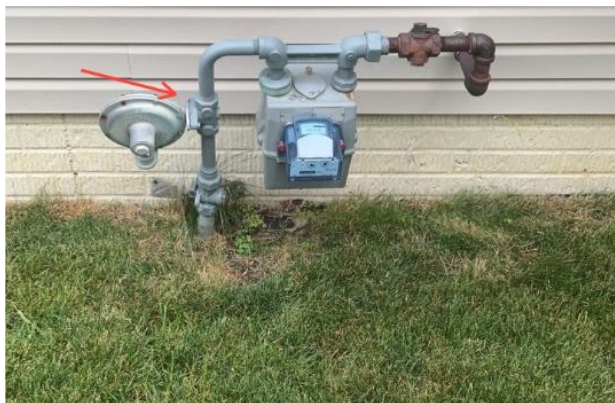
The gas meter assembly appears tilted. Recommend evaluation by the gas, utility provider or qualified contractor to determine if movement, settlement, or stress on the gas piping is present.

**Photo 14: Gas meter is tilted and out of level**

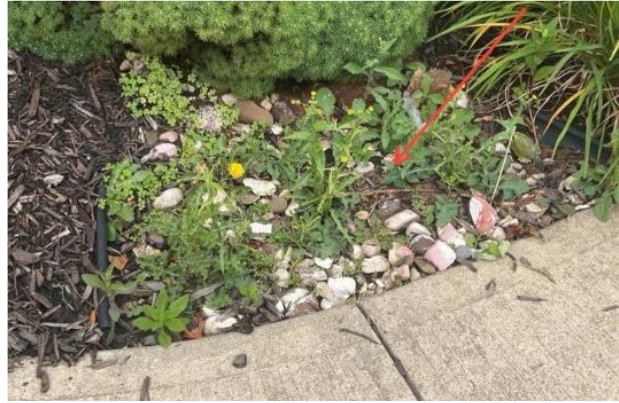
**Photo 16: Front downspout drains into flower bed**

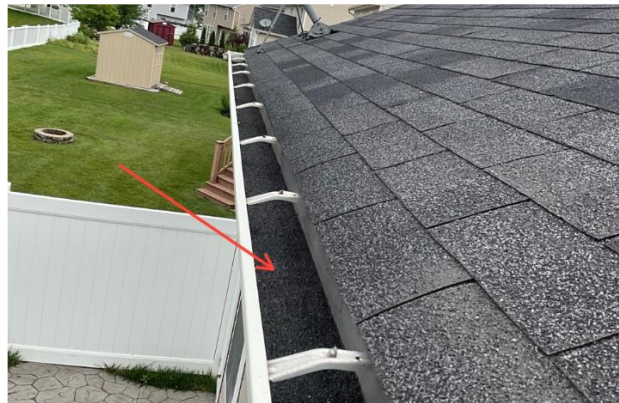
**Photo 18: Granules from the shingles**

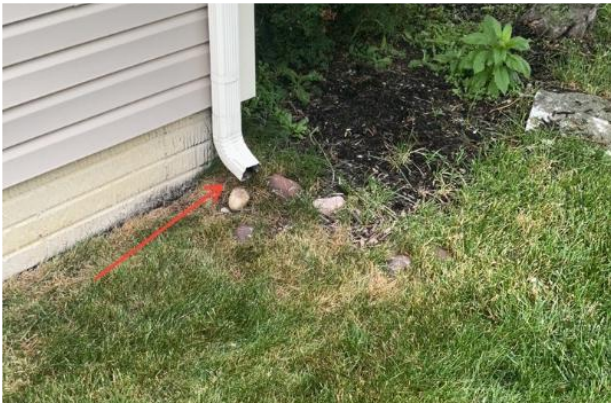
**Multiple downspouts were draining at or too close to the base of the foundation.**

**Photo 20: Left front corner of home downspout draining at foundation**

To reduce the likelihood of water problems at the base of the structure, all roof drainage should be directed at least six feet from the base of the foundation.

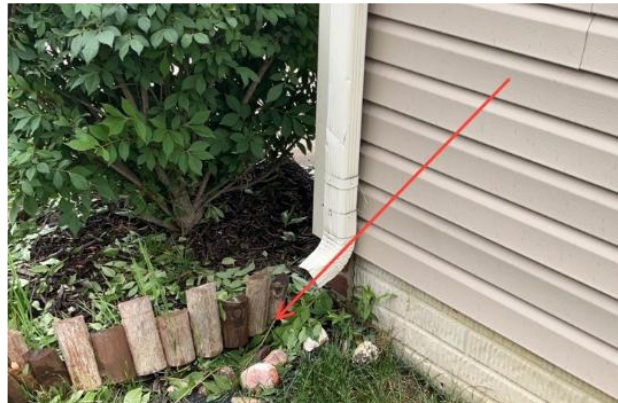
**Photo 21: Right front corner of garage draining at foundation**

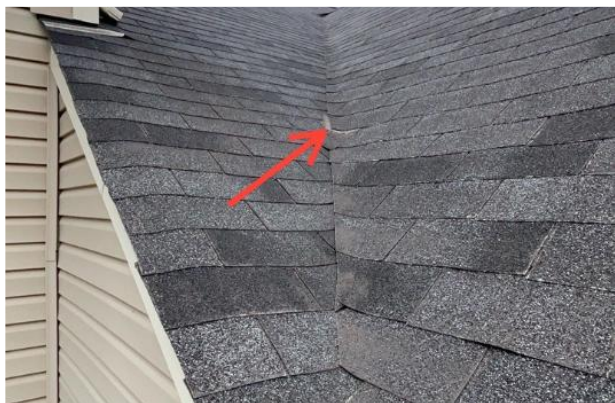
**Photo 24: Front roof damaged shingle**

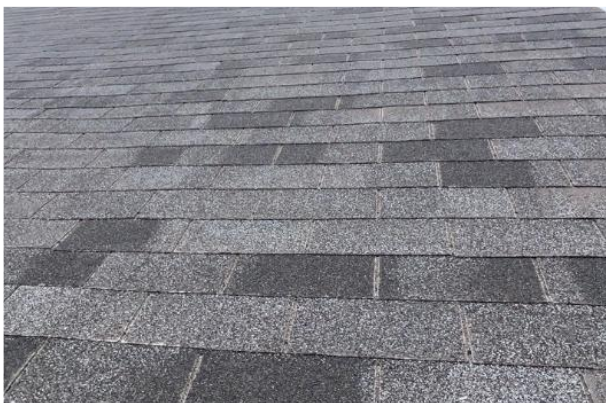
**Photo 25: Lifted shingle front roof**

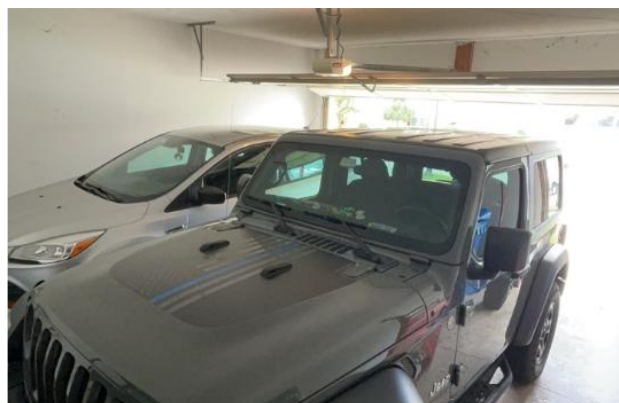
**Photo 36: Damaged trim front left corner of garage**

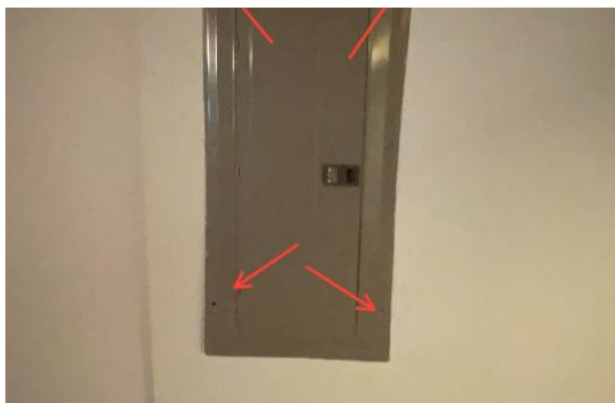
**Photo 59: Panel was missing four screws**

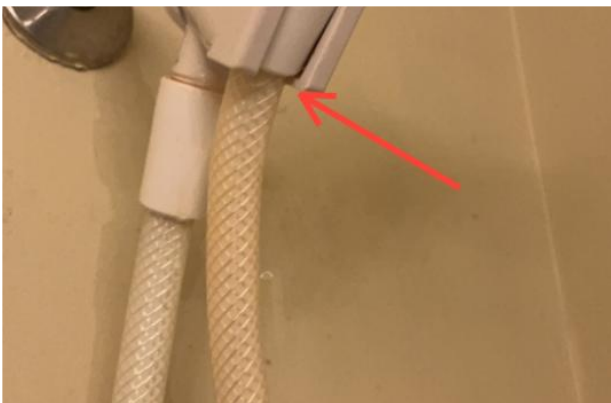
**Photo 80: Shower head leaks in upstairs bathroom**

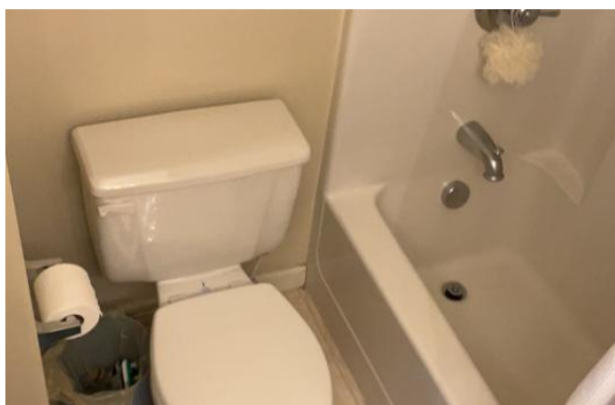
**The toilet in the second floor hall bathroom is loose.** Failure to secure the toilet may lead to leakage around the wax ring. The toilet should be secured.

**Photo 86: Loose toilet at base**

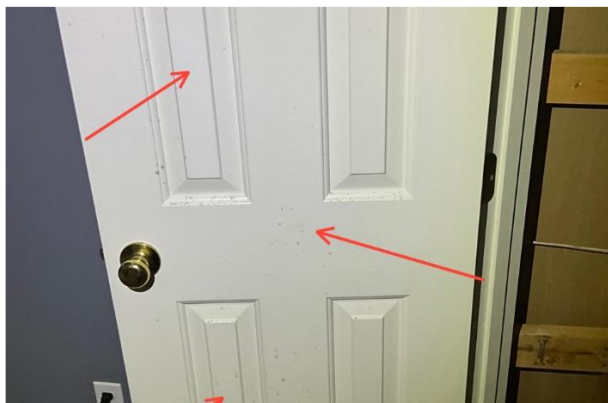
**Photo 88: Signs of previous moisture were present on the inside of the door leading to the main water shut off. The stains were dry at the inspection.**

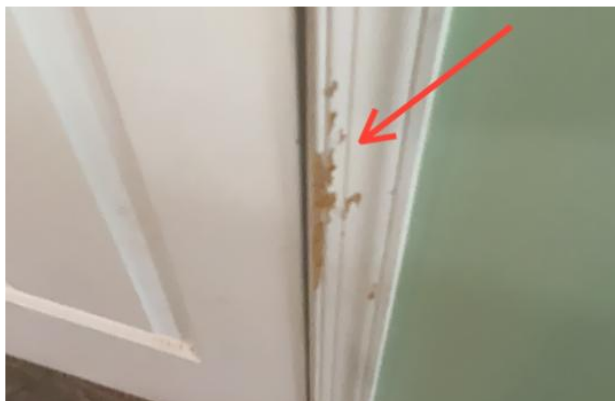
Photo 95: Damage to trim in livingroom

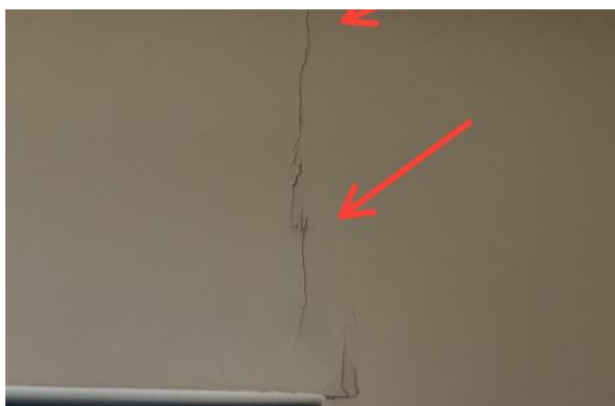
**Photo 103: Common settlement cracking in upstairs left bedroom**

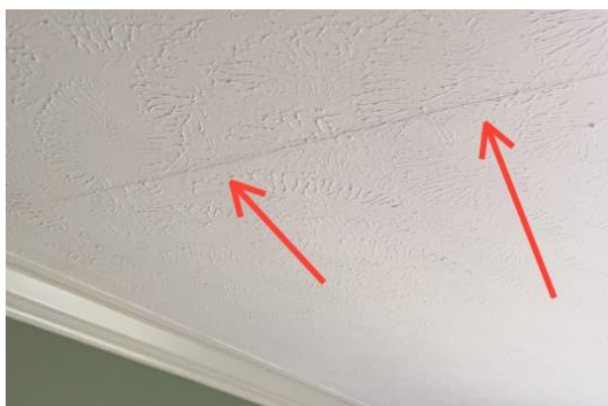
**Photo 104: Normal settlement cracking in common area ceiling**

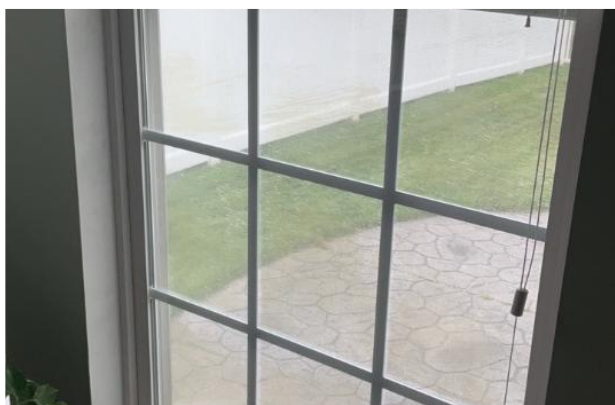
**One of the windows in the structure had a broken thermal seal.** A window with a defective thermal seal will show a slow but gradual "fogging" effect, and the insulation value of the window is marginally reduced. HomeTeam recommends having the affected window(s) repaired or replaced and further assessed.

**Photo 105: Loss of thermal seal in dining room**

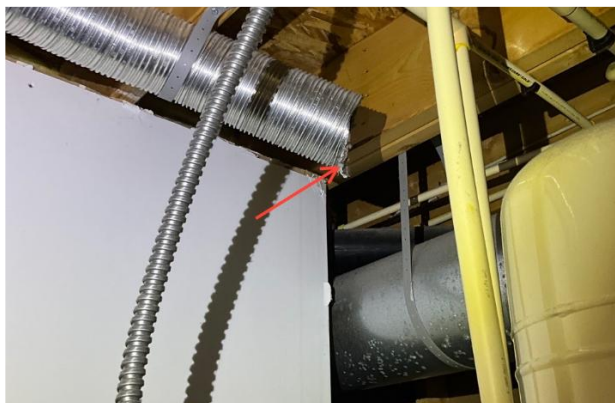
The clothes dryer exhaust duct terminates within the basement rather than discharging to the exterior. Lint accumulation was observed at the termination point. If a dryer is connected to this event, moisture, heat, and lint will be discharged into the basement, creating a potential fire hazard and contributing to elevated humidity levels. Recommend modifying the dryer vents to terminate at an improved exterior location before the dryer connection is used.

**Photo 119: Vent terminates in the ceiling area of the basement near the furnace**

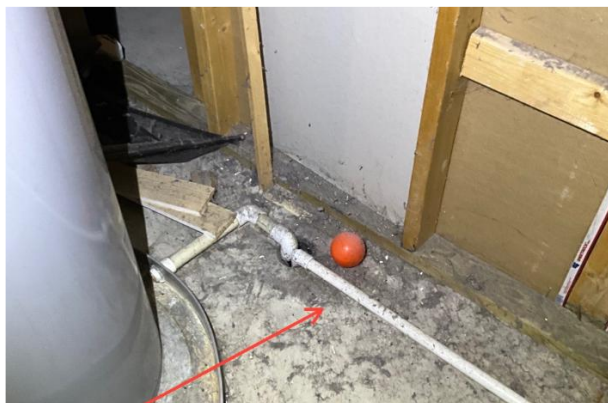
**Photo 120: Dryer lint was observed on the floor behind the water heater and near the furnace**

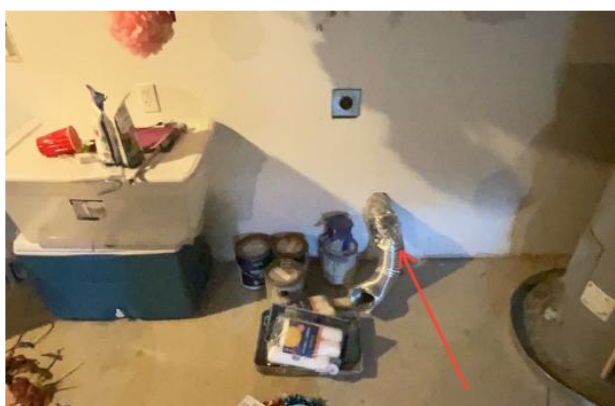
**Photo 121: Dryer vent in basement**
