HOME INSPECTION REPORT

File Number: **000000**
Address of Inspection: **123 Sample Drive**

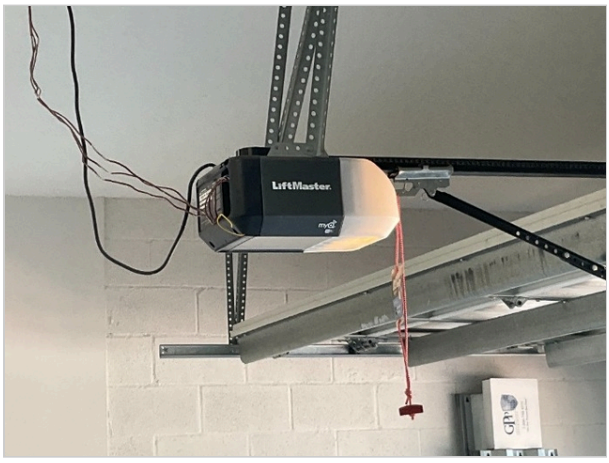
At the time of the inspection, the garage doors where noisy upon closing which could indicate a few issues. It might need lubrication on the rollers, hinges, or tracks. Loose hardware could also be the culprit. If the problem persists after checking these., it might be best to have a professional inspect it to ensure everything is functioning correctly. HomeTeam recommends contacting a professional door company for repairs.

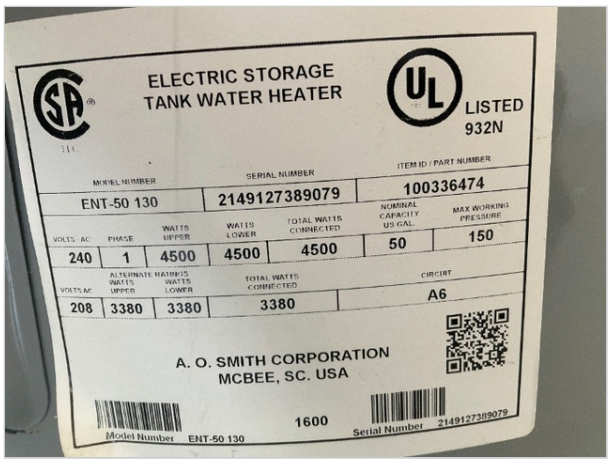
WATER HEATER

A 50 gallon capacity, electric water heater was located in the garage. The water heater was manufactured by A. O. Smith, model number ENT-50 130 and serial number 2149127389079. Information on the water heater indicated that it was manufactured 5 years ago. Hot water temperature was approximately 122.5 degrees F.

A temperature and pressure relief valve (T & P) was present. An overflow leg was present. It did terminate properly. Your safety depends on the presence of a T & P valve and proper termination of the overflow leg. The water heater was functional.

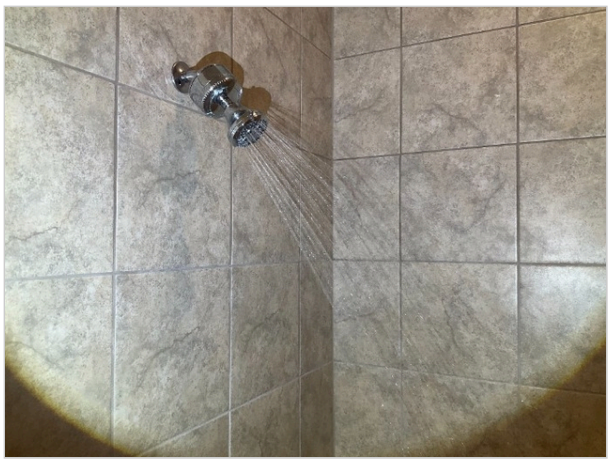
BATHROOMS AND MISC PLUMBING

Bathrooms were inspected using various techniques to help identify any areas of leakage or damage. Please note that bathtubs and showers are tested without the weight of a person in the enclosure. We attempt to identify areas of potential leakage, but some problem areas may not be visible without the weight of a person in the enclosure, ie, a person taking a shower or bath. Any latent deficiencies noted under these conditions once the structure is occupied should be sealed to prevent water intrusion and damage.

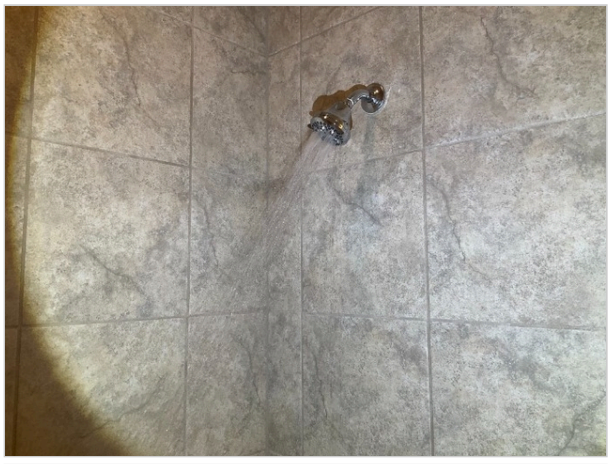
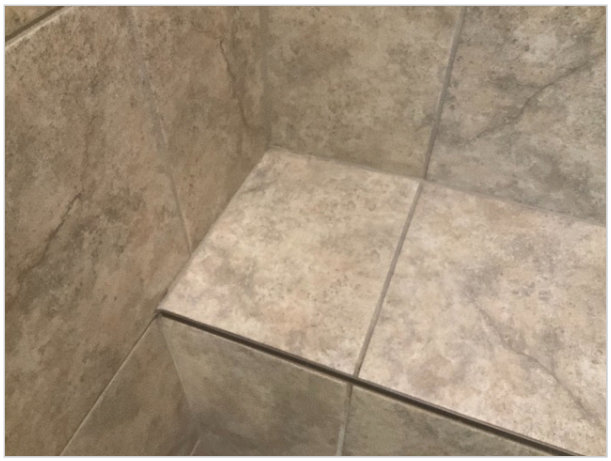
Some of the caulk was missing from around the shower wall in the master bathroom. These areas should be sealed to prevent moisture penetration. Failure to keep walls sealed can cause deterioration and extensive moisture damage including mold growth to the interior walls, which is not always visible at the time of the inspection.

Some of the caulk was missing from around the vanity in the master bathroom. These areas should be sealed to prevent moisture penetration. Failure to keep walls sealed can cause deterioration and extensive moisture damage including mold growth to the interior walls, which is not always visible at the time of the inspection.

Some of the caulk was missing from around the tub and walls in the guest bathroom. These areas should be sealed to prevent moisture penetration. Failure to keep walls sealed can cause deterioration and extensive moisture damage including mold growth to the interior walls, which is not always visible at the time of the inspection.

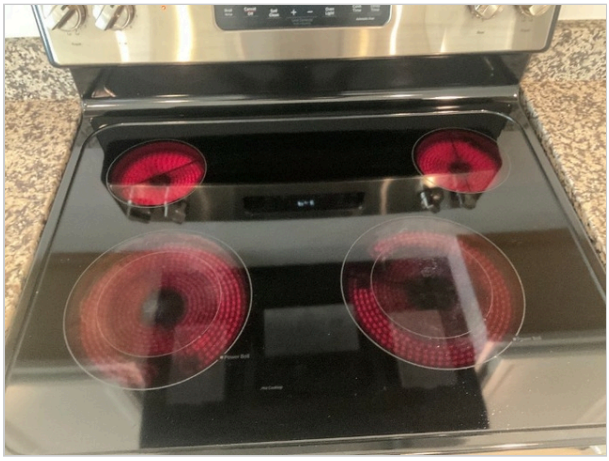
KITCHEN

The visible portions of the kitchen cabinets and counter tops were in good condition. The appliances were operated to check basic operational function only. No consideration is given regarding the age or components that may be worn or otherwise affected by wear and tear or use. The kitchen contained the following appliances:

The electric oven and range combo was inspected and did appear to be functional. The accuracy of the clock, timers and settings on ovens are not within the scope of this inspection.

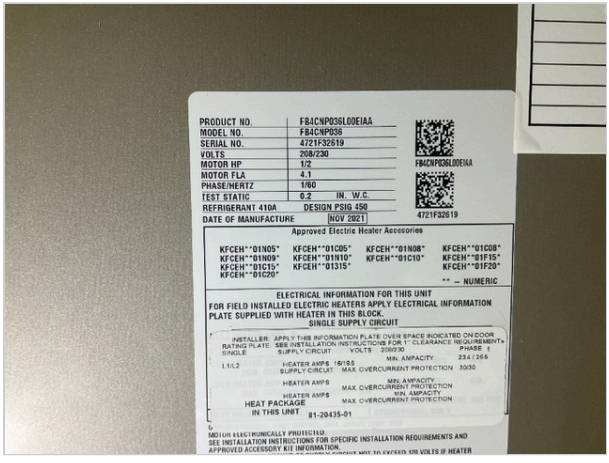
HEATING AND AIR CONDITIONING UNIT

The electric outdoor condensing unit was a Carrier, Serial Number 4621X67412. The unit is located on the left side of the home. This unit is approximately five years old. There was a disconnect present. The refrigerant line was insulated.

The air handler was a Carrier, Serial Number 4721F32619. The unit is located in the hallway closet.This unit is approximately five years old. The condensate lines appeared to be properly installed. Temperature differentials (TD) were determined by calculating the difference in the temperature at the warm air return against each cold air supply vents. The TDs were: 19.4 F. The ideal range is from 13* to 20* F. Periodic preventive maintenance is recommended to keep this unit in good working condition. The heating and cooling system was found to be functional.

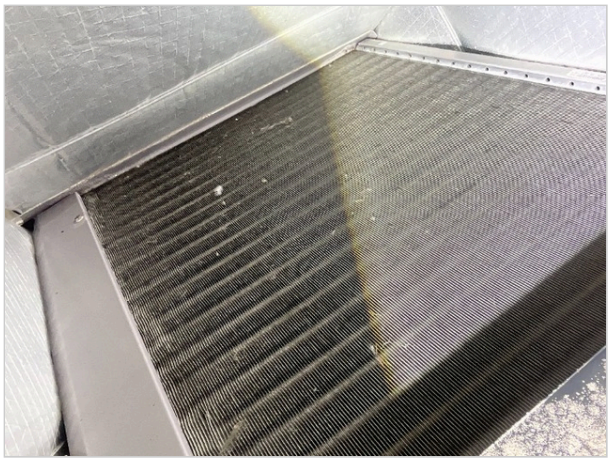
The outdoor compressor unit is not level. The unit should be leveled to ensure proper lubrication of the moving parts.
