HOME INSPECTION REPORT

The HomeTeam Inspection Service made a visual inspection of 123 Main Street, Anytown, USA 55555. Enclosed please find a written, narrative report of our findings in accordance with the terms of our Inspection Agreement.

File Number: **1132 - 083016**

Address of Inspection: **123 Main Street**

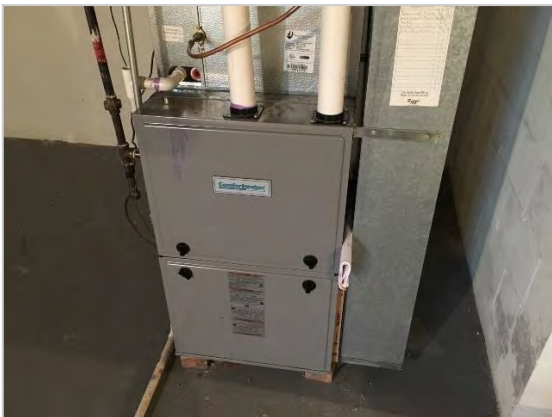
Photo 17

The unit was located in the basement of the structure.

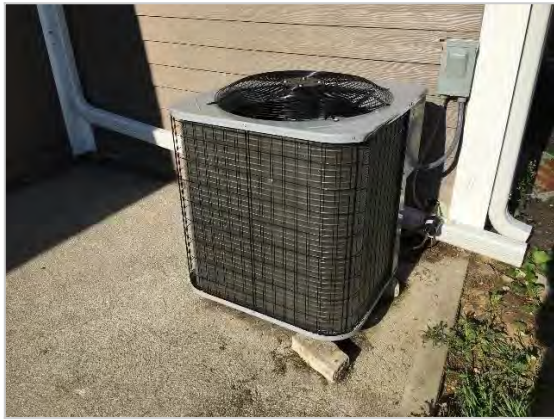
Photo 21

The second electric outdoor air conditioner condensing unit was a Comfortmaker, Model Number R4A348AKN100 and Serial Number X152462739. The unit is located in the back of the structure. This unit is approximately 1 years old. Periodic preventive maintenance is recommended to keep this unit in good working condition. The air conditioning system was tested and found to be functional.
