HOME INSPECTION REPORT

Address of Inspection: **9650 Eden Manor**

**9650 Eden Manor
Parkland, FL 33076
Inspection # 15664**

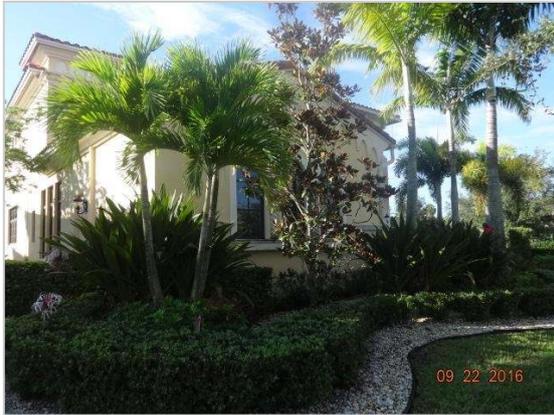
There were areas of foliage and/or tree growth near the home, which prevented a detailed visual inspection of the foundation and walls.

Any foliage or trees in contact with the home should be monitored to prevent damage to the exterior walls or roofing system.

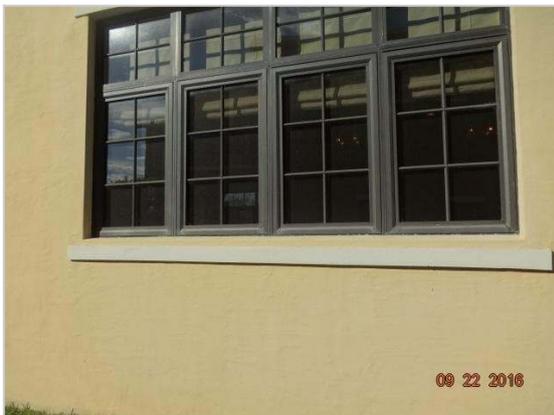
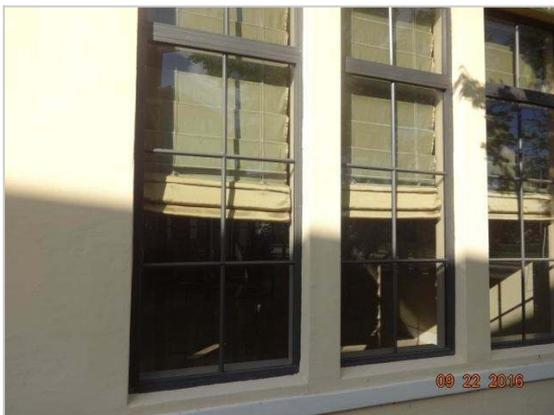
Stucco/sealant repairs were required to hairline surface cracks.

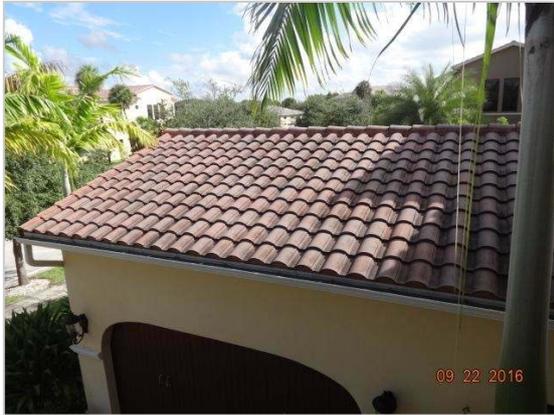
There were material defects detected on the exterior of the roof. For additional information, please refer to the attached Roof Report.

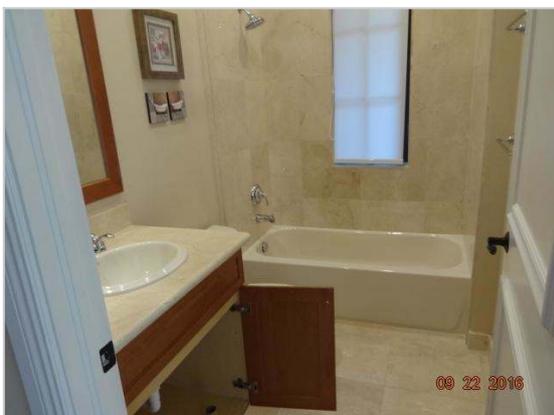
The water pressure was reduced/limited at the sink in the hall bathroom.

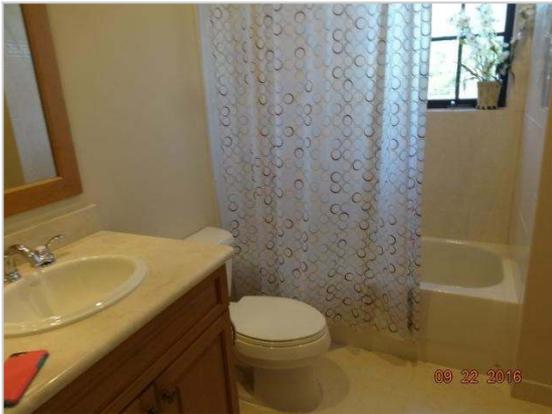
The supply lines did not appear to be secure inside the wall.

Recommend further review and correction by a qualified licensed Plumbing contractor.

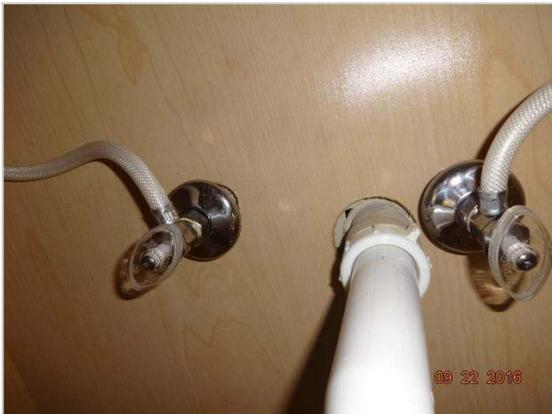
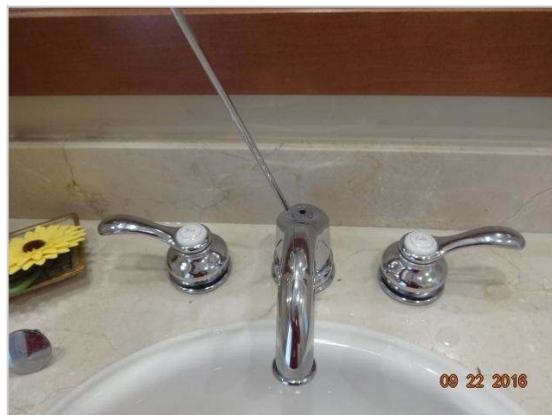
The sink stopper required repair in the hall bathroom.

A qualified Plumbing Contractor should conduct further evaluation to determine an accurate cost for repairs.

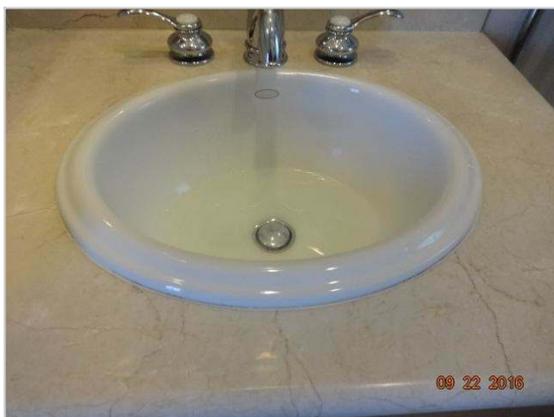
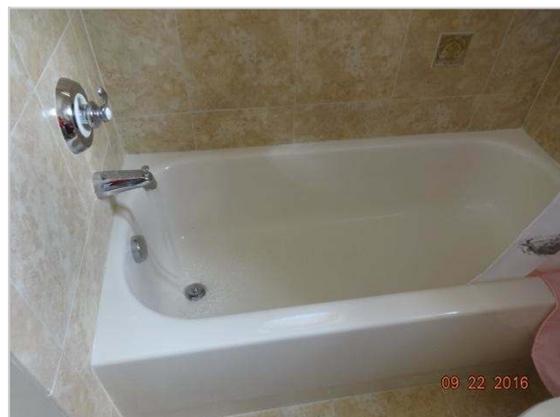
The tub and sink were slow to drain in the guest bathroom.

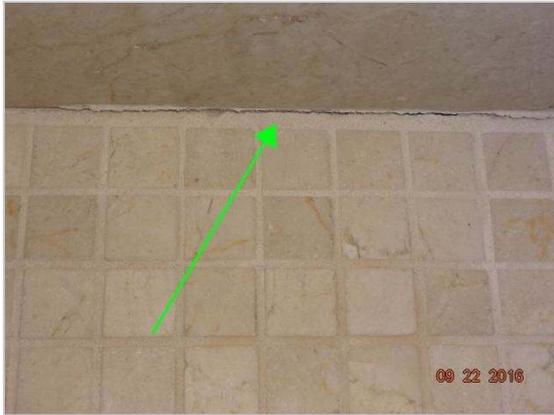
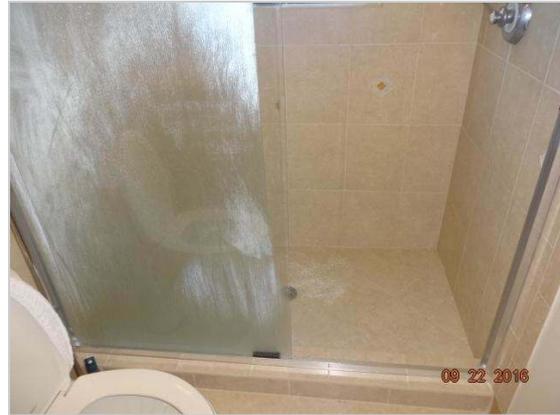
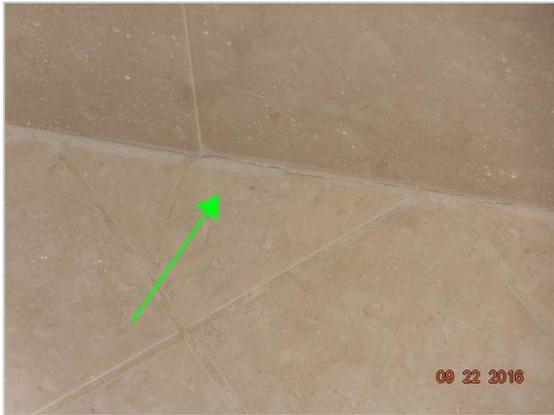
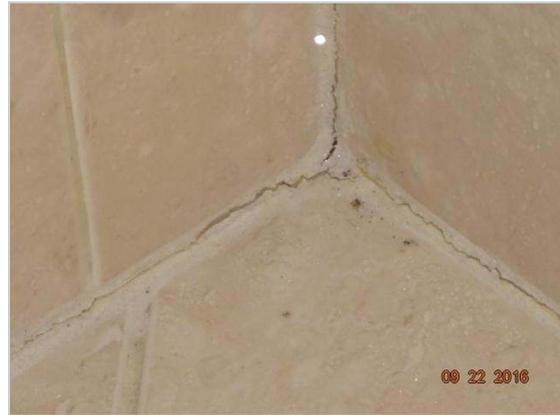
Additional caulk/sealant repairs were required to the whirlpool tub, shower, wall, and floor joins in the bathrooms to provide adequate seals.

A qualified Plumbing Contractor should conduct repairs.

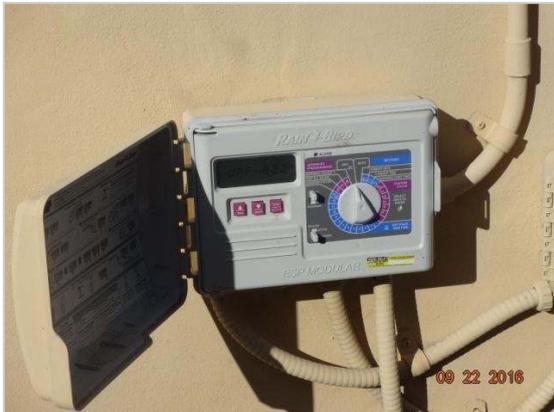
Some sprinkler heads required cleaning and adjustment to restore full function.

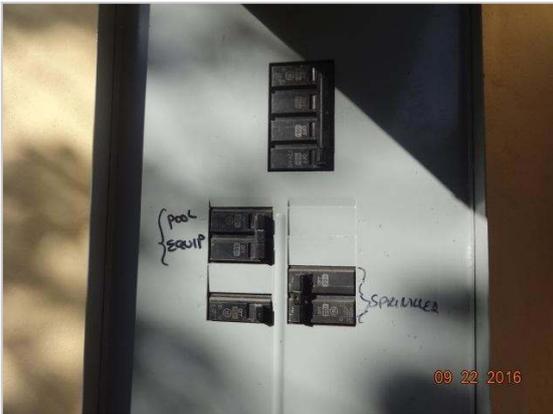
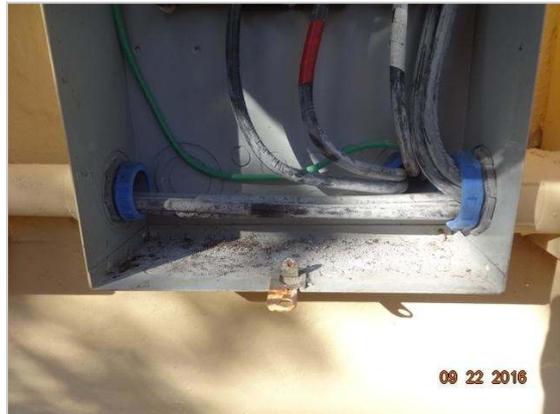
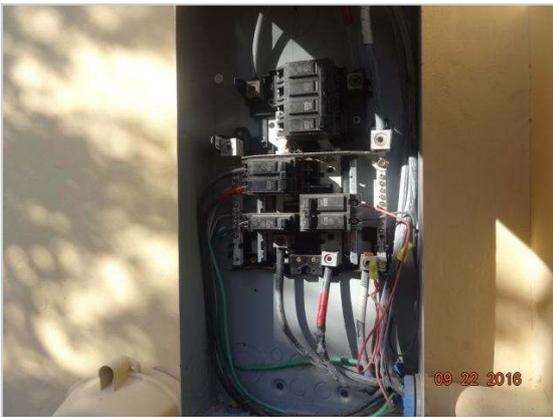
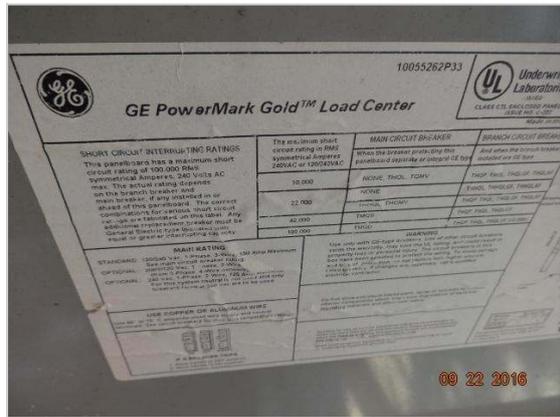
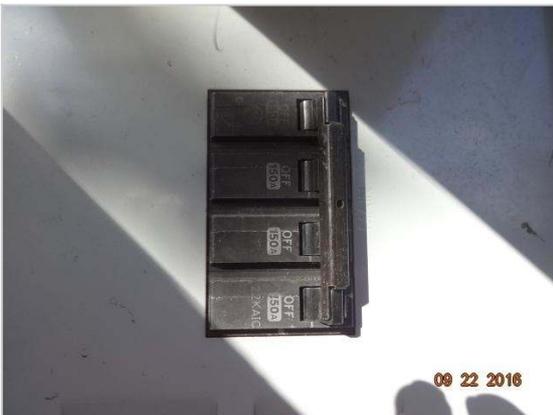
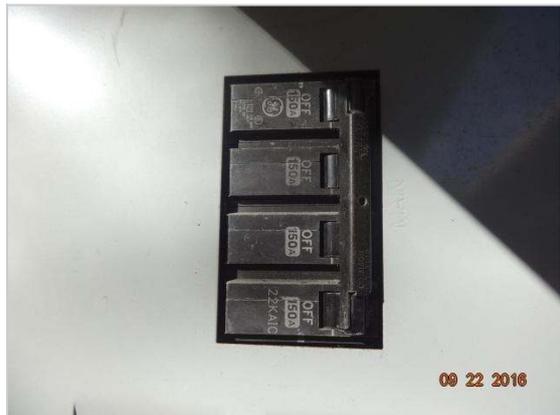
The service wire entered two main General Electric service panels with a 150 amp rated capacity in each. The main breaker was rated for 150 amps.

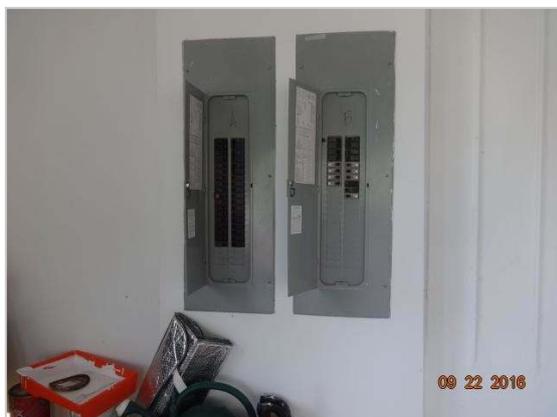
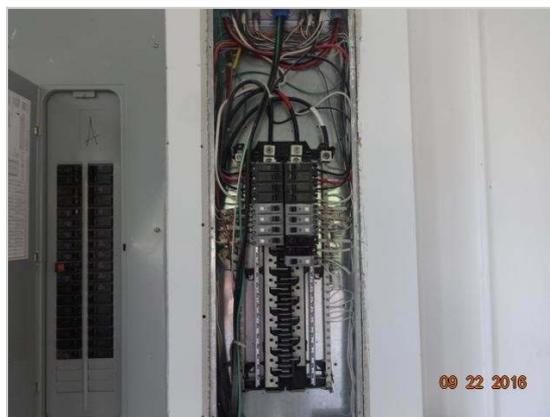
There was a 150-amp rated capacity General Electric sub panels located in the garage. The branch circuits within the sub panel were copper. These branch circuits and the circuit breakers to which they were attached did appear to be appropriately matched.

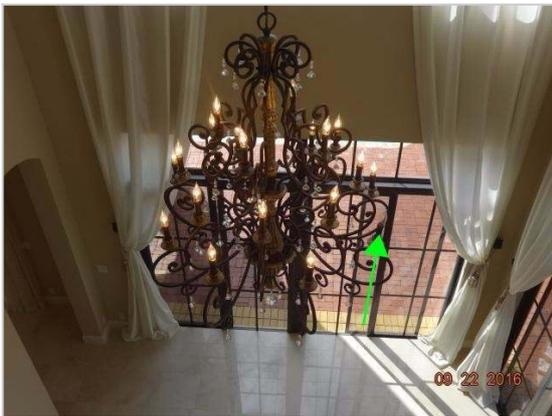
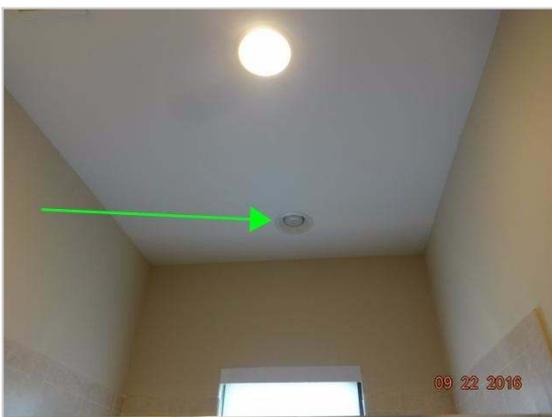
Some light bulbs were missing or inoperative. All interior and exterior light bulbs should be installed and tested prior to the final walk-through.

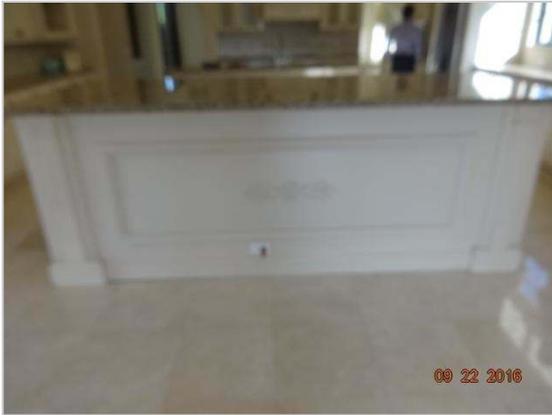
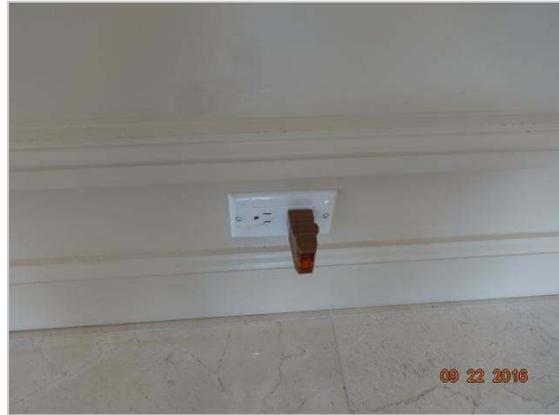
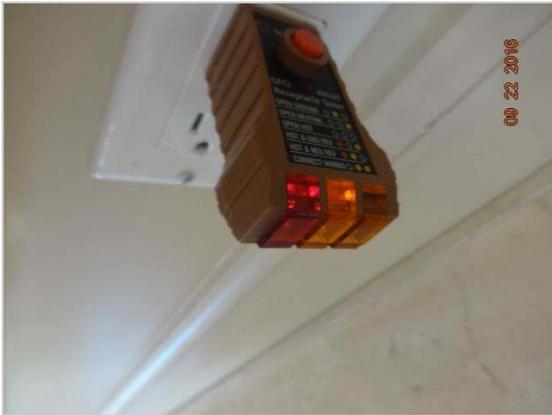
The island receptacle was wired incorrectly.

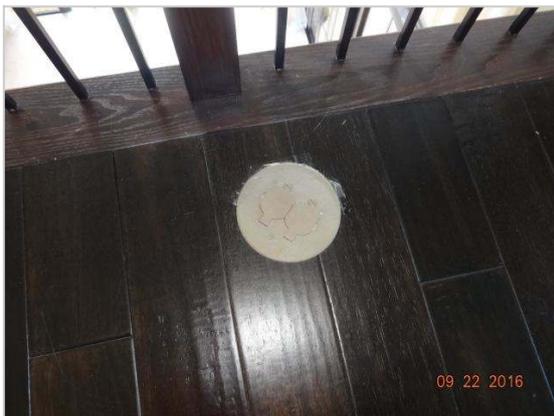
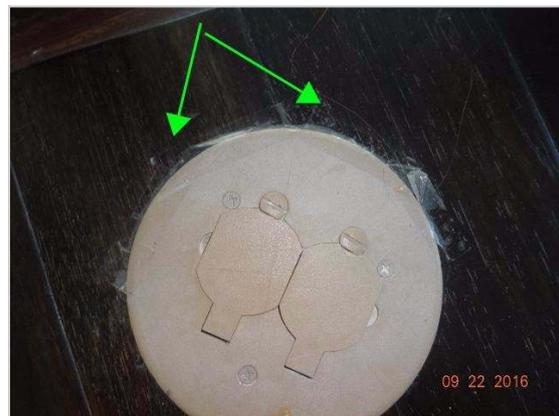
The receptacle cover plate (second floor landing) was secured to the floor with tape.

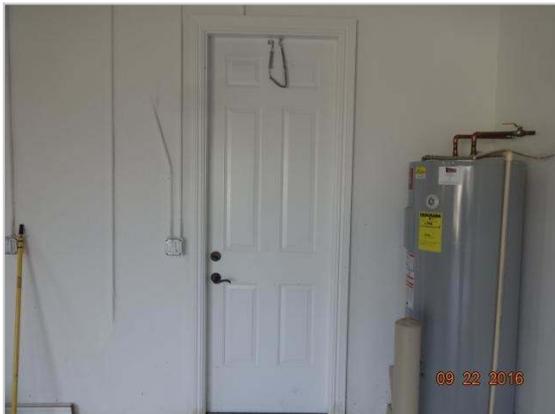
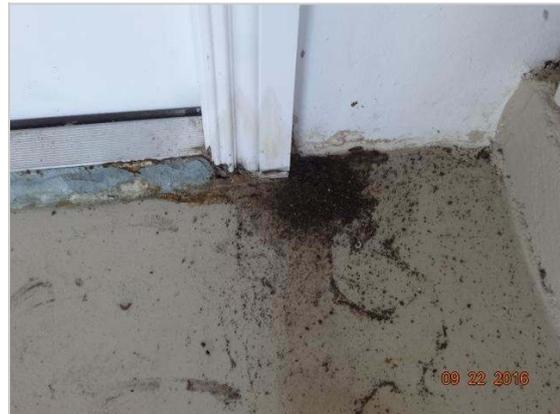
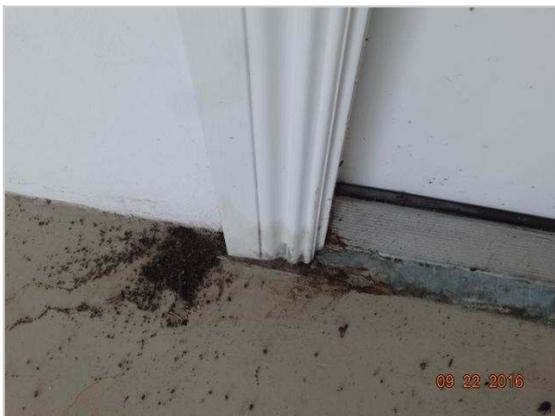
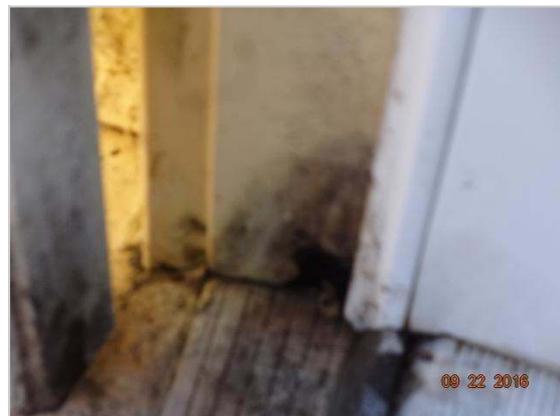
Repair was required to the garage pedestrian door frame.

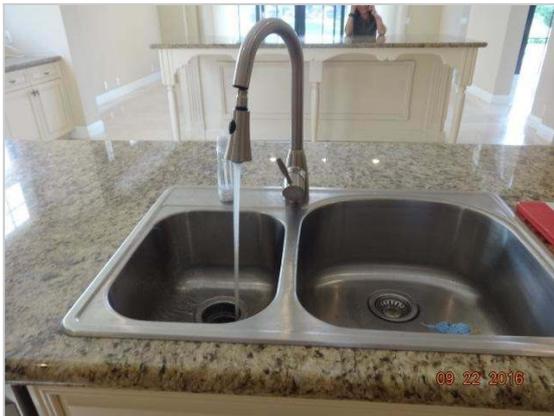
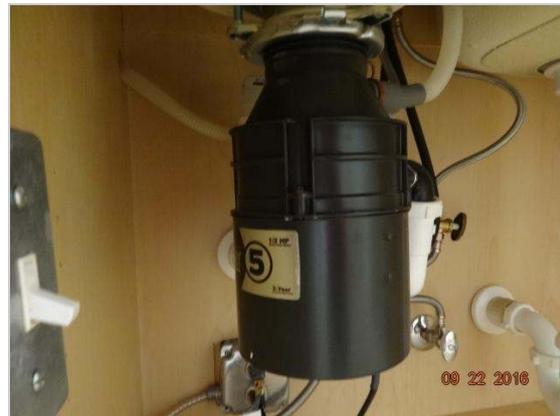
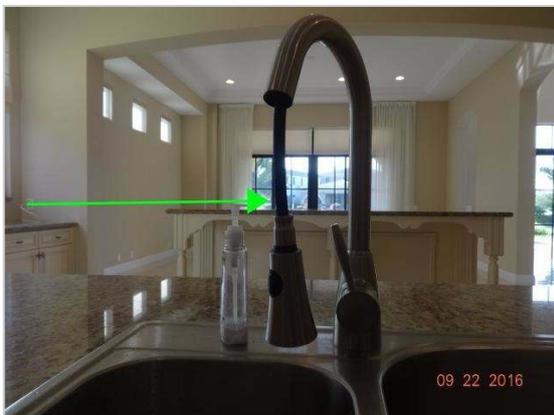
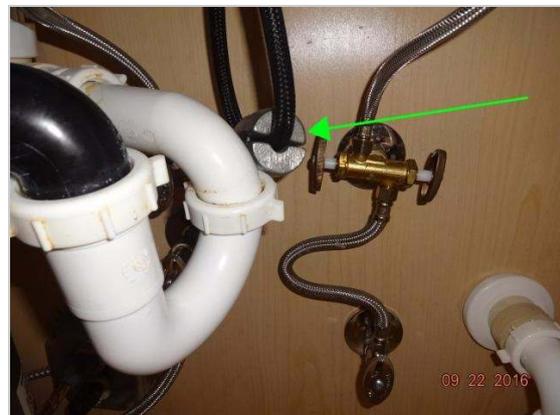
The disposal was inspected and did appear to be functional. The efficiency rating is not within the scope of the inspection. *The weight for the faucet was contacting the waste line.*

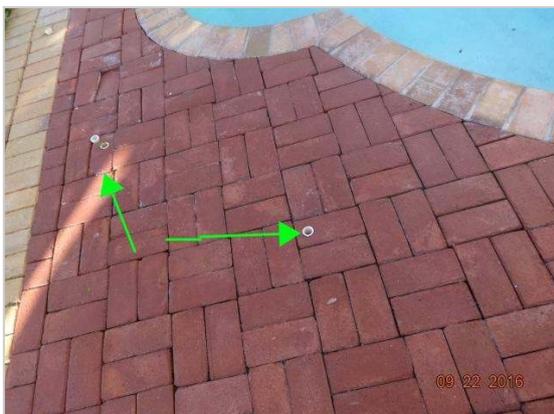
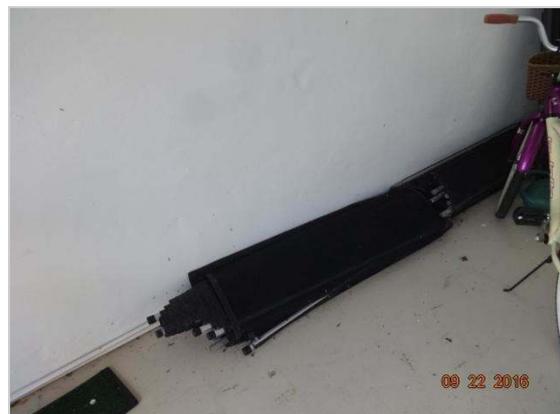
There were no handrails at the pool steps.

There were support holes in the deck for a child safety fence, and it appeared that the fence was stored in the garage. *The safety fencing should be installed and checked for function.*

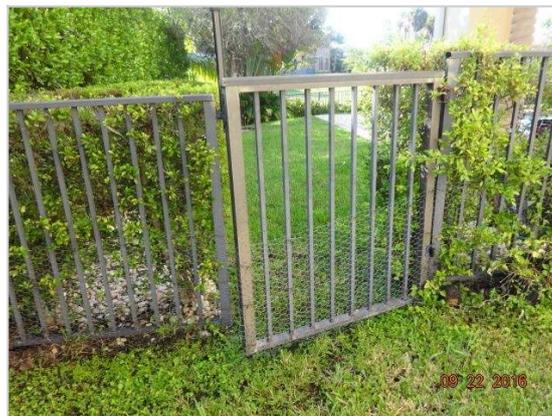
The fencing was in serviceable condition and **the left side gating required repair to be self closing as designed at the time of the inspection.**

Gate repairs, \$75 to \$100
