**HomeTeam**  
INSPECTION SERVICE

April 9, 2010

**RE: Sample Report  
Jonesboro, AR 72401  
Inspection #: 406-042010-0056**

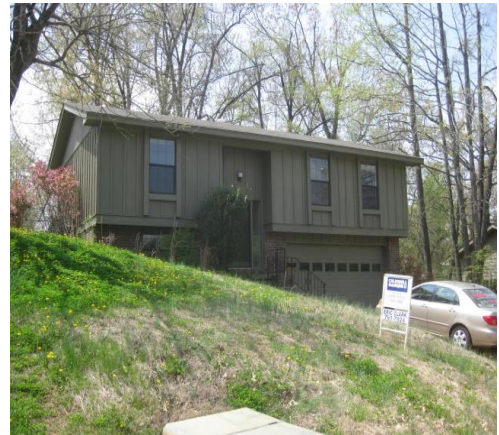
The inspected property consisted of a one story with a partial basement wood-framed structure with brick veneer and wood that was vacant at the time of the inspection. There were no significant deficits on the visible portions of the siding. The age of the home was not reported. If the age was judged by the age of the components it would appear to be thirty years old. The approximate temperature at the time of the inspection was 70-75 degrees Fahrenheit, and the weather was sunny and clear. The utilities were on at the time of the inspection. The Buyer was present during the inspection.
