HOME INSPECTION REPORT

**123 Sample Drive
Anytown, TX 55555**

PROPERTY INSPECTION REPORT

Prepared For:	Bill Sample	
	(Name of Client)	
Concerning:	123 Sample Drive, Anytown, TX, 55555	
	(Address or Other Identification of Inspected Property)	
By:	Inspector 1 Inspector 2	9-29-2017
	(Name and License Number of Inspector)	(Date)
	(Name, License Number of Sponsoring Inspector)

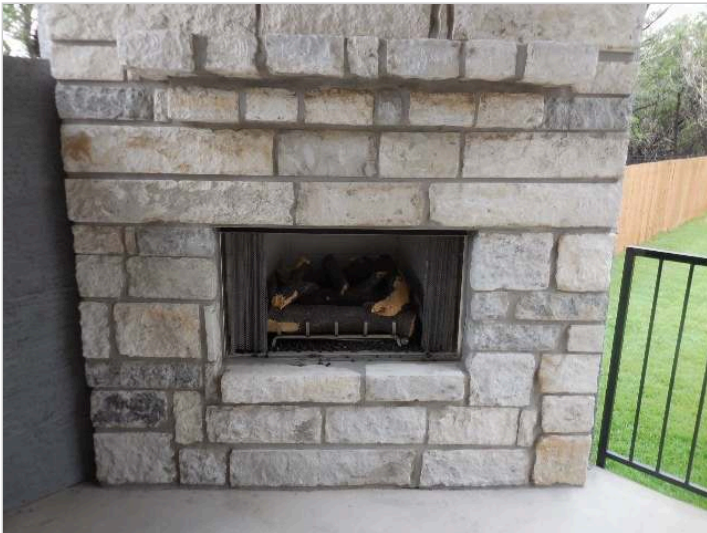
(none) There were no significant visible deficiencies to the fireplace or chimney were observed at the time of the inspection.

View of patio fireplace.

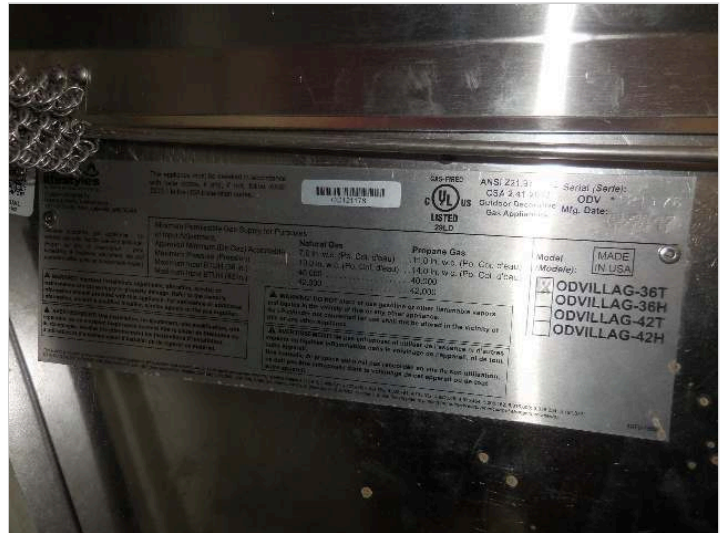
View of fireplace data plate.

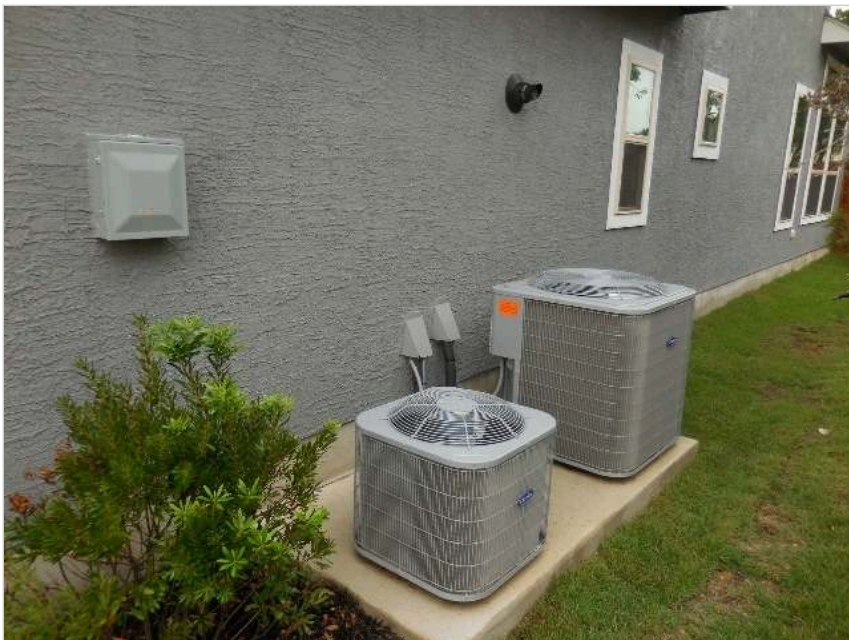
View of condenser units.
