HOME INSPECTION REPORT

**123 Sample Drive
Anytown, TX 55555**

PROPERTY INSPECTION REPORT

Prepared For:	Bill Sample	
	(Name of Client)	
Concerning:	123 Sample Drive, Anytown, TX, 55555	
	(Address or Other Identification of Inspected Property)	
By:	Inspector 1 Inspector 2	9-29-2017
	(Name and License Number of Inspector)	(Date)
	(Name, License Number of Sponsoring Inspector)

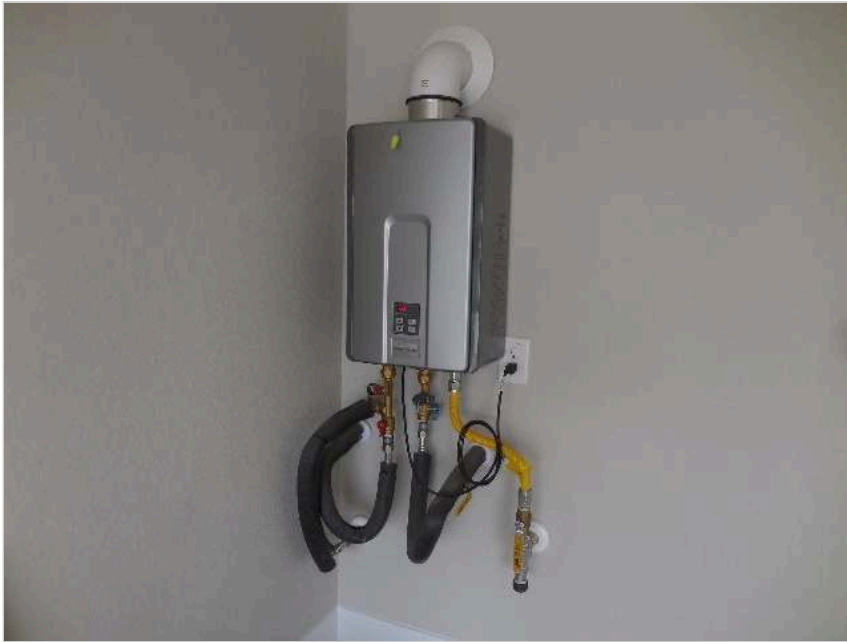
(none) There were no visible deficiencies noted on the water heater(s) at the time of inspection.

View of tankless water heater in garage.
