HOME INSPECTION REPORT

The HomeTeam Inspection Service made a visual inspection of 123 Main Street, Anytown, USA 55555. Enclosed please find a written, narrative report of our findings in accordance with the terms of our Inspection Agreement.

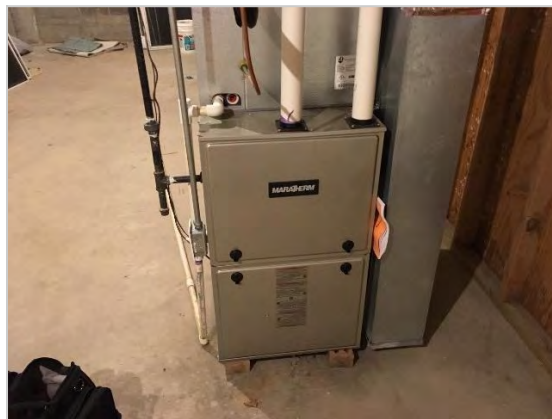
Photo 15

A condensate leak was noted on the air handler drain line. Repairs should be made by a qualified contractor.
