HOME INSPECTION REPORT

The inspected property consisted of a ranch wood-framed structure with plywood siding / cladding that was occupied at the time of the inspection. Minor, exterior type caulking and maintenance, painting are common on most homes and may be present but may or may not be specifically identified in this report. The approximate temperature at the time of the inspection was 70-75 degrees Fahrenheit, and the weather was sunny and clear. The utilities were on at the time of the inspection. The buyer was present during the inspection. The home was situated on a lightly sloped lot. The general grade around the home appeared to be mostly adequate to direct rain water away from the foundation. The age of the home, as reported by the building permits was said to be 37 years old.

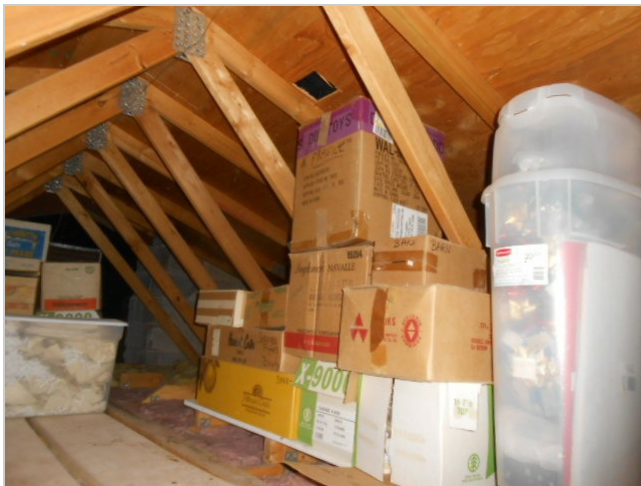
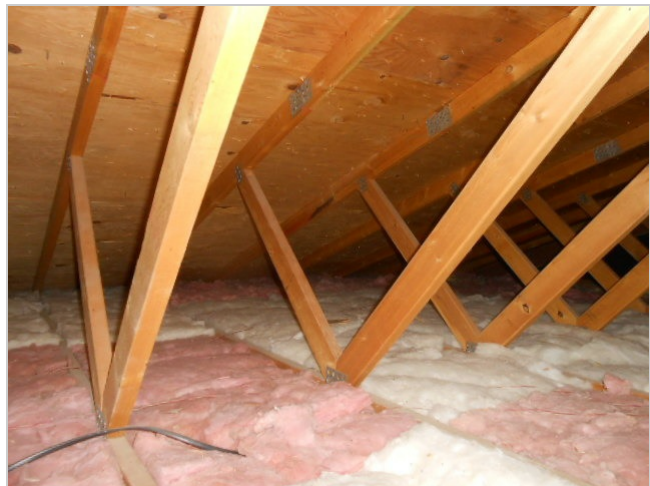
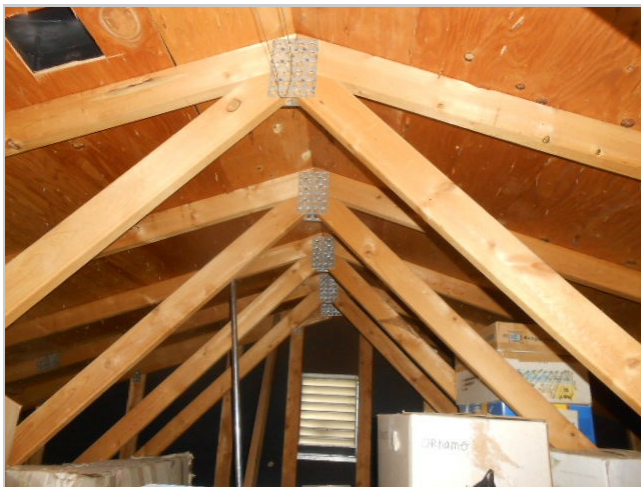
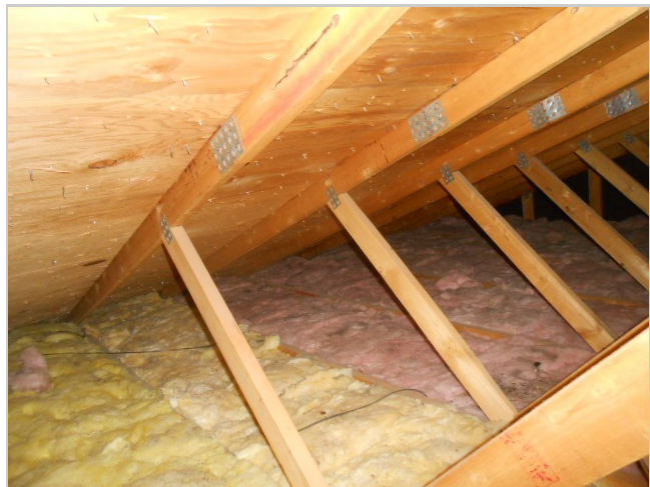
The attic was accessed through a scuttle in the garage and hallway. The attic above the living space was insulated with batted fiberglass insulation, approximately 6-inches in depth. Ventilation throughout the attic was provided by gable and roof vents.

The roof structure consisted of two-inch by four-inch wood trusses spaced 24 inches on center and plywood sheathing. Because of the configuration of the trusses and absence of any catwalk, which limited access, it was not possible to inspect all areas of the attic. There was no moisture visible in the attic space. There were no major visual defects observed in the attic or roof structure.
