# HomeTeam<sup>®</sup>

### HOME INSPECTION REPORT

HomeTeam Inspection Service has made a visual inspection of 124 Sample Street. Enclosed please find a written, narrative report of our findings in accordance with the terms of our Inspection Agreement.

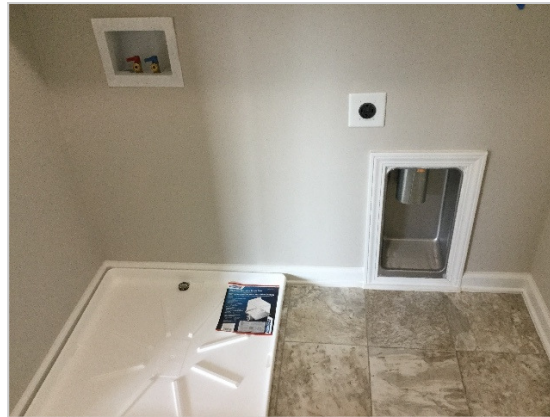
Photo 15

**No GFCI outlet located in the laundry room** and should be replaced.

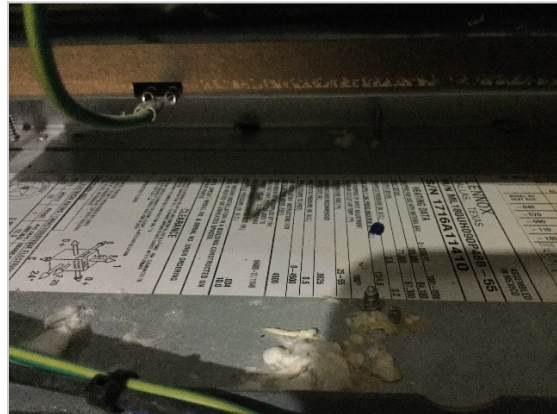
Photo 18

1. A condensate leak was observed on the air handler drain line.

**A condensate leak was noted on the air handler drain line.** Repairs should be made by a qualified contractor.
