# HomeTeam<sup>®</sup>

### HOME INSPECTION REPORT

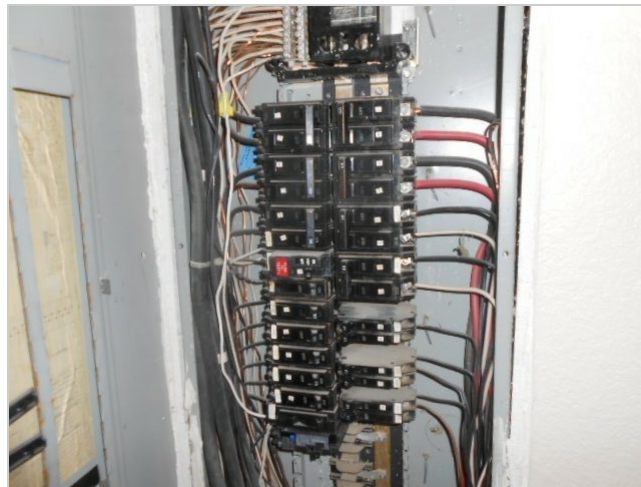
The electrical panel cover was removed for inspection of the house wiring, circuits and breakers.

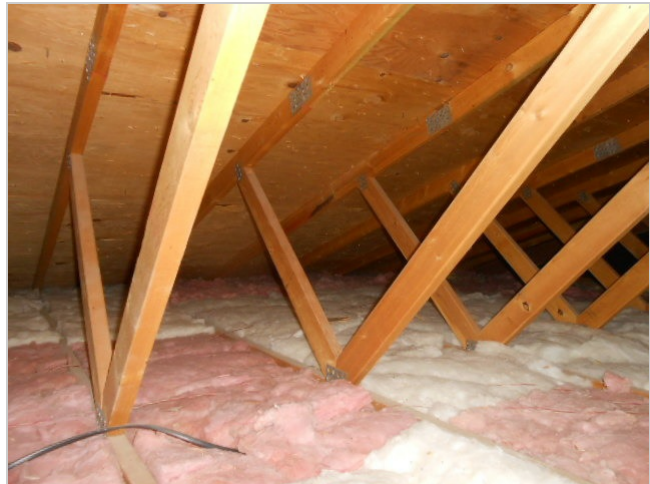
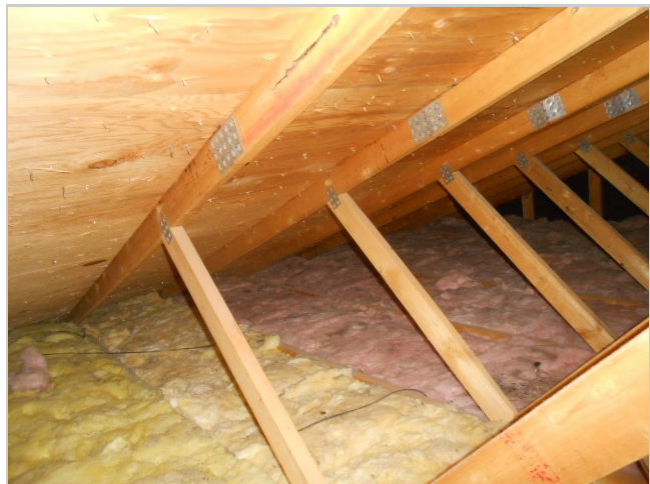
The attic was accessed through a scuttle in the garage and hallway The attic above the living space was insulated with batted fiberglass insulation, approximately 6-inches in depth. Ventilation throughout the attic was provided by gable and roof vents.

The roof structure consisted of two-inch by four-inch wood trusses spaced 24 inches on center and plywood sheathing. Because of the configuration of the trusses and absence of any catwalk, which limited access, it was not possible to inspect all areas of the attic. There was no moisture visible in the attic space. There were no major visual defects observed in the attic or roof structure.
