HOME INSPECTION REPORT

The HomeTeam Inspection Service made a visual inspection of 123 Anywhere St., City, ST 12345. Enclosed please find a written, narrative report of our findings in accordance with the terms of our Inspection Agreement.

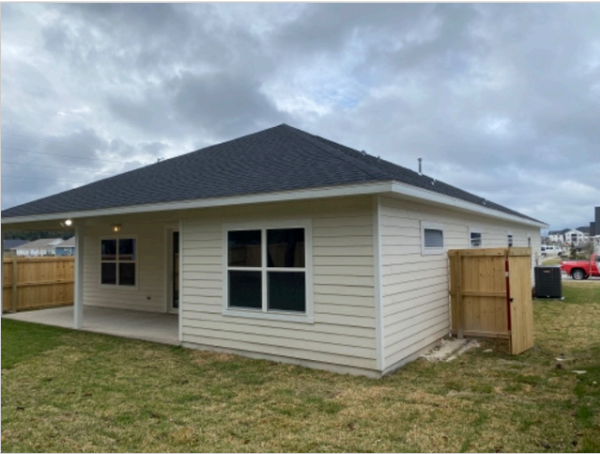
Photo 5

Damaged siding was observed on the right side of the structure. Consult with a qualified contractor for replacement.

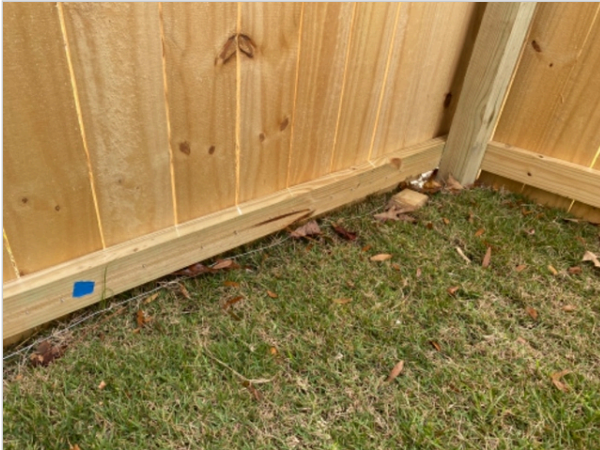
Photo 9

The screws securing the bottom trim board on the right side privacy fence are sharp and longer than what is needed. Resulting in a safety hazard. They should be replaced with shorter screws.

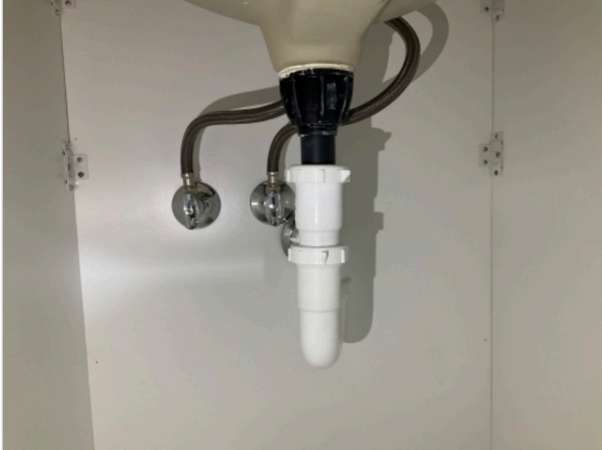
Photo 42

Jack and Jill bathroom

Leaks were observed at the toilet shut off in the Jack and Jill bathroom when in use. The tub and sink in the hall bathroom drain slowly. A licensed plumbing company should be called to evaluate the system and make any repairs.

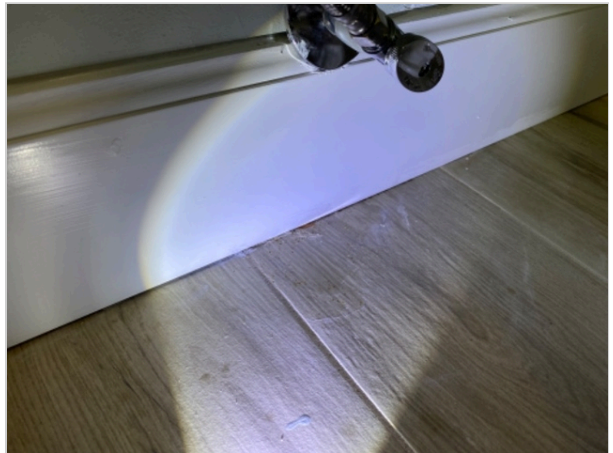
Photo 44

The Jack and Jill toilet shut off is leaking.

1. Leaks were observed at the toilet shut off in the Jack and Jill bathroom when in use. The tub and sink in the hall bathroom drain slowly. A licensed plumbing company should be called to evaluate the system and make any repairs.

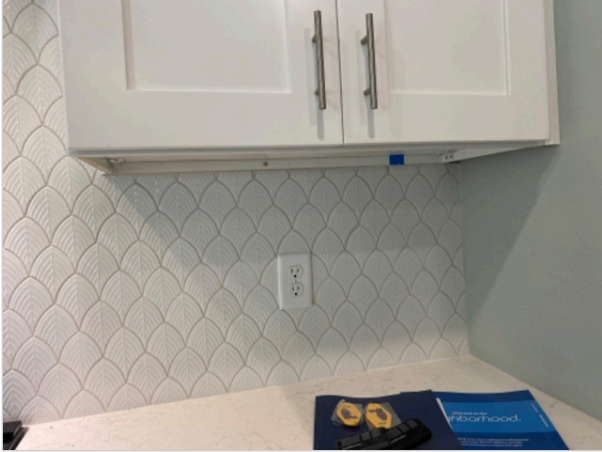
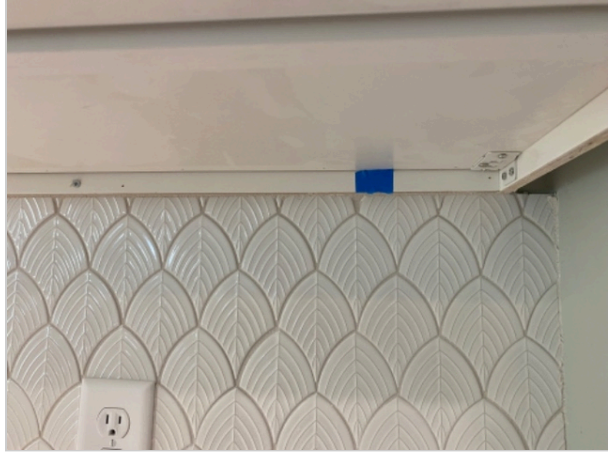
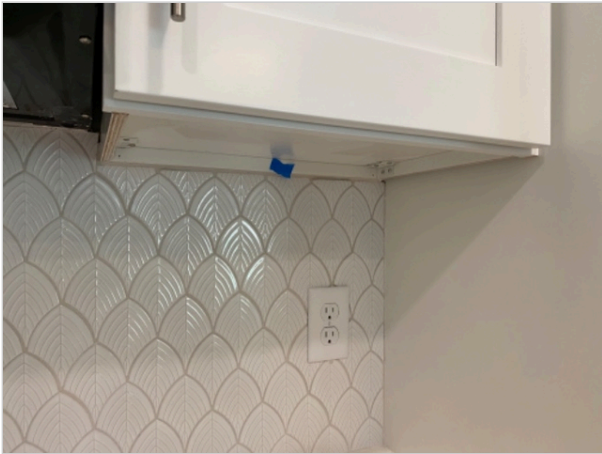
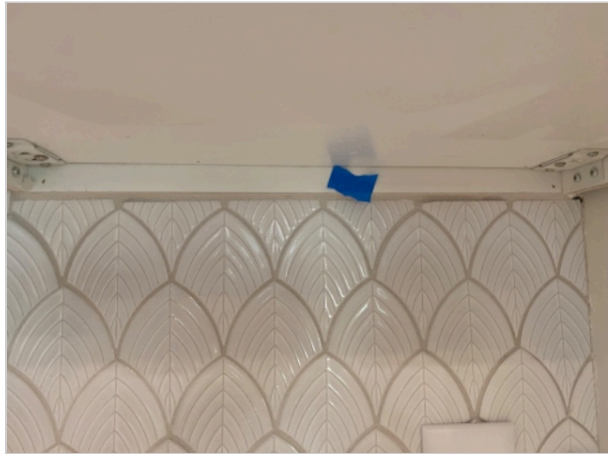
Portions of the kitchens cabinets were not completely secure to the wall. The cabinets should be secured to prevent them from falling.
