HOME INSPECTION REPORT

The HomeTeam Inspection Service made a visual inspection of 123 Anywhere St., City, ST 12345. Enclosed please find a written, narrative report of our findings in accordance with the terms of our Inspection Agreement.

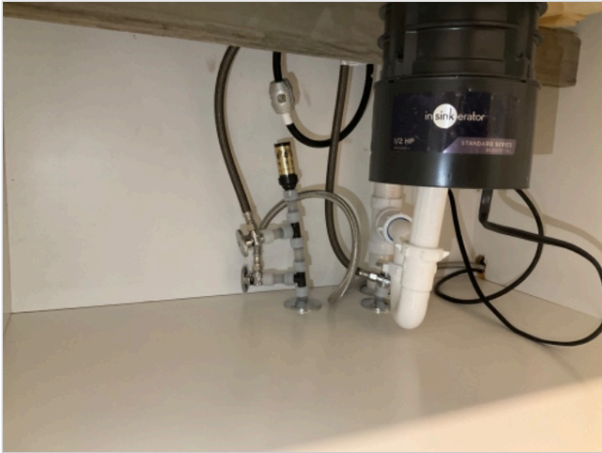
Photo 38

Kitchen

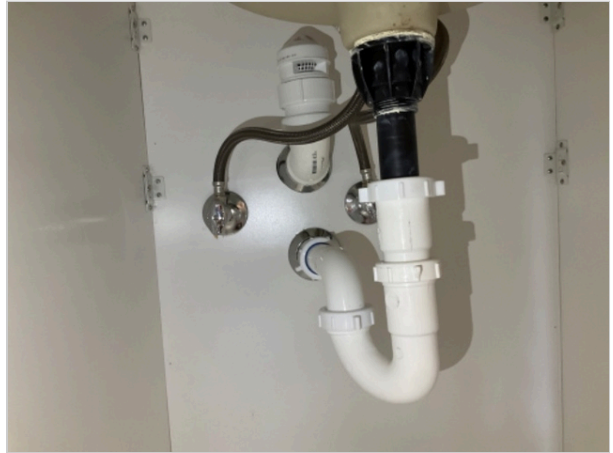
Photo 39

Guest bathroom

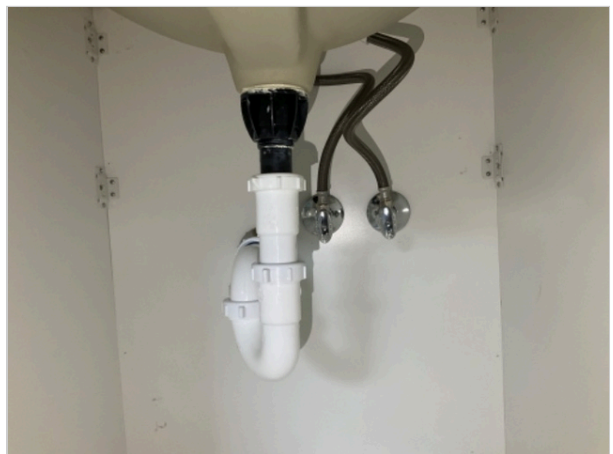
Photo 41

Master right

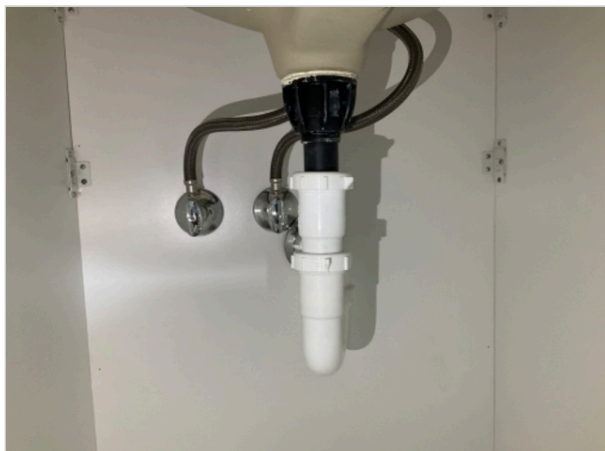
Photo 42

Jack and Jill bathroom

Leaks were observed at the toilet shut off in the Jack and Jill bathroom when in use. The tub and sink in the hall bathroom drain slowly. A licensed plumbing company should be called to evaluate the system and make any repairs.

The Jack and Jill toilet shut off is leaking.

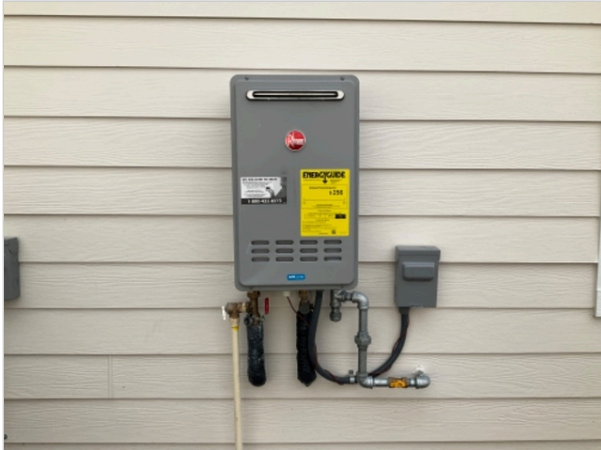
Photo 53

Left side

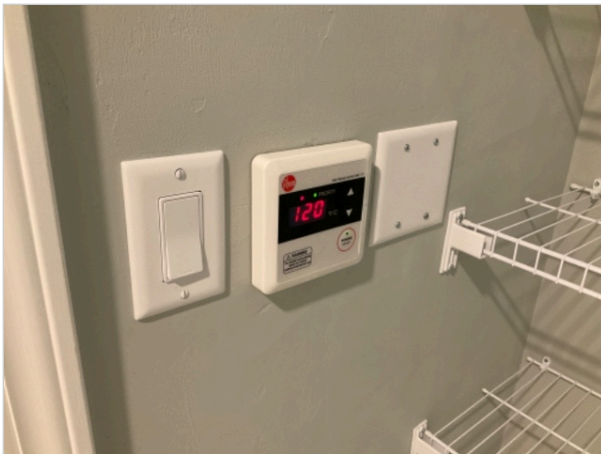
Photo 55

Master closet

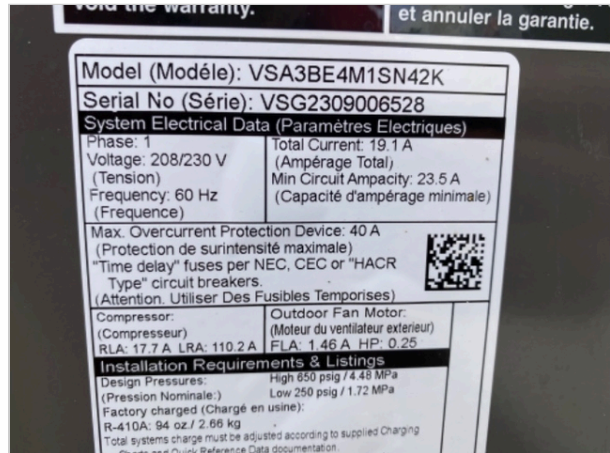
Number VSG2309006528. The unit is located on the left side of the structure. This unit is approximately less than one years old. Periodic preventive maintenance is recommended to keep this unit in good working condition. The cooling system was functional.

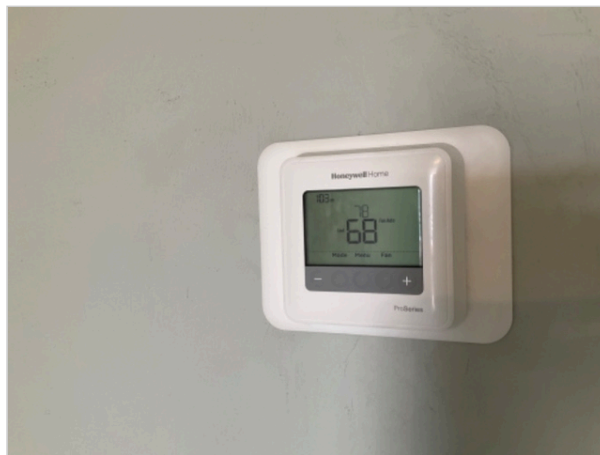
Photo 84

The control for the heating and air conditioning system was a 24 volt digital programmable thermostat located on the hallway wall of the home. The thermostat was manufactured by Honeywell and was found to be in working order.
