HOME INSPECTION REPORT

On Saturday, August 4, 2018 The HomeTeam Inspection Service made a visual inspection of 123 Sample Dr, Anytown, AZ 55555. Enclosed please find a written, narrative report of our findings in accordance with the terms of our Inspection Agreement.

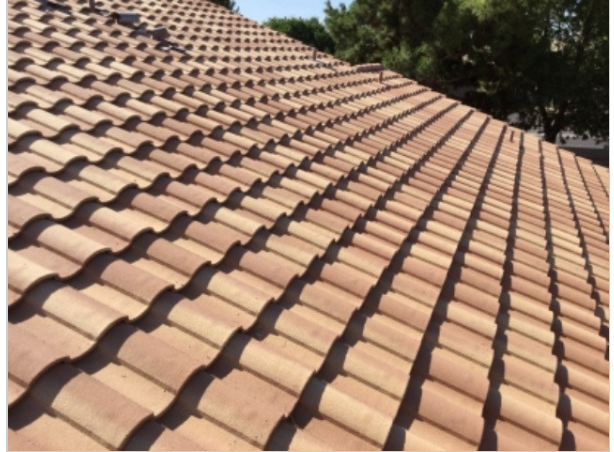
Photo 4

> **Concrete mortar packs missing or cracked were observed.** Suggest repair or replacement by a qualified roofing contractor.

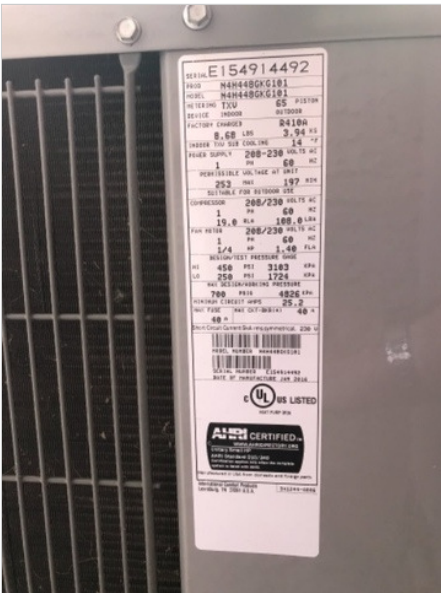
Photo 23

> HVAC unit does not have the correct fusing or breakers based on the information on the HVAC label. Suggest repair by a qualified HVAC technician or qualified electrician.

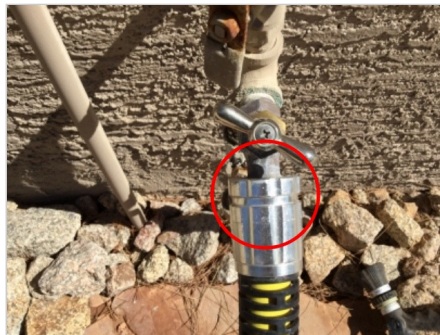
Photo 47

No Vacuum Breaker

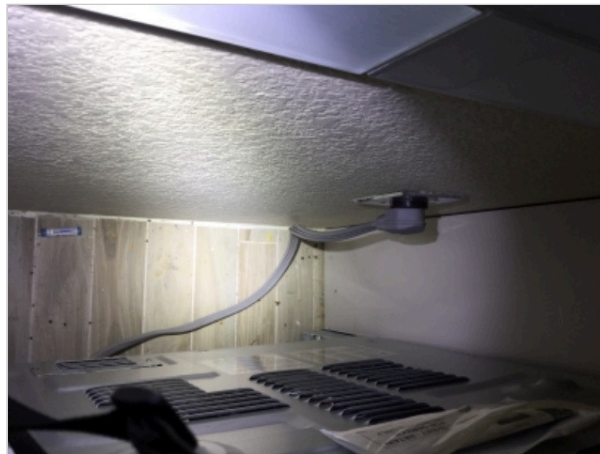
Photo 49

> Oven and range combination does not have an anti-tilt bracket installed to keep the unit from tipping forward. An anti-tilt bracket should be installed by a qualified party.

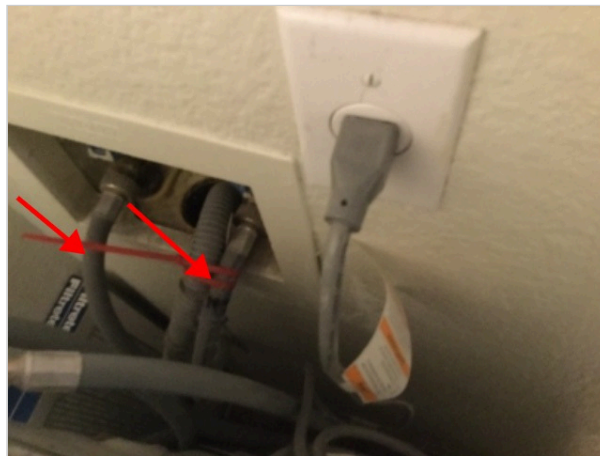
Photo 50

> **Rubber hose(s) under constant water pressure found in home.** HomeTeam recommends replacement of any rubber hose that under constant pressure (water heater, washing machine, toilet, sinks) with a stainless steel braided reinforced hose. The stainless steel braided hose will last much longer in the dry Arizona air than a typical rubber hose although the stainless steel hose will need to be replaced per the manufacturer's suggested interval.

Washer Supply Hoses

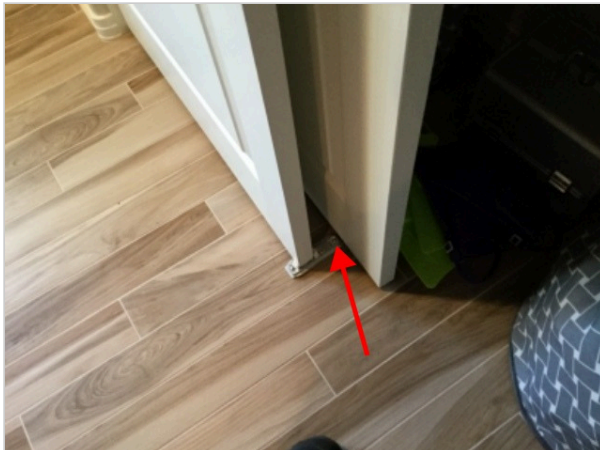
Photo 51

> **Closet door hardware missing or in need of repair.** Suggest repair or installation by a qualified party.

Left Front Bedroom Closet

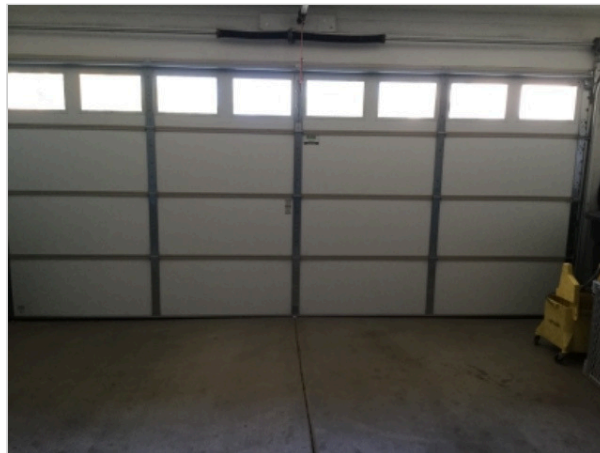
Photo 52

> **The garage door safety pressure reverse system is not operable.** This means that the door does not stop and reverse when resistance is placed at the base of the door. The opener should be adjusted or repaired.

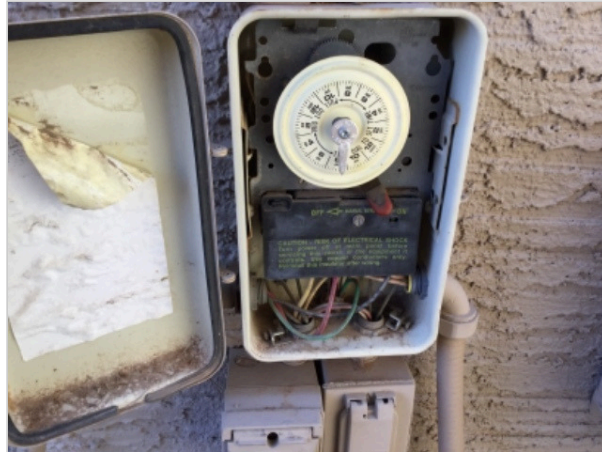
Photo 66

> **Terminal shield in timer box is damaged or missing.** Suggest replacement to ensure that electrical connections are not accidentally contacted while actuating timer.
