**HomeTeam**<sup>®</sup>  
INSPECTION SERVICE

### HOME INSPECTION REPORT

*This summary provides a simplified overview of the results of the Friday, April 13, 2018 inspection at 123 Sample Drive, Woodbridge, VA 22191. Be sure to read the full body of the inspection report; it contains much more detail about the property. Any additional evaluations we've recommended must be performed prior to the conclusion of the inspection contingency period.*

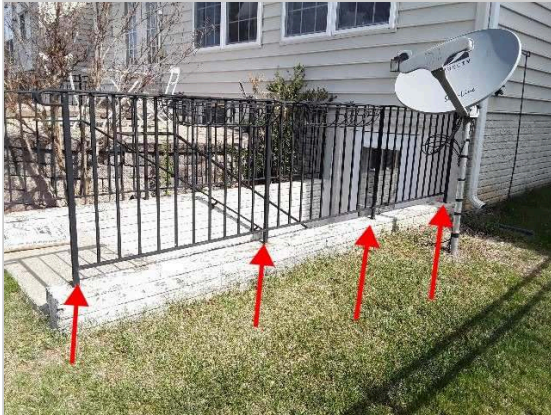
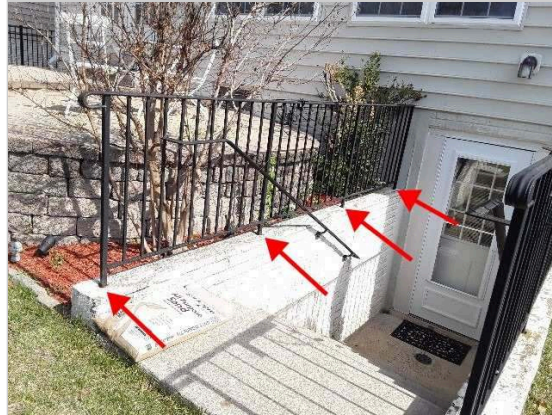
1. There was corrosion noted at the base of the guard rails on the exterior basement stairs. The corrosion should be treated to prevent further corrosion and damage to the rails.

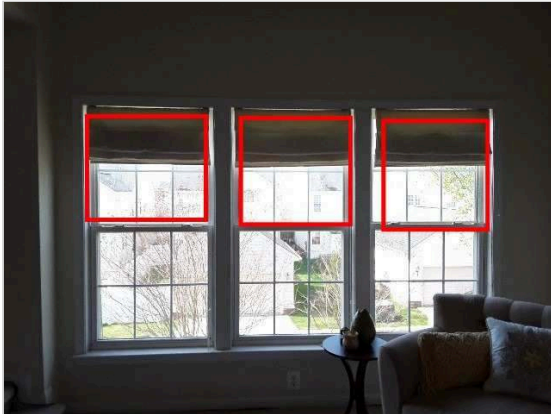
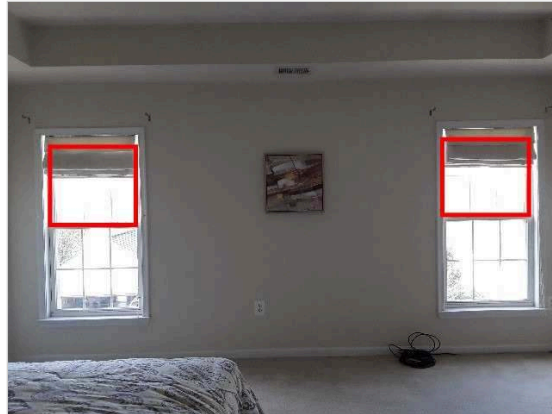
2. One or more of the insulated window panes in the master bedroom had a defective thermal seal. A defective thermal seal can be identified when fogging is observed between the panes of glass. A defective thermal seal does not affect the performance of the window. Repair of the thermal seal can be accomplished by replacing the affected glass panel.

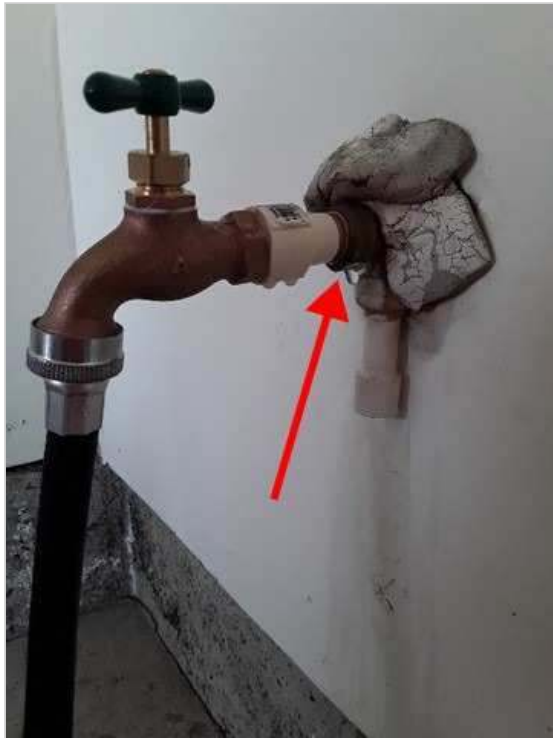
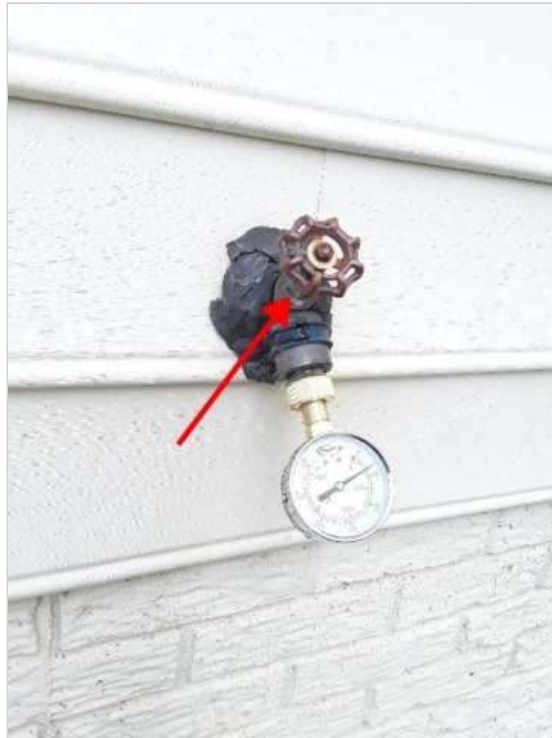
1. The left hose bib and the hose bib in the garage leaked when tested. Consult with a qualified contractor for repair.

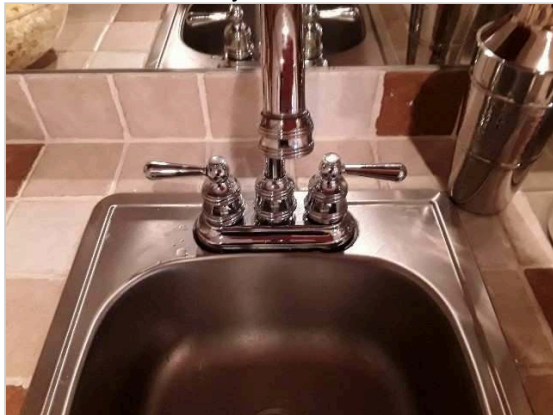
2. The faucet assembly located in the basement wet bar was loose.

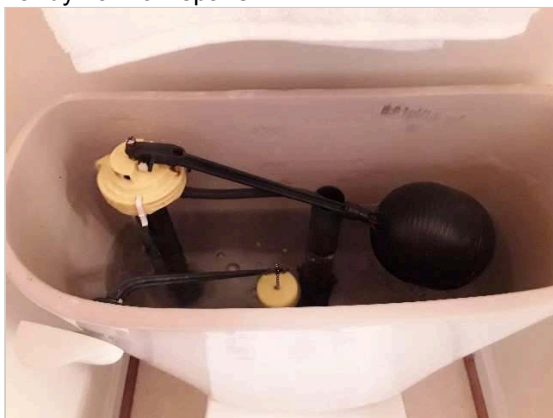
3. There was a leaky fill valve in the toilet located in the 2nd floor hallway bathroom. Consult with a qualified plumber or handyman for repairs.

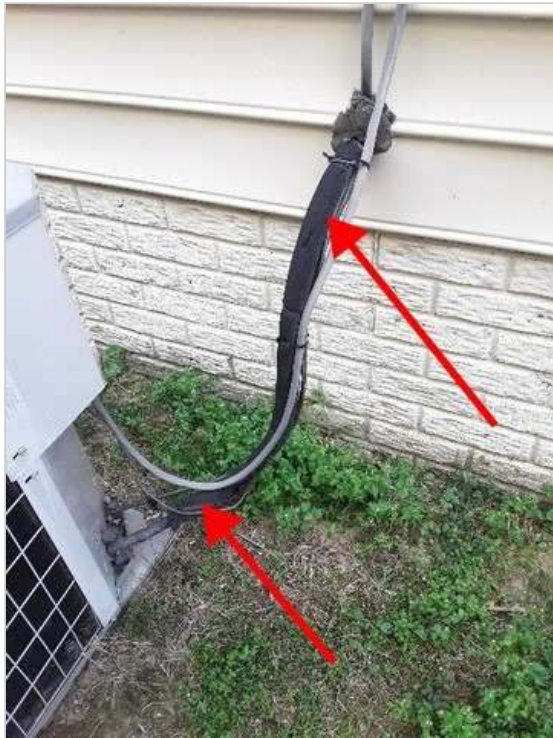
1. The insulation on the exterior air conditioning line set is dry-rotted. This could affect the efficiency of the system and should be replaced.

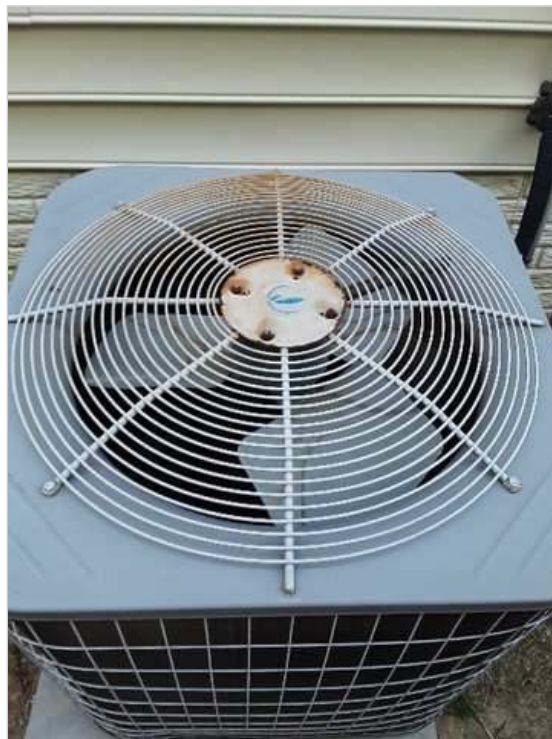
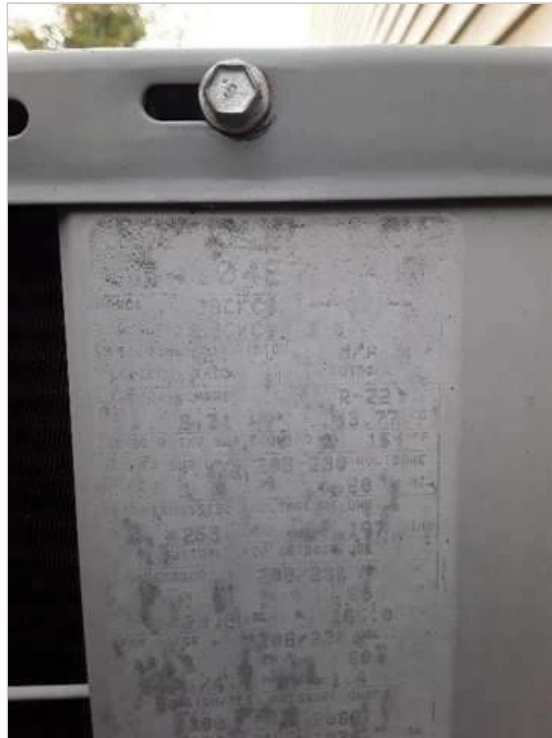
2. Outdoor air conditioner condensing units will typically last approximately 12-15 years before needing to be replaced. An outdoor condensing unit will last longer by doing regular maintenance. The subject condensing unit has been in service for approximately 13 years and was functioning at the time of inspection. The label on the unit was not legible due to wear and therefore the model and serial numbers were not available. The unit may potentially be at or nearing the end of its usable life.

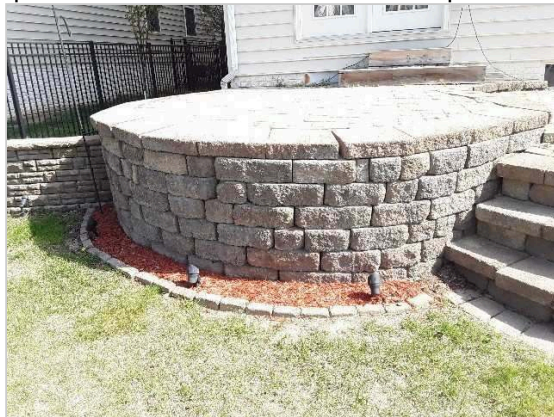
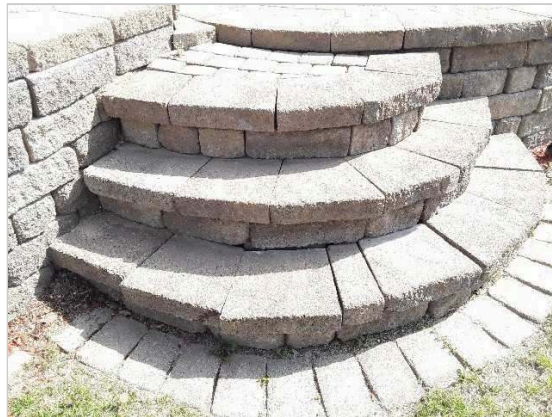
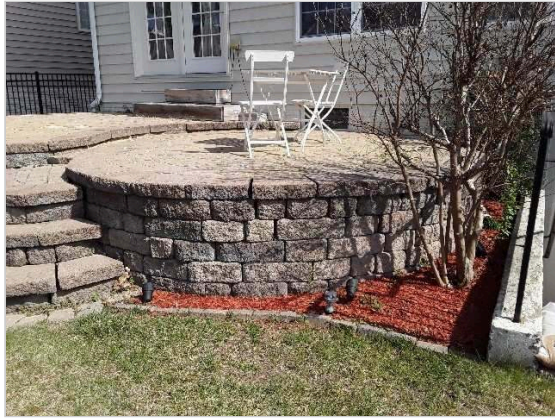
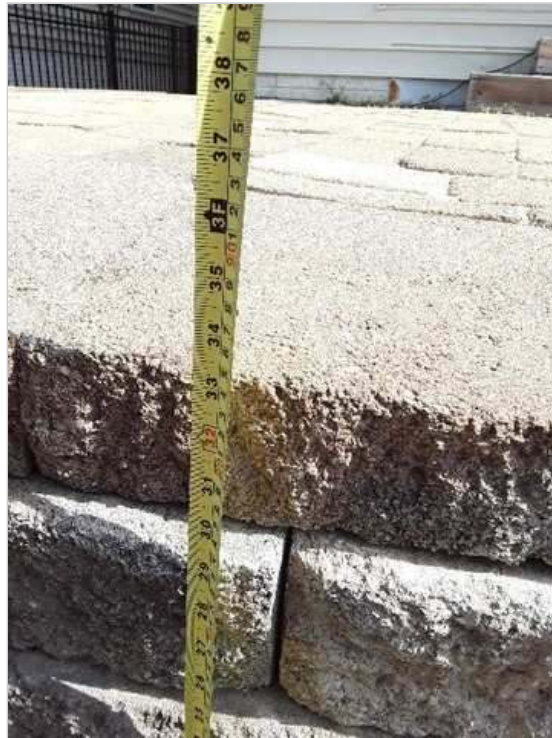
1. The earth beneath the cement paver patio in the rear of the home over time has started to erode away causing the pavers to shift creating several trip hazards found on the walkways around the house. In order to remedy the safety concern it will take extensive landscaping to relevel all of the pavers and the earth beneath them. Consult with a qualified contractor for estimates on repairs.

The earth beneath the cement paver patio in the rear of the home over time has started to erode away causing the pavers to shift creating several trip hazards found on the walkways around the house. In order to remedy the safety concern it will take extensive landscaping to relevel all of the pavers and the earth beneath them. Consult with a qualified contractor for estimates on repairs.

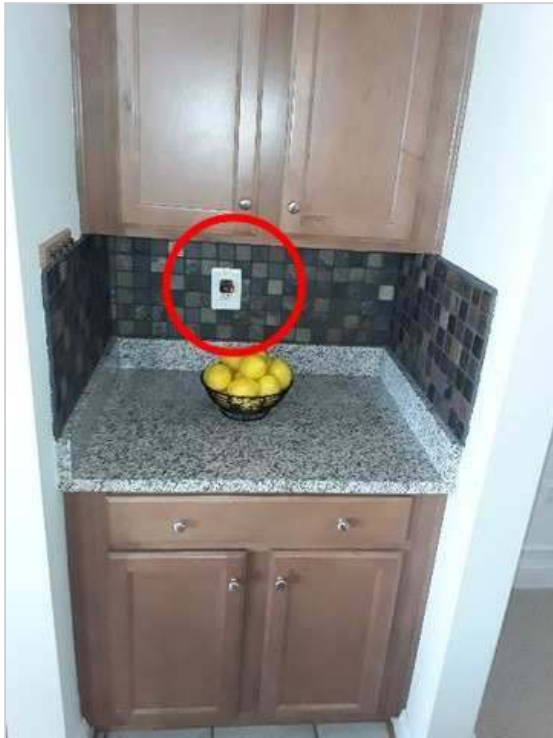
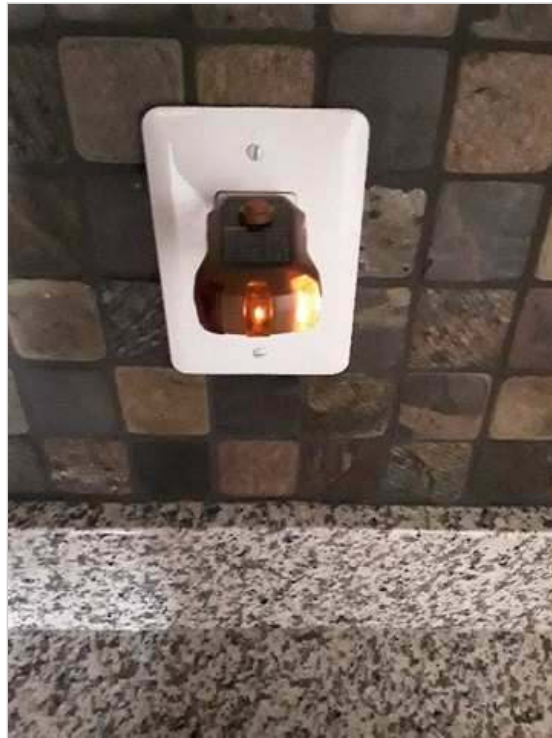
1. The GFCI outlet located in the kitchen is defective and should be replaced by a qualified electrician.

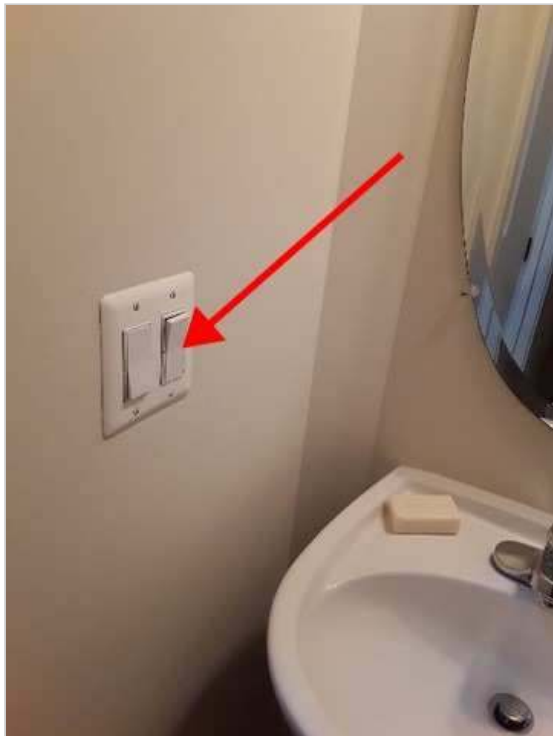
2. A broken switch was noted in the main level half bath. This could be a shock hazard due to exposed electrical contacts. The affected outlet(s) should be replaced by a qualified contractor.

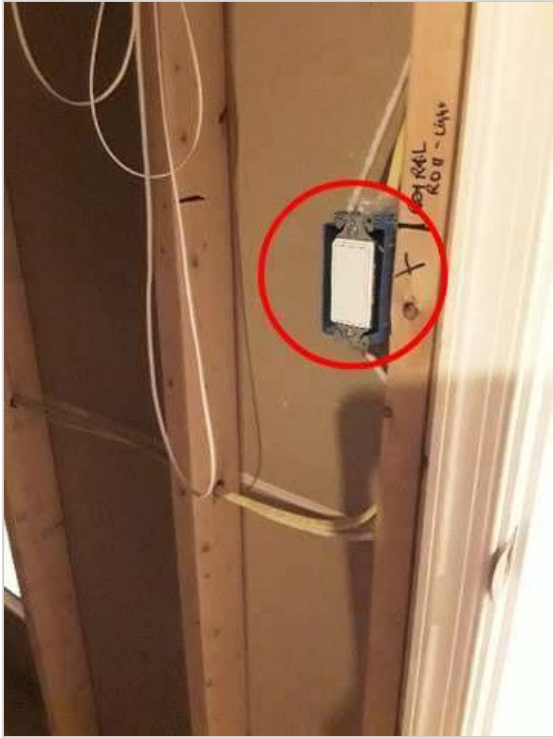
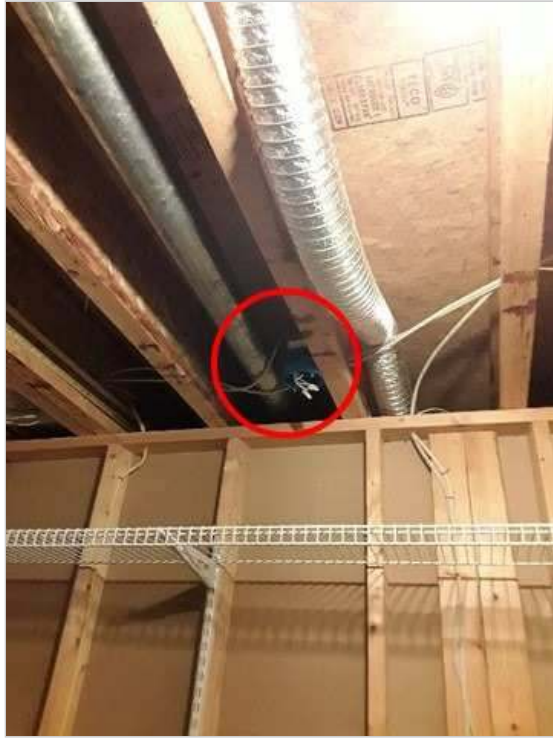
3. One or more devices were missing a switch/junction box/outlet cover in the mechanical/plumbing room. All switch/outlet boxes should be properly covered to avoid a shock hazard. Electrical related repairs should be performed by a qualified electrician.

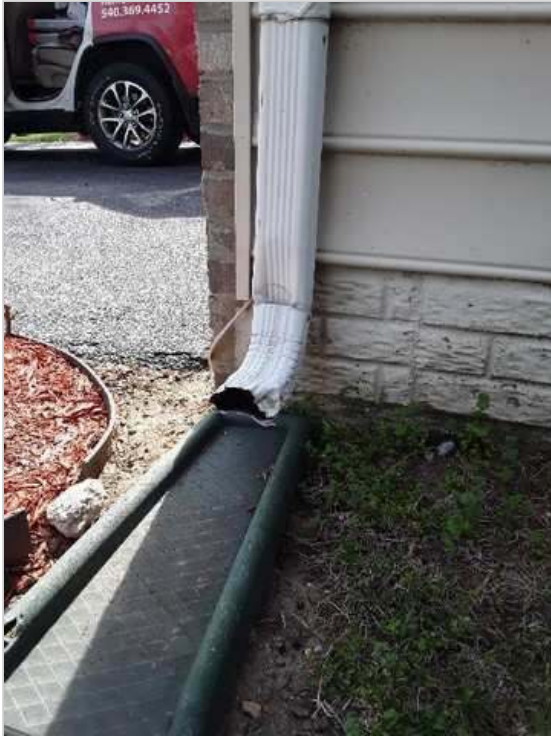
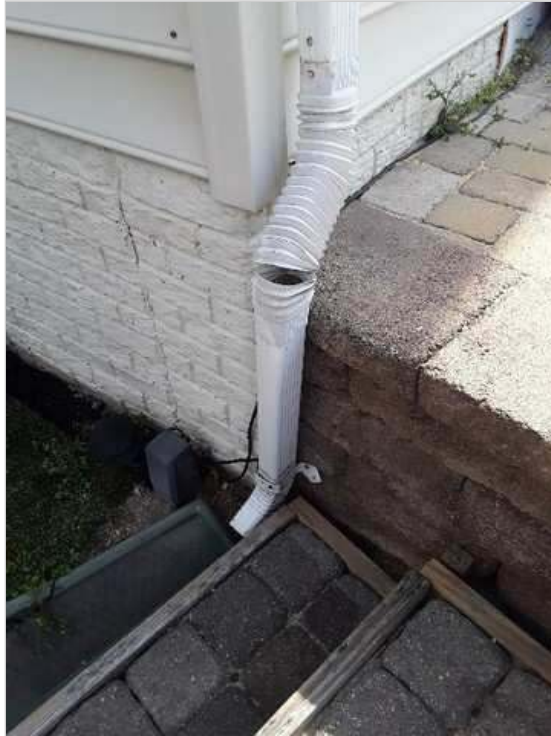
2. The right front and the right rear downspouts were damaged. This may restrict or improperly flow the water away from the foundation and should be corrected.

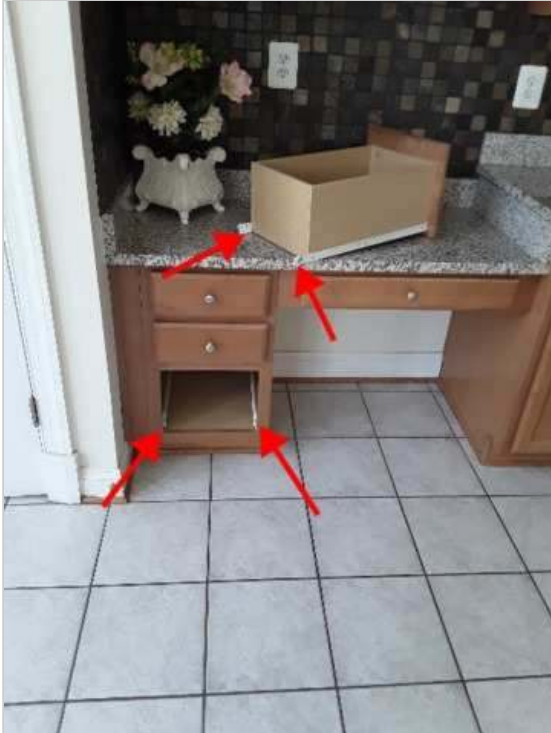
3. The drawer slides were bent on one of the kitchen drawers.

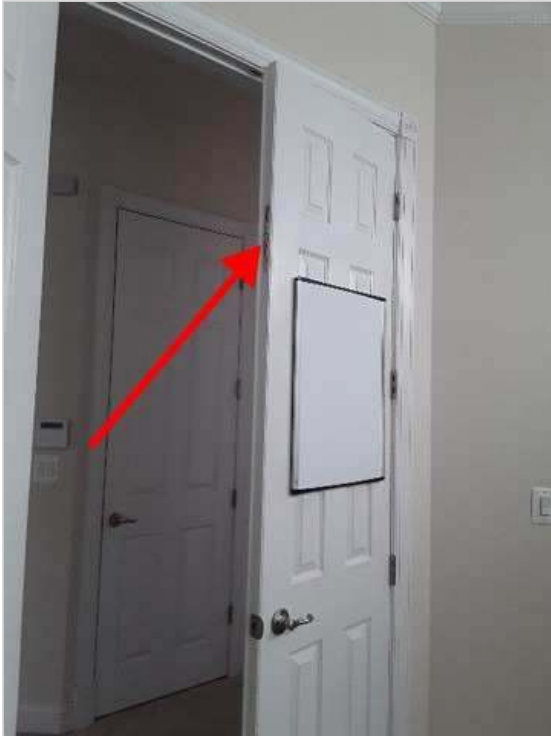
4. The latch was missing hardware on one of the door leading to the office on the main floor.

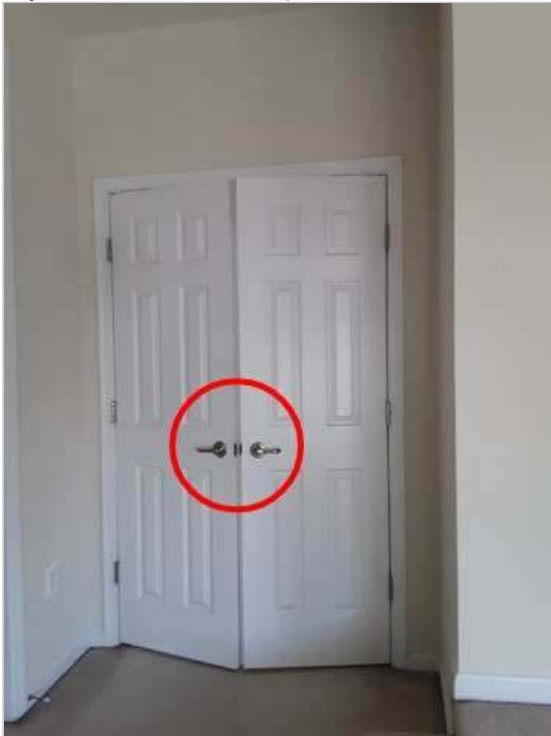
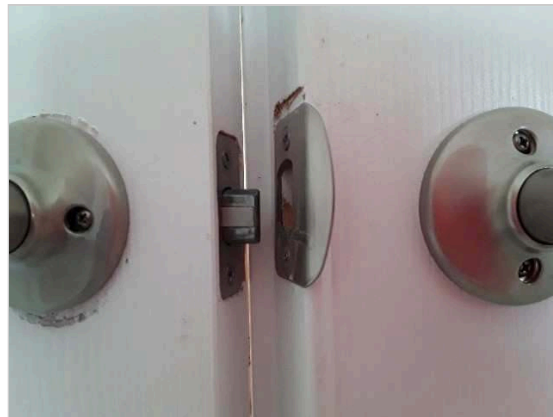
5. The french doors leading to the master bedroom did not latch properly,. This is normally easily corrected by a slight adjustment in the striker plate.

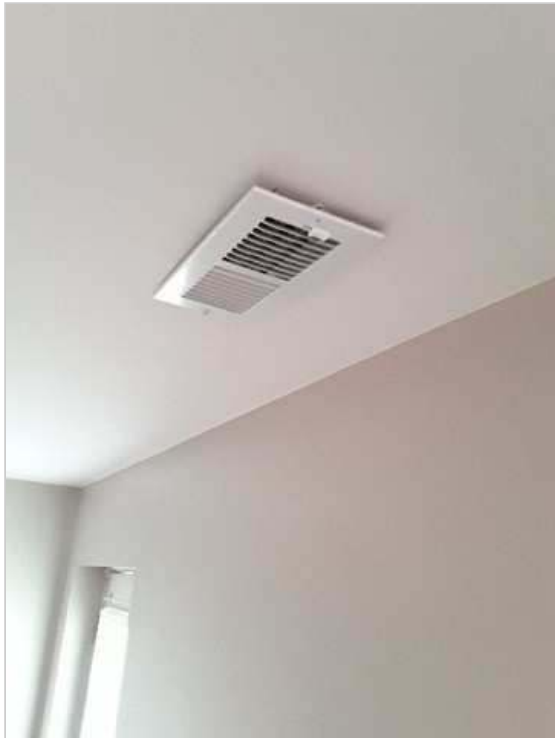
6. The supply grill located in the basement level ceiling was not properly fastened.

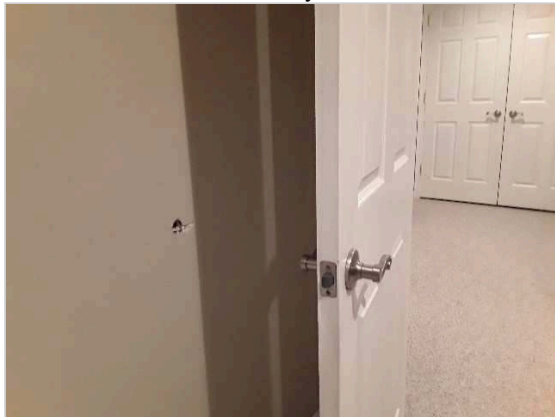
7. There was a hole in the drywall located in the 2nd level bedroom behind the bedroom door.

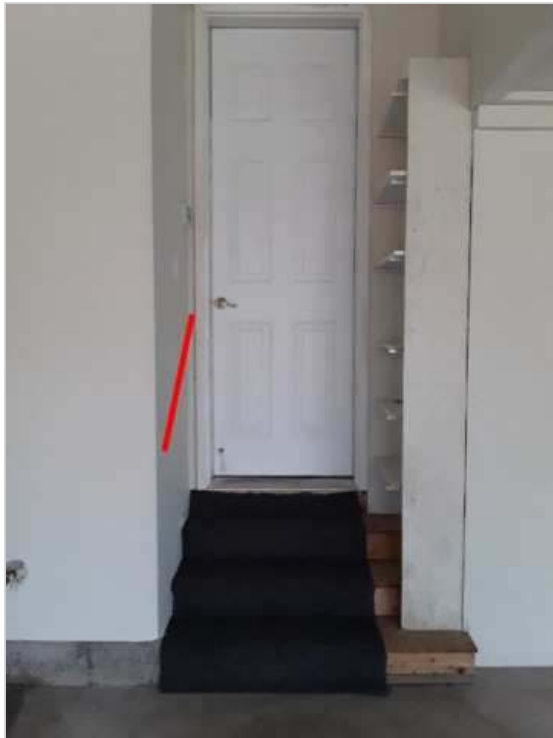
1. There was no handrail on the stairs leading to the garage. This can be a safety concern.

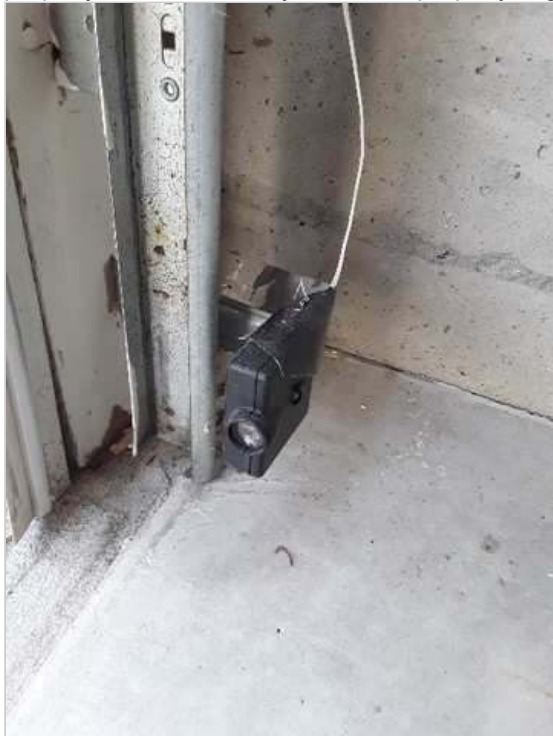
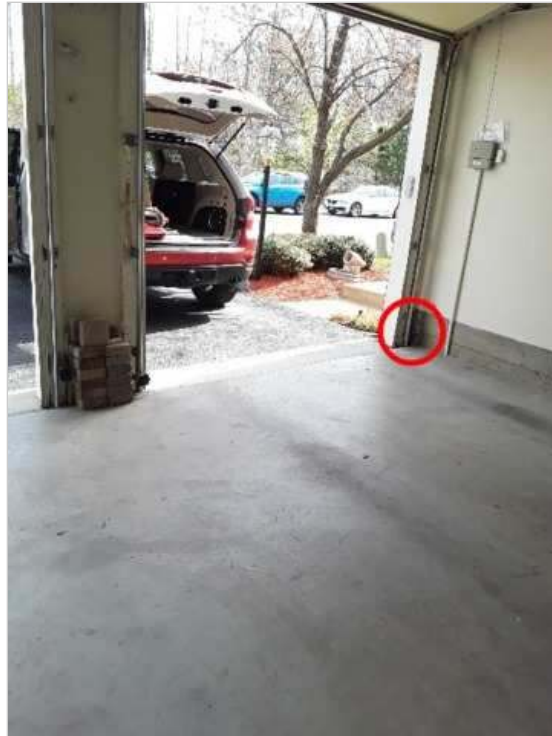
2. One of the laser eyes at the base of the door was not properly secured to the bracket. The safety reverse will not properly function if the eyes are not properly aligned.

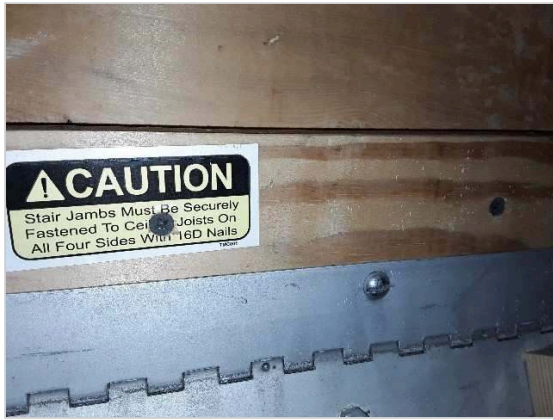
3. The pull-down ladder was not mounted with proper nails. Standard 16d penny nails or 1/4" x 3" lag screws should be used in mounting the ladders. Nails and screws that are intended for other purposes such as drywall or deck screws are not an approved fastener when mounting pull-down ladders because they may have reduced shear strength and may not support the ladders.

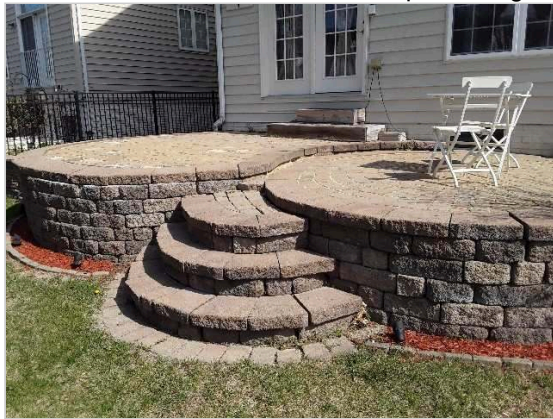
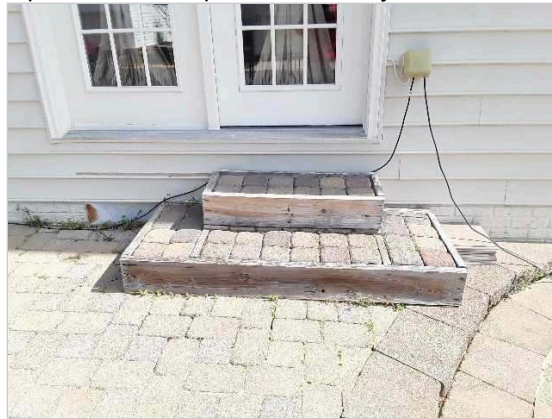
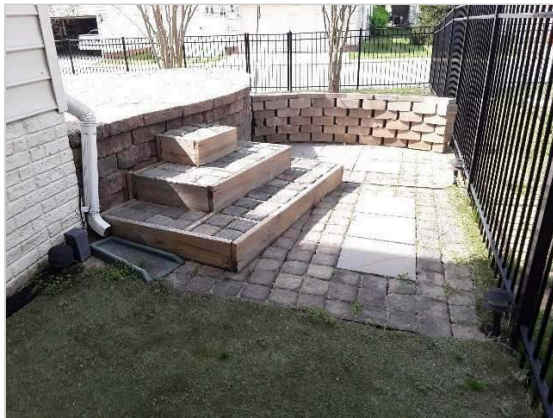
4. There were no handrails on the steps leading to the patio. This can pose as a safety concern for falling.

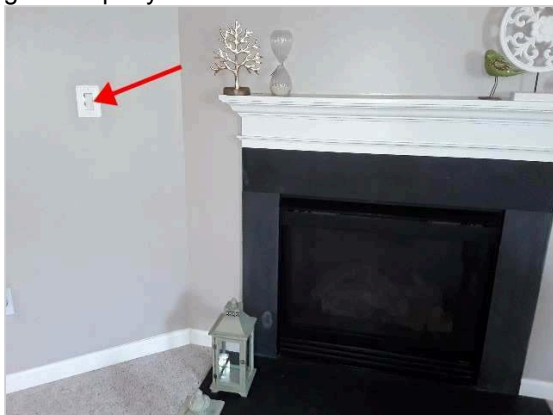
Switch for fireplace

5. The pilot light was tested on the basement fireplace. The fireplace would not light after the pilot was lit. Consult with a gas company for further evaluation.

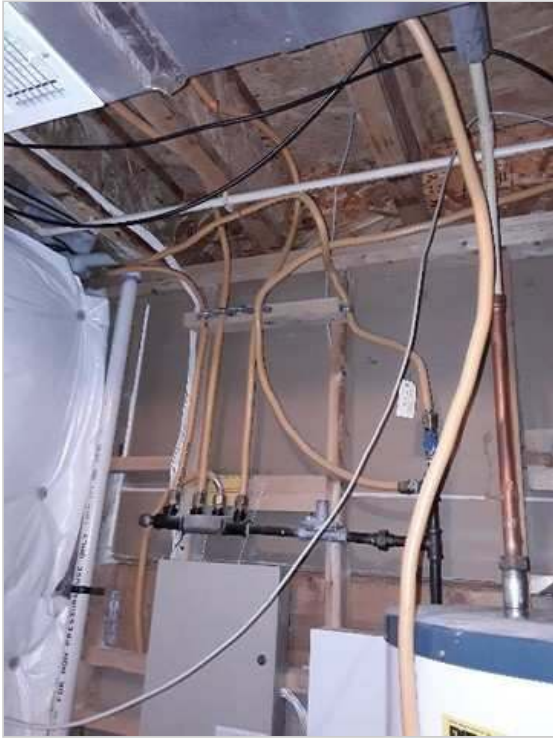
6. There was no bonding on the CSST gas plumbing found within the home. Manufacturers believe that this product is safer if properly bonded and grounded by the manufacturer's installation instructions. Proper bonding and grounding of

the product should be determined by a contractor licensed to perform the work in the Commonwealth of Virginia.

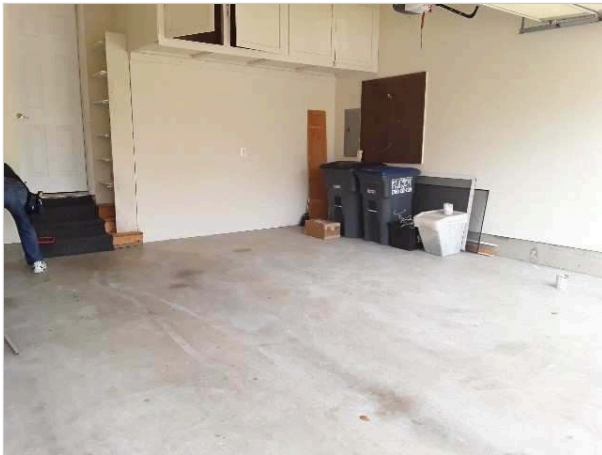
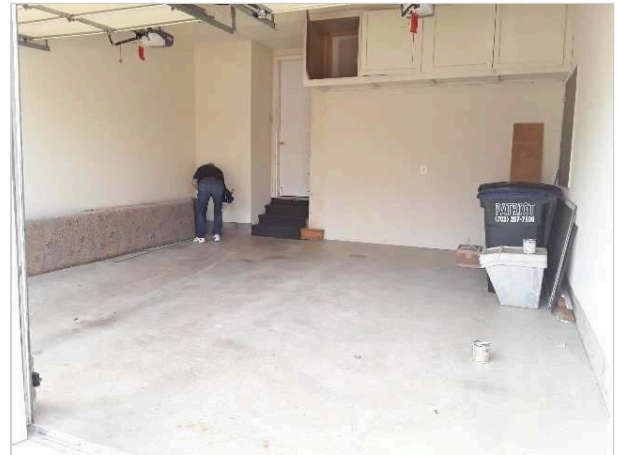
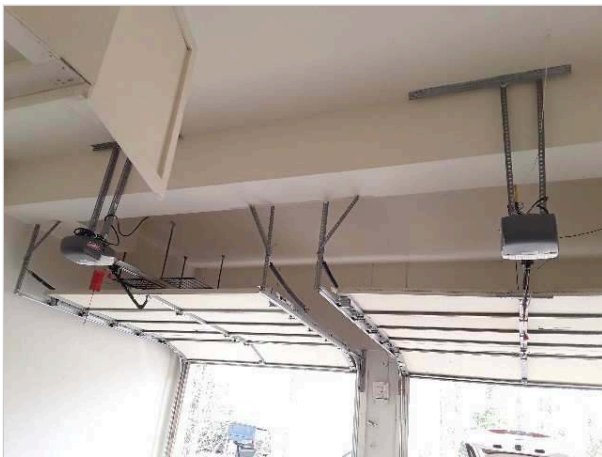
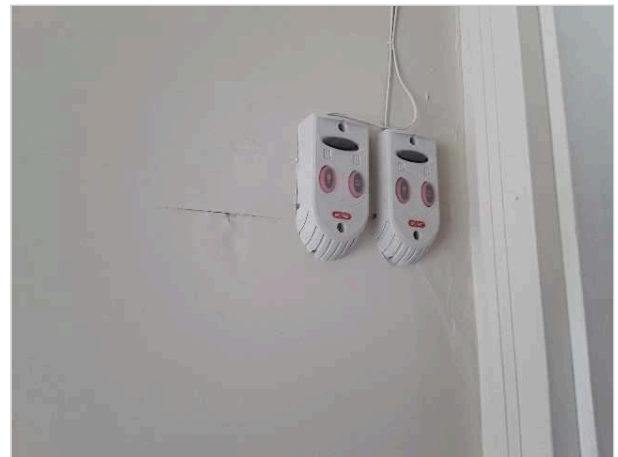
One of the laser eyes at the base of the door was not properly secured to the bracket. The safety reverse will not properly function if the eyes are not properly aligned.

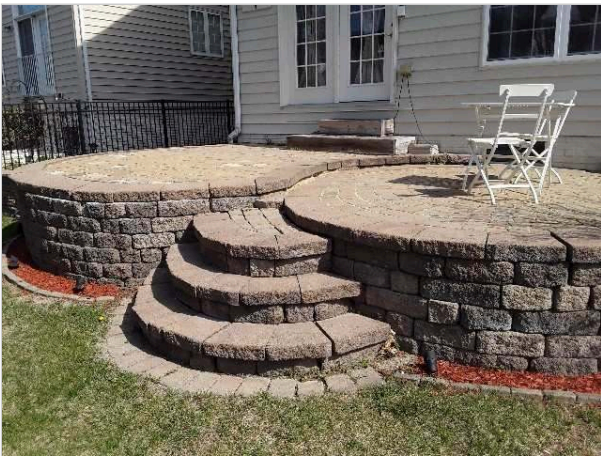
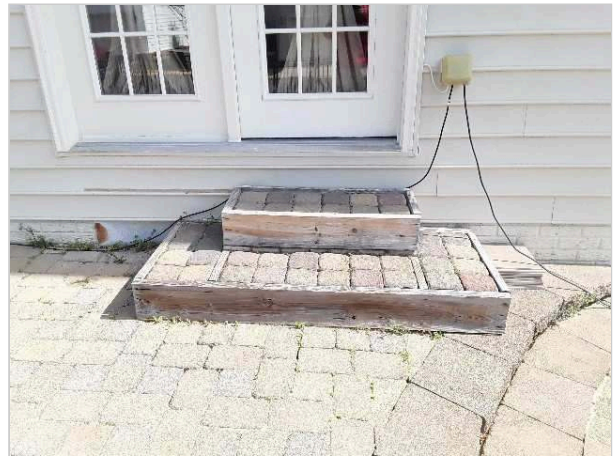
There were no handrails on the steps leading to the patio. This can pose as a safety concern for falling.

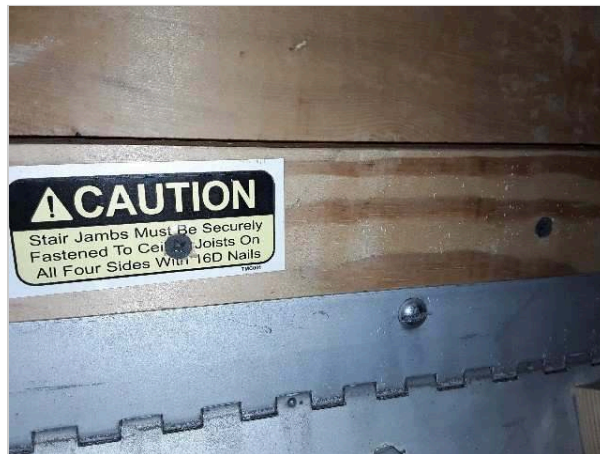
The pull-down ladder was not mounted with proper nails. Standard 16d penny nails or ¼" x 3" lag screws should be used in mounting the ladders. Nails and screws that are intended for other purposes such as drywall or deck screws are not an approved fastener when mounting pull-down ladders because they may have reduced shear strength and may not support the ladders.

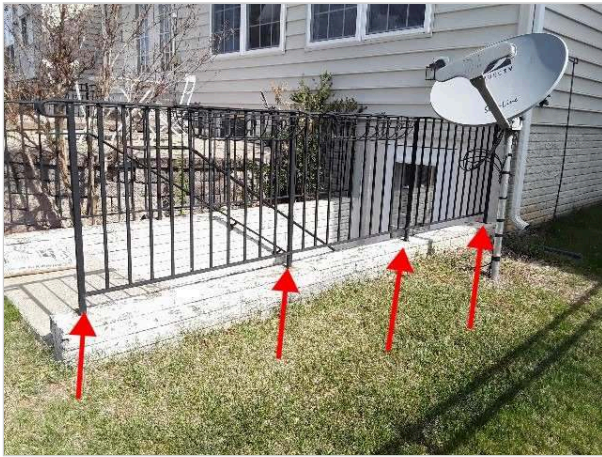
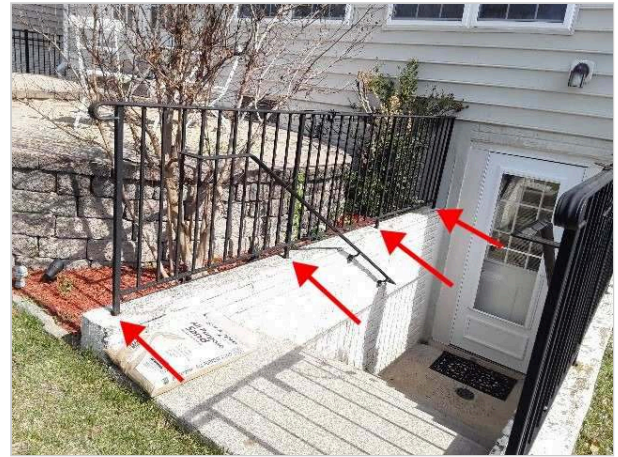
There was corrosion noted at the base of the guard rails on the exterior basement stairs. The corrosion should be treated to prevent further corrosion and damage to the rails.

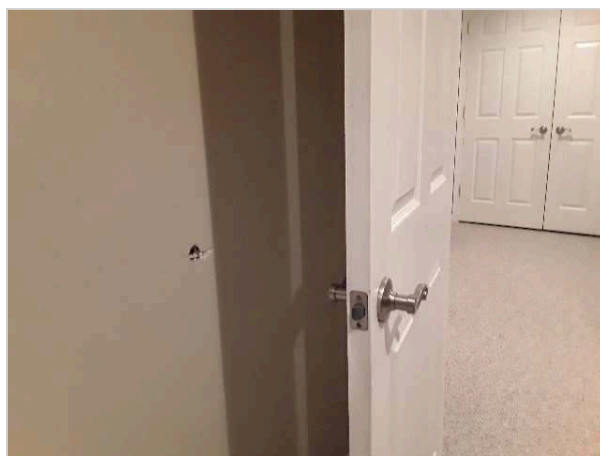
There was a hole in the drywall located in the 2nd level bedroom behind the bedroom door.

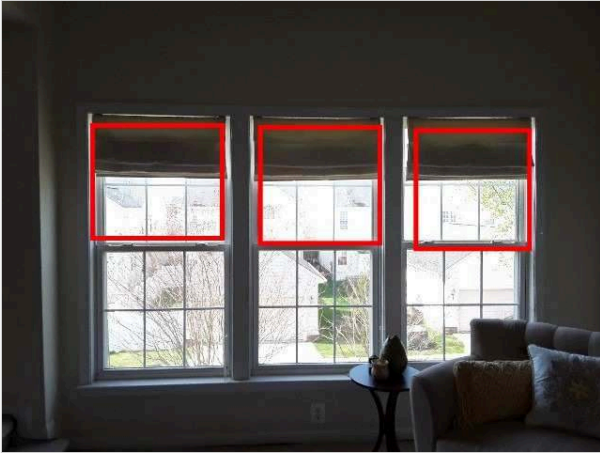
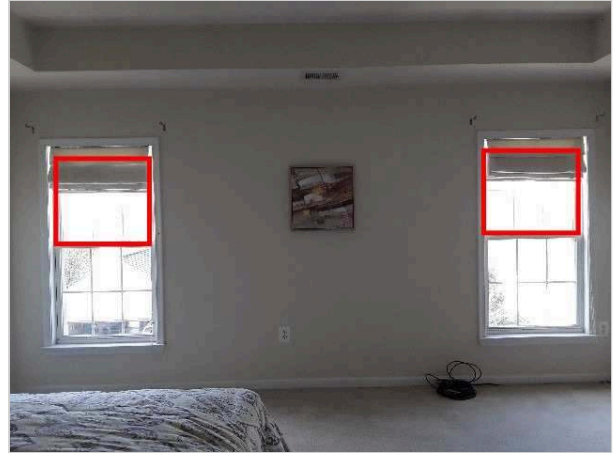
One or more of the insulated window panes in the master bedroom had a defective thermal seal. A defective thermal seal can be identified when fogging is observed between the panes of glass. A defective thermal seal does not affect the performance of the window. Repair of the thermal seal can be accomplished by replacing the affected glass panel.

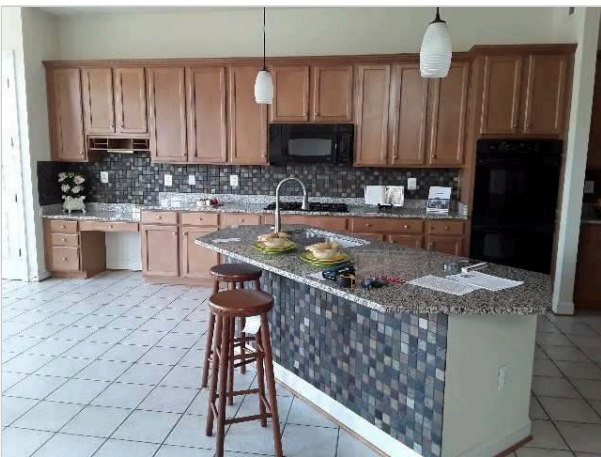
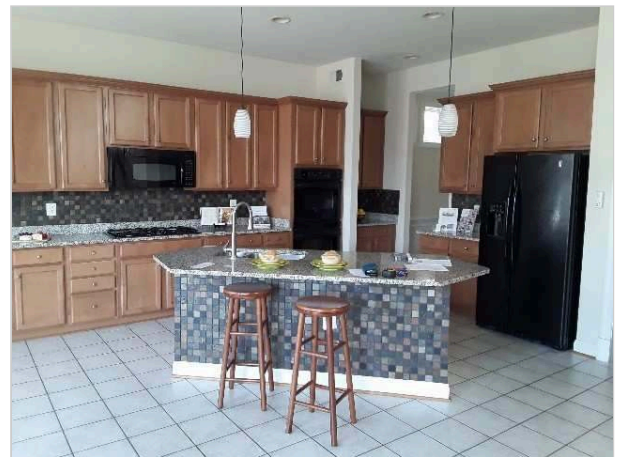
The drawer slides were bent on one of the kitchen drawers.

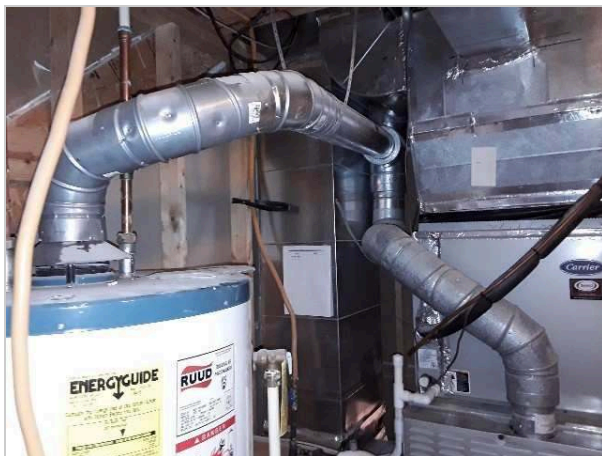
Most tank-type water heaters last 10 to 20 years, with the average age of replacement between 12 and 14 years. The age of the water heater was approximately 14 years old and was most likely at or nearing the end of its useful life.

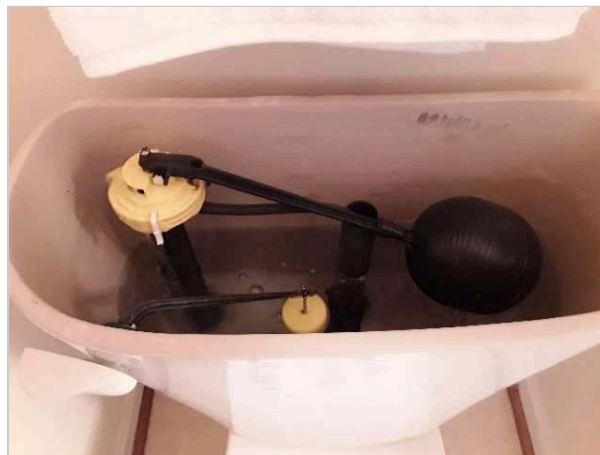
There was a leaky fill valve in the toilet located in the 2nd floor hallway bathroom. Consult with a qualified plumber or handyman for repairs.

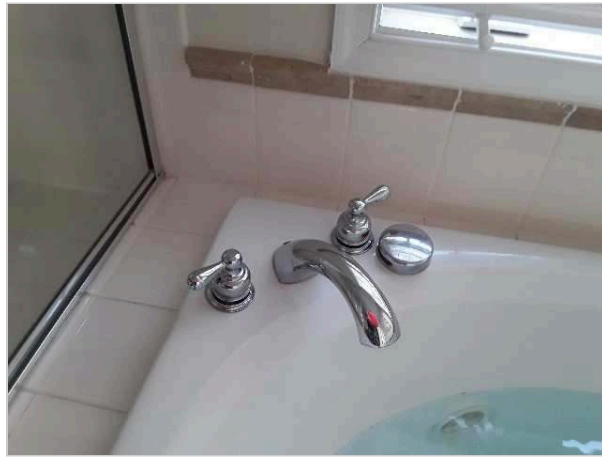
The hot and cold water handles on the jetted tub were loose and could be pulled off.

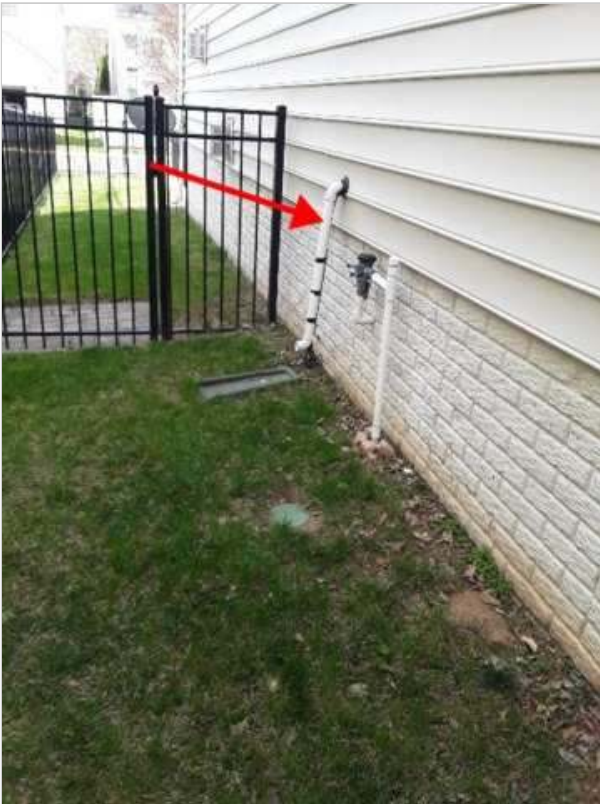
There was a sump pump located in the basement. The sump pump was functional.

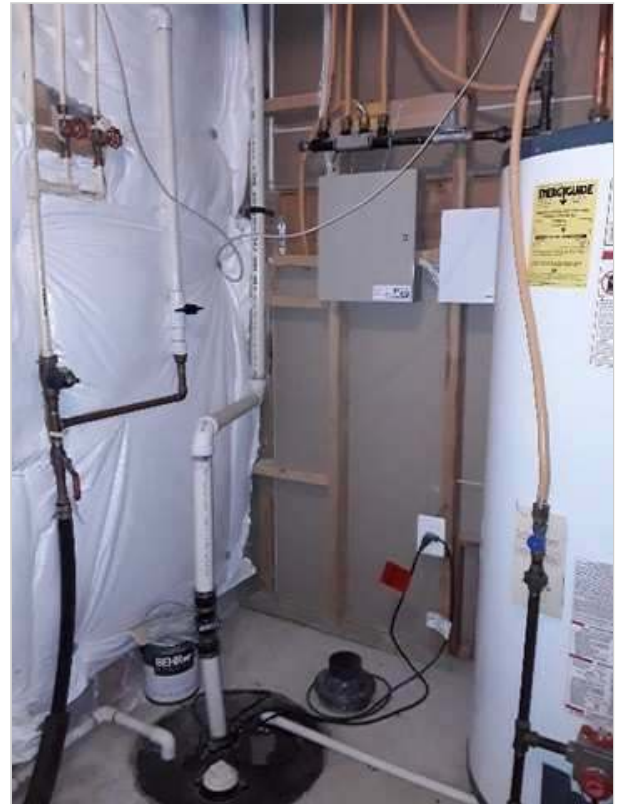
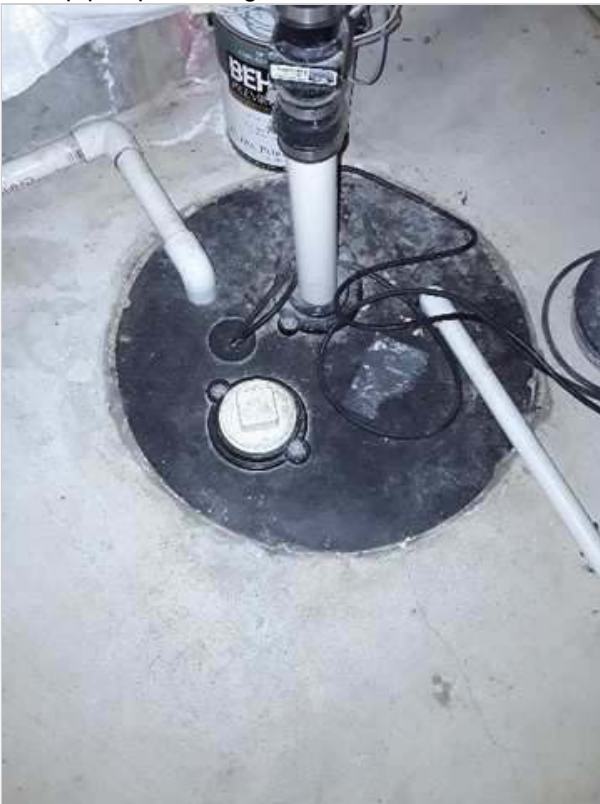
Sump pump discharge on the left side of the home

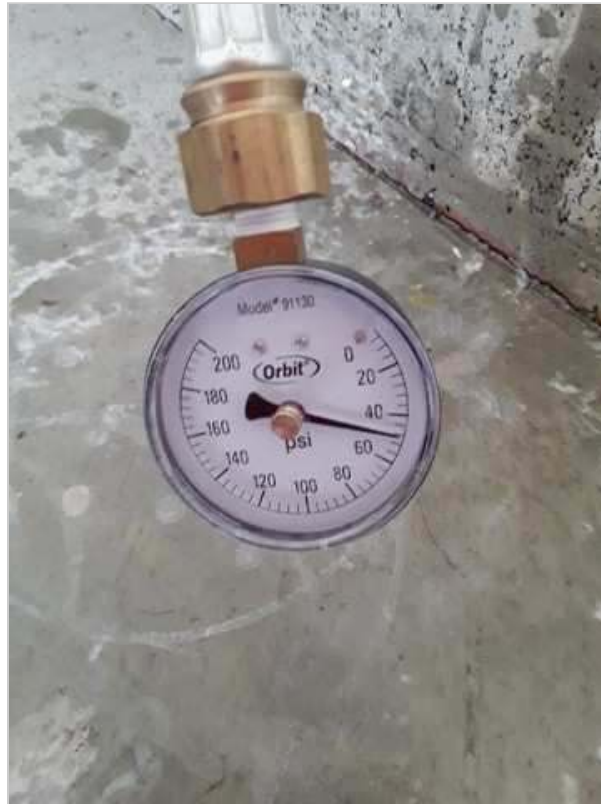
The left hose bib and the hose bib in the garage leaked when tested. Consult with a qualified contractor for repair.

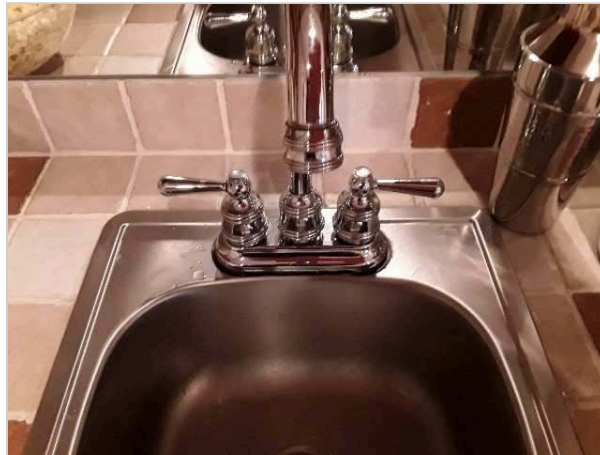
The faucet assembly located in the basement wet bar was loose.

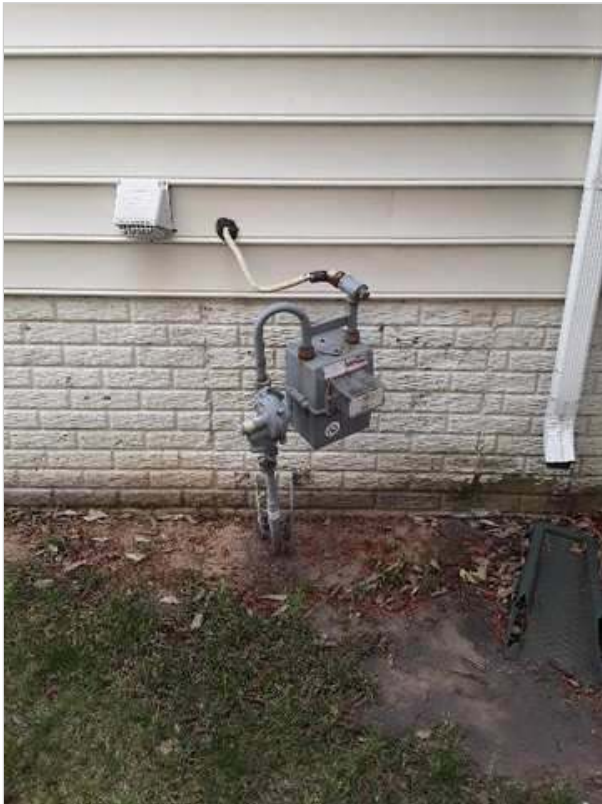
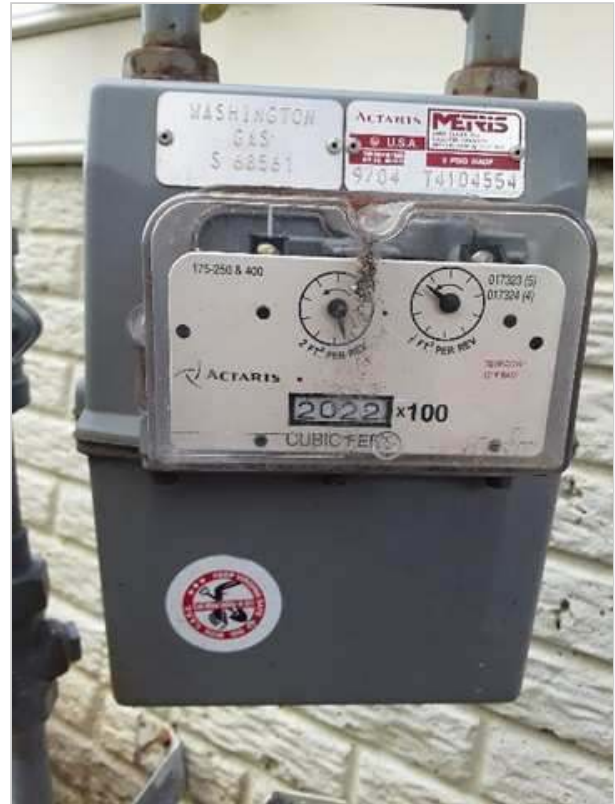
There was no bonding on the CSST gas plumbing found within the home. Manufacturers believe that this product is safer if properly bonded and grounded by the manufacturer's installation instructions. Proper bonding and grounding of the product should be determined by a contractor licensed to perform the work in the Commonwealth of Virginia.

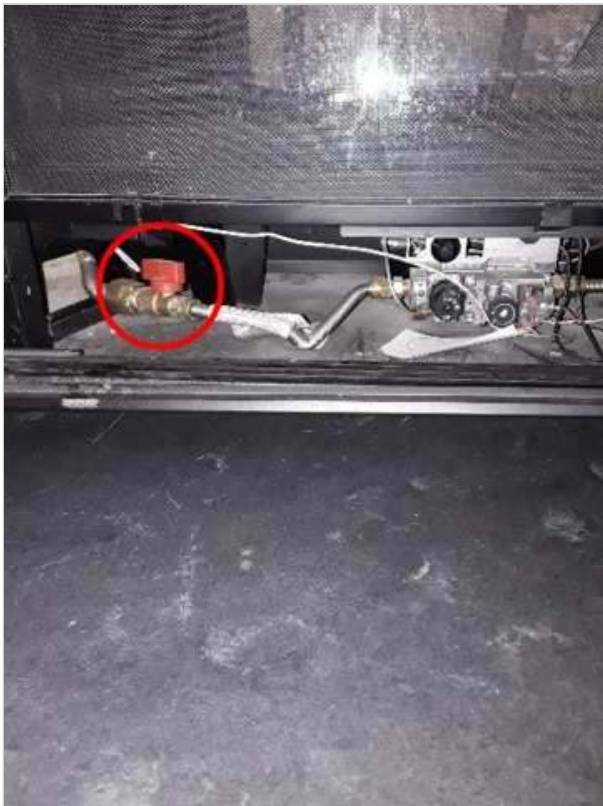
Main gas shutoff

The pilot light was tested on the basement fireplace. The fireplace would not light after the pilot was lit. Consult with a gas company for further evaluation.
