**HomeTeam**<sup>®</sup>  
INSPECTION SERVICE

### HOME INSPECTION REPORT

*This summary provides a simplified overview of the results of the Friday, April 13, 2018 inspection at 123 Sample Drive, Woodbridge, VA 22191. Be sure to read the full body of the inspection report; it contains much more detail about the property. Any additional evaluations we've recommended must be performed prior to the conclusion of the inspection contingency period.*

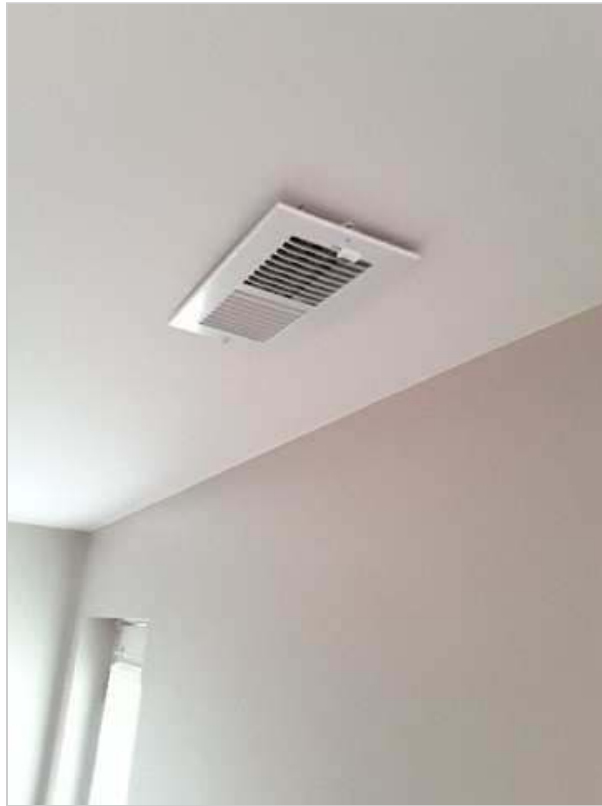
The supply grill located in the basement level ceiling was not properly fastened.
