HOME INSPECTION REPORT

On Monday, August 7th, 2023 The HomeTeam Inspection Service made a visual inspection of 123 Sample Dr, Anytown, WA 12345. Enclosed please find a written, narrative report of our findings in accordance with the terms of our Inspection Agreement.

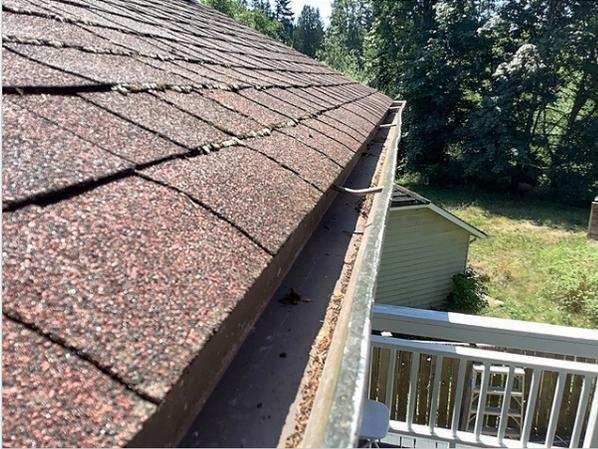
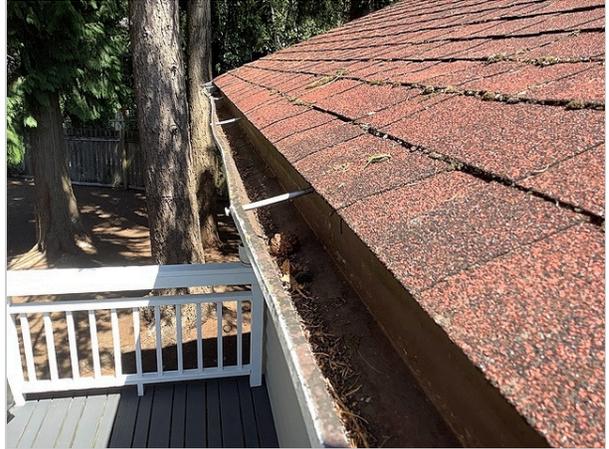
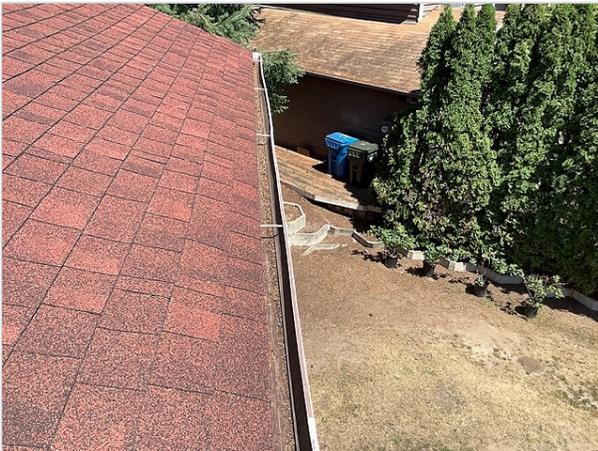
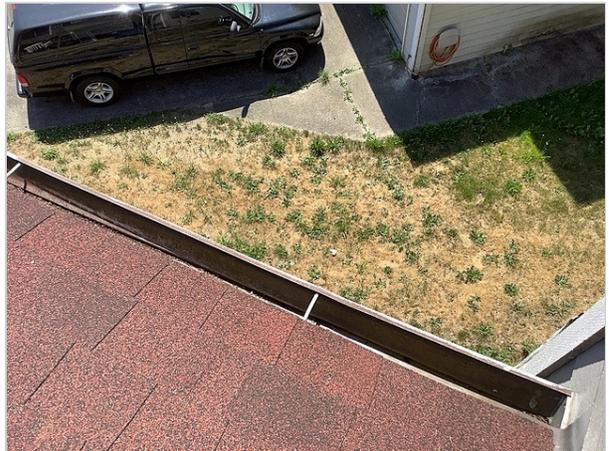
Gutters were in need of repair at the time of the inspection. Clogged or damaged gutters can cause roof drainage water to drain at the base of the foundation, causing basement water problems. Overflow from gutters can cause damage to fascia that is not visible or apparent at the time of the inspection. The gutters should be repaired.

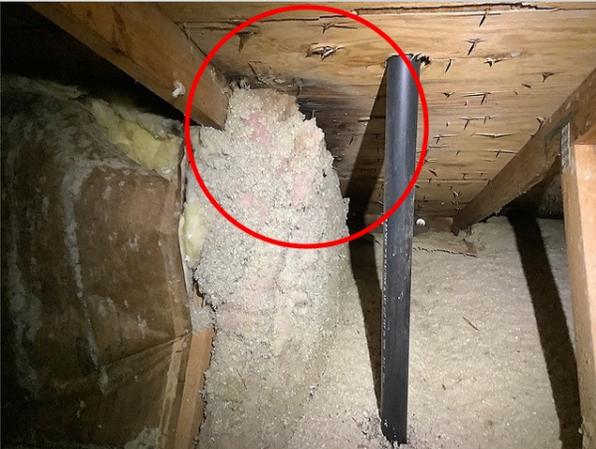
Photo 22

The roof has skylights. Water stains were visible at the time of the inspection. The roof sheathing in the attic appears to be black and from repeated water intrusion. The absence of staining is not necessarily conclusive proof that a skylight does not leak. Skylights in general have historically been problem areas for water intrusion, and whether or not signs of previous water intrusion were observed at the time of the inspection, the client should maintain vigilance for any water intrusion. If any is observed, the areas should be sealed and further assessed to prevent future water intrusion.

Sheathing in attic around skylight penetration

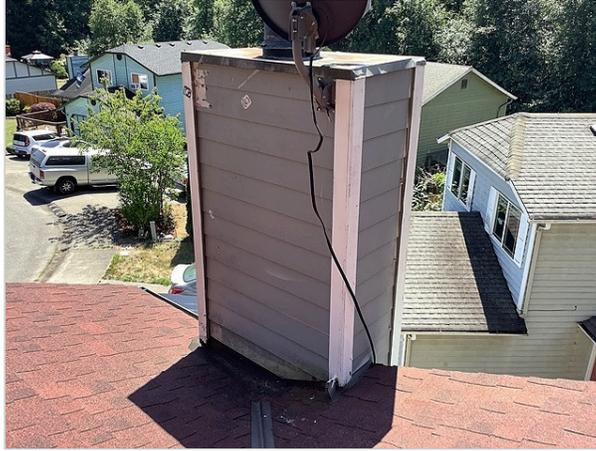
Photo 25

Exterior painted wood surfaces on the flu chase were moderately deteriorated. Wooden surfaces, particularly those exposed to the elements, should be repaired and refinished to prevent further deterioration and water intrusion.

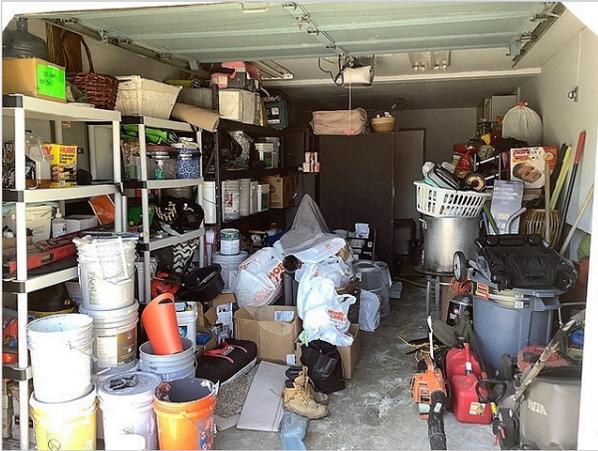
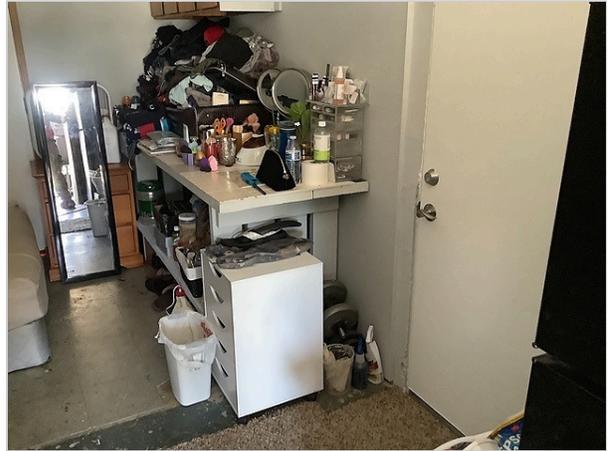
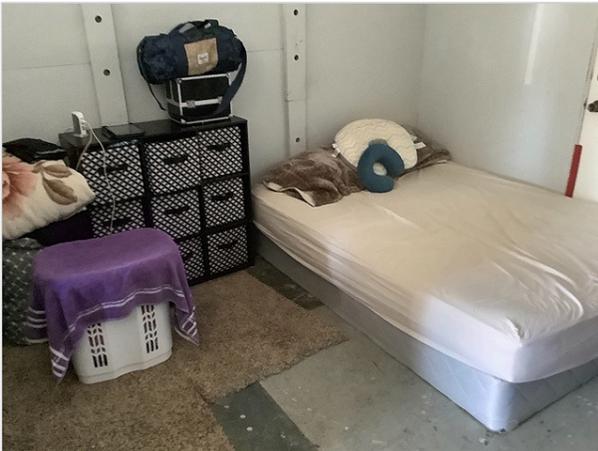
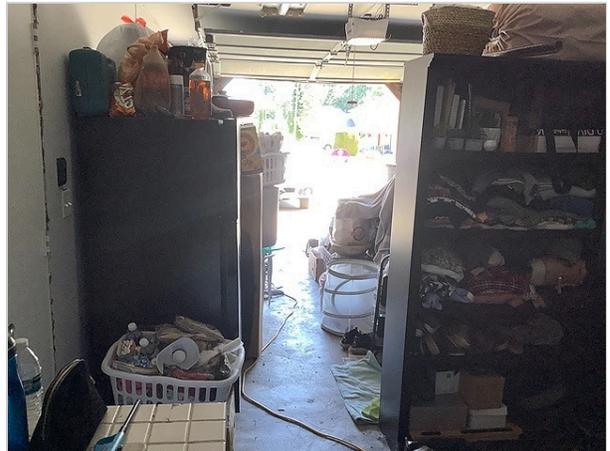
The garage was cluttered with many stored items and/or shelves at the time of inspection. The obstructed areas were not able to be visually inspected.

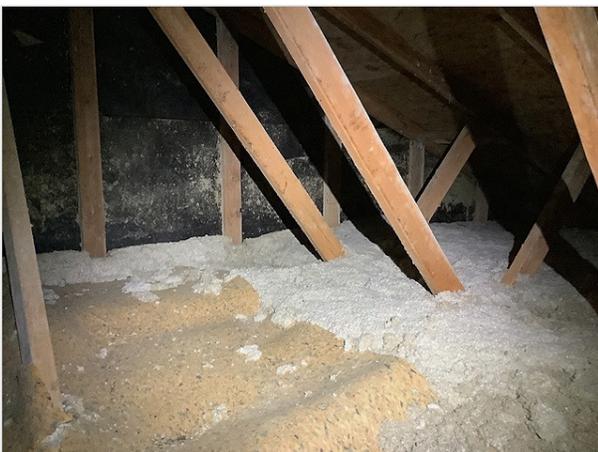
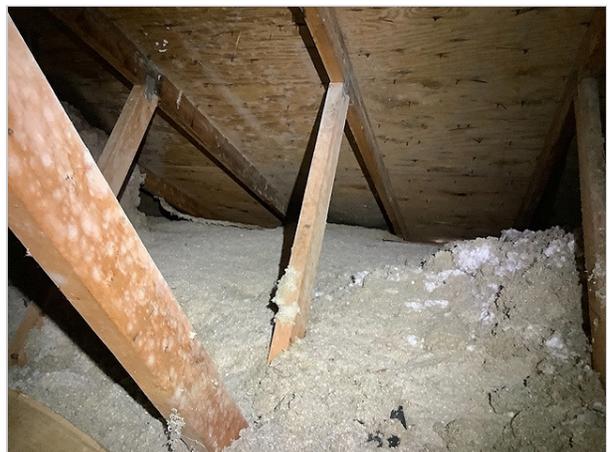
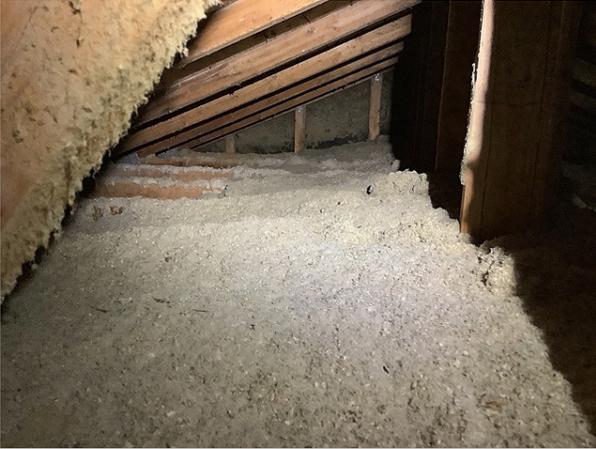
Parts of the attic show signs of previous water intrusion. The areas were dry at the time of the inspection. Multiple moisture readings were taken and reading were lol below 6% moisture content. The buyer should maintain vigilance in monitoring the areas for any recurrence of the previous issue and should rectify any issues immediately upon observing them.

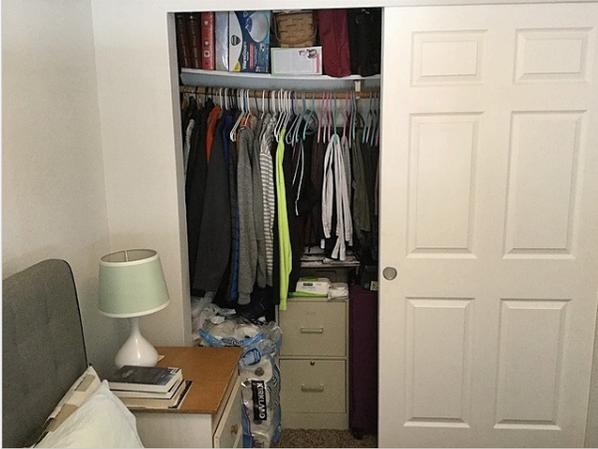
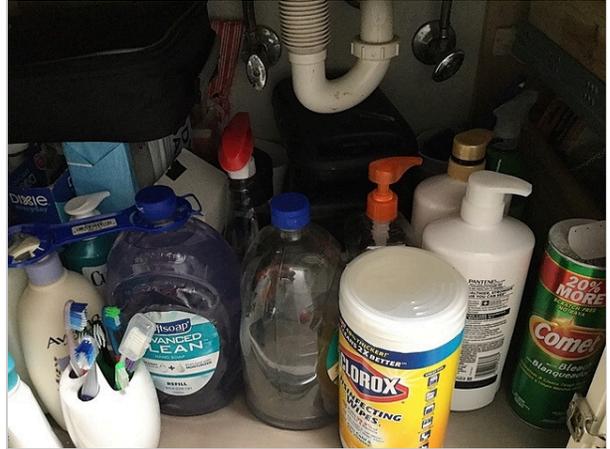
The closets and under sink cabinets cluttered with many stored items and/or shelves at the time of inspection. The obstructed areas were not able to be visually inspected.

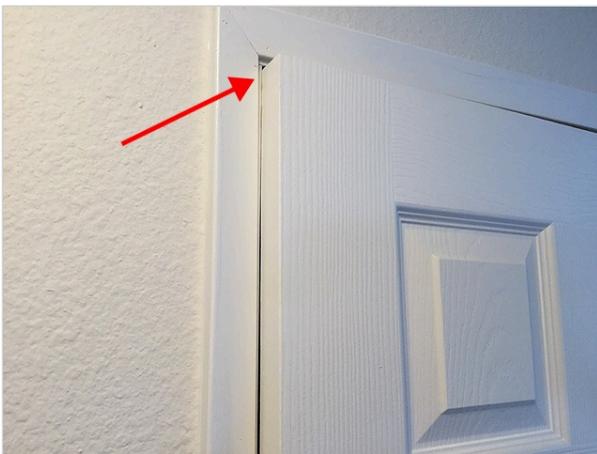
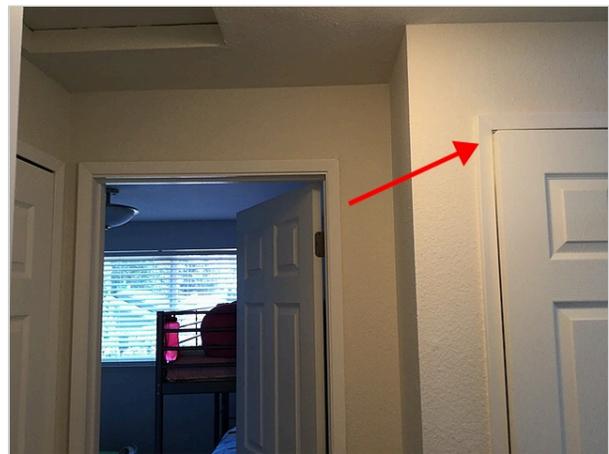
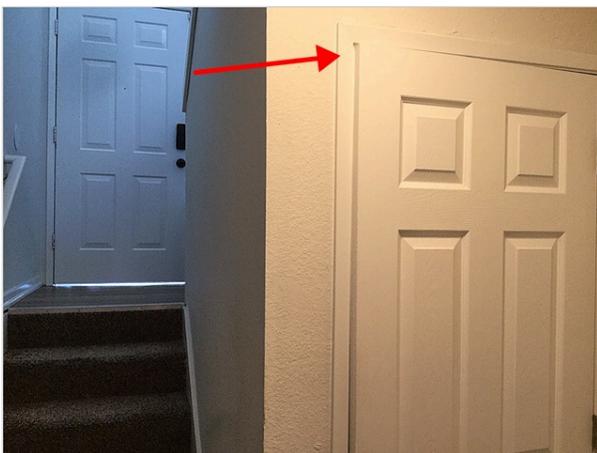
Multiple interior doors catch the door frame when closing. A door that rubs against the frame can either be from improper installation or swelling of the wood of the frame or the door on unpainted areas, such as the top of the door. Recommend sanding of the appropriate area and repainting all applicable services to ensure a thorough seal against moisture and future friction.

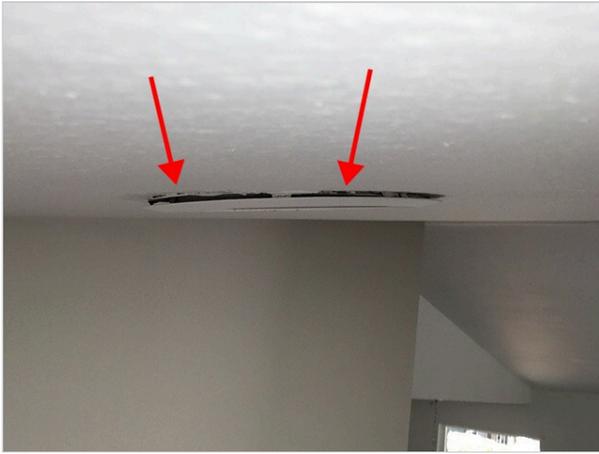
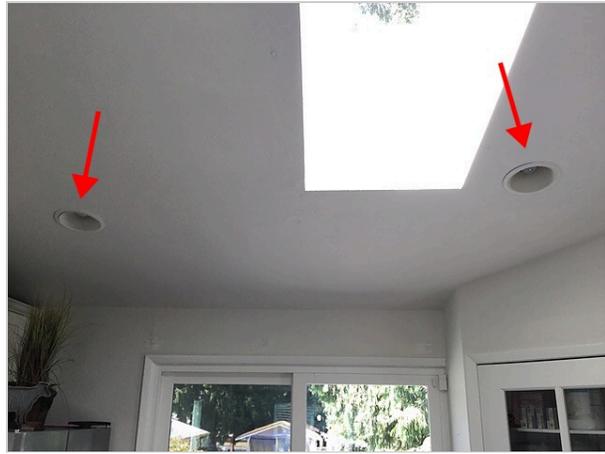
One or more recessed can lights was not flush to the ceiling. Can lights that are not flush can allow heat and moisture into undesirable areas of the home, such as the attic, which can result in moisture damage and pest highways. Recommend tightening as to prevent any air gaps.
