*HOME INSPECTION REPORT*

On Monday, March 31, 2025 The HomeTeam Inspection Service made a visual inspection of 123 Anywhere St., City, ST 12345. Enclosed please find a written, narrative report of our findings in accordance with the terms of our Inspection Agreement.

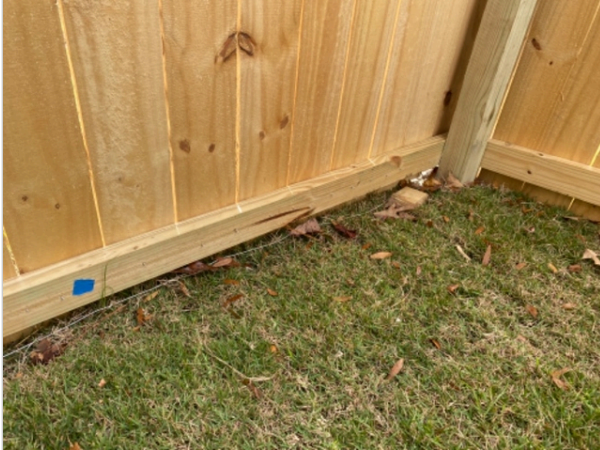
**Photo 9**

**The screws securing the bottom trim board on the right side privacy fence are sharp and longer than what is needed. Resulting in a safety hazard. They should be replaced with shorter screws.**

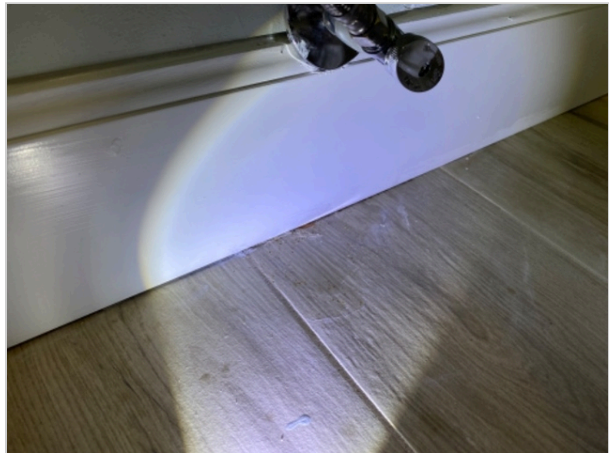
**Photo 44**

Leaks were observed at the toilet shut off in the Jack and Jill bathroom when in use. The tub and sink in the hall bathroom drain slowly. A licensed plumbing company should be called to evaluate the system and make any repairs.

The Jack and Jill toilet shut off is leaking.
